Vibration Monitoring Assessment Report (June 2020)

Tweed Valley Hospital Project, Kingscliff NSW

Prepared for: Delta Group

DLT-01-Q1013 / VIB11 / v1f
10th July 2020

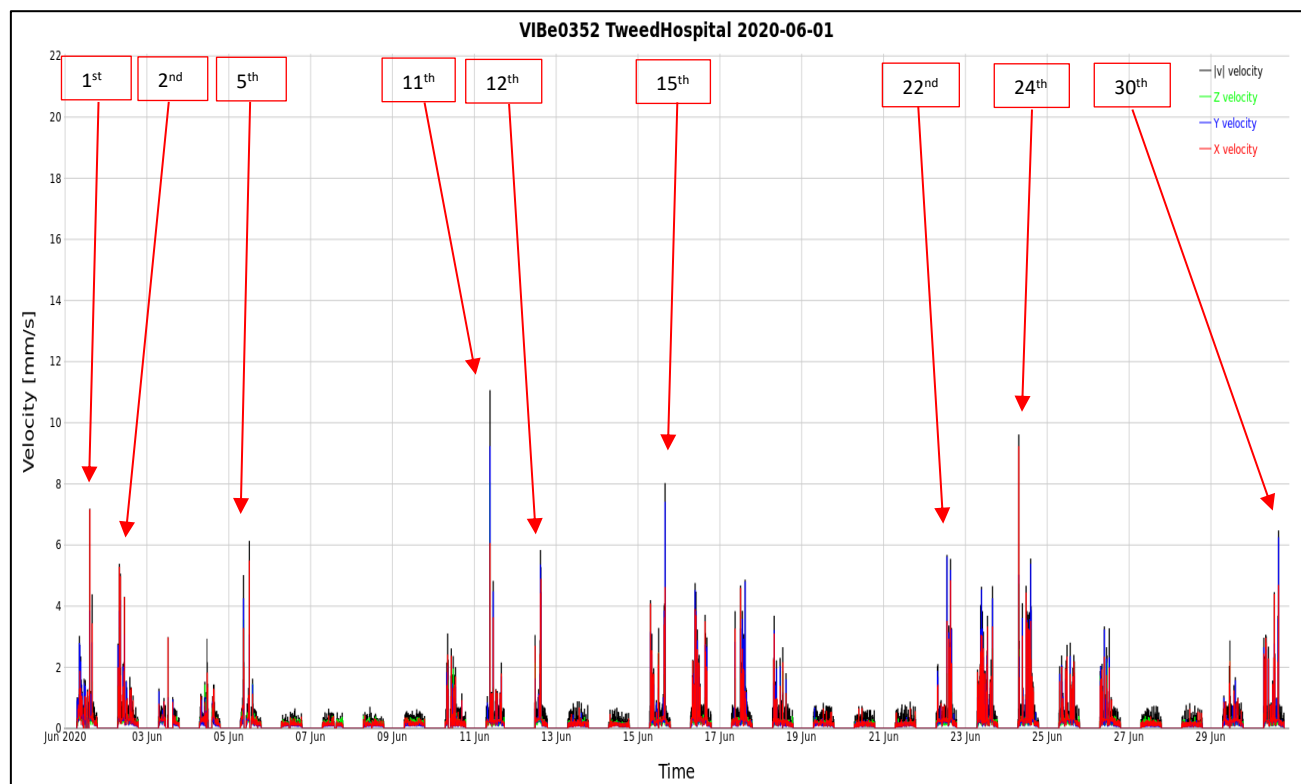
- Location 001 (Figure 1):
 - June 1st, 2nd, 5th, 11th, 12th, 15th, 22nd, 24th and 30th
- Location 002 (Figure 2):
 - June 18th
- Location 003 (Figure 3):
 - June 3rd

Figure 1. Results of the vibration monitoring from 1st – 30th June 2020 at monitoring location 001 – Adjacent carpark.

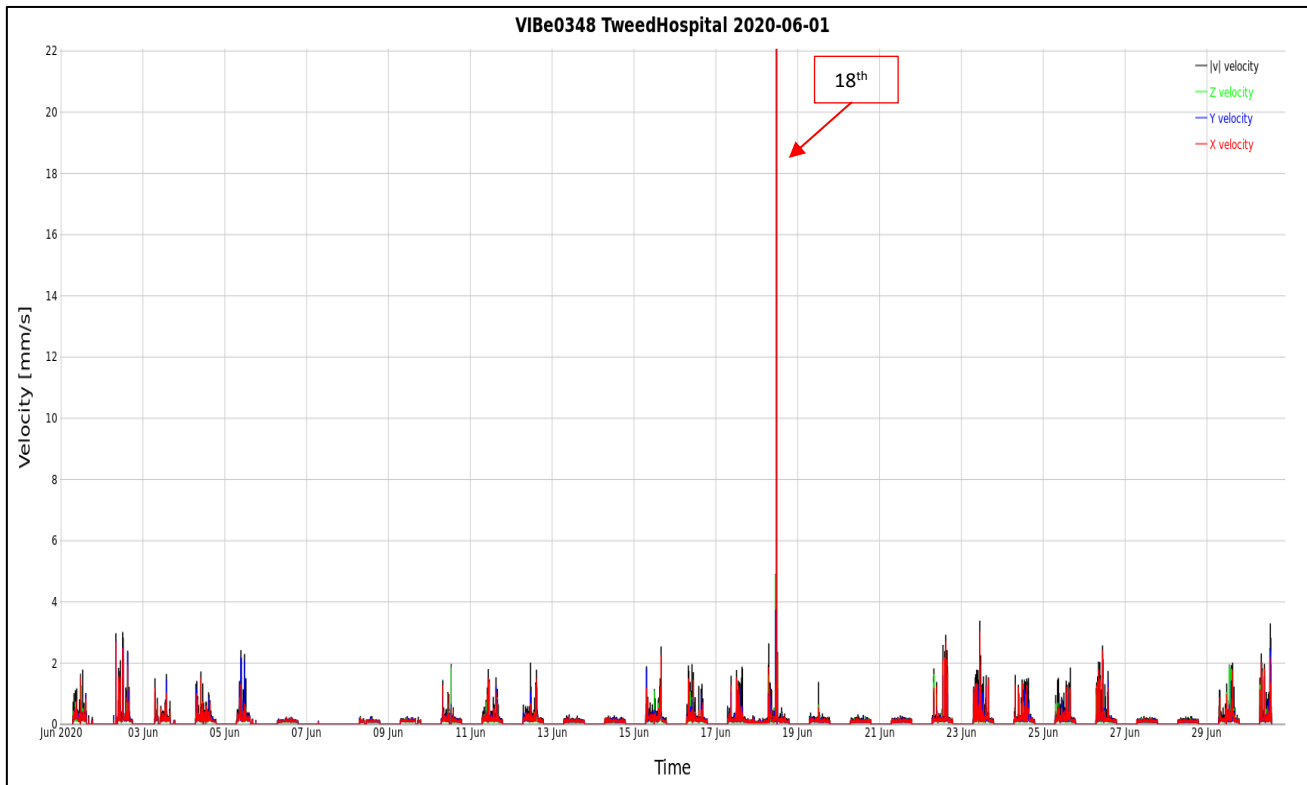
Figure 2. Results of the vibration monitoring from 1st – 30th June 2020 at monitoring location 002 – Central monitor.

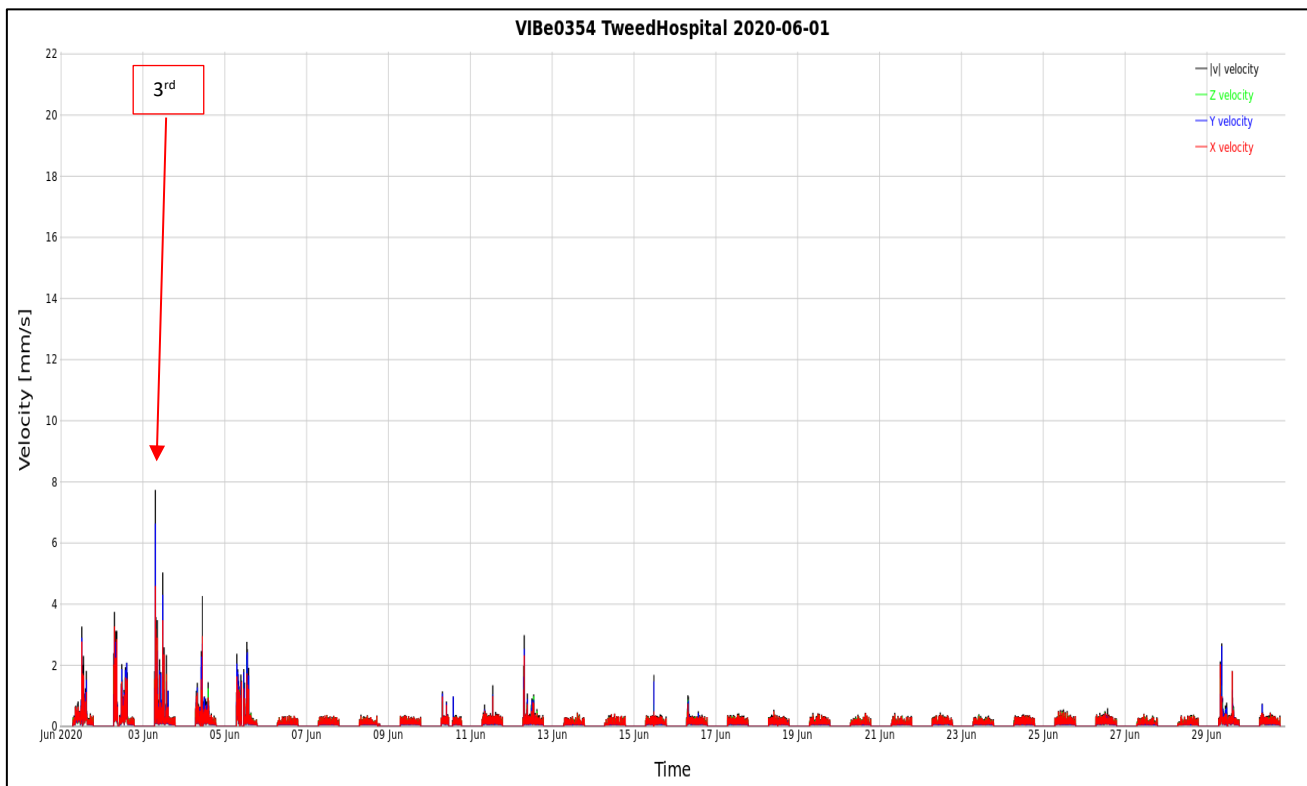
Figure 3. Results of the vibration monitoring from 1st – 30th June 2020 at monitoring location 003 – Eastern section of site.

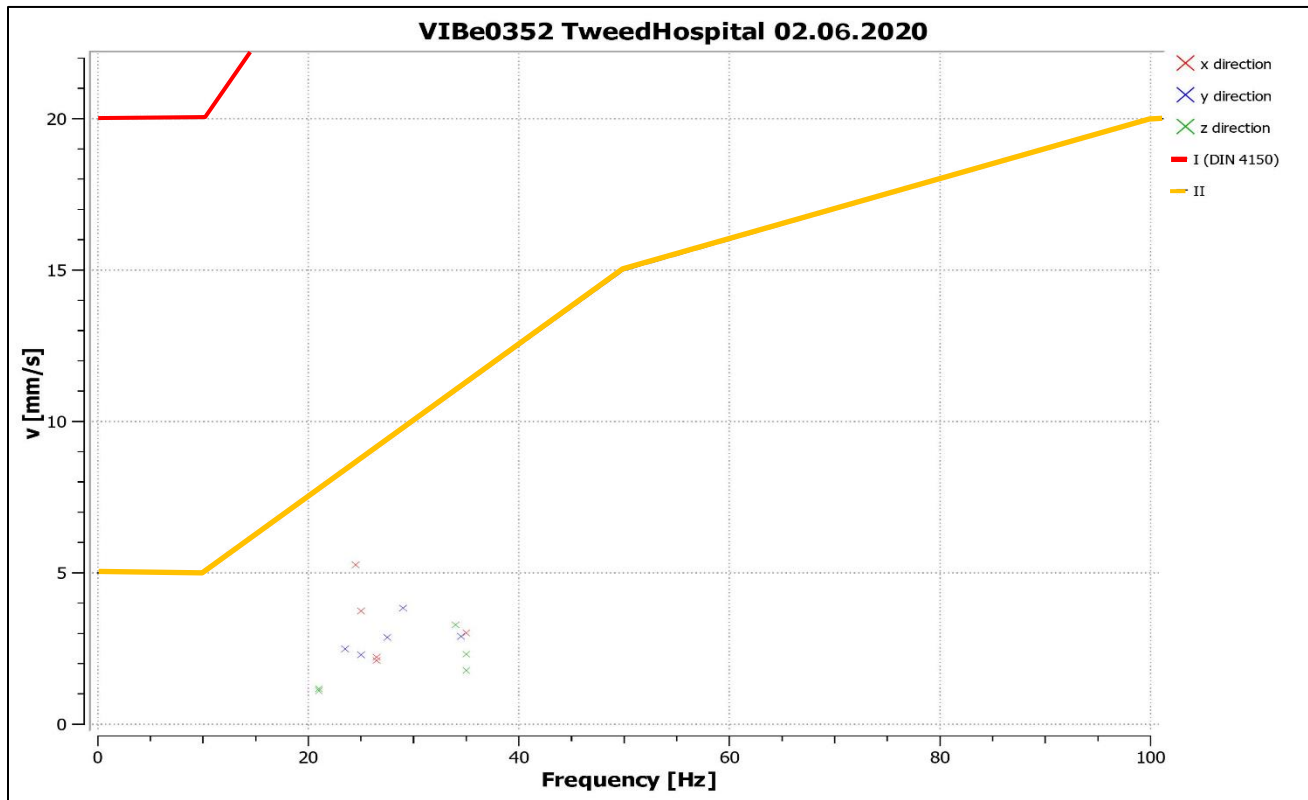
Figure 4. Results of the exceedance on Tuesday 2nd June 2020 at monitoring location 001 – Adjacent carpark.

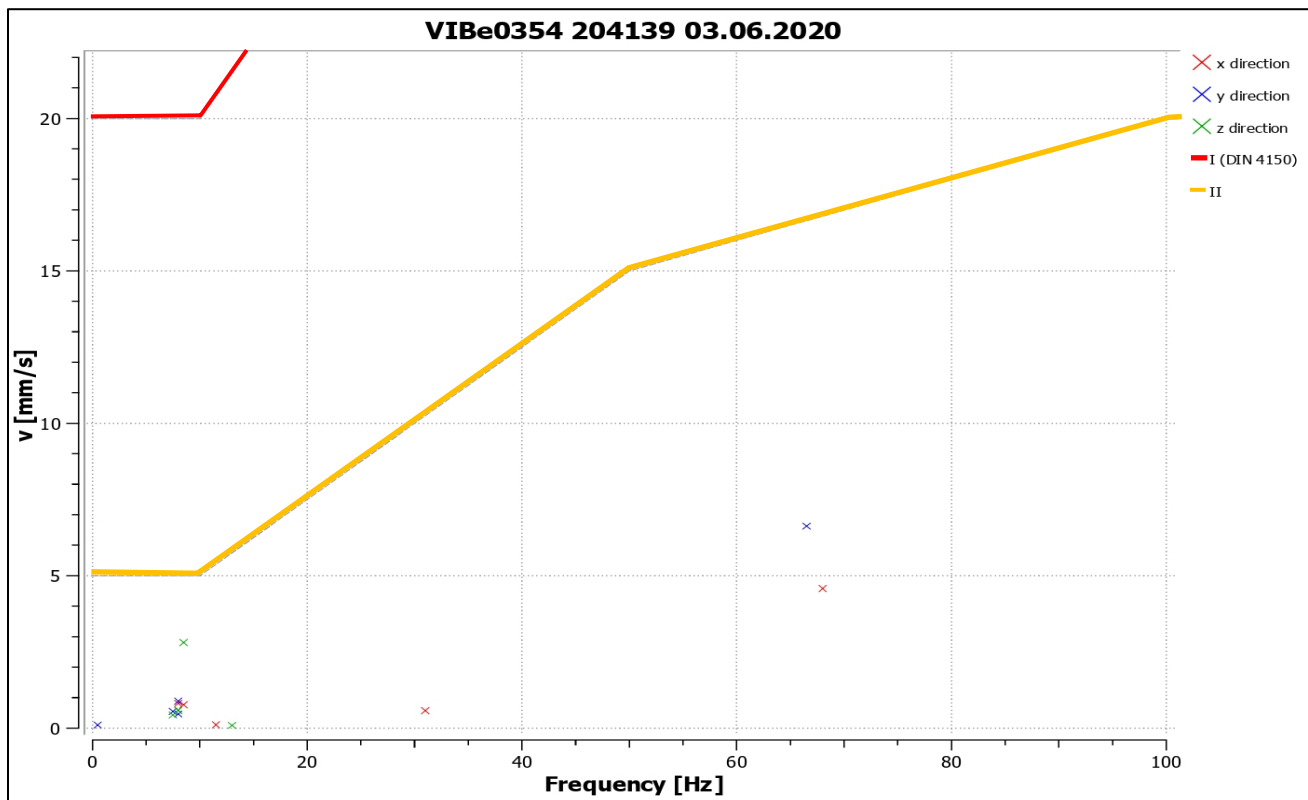
Figure 5. Results of the exceedance on Wednesday 3rd June 2020 at monitoring location 003 – Eastern Section of Site.

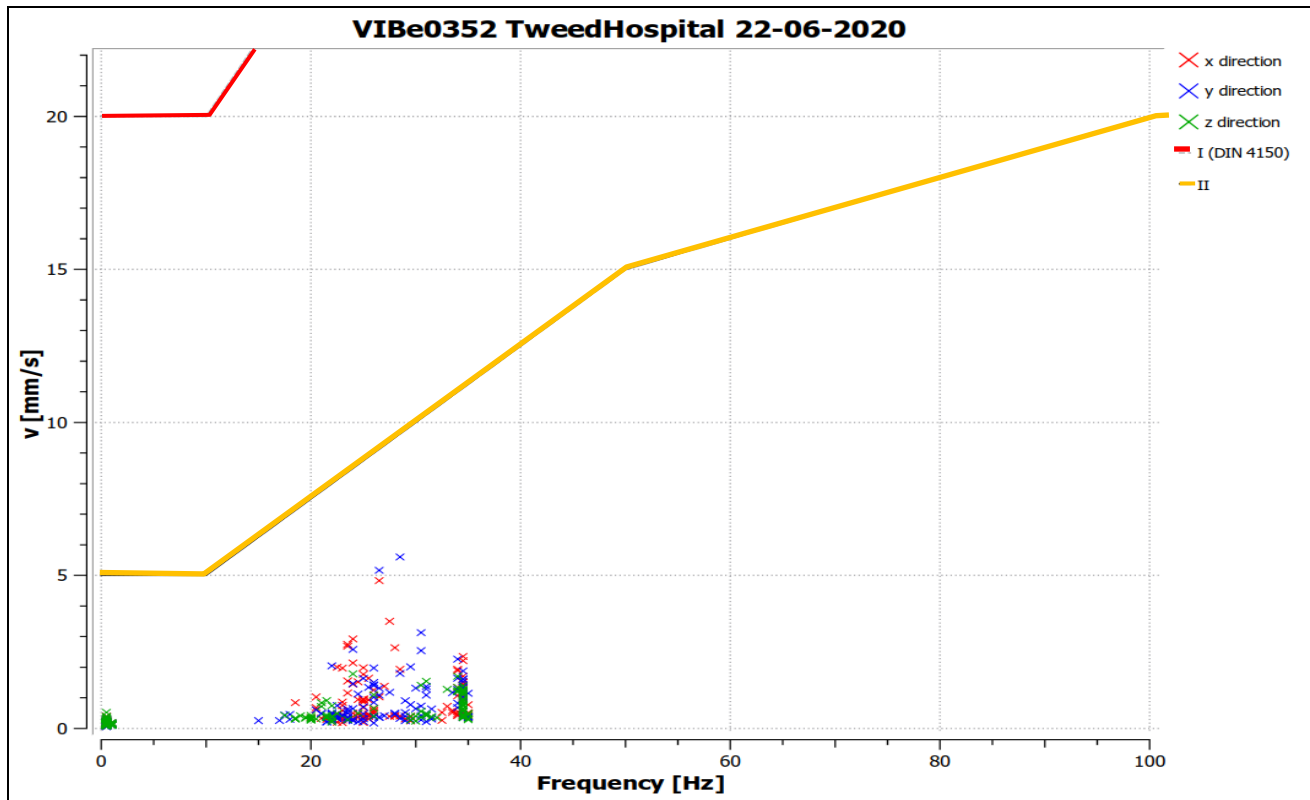
Figure 8. Results of the exceedance on Monday 22nd June 2020 at monitoring location 001 – Adjacent carpark.

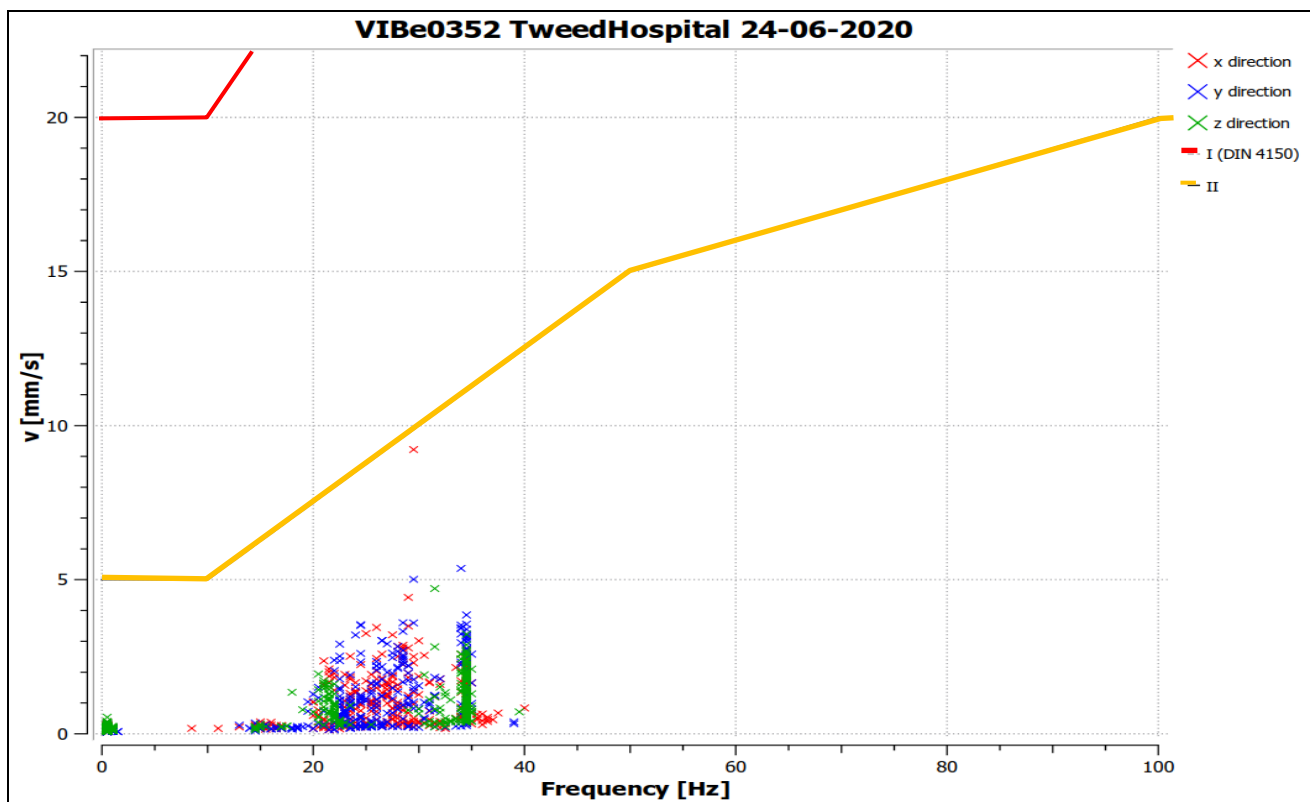
Figure 9. Results of the exceedance on Wednesday 24th June 2020 at monitoring location 001 – Adjacent carpark.

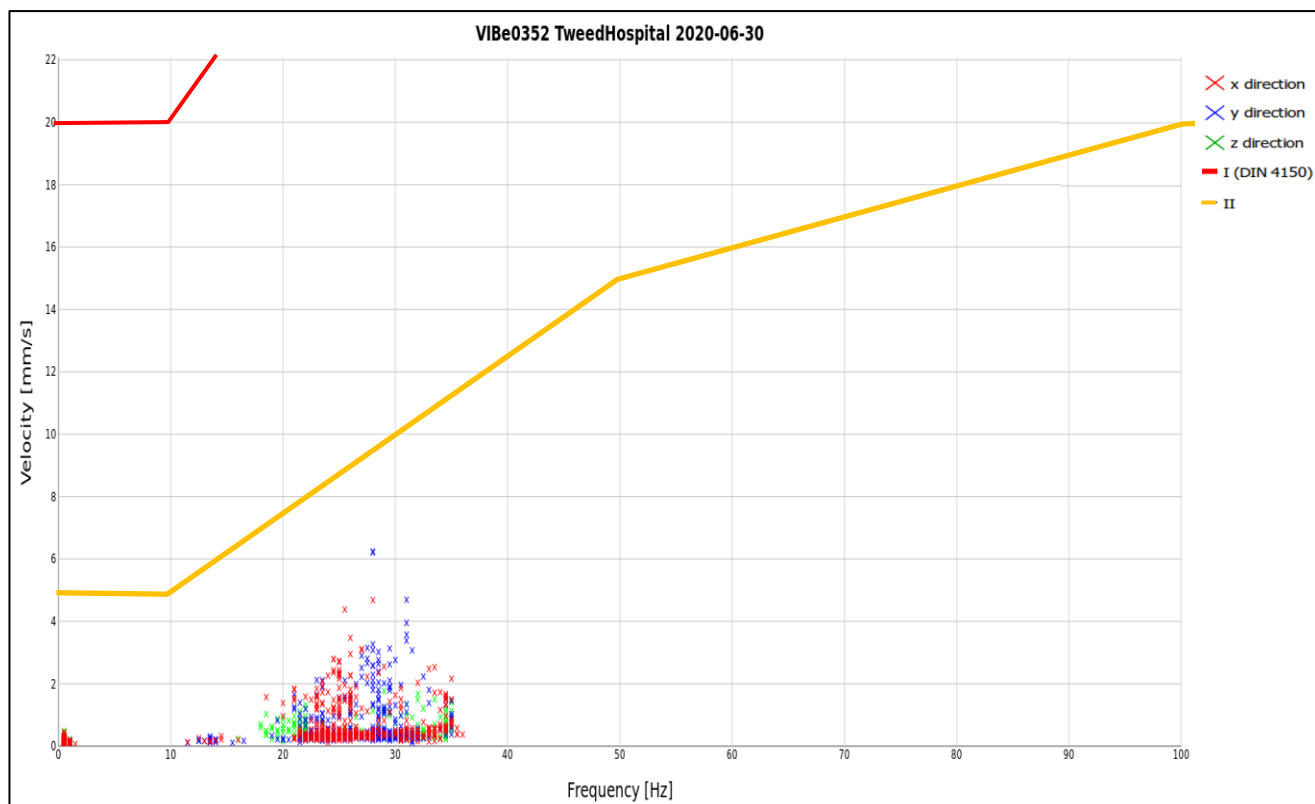
Figure 10. Results of the exceedance on Tuesday 30th June 2020 at monitoring location 001 – Adjacent carpark.
