Vibration Monitoring Assessment Report (August 2020)

Tweed Valley Hospital Project, Kingscliff NSW

Prepared for: Delta Group

DLT-01-Q1013 | VIB13.V1F | Date: 04/09/2020

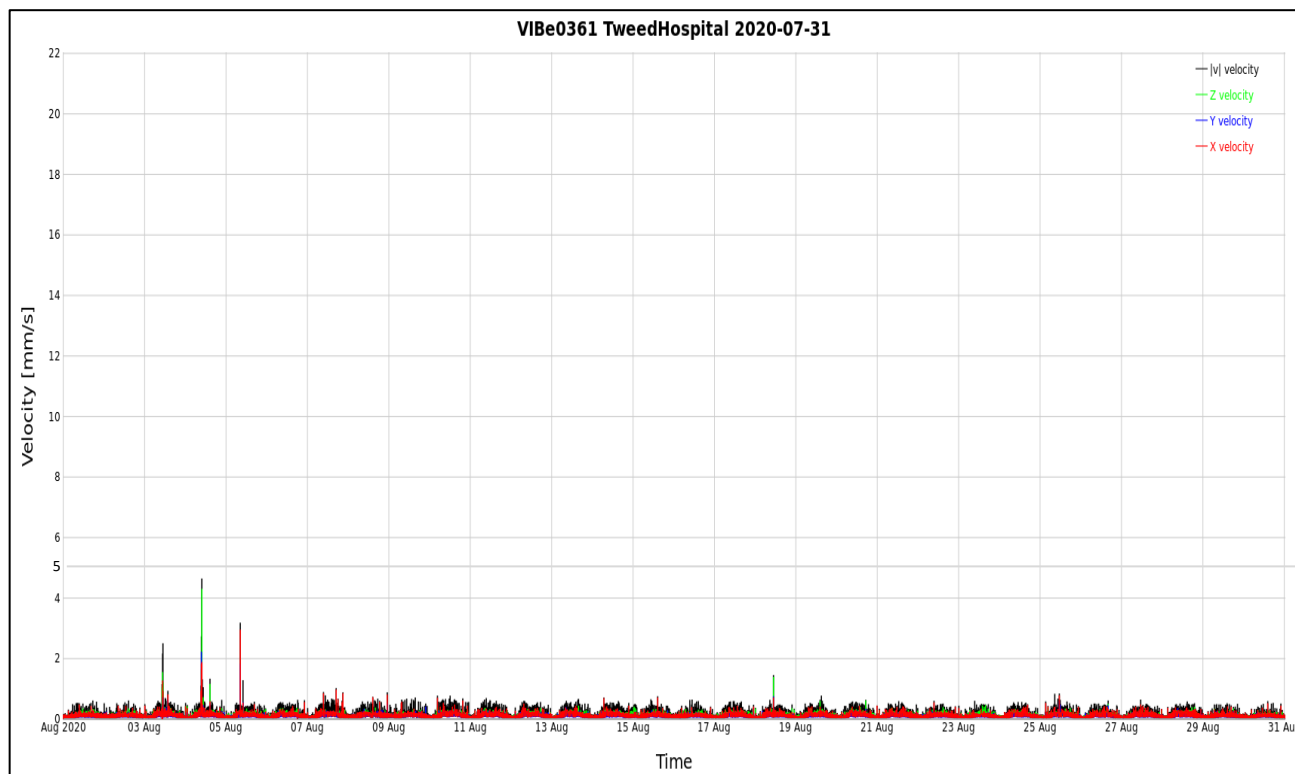
Figure 1. Results of the vibration monitoring from 1st – 31st August 2020 at monitoring location 001 – Adjacent carpark.

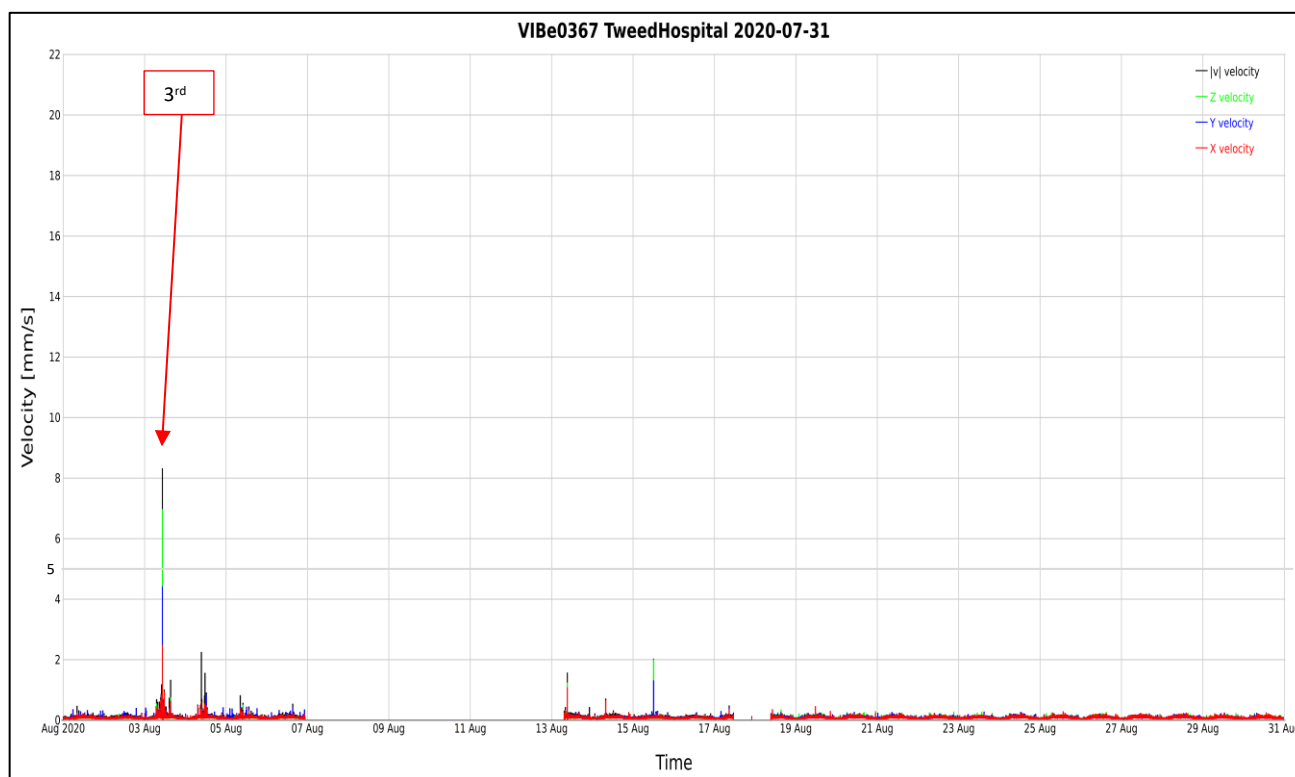
- Location 002
 - 3rd of August.

ADE notes that values >5mm/s recorded at on the 3rd, 13th and 18th of August coincide with ADE site visits (refer to **Appendix III – ADE Site Time Summary**). ADE visits to monitor the instruments caused false readings not related to construction works and therefore have been omitted from the report.

Monitor 002 experienced issues uploading to the telemetry on 06/08/2020 @ 1459, see timeline of ADEs actions below:

- Thursday 13/08/2020 – ADE attends site to rectify the issue with the vibration monitor. Data upload incomplete, the issue at hand which was presumed to be similar to previous issues (i.e. modem/signalling), was not the result of the telemetry cutting out. When ADE connected to the vibration monitor today it was observed that the monitor had continually switched off/on between the 11th-13th which was a result of a battery error. Rationale for this is still unknown. Data loss recorded from 7th-12th August 2020 (4 business/working days in total).

Figure 2. Results of the vibration monitoring from 1st – 31st August 2020 at monitoring location 002 – Central monitor.

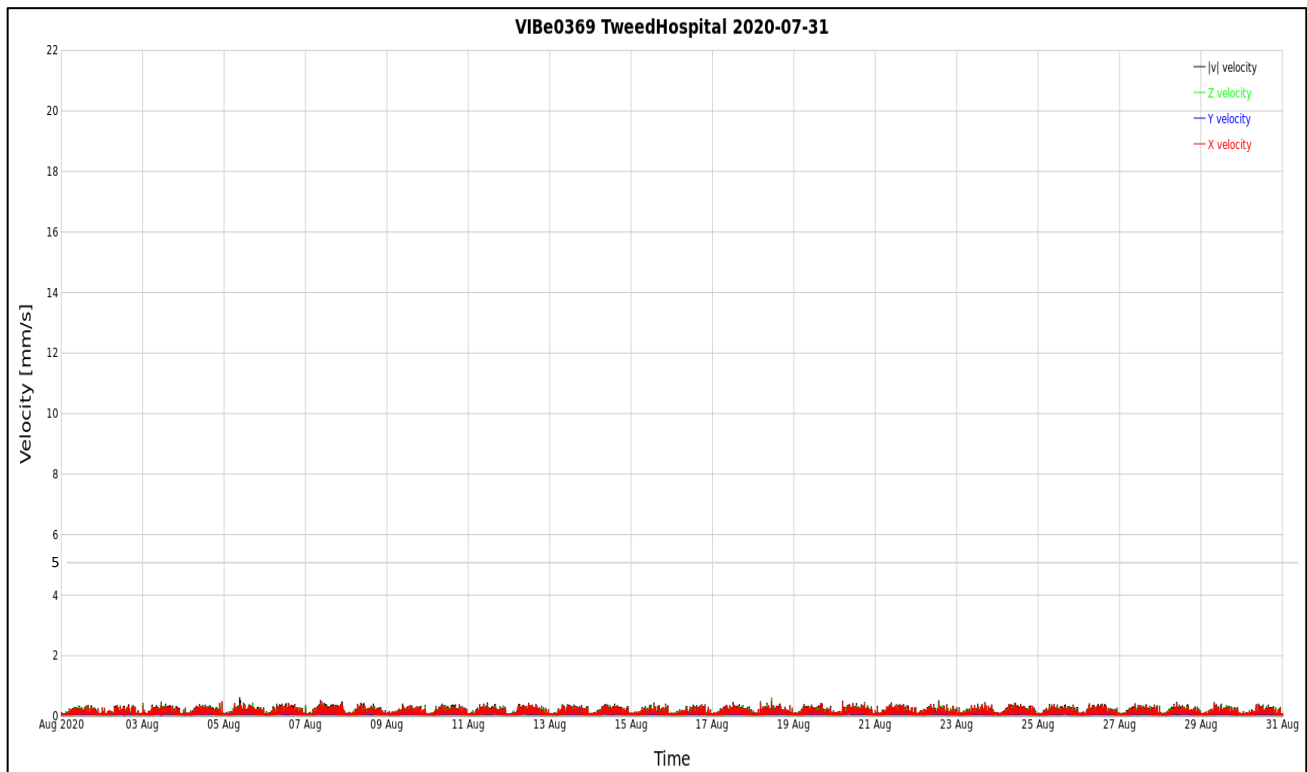
Figure 3. Results of the vibration monitoring from 1st – 31st August 2020 at monitoring location 003 – Eastern section.
