# Vibration Monitoring Assessment Report (March 2020)

771 Cudgen Road, Kingscliff NSW

Prepared for: Delta Group

DLT-01-Q1013 / VIB8 / v1.4f  
24<sup>th</sup> June 2020

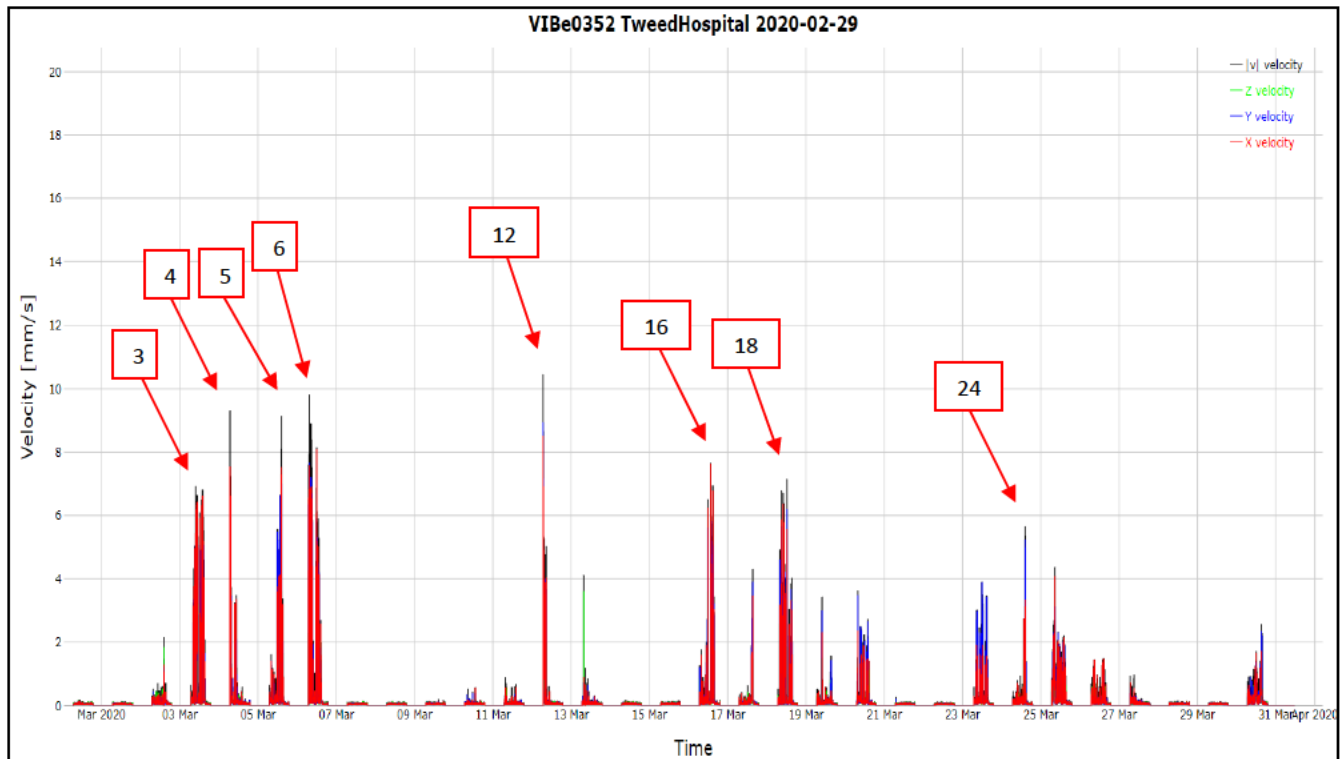
**Figure 2.** Results of the vibration monitoring from Sunday 1<sup>st</sup> March 2020 to Tuesday 31<sup>st</sup> March 2020 at monitoring location 001 – Adjacent carpark.

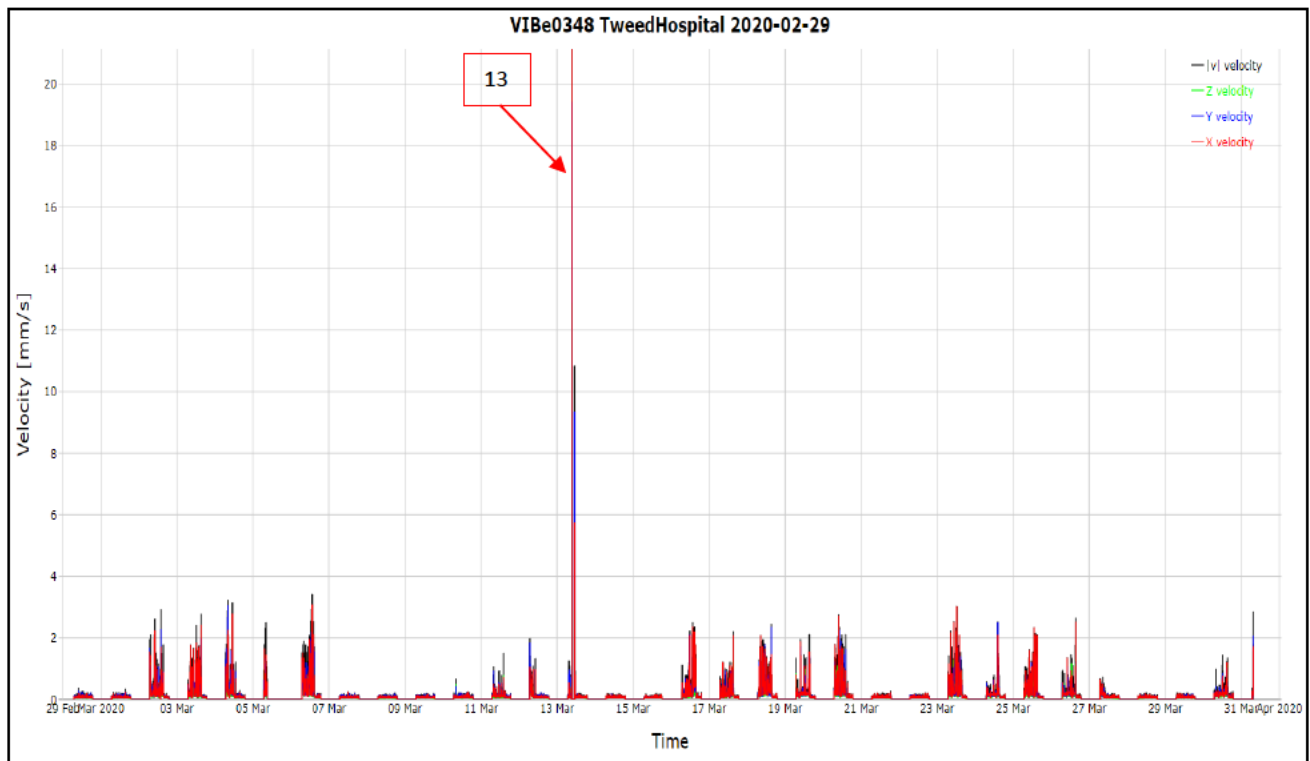
**Figure 3.** Results of the vibration monitoring from Sunday 1<sup>st</sup> March 2020 to Tuesday 31<sup>st</sup> March 2020 at monitoring location 002 – Central monitor.

Vibration values >5mm/s on the 13<sup>th</sup> of March 2020 at monitoring location 002 were caused by ADE performing maintenance on the monitors and are not due to construction works. All other values are below Line 1 and Line 2.

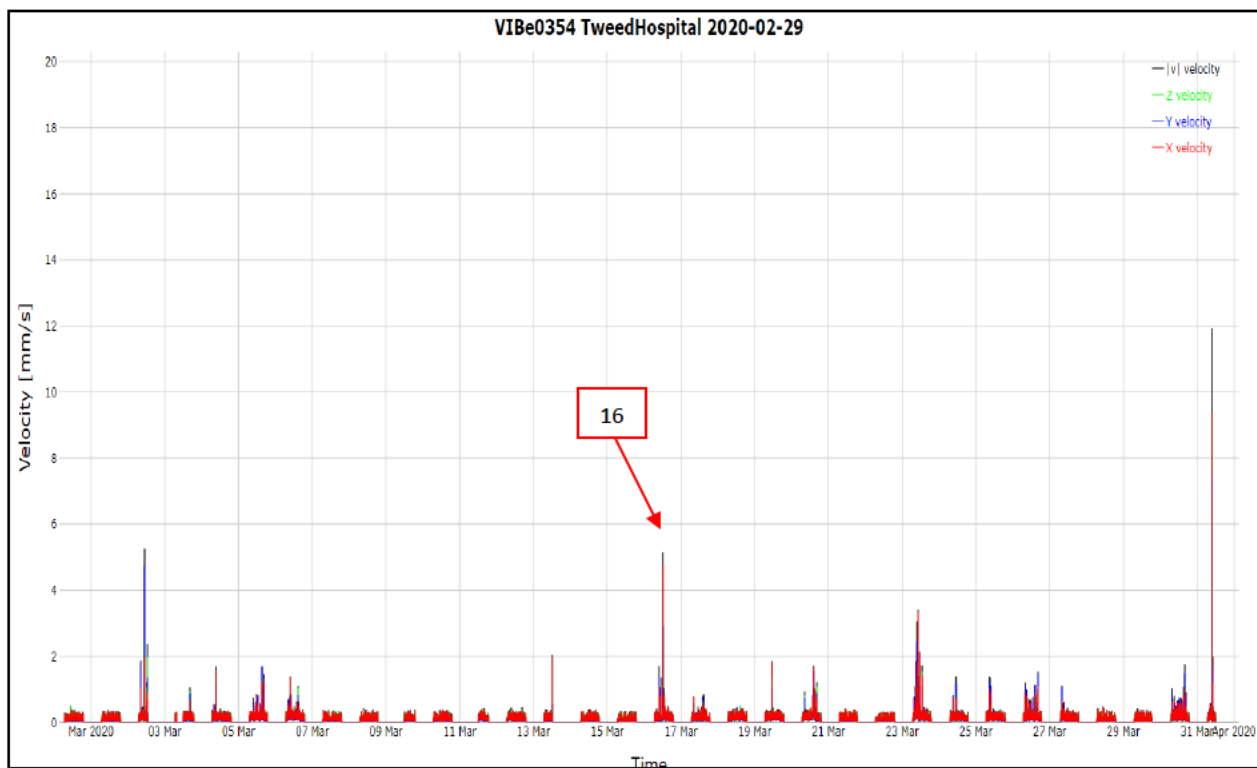
**Figure 4.** Results of the vibration monitoring from Sunday 1<sup>st</sup> March 2020 to Tuesday 31<sup>st</sup> March 2020 at monitoring location 003 – Eastern section of site.

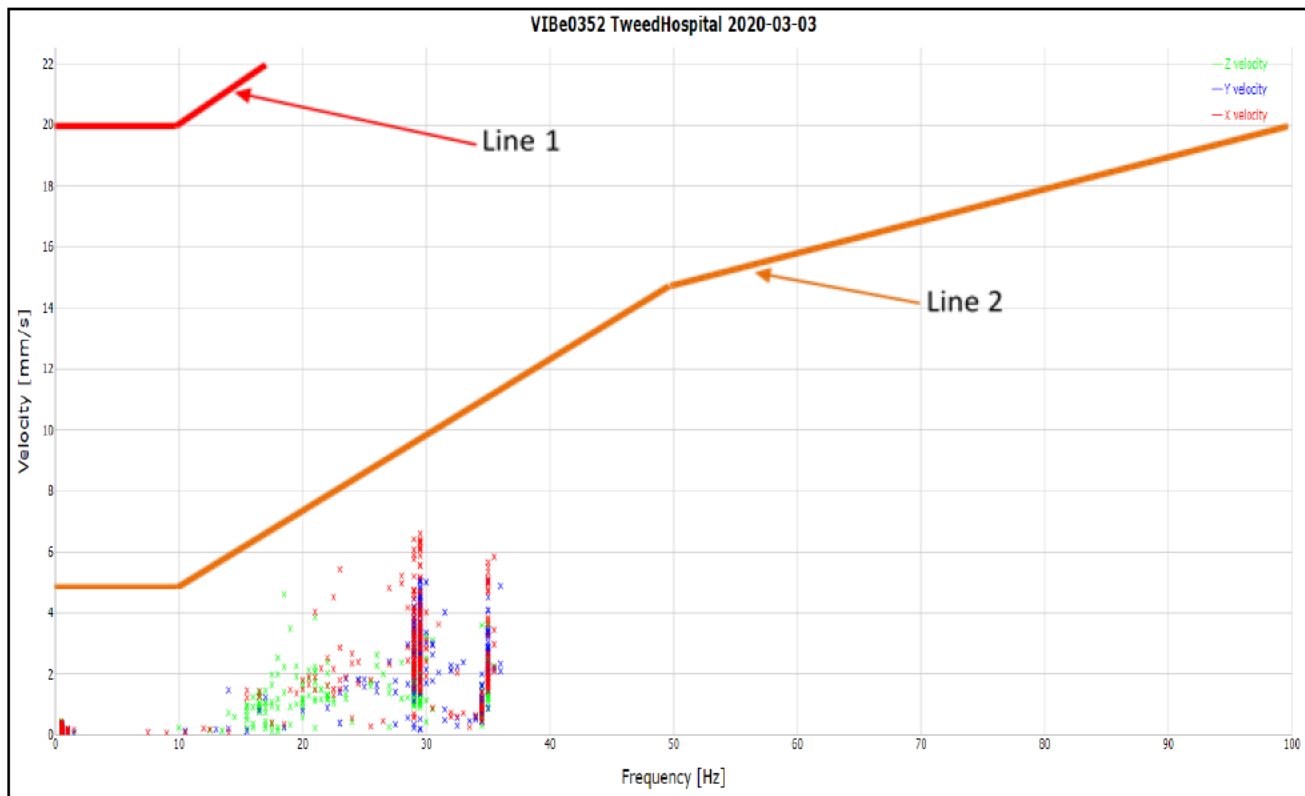
**Figure 5. Results of the exceedance on Tuesday 3<sup>rd</sup> March 2020 at monitoring location 001 – adjacent carpark monitor.**

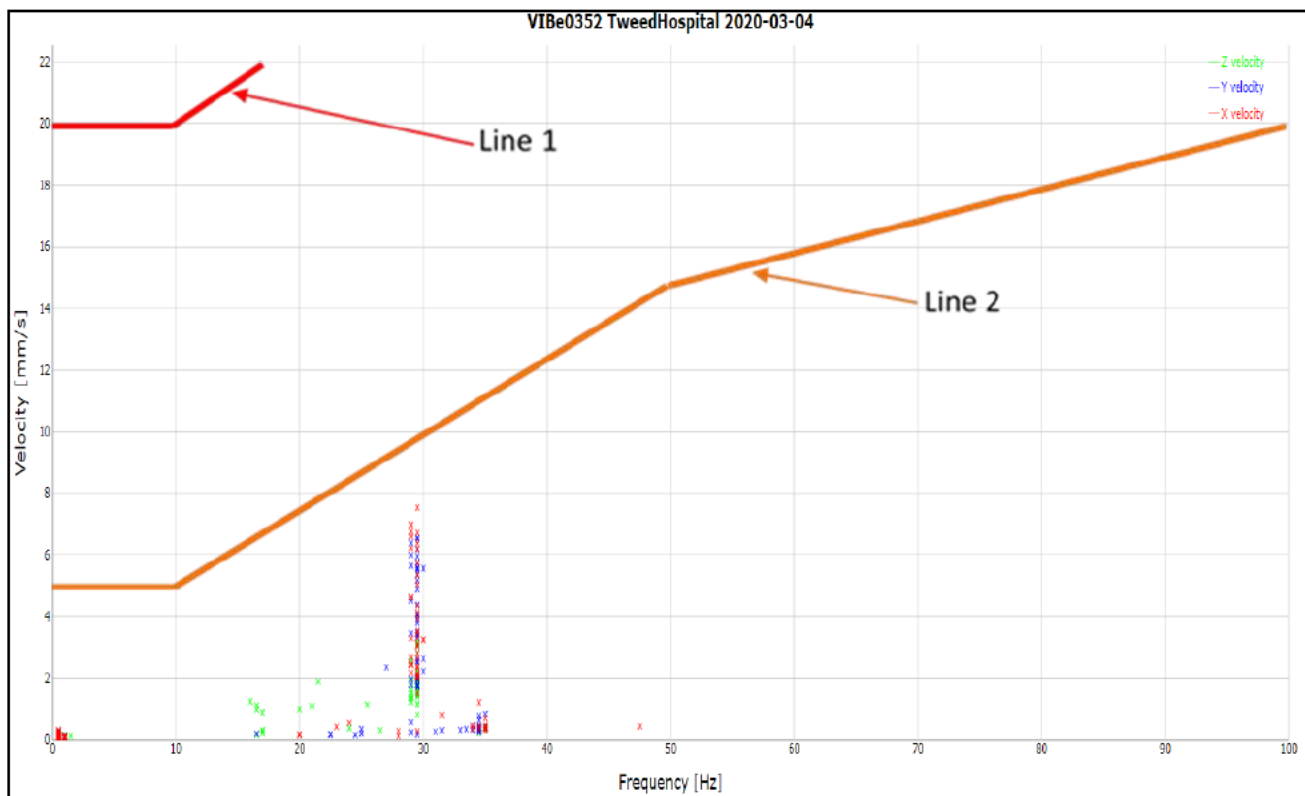
**Figure 6. Results of the exceedance on Wednesday 4<sup>th</sup> March 2020 at monitoring location 001 – adjacent carpark monitor.**

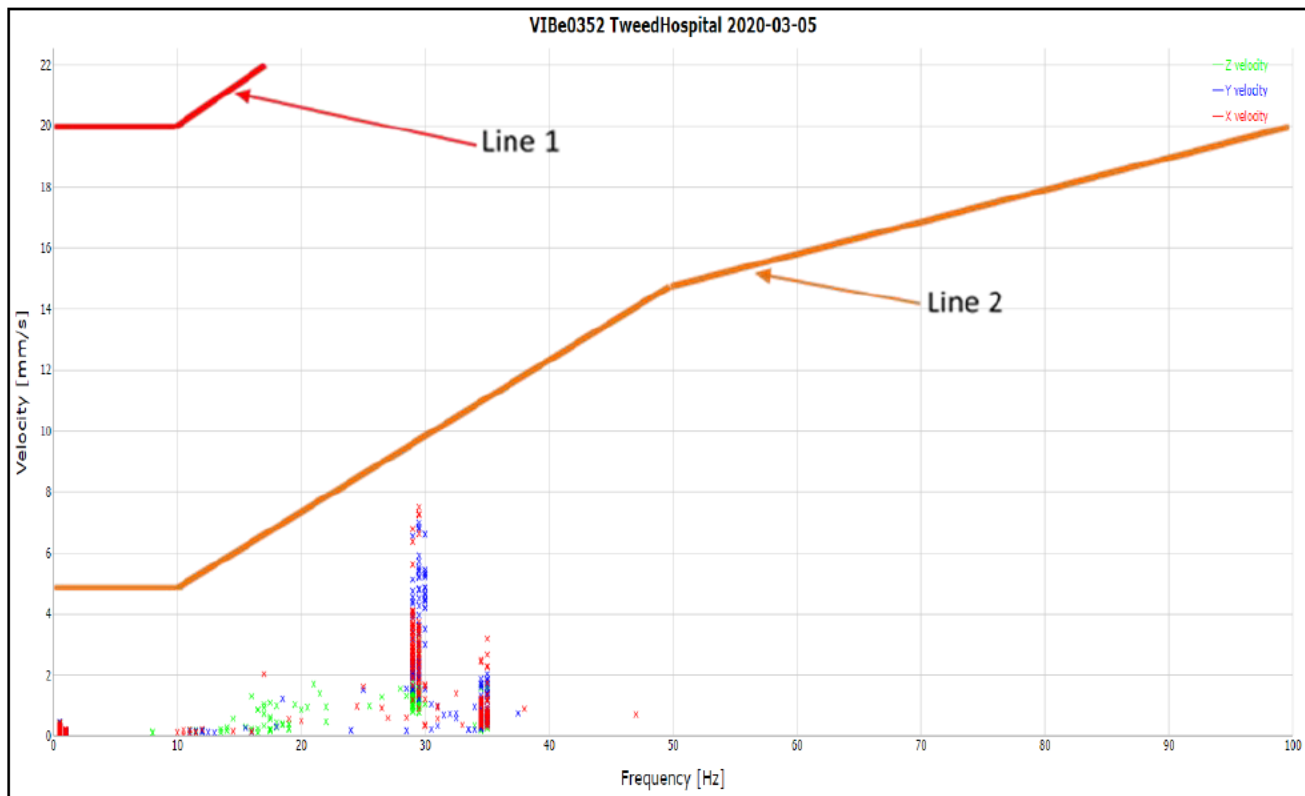
**Figure 7.** Results of the exceedance on Thursday 5<sup>th</sup> March 2020 at monitoring location 001 – adjacent carpark monitor.

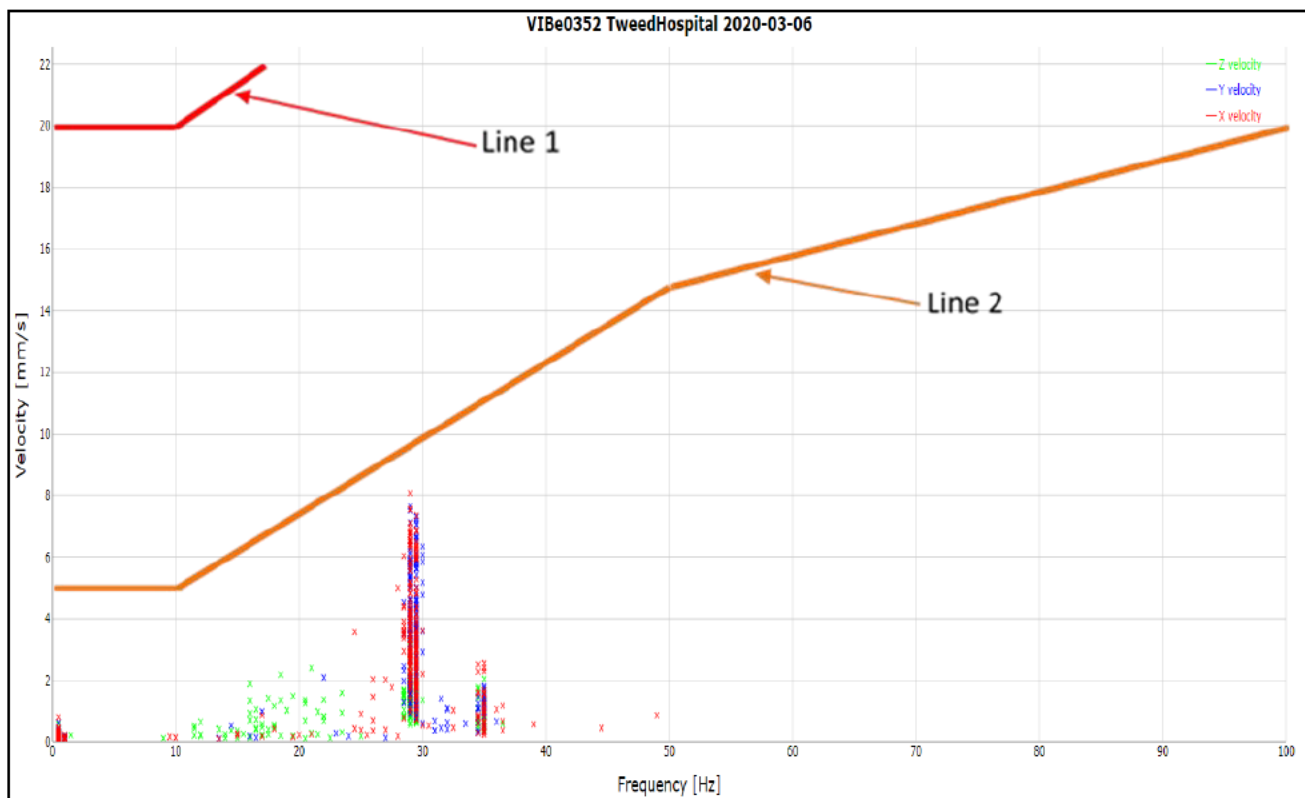
**Figure 8.** Results of the exceedance on Friday 6<sup>th</sup> March 2020 at monitoring location 001 – adjacent carpark monitor.

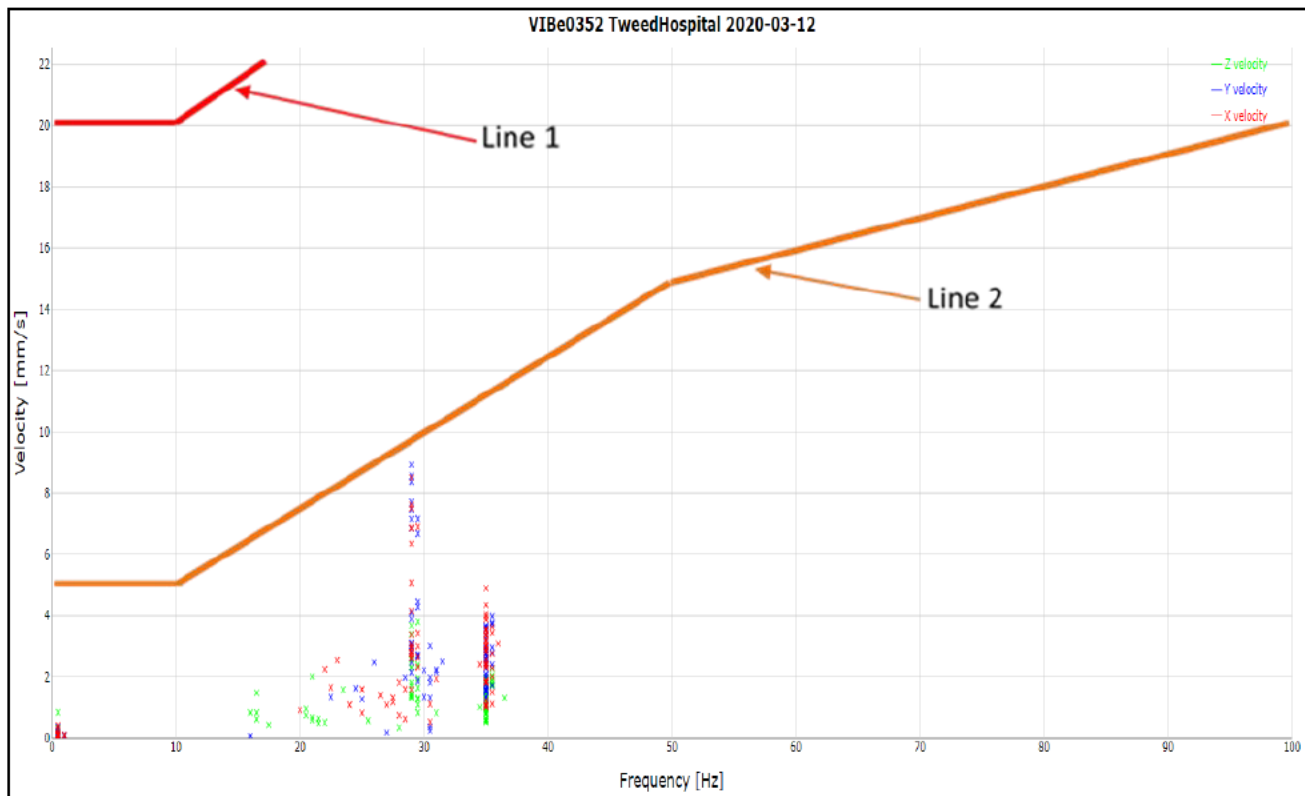
**Figure 9.** Results of the exceedance on Thursday 12<sup>th</sup> March 2020 at monitoring location 001 – adjacent carpark monitor.

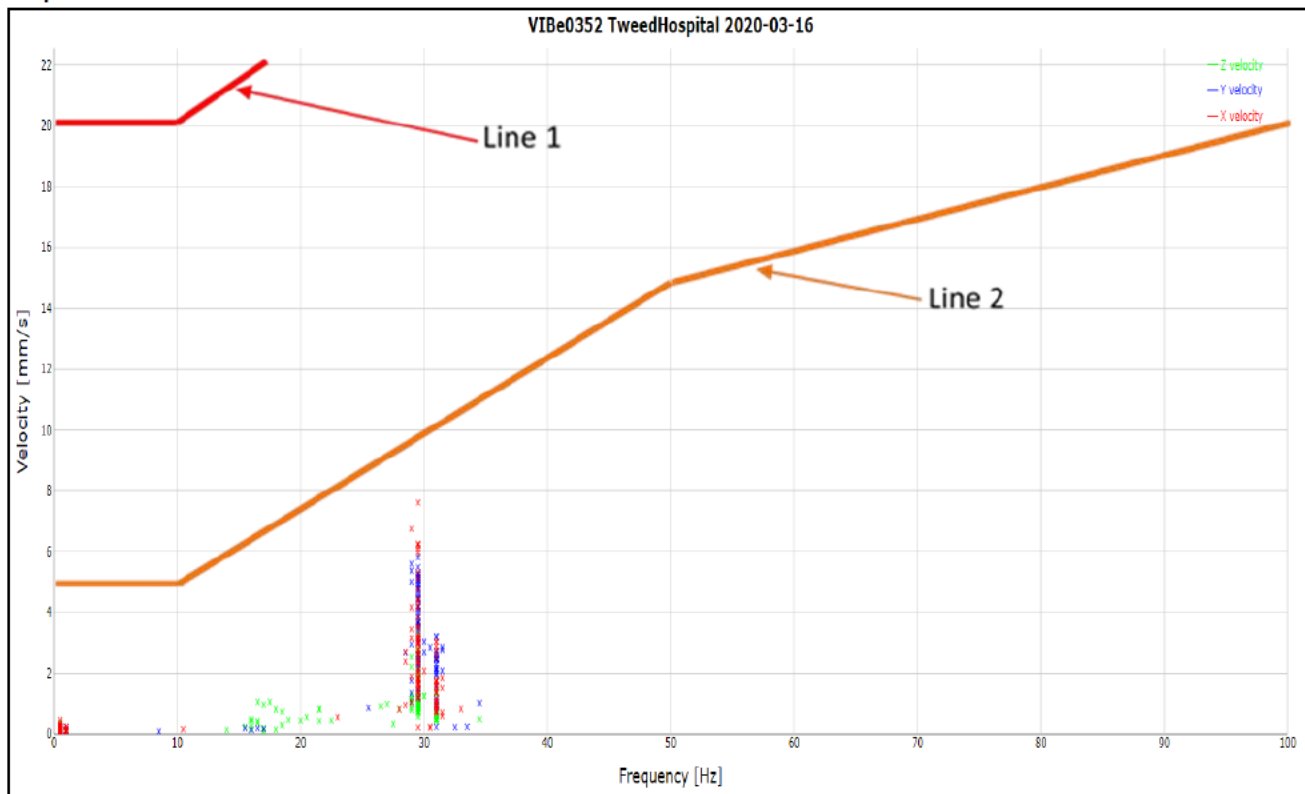
**Figure 10.** Results of the exceedance on Monday 16<sup>th</sup> March at monitoring location 001 – adjacent carpark monitor.

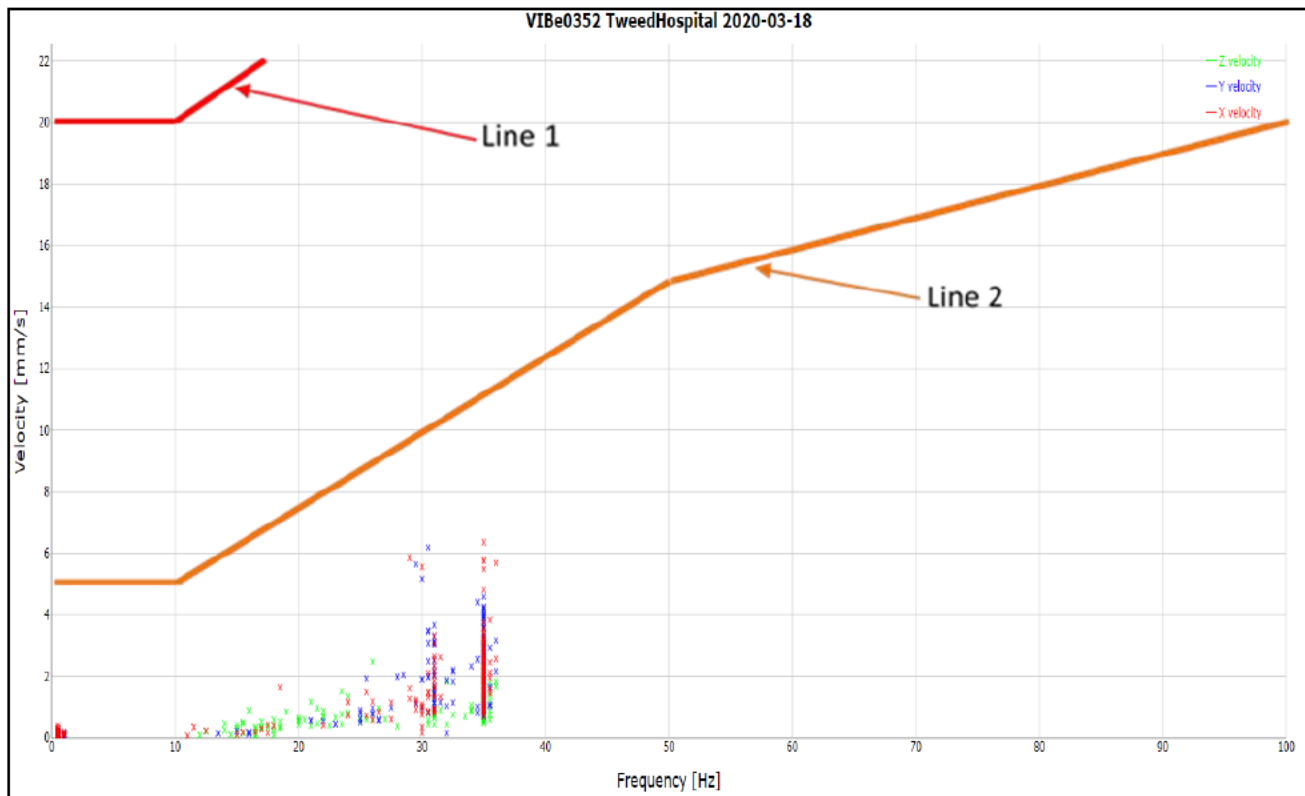
**Figure 11.** Results of the exceedance on Wednesday 18<sup>th</sup> March at monitoring location 001 – adjacent carpark monitor.

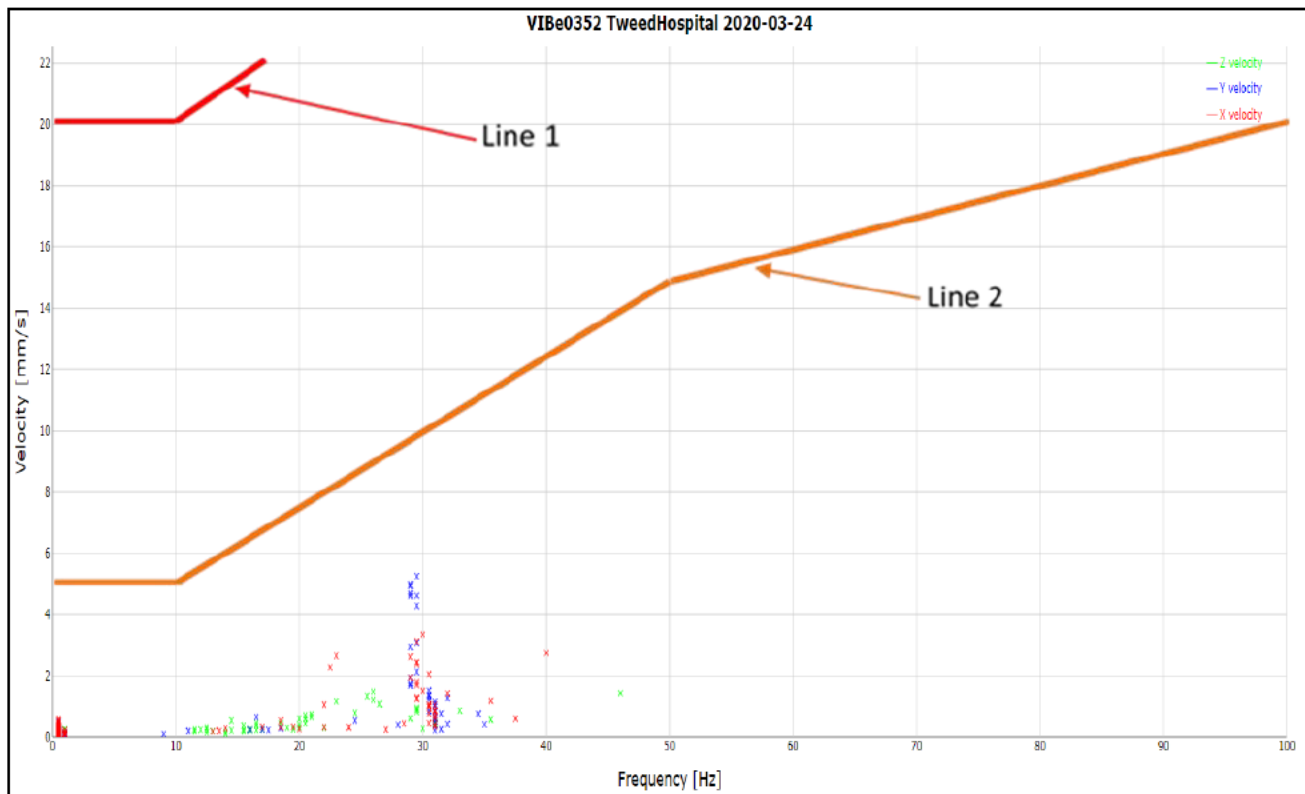
**Figure 12.** Results of the exceedance on Friday 24<sup>th</sup> March at monitoring location 001 – adjacent carpark monitor.

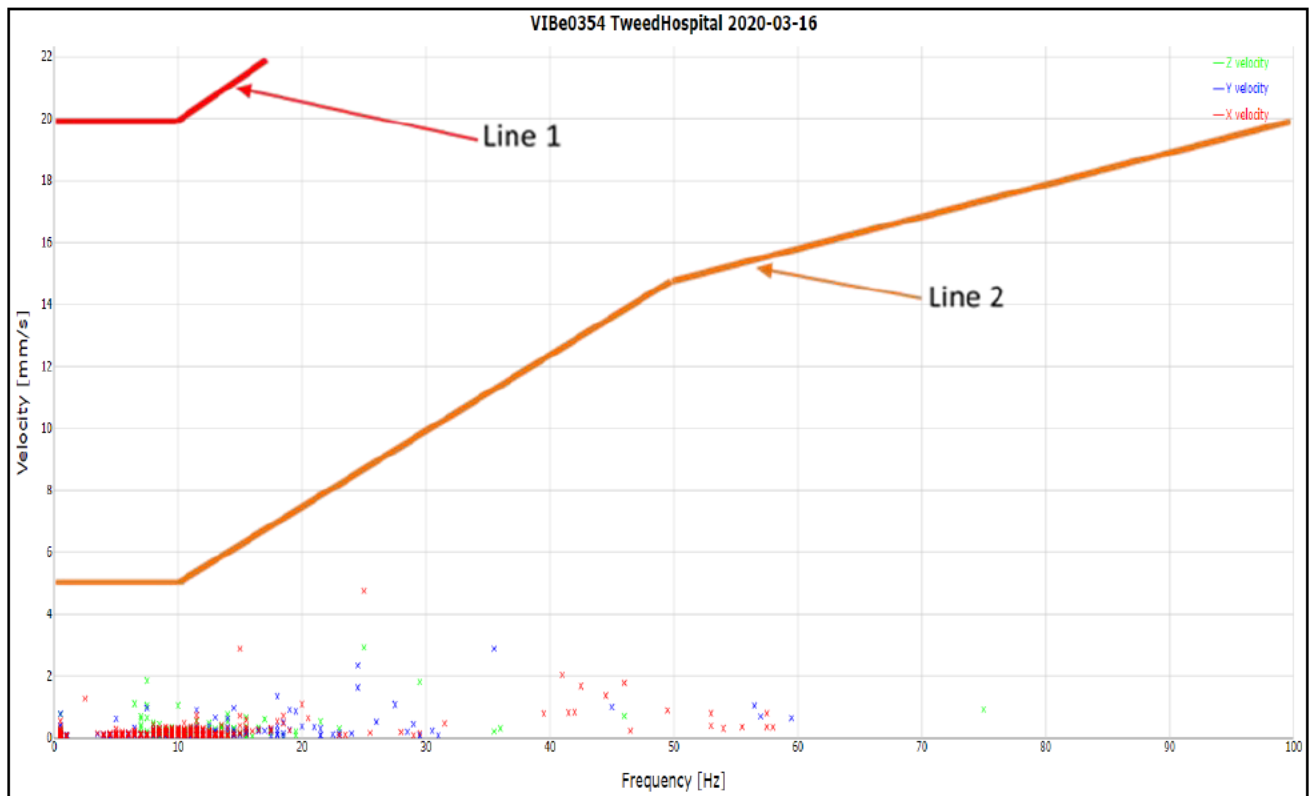
**Figure 13.** Results of the exceedance on Monday 16<sup>th</sup> March at monitoring location 003 –Eastern Section of Site.
