# Environmental Dust Assessment Report (June 2020)

Tweed Valley Hospital Project, Kingscliff NSW

## Environmental Dust Assessment Report

DLT-01-Q1013 / EDM11 / v1f

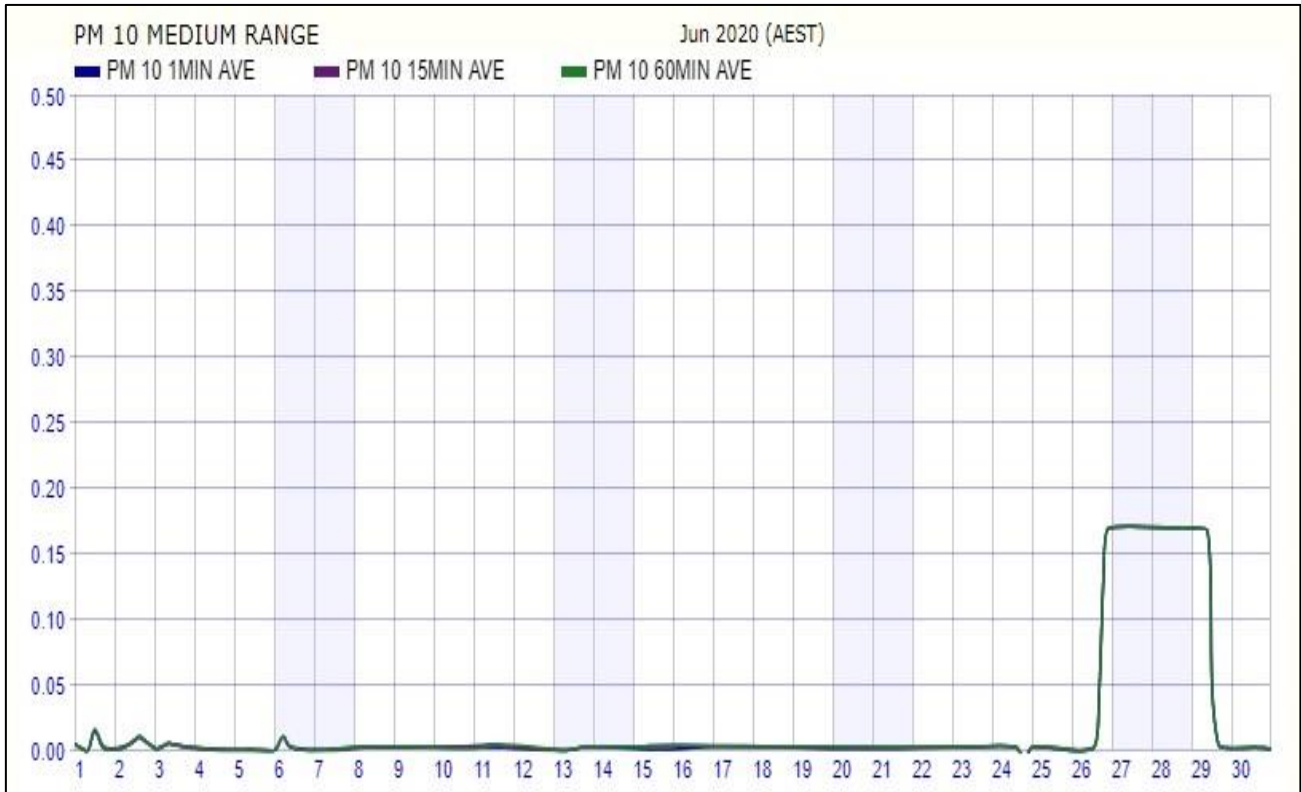
Figure 4. Summary of PM10 from the real time monitoring at location 003 – Eastern Section of site.

- The monitor was uploading to telemetry a constant value of 0.17mg/m<sup>3</sup>.
  - The issue continued through the weekend.

- ADE attended site on Monday June 29<sup>th</sup> to identify and rectify the issue. It was determined that the issue was due to the Dust Monitor Auto-Zero Module failing to complete a scheduled auto-zero function.

- ADE disassembled and cleaned all internal components, replaced all filters, and re-calibrated the monitor and the Auto-Zero Module.
- Monitor 003 resumed normal operation and has since been running 24 hours a day.

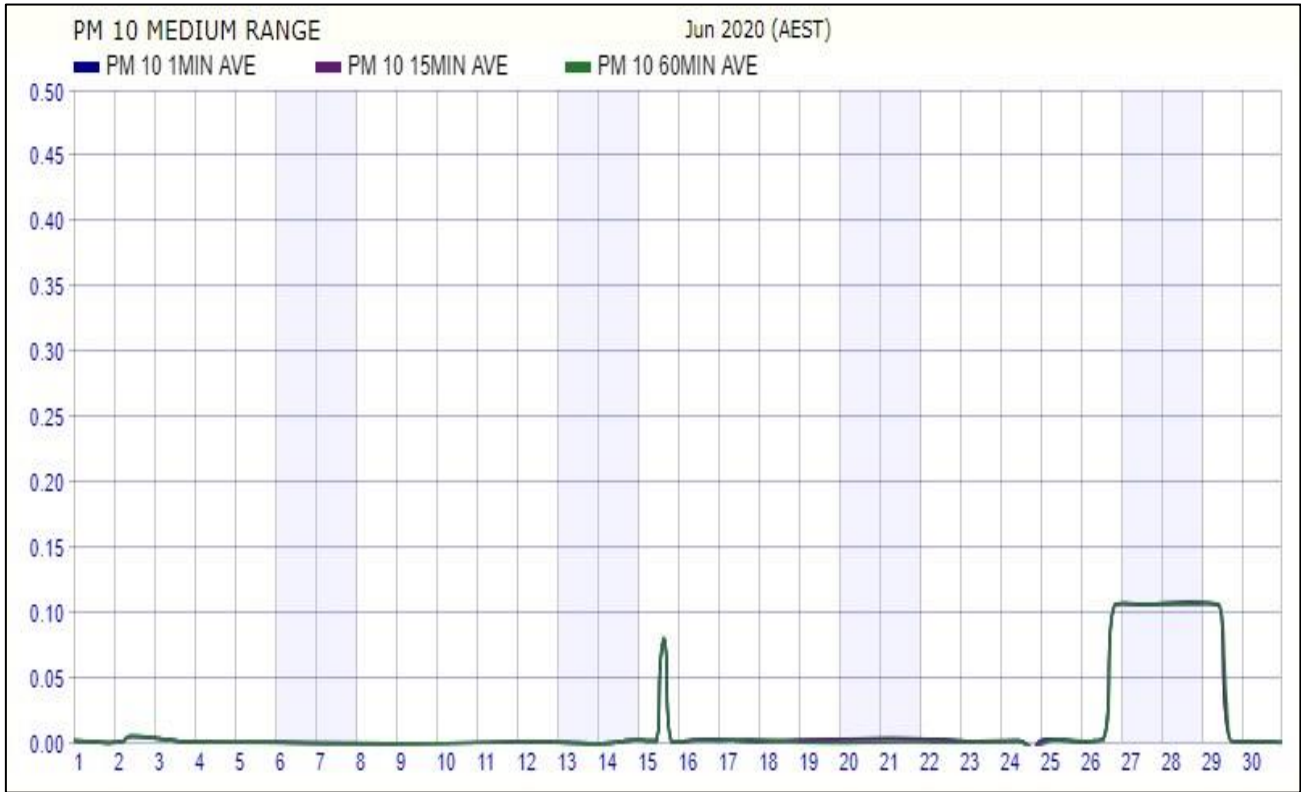
Figure 5. Summary of PM10 from the real time monitoring at location 004 – North Eastern Dust Monitor.

- Monitor 004, Friday June 26<sup>th</sup> (approximately 16:00) to Monday June 29<sup>th</sup> (approximately 12:30)
  - The monitor was uploading to telemetry a constant value of 0.11mg/m<sup>3</sup>.

- The issue continued through the weekend.
  - ADE attended site on Monday June 29<sup>th</sup> to identify and rectify the issue. It was determined that the issue was due to the Dust Monitor Auto-Zero Module failing to complete a scheduled auto-zero function.

- ADE disassembled and cleaned all internal components, replaced all filters, and re-calibrated the monitor and the Auto-Zero Module.
  - Monitor 004 resumed normal operation and has since been running 24 hours a day.

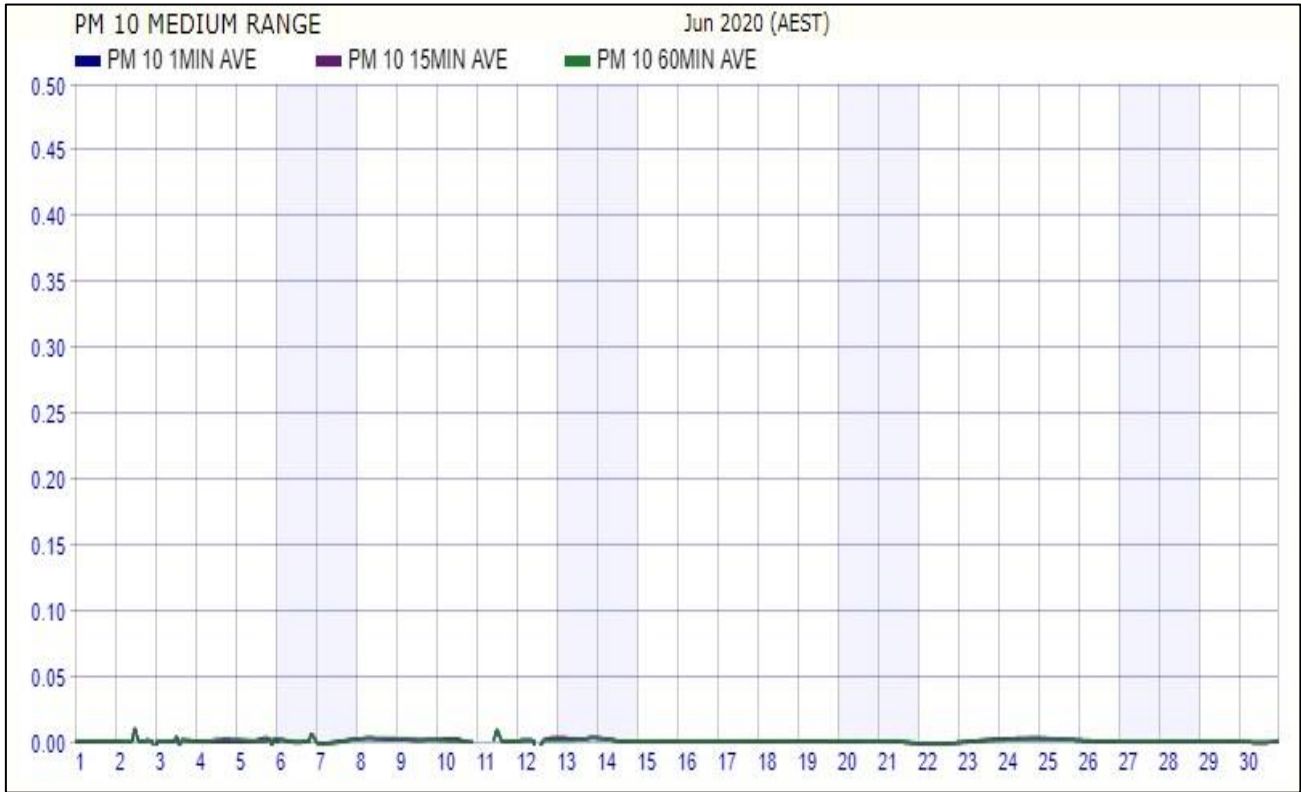
Figure 7. Summary of PM10 from the real time monitoring at location 006 – South Western Dust Monitor.

- Monitor 006, Thursday June 11<sup>th</sup> (approximately 06:45 – 09:00)
  - It was determined that this gap was caused by solar conditions (less sunlight and several overcast days in a row) combined with the position of Monitor 006 beneath a large stand of trees causing the solar panel to be in complete shade as early as 12:30 each day (refer to *Appendix I – Monitoring Locations*).

- ADE closely monitored the battery voltage via telemetry over the weekend and determined the additional solar panel had increased the rate of charge but would not be sufficient to prevent data gaps occurring on overcast days.

- ADE attended site on Friday June 12<sup>th</sup> to install an additional solar panel to increase the rate of charge gained each morning. ADE requested approval from Lendlease to relocate the monitor no more than 10 m to a more suitable location.

- ADE's request to relocate Monitor 006 was approved by Lendlease on Monday June 15<sup>th</sup>. ADE mobilised immediately to move Monitor 006 and both solar panels 10 m east to a more suitable location (refer to *Appendix I – Monitoring Locations*).

- The new location of Monitor 006 has rectified the battery shortage issue: it has since been running 24 hours a day.
- Monitor 003, Friday June 26<sup>th</sup> (approximately 17:00) to Monday June 29<sup>th</sup> (approximately 11:30)

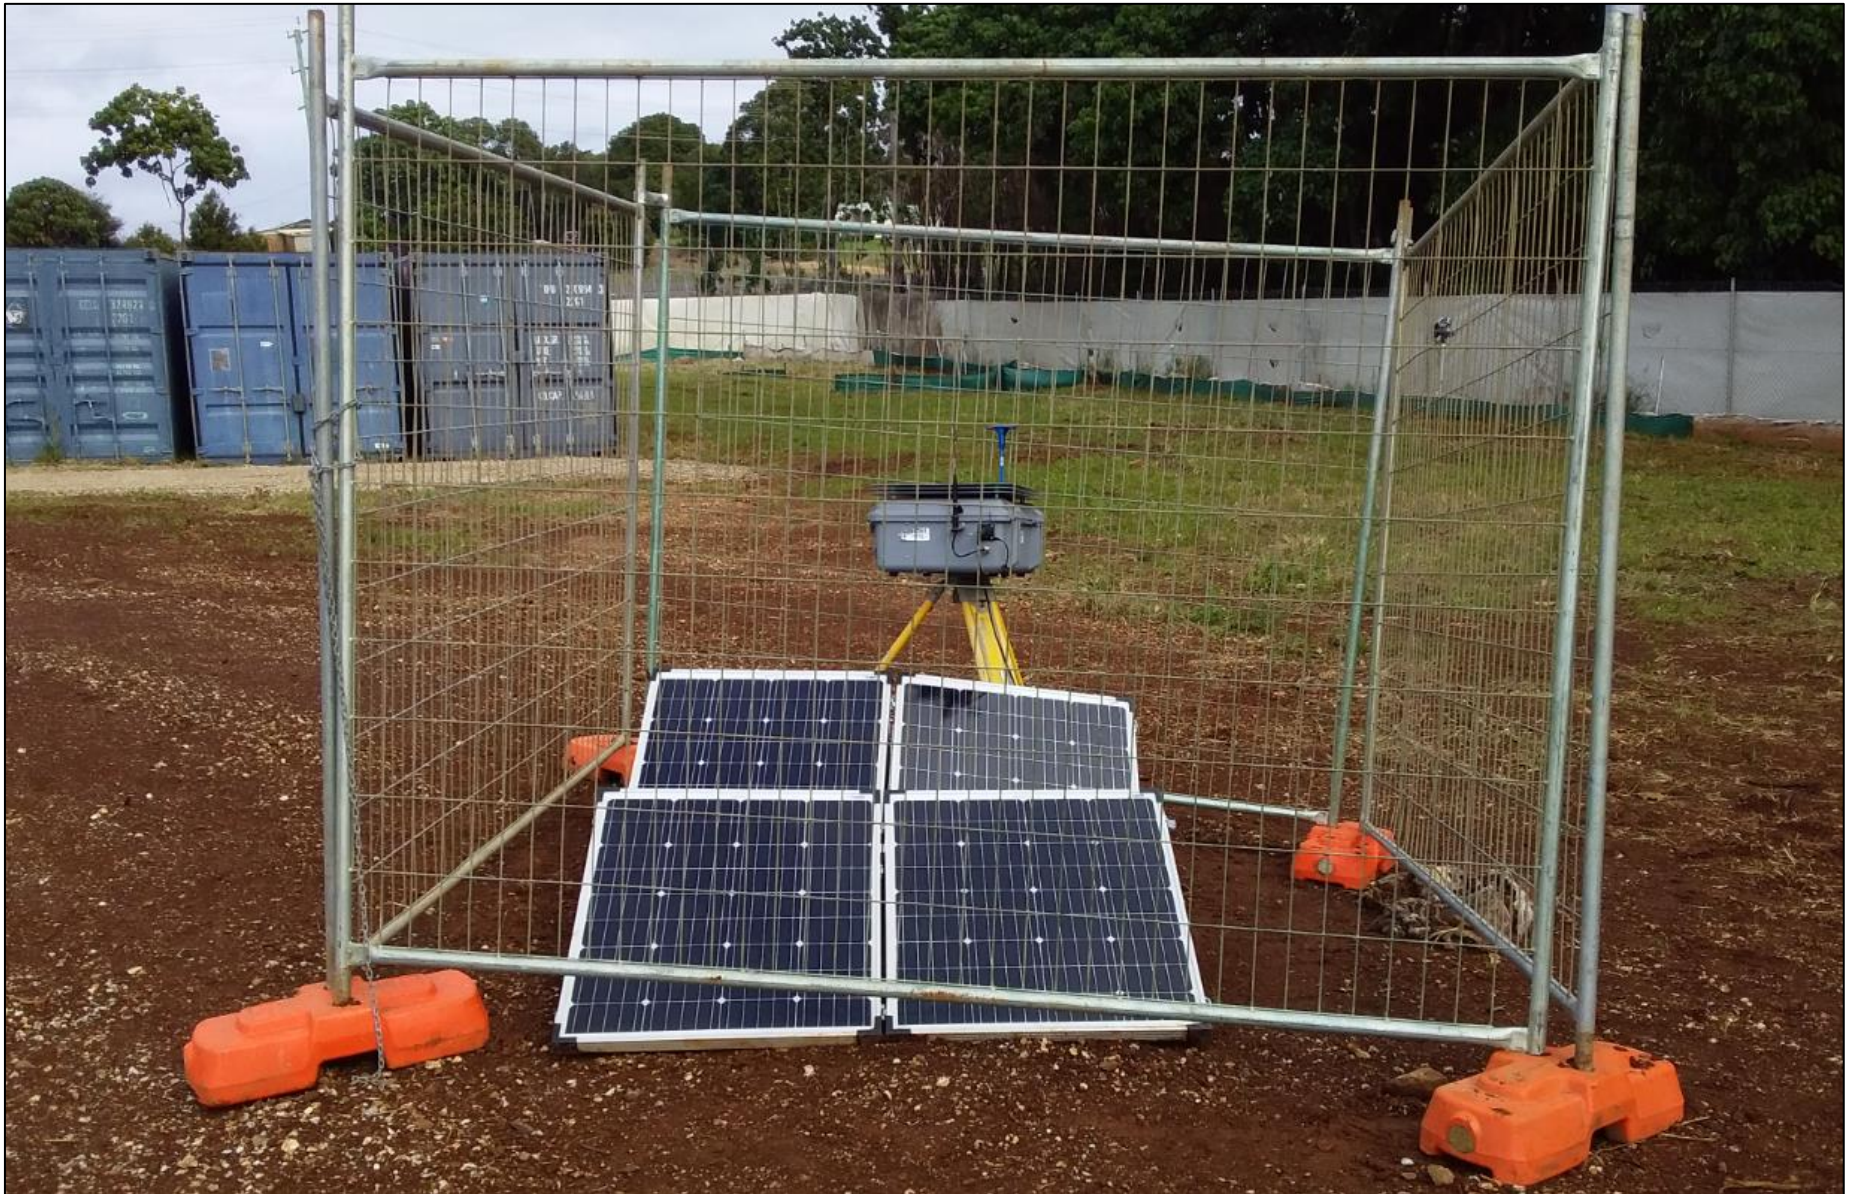
**Photograph 6.** Representative photo of monitoring location 006 – South Western Dust Monitor, as observed 18.06.2020.

- Monitor 006, Thursday June 11<sup>th</sup> (approximately 06:45 – 09:00)
  - It was determined that this gap was caused by solar conditions (less sunlight and several overcast days in a row) combined with the position of Monitor 006 beneath a large stand of trees causing the solar panel to be in complete shade as early as 12:30 each day (refer to *Appendix I – Monitoring Locations*).

- ADE closely monitored the battery voltage via telemetry over the weekend and determined the additional solar panel had increased the rate of charge but would not be sufficient to prevent data gaps occurring on overcast days.

- ADE attended site on Friday June 12<sup>th</sup> to install an additional solar panel to increase the rate of charge gained each morning. ADE requested approval from Lendlease to relocate the monitor no more than 10 m to a more suitable location.
