Environmental Dust Assessment Report (April 2020)

Tweed Valley Hospital Project

DLT-01-Q1013 / EDM9 / v1.4f

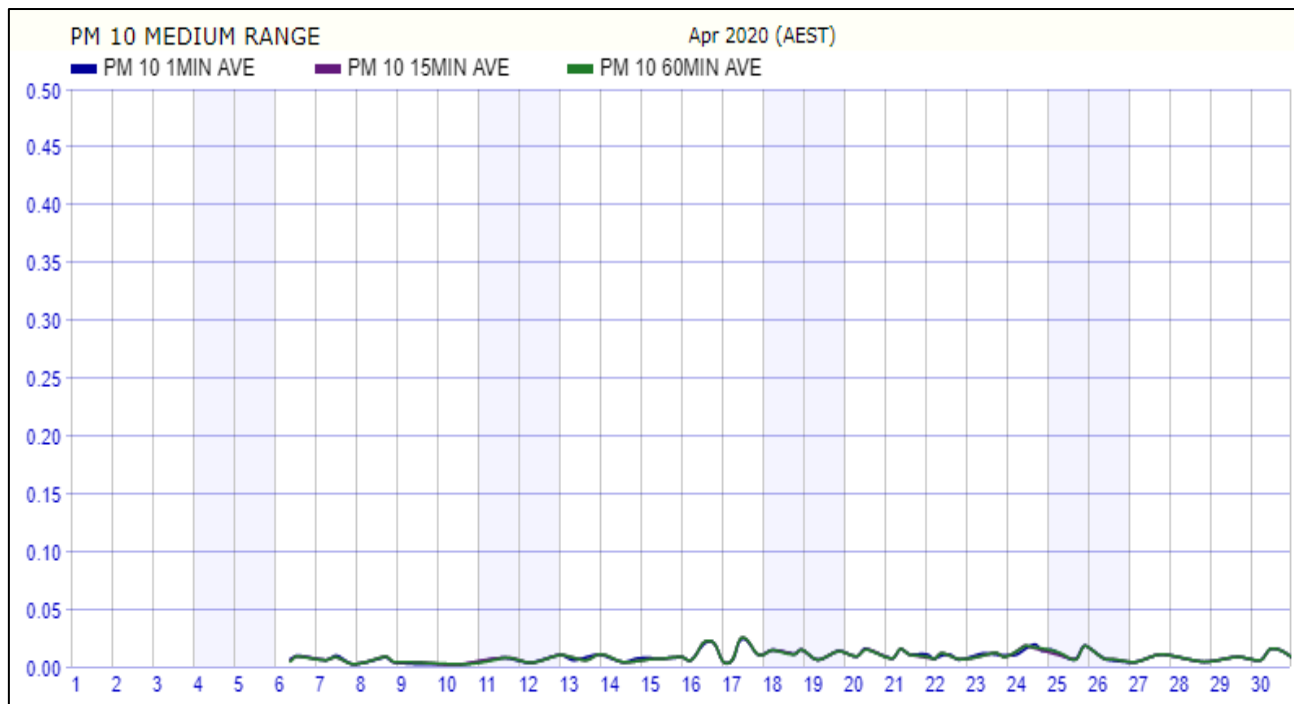
Figure 2. Summary of PM10 from the real time monitoring at location 001 – Adjacent the carpark.

Data gaps from the 1st - 6th at locations 001 and 002 were due to monitors being removed on the 1st of April whilst tree clearing took place and reinstalled on the 6th of April 2020 at the client's request.

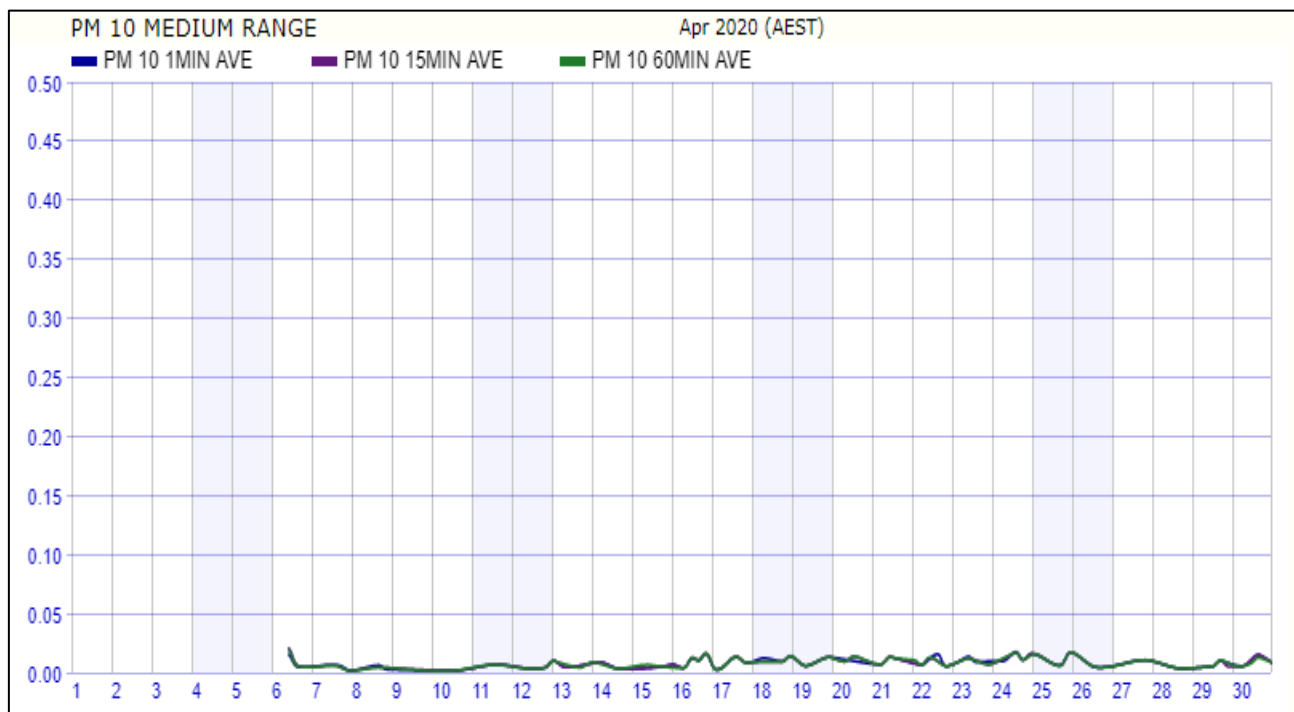
Figure 3. Summary of PM10 from the real time monitoring at location 002 – Central location.

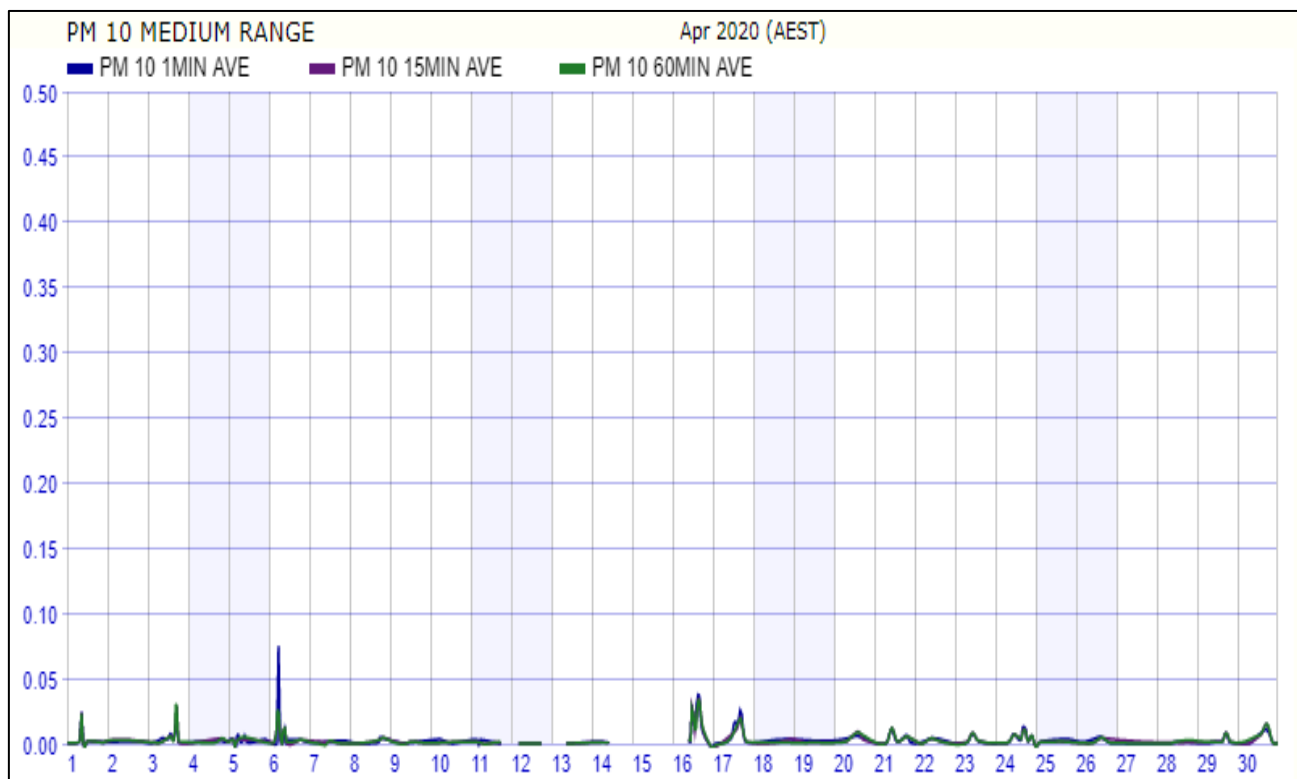
Figure 4. Summary of PM10 from the real time monitoring at location 003 – Eastern end of site.

Data gaps from the 11th - 16th at location 003 were the result of the monitor displaying constant values of 0.00 and failing to record and upload any readings. ADE attended Site on the 16th of April to investigate and rectify the issues (*refer to Appendix II – ADE Site Time Summary*). The filters of the dust monitor were replaced, all cables and connections were checked for damage, power to the monitor was reset and each monitor was calibrated by ADE while on site.

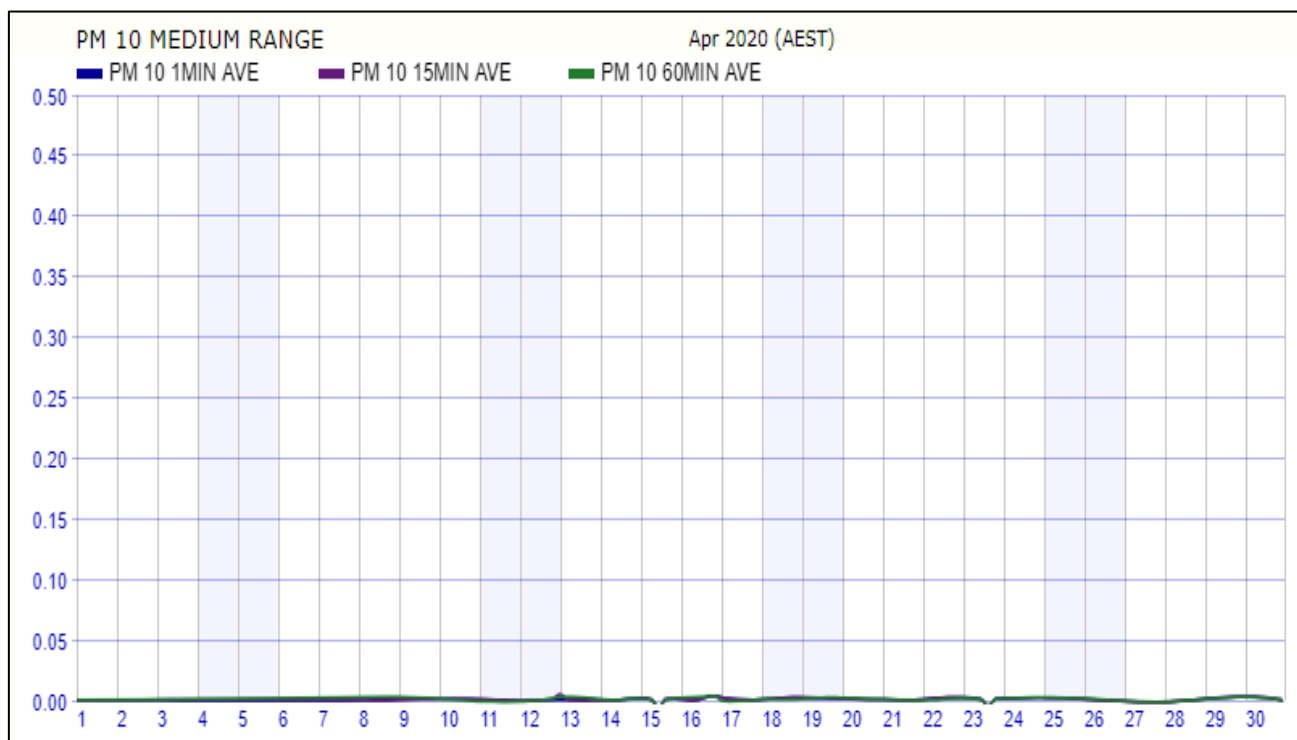
The battery and solar panels powering the dust monitor at location 004 (North Eastern section) were stolen around 22:00 on the 30th of April 2020. As a result, there is a 2-hour data gap between 22:00 and 24:00. ADE visited the site on the 1st of May 2020 and increased security measures at each monitoring station.

Figure 5. Summary of PM10 from the real time monitoring at location 004 – North Eastern Dust Monitor.

A data gap was identified on the 30th of April 2020. ADE attended Site on the 1st of May 2020 to investigate, whereby it was determined that the theft of the power supply (solar panels and battery) has caused dust monitor 004 to power down. At the time of writing the report, dust monitor 004 is still inactive and awaiting replacement power supply.

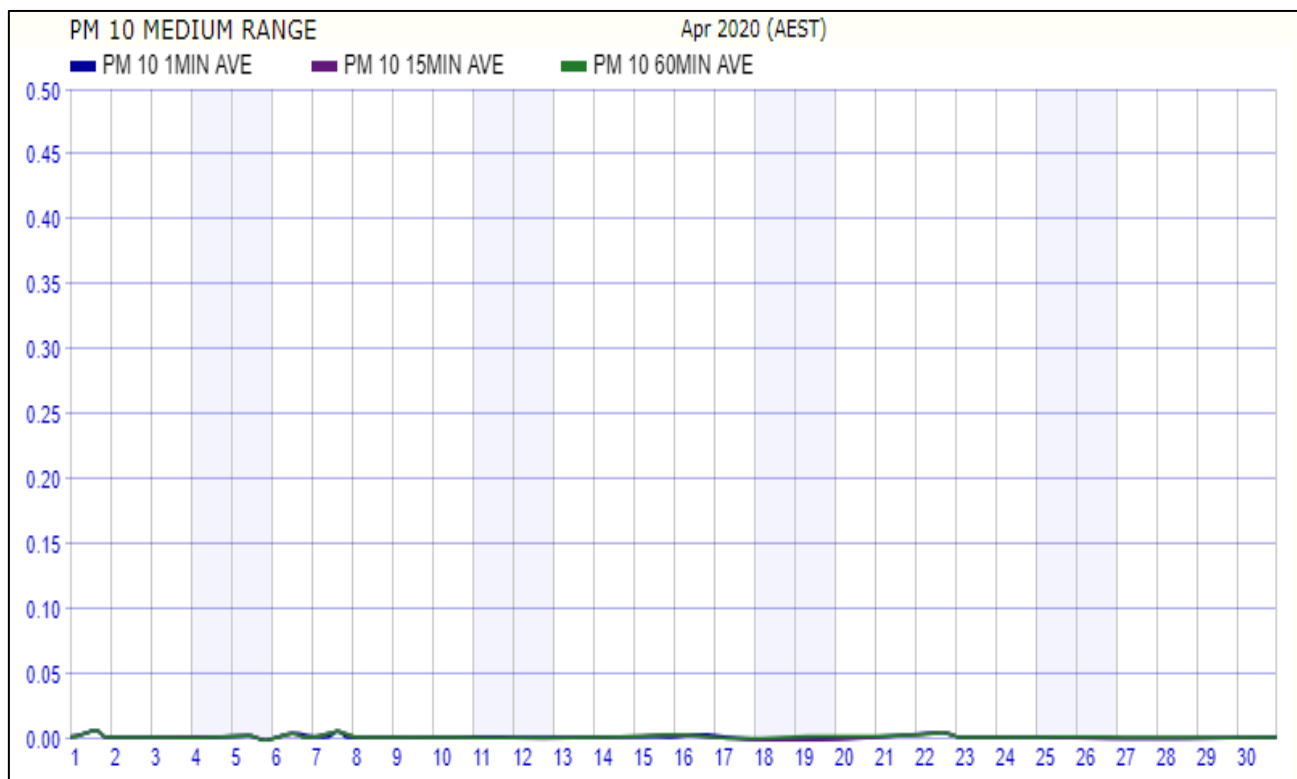
Figure 6. Summary of PM10 from the real time monitoring at location 005 – North Western Dust Monitor.

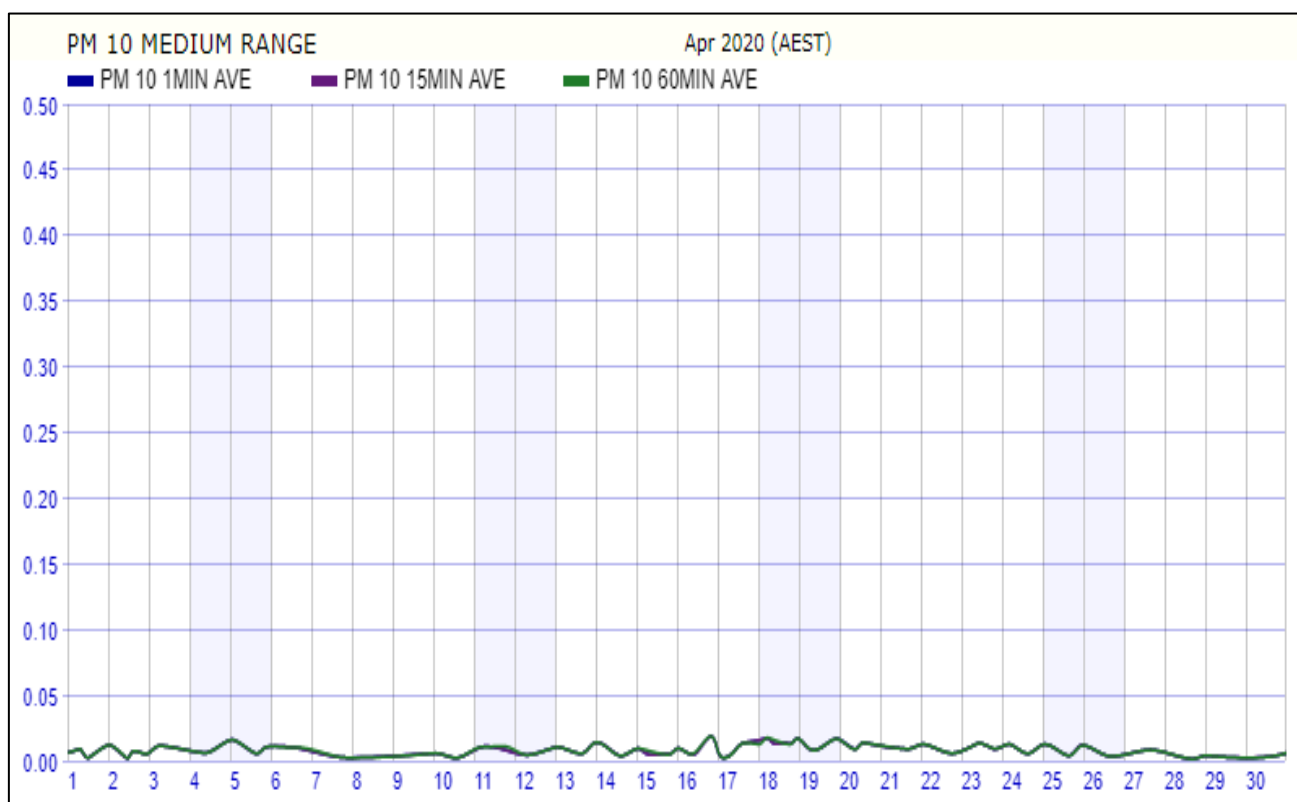
Figure 7. Summary of PM10 from the real time monitoring at location 006 – South Western Dust Monitor.

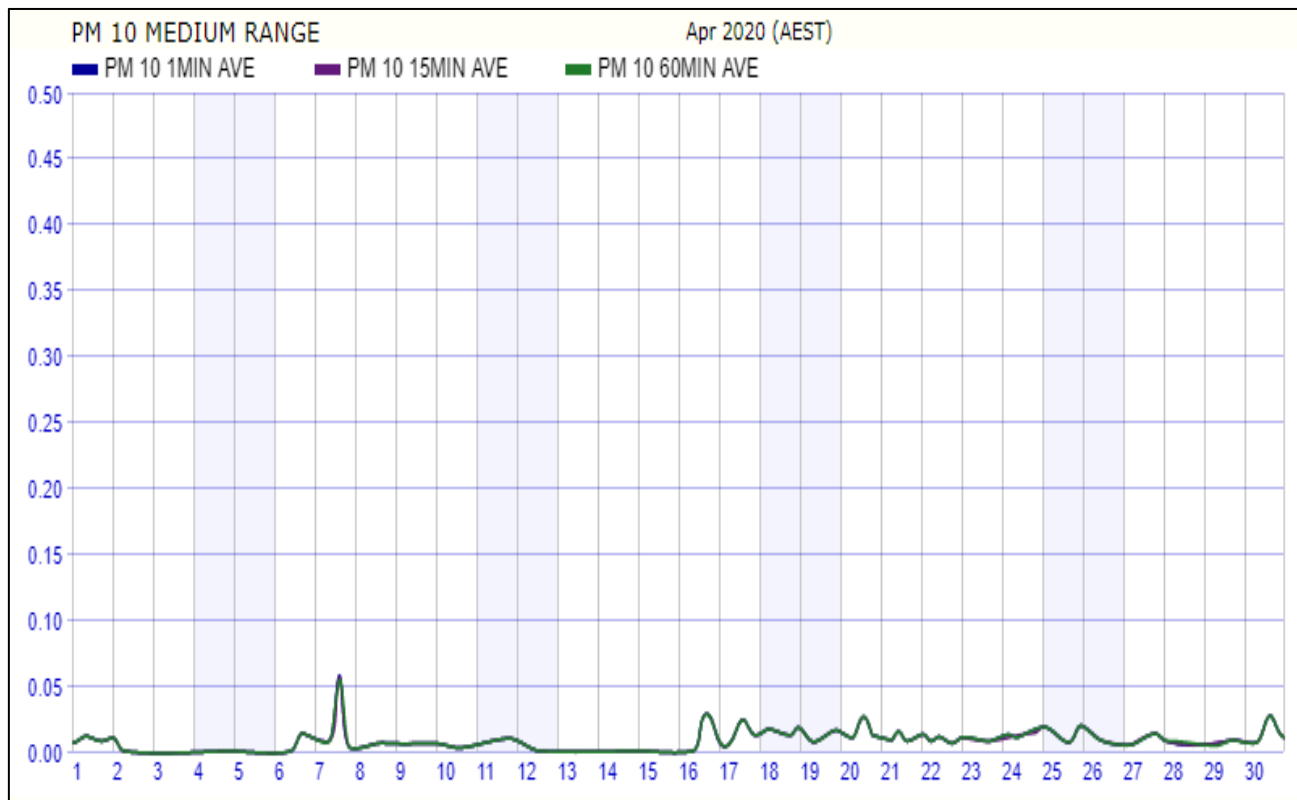
Figure 8. Summary of PM10 from the real time monitoring at location 007 – Southern Dust Monitor.

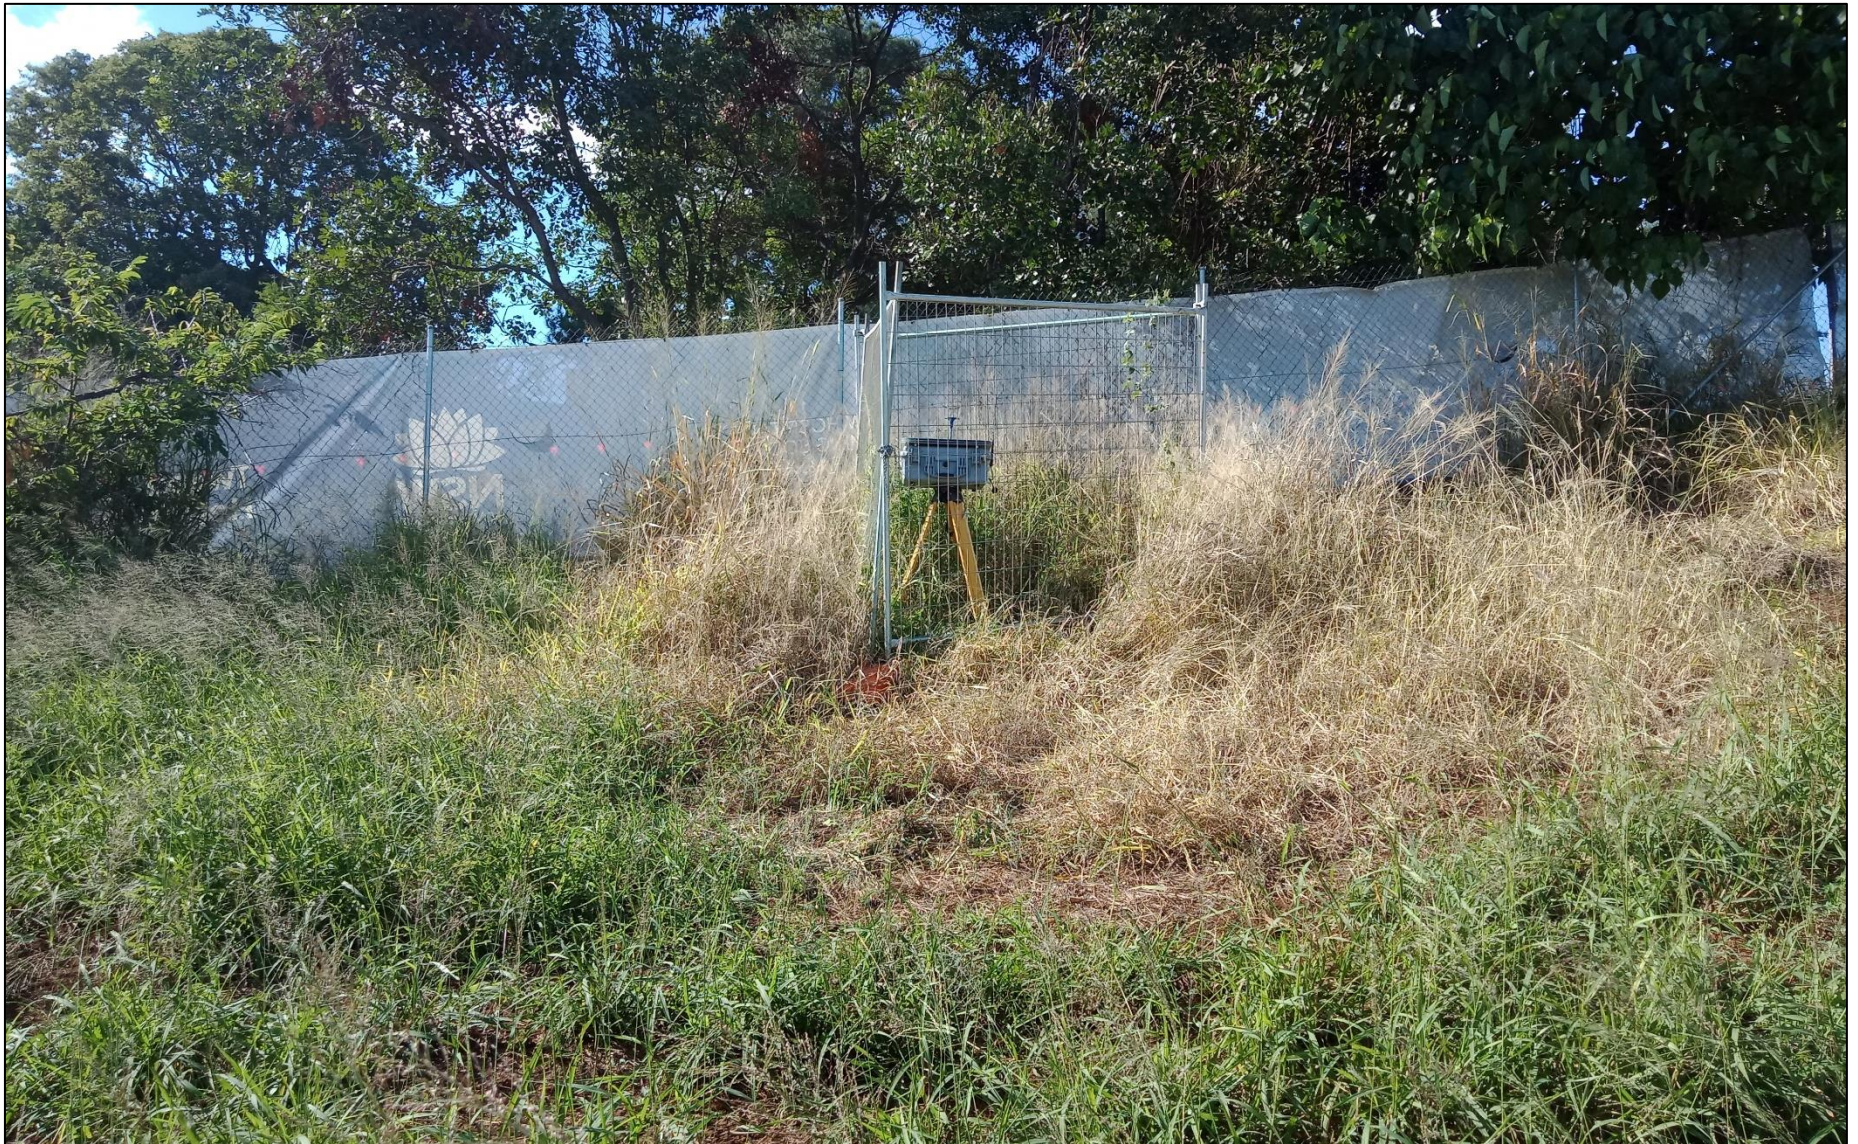
Photograph 4. Representative photo of the monitoring location 004 – Eastern Section 2 of Site, as observed on the 05.05.2020.
