# Vibration Monitoring Assessment Report (July 2020)

Tweed Valley Hospital Project, Kingscliff NSW

DLT-01-Q1013 / VIB12 / v1f  
7<sup>th</sup> August 2020

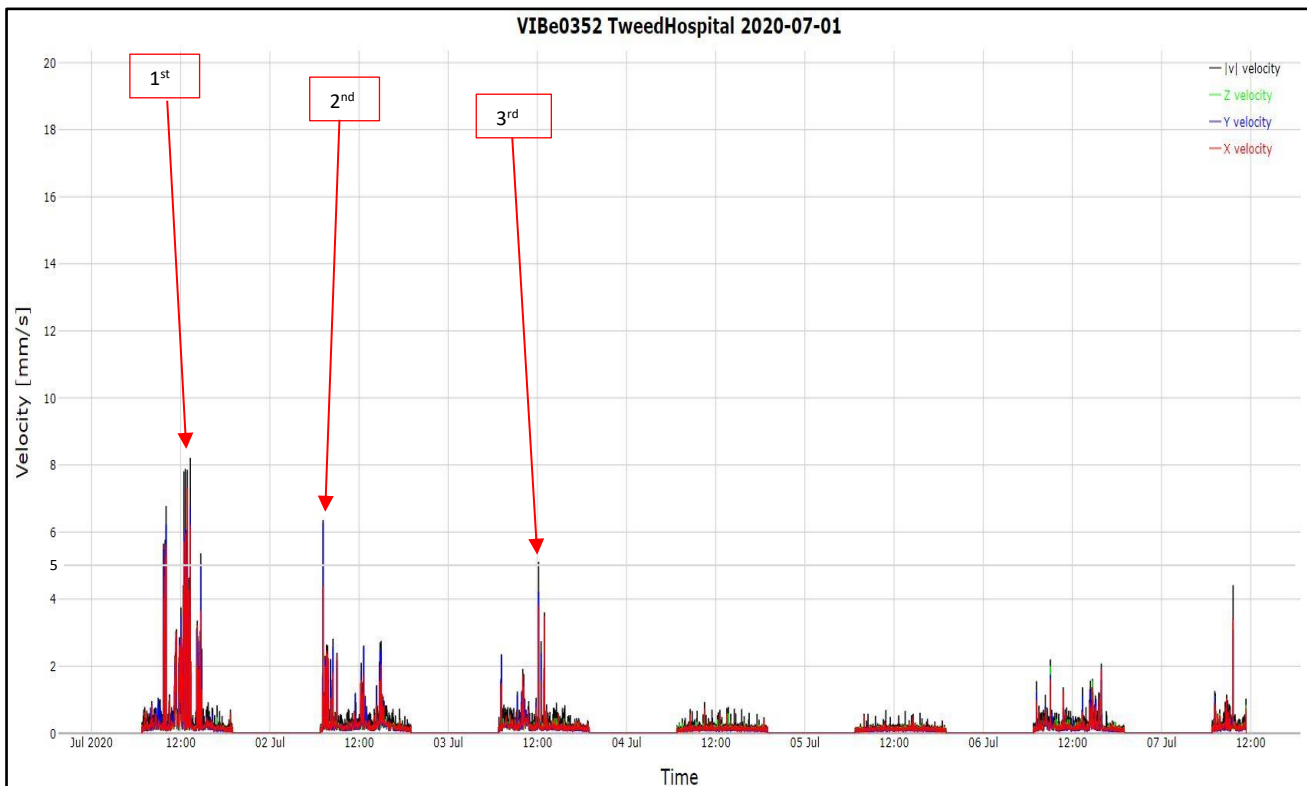
**Figure 1.** Results of the vibration monitoring from 1<sup>st</sup> – 7<sup>th</sup> July 2020 at monitoring location 001 – Adjacent to the carpark.

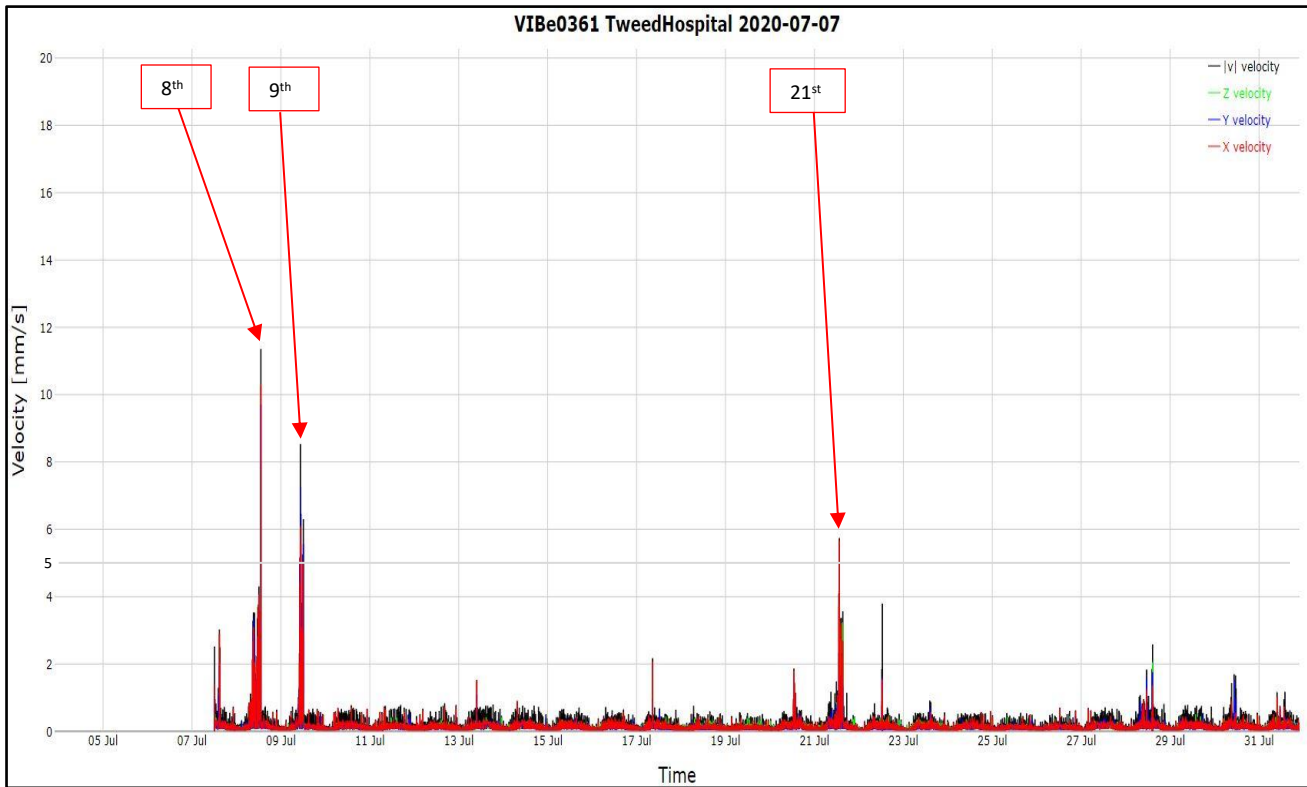
**Figure 2.** Results of the vibration monitoring from 7<sup>th</sup> – 31<sup>st</sup> July 2020 at monitoring location 001 – Adjacent to the carpark.

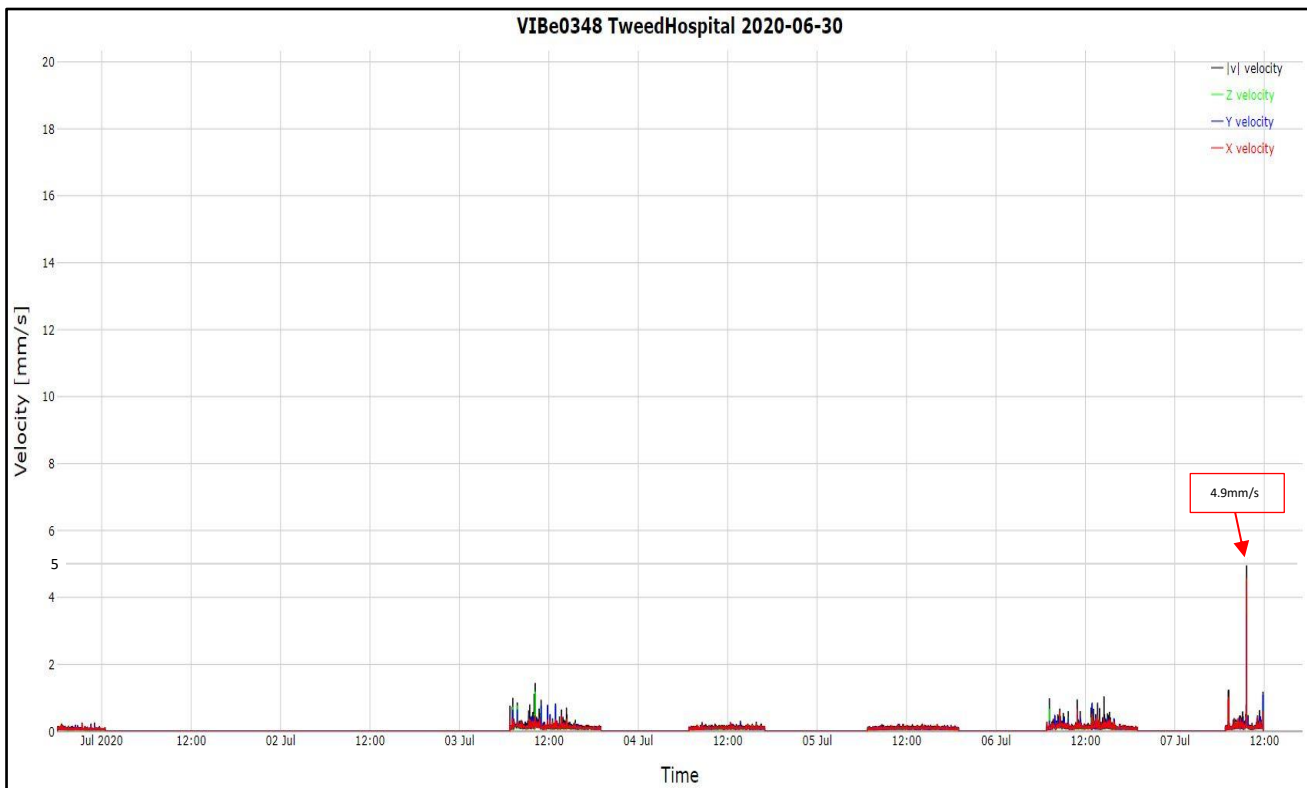
**Figure 3.** Results of the vibration monitoring from 1<sup>st</sup> – 7<sup>th</sup> July 2020 at monitoring location 002 – Central monitor.

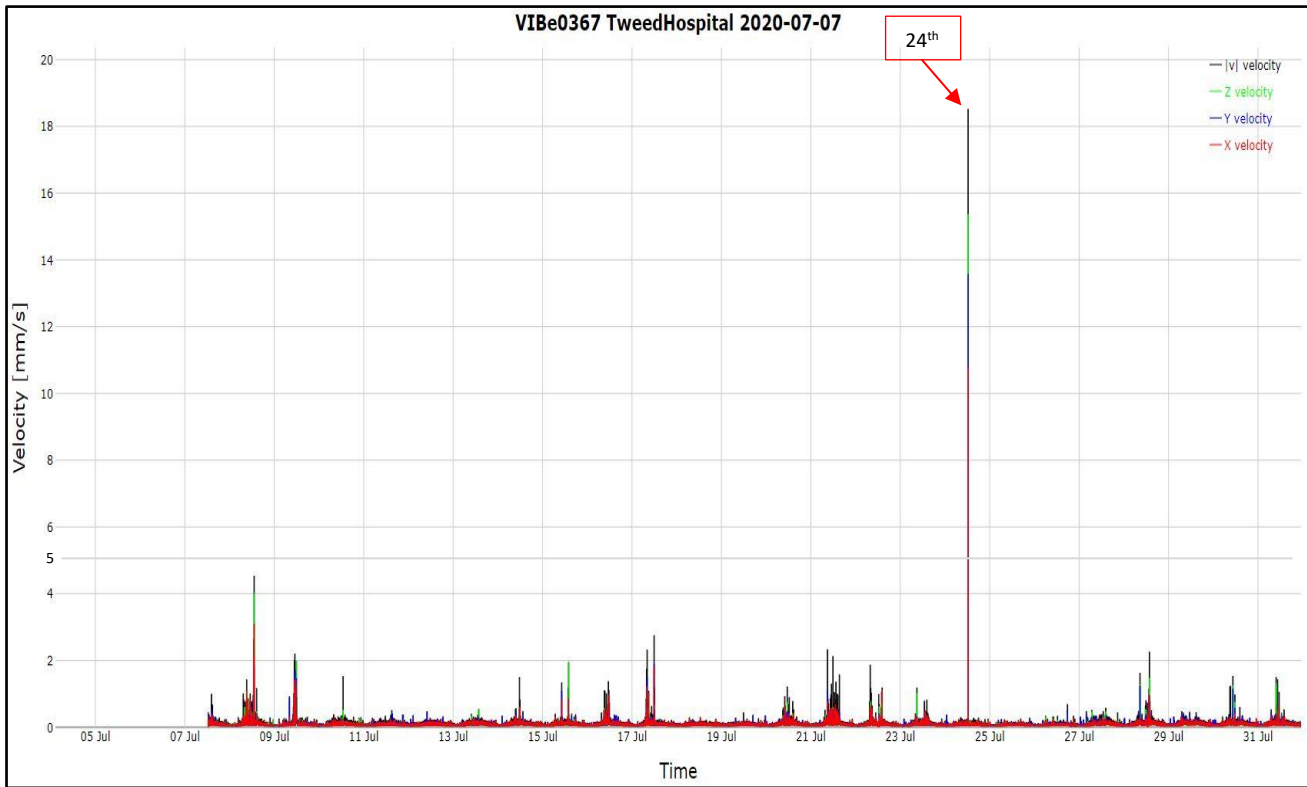
**Figure 4.** Results of the vibration monitoring from 7<sup>th</sup> – 31<sup>st</sup> July 2020 at monitoring location 002 – Central monitor.

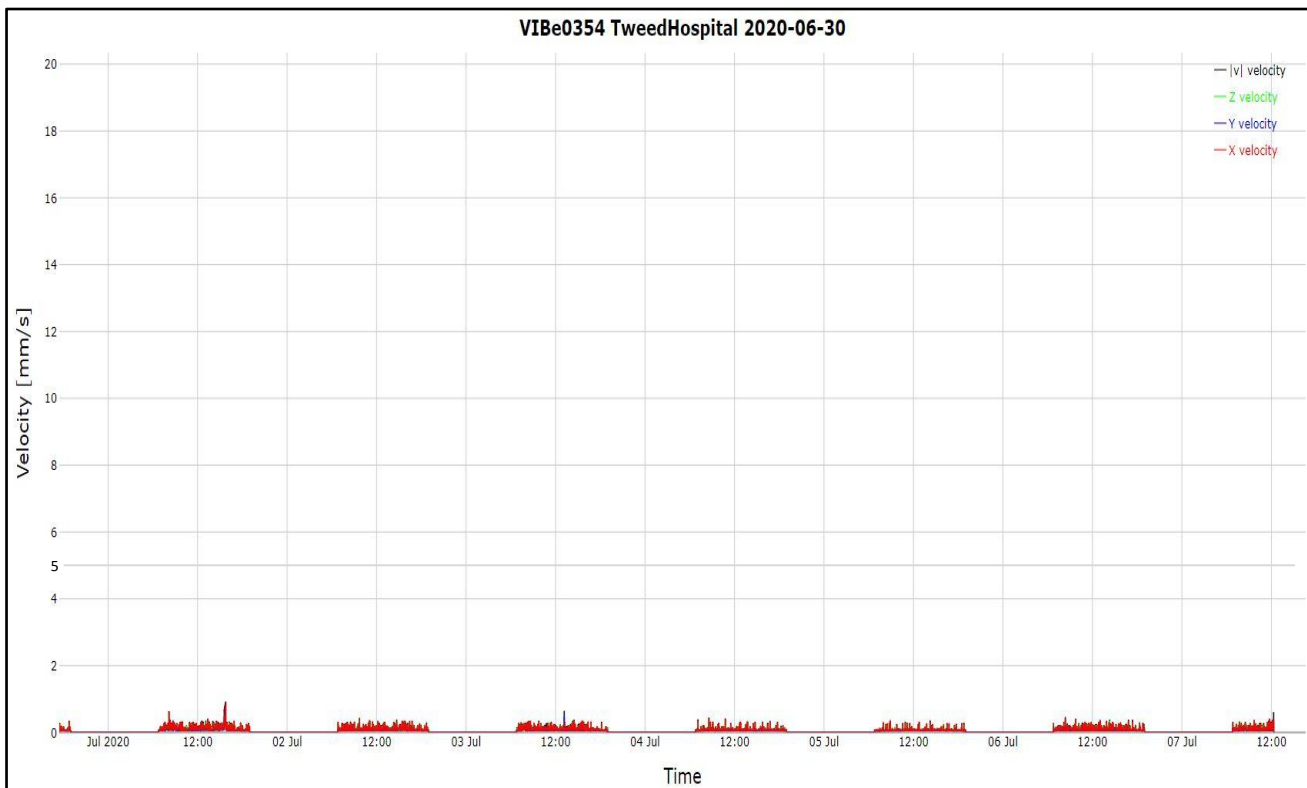
**Figure 5.** Results of the vibration monitoring from 1<sup>st</sup> – 7<sup>th</sup> July 2020 at monitoring location 003 – Eastern section of site.

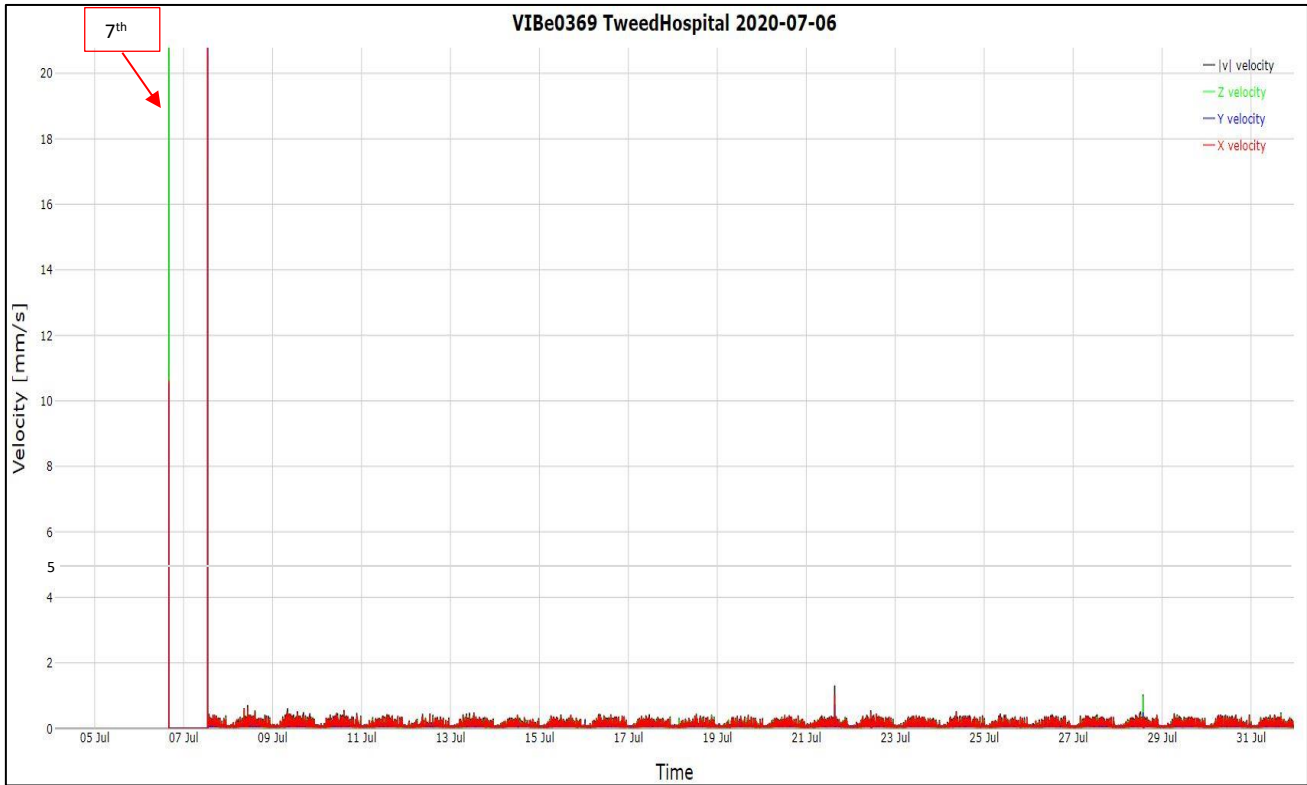
**Figure 6.** Results of the vibration monitoring from 7<sup>th</sup> – 31<sup>st</sup> July 2020 at monitoring location 003 – Eastern section of site.

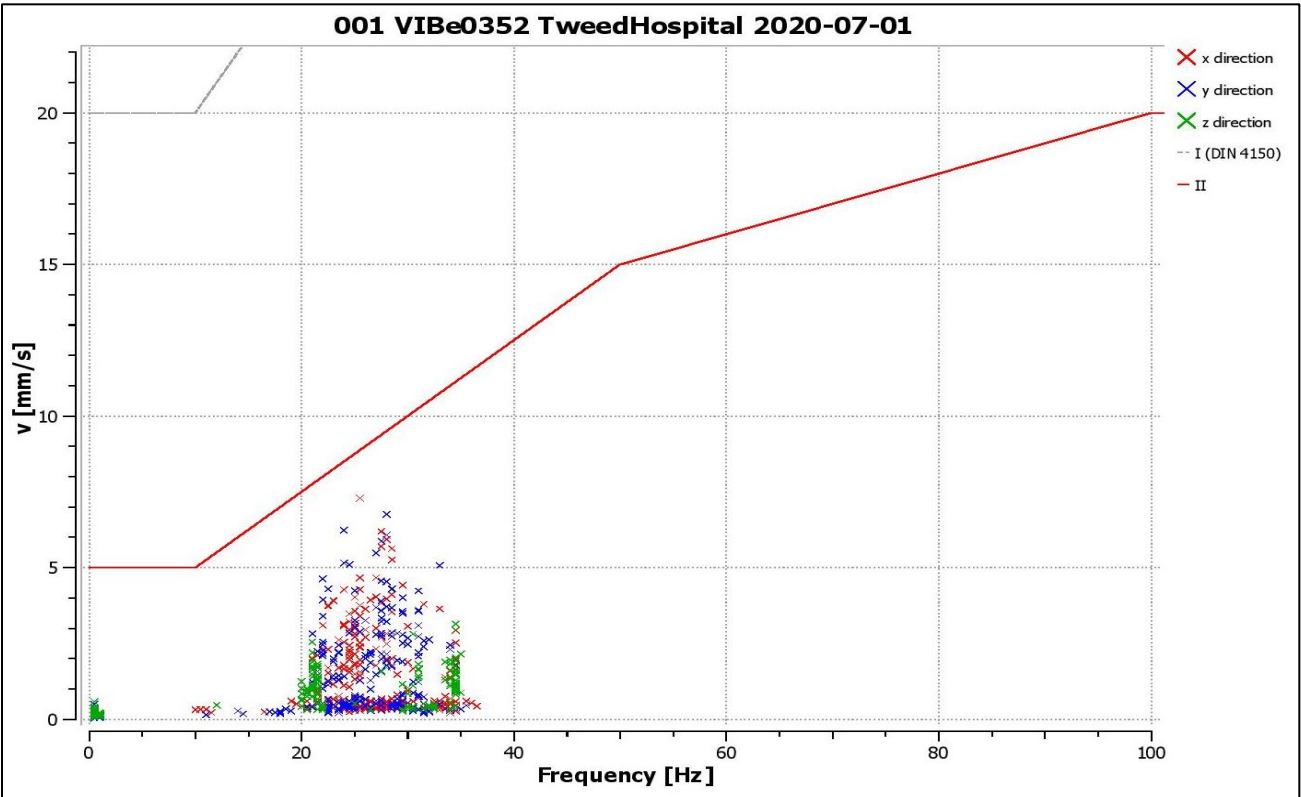
**Figure 7.** Results of the exceedance on Wednesday 1<sup>st</sup> July 2020 at monitoring location 001 – Adjacent to the carpark

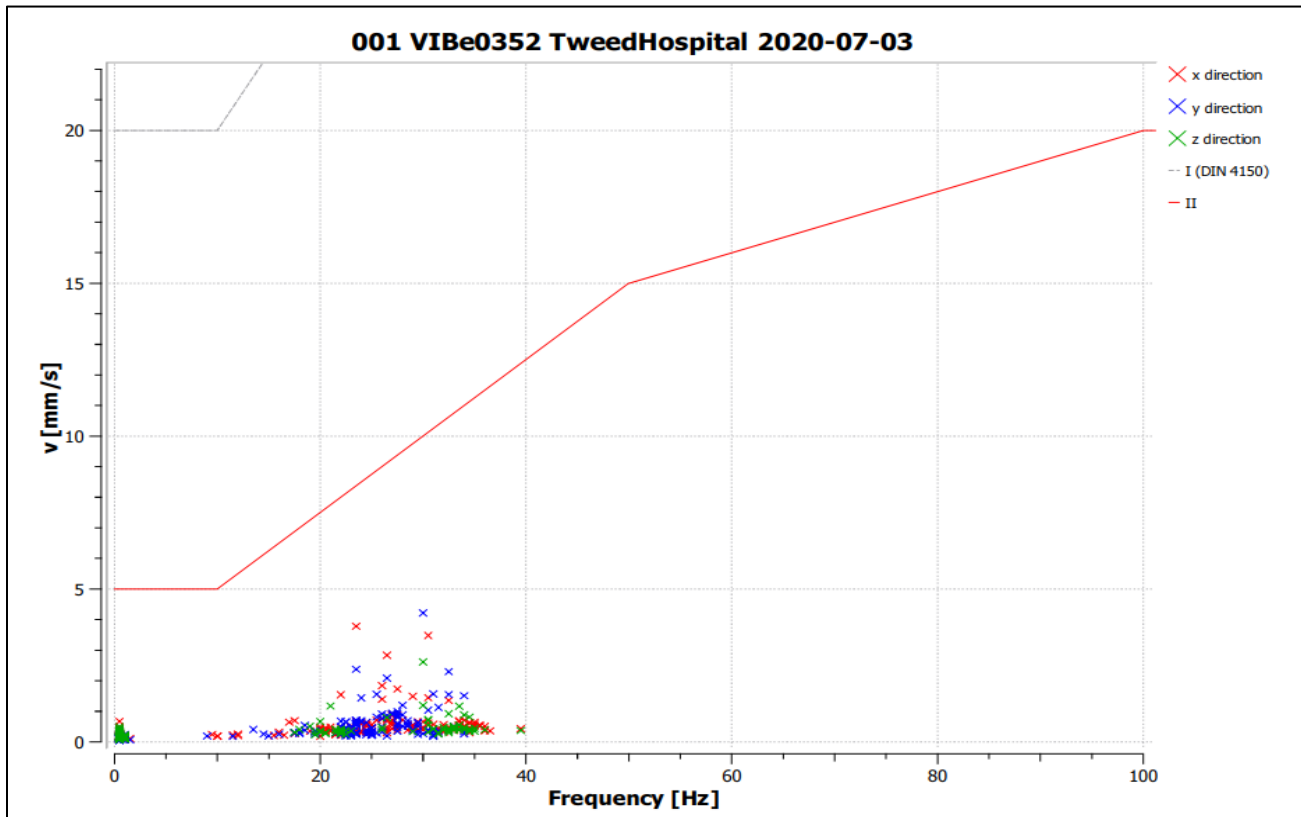
**Figure 9.** Results of the exceedance on Wednesday 3<sup>rd</sup> July 2020 at monitoring location 001 – Eastern Section of Site.

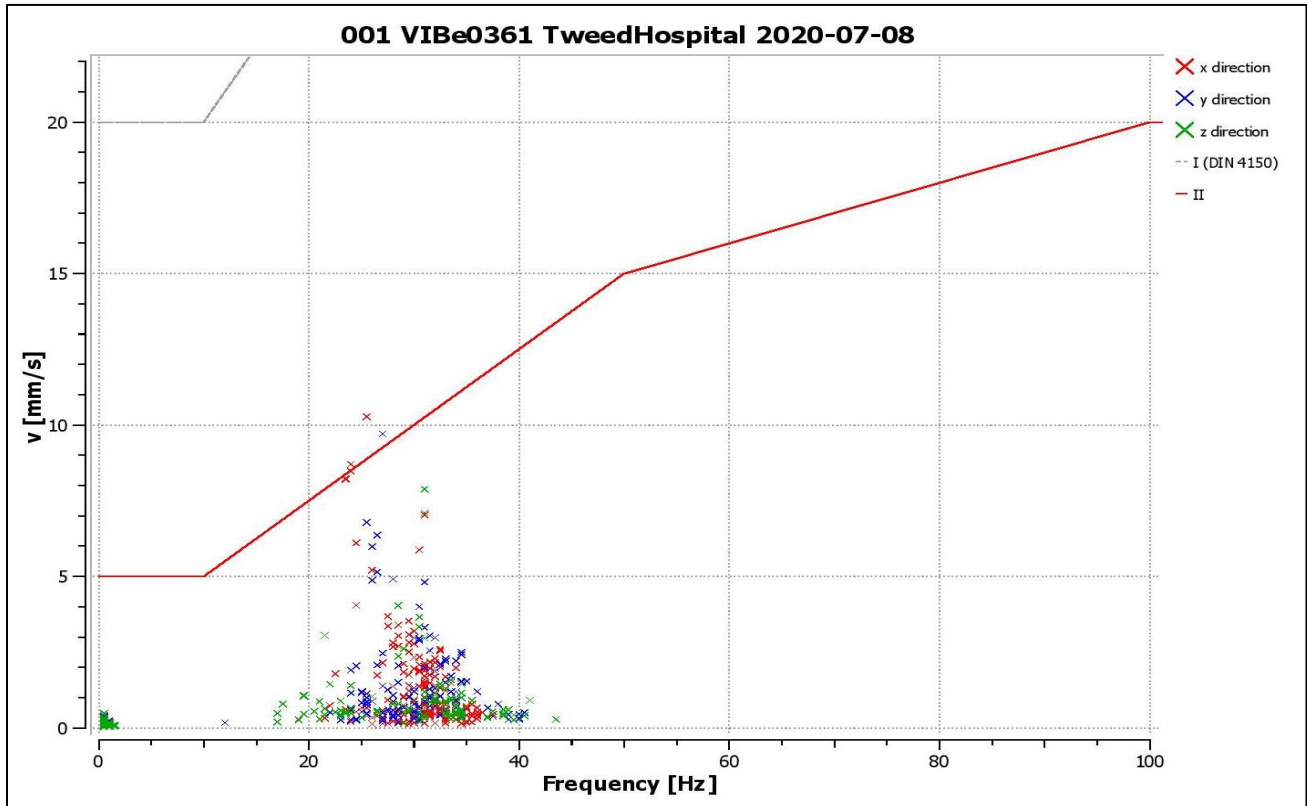
Figure 10. Results of the exceedance on Wednesday 8<sup>th</sup> July 2020 at monitoring location 001 – Adjacent to the carpark

One (1) exceedance of DIN 4150 Line 2 occurred during this reporting period.

The exceedance occurred at Location 001 on Wednesday 8<sup>th</sup> July 2020, between approximately 13:05 – 13:15. The vibration exhibited a maximum velocity of 10.3mm/s at a frequency of 25 Hz.

The distance from the monitor at Location 001 and the nearest sensitive receiver is 36 m, over this distance a 25 Hz vibration will reduce to 75% of the initial velocity before reaching the receiver (DIN 4150-1, 2016).

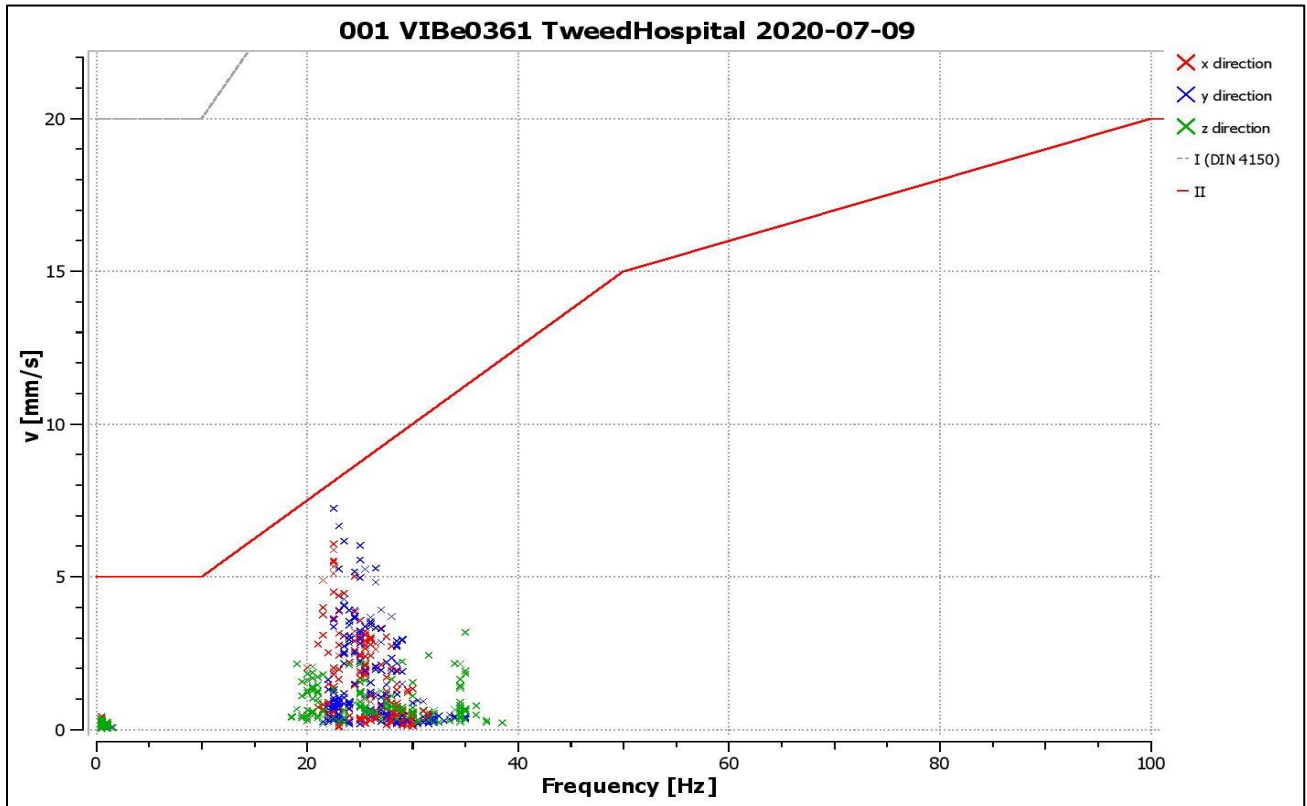
Figure 11. Results of the exceedance on Thursday 9<sup>th</sup> July 2020 at monitoring location 001 – Adjacent to the carpark

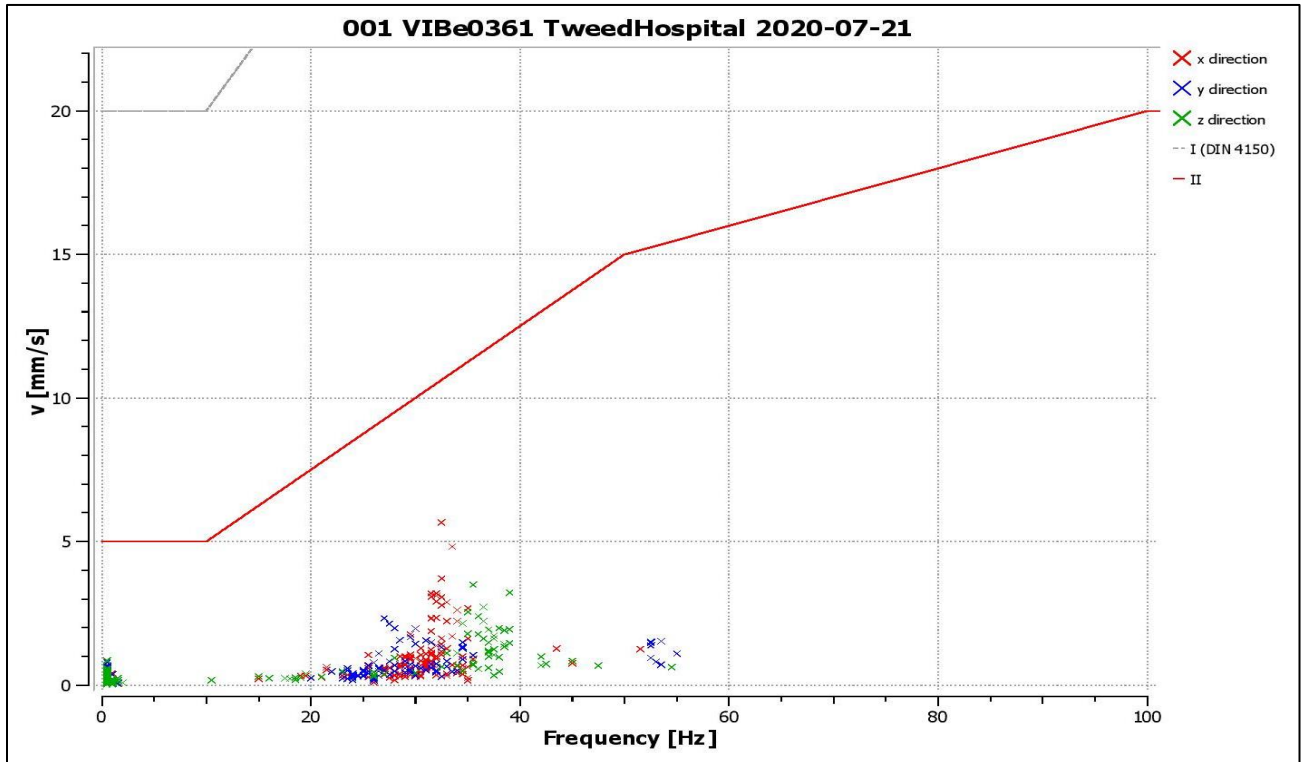
Figure 12. Results of the exceedance on Tuesday 21<sup>st</sup> July 2020 at monitoring location 001 – Adjacent to the carpark

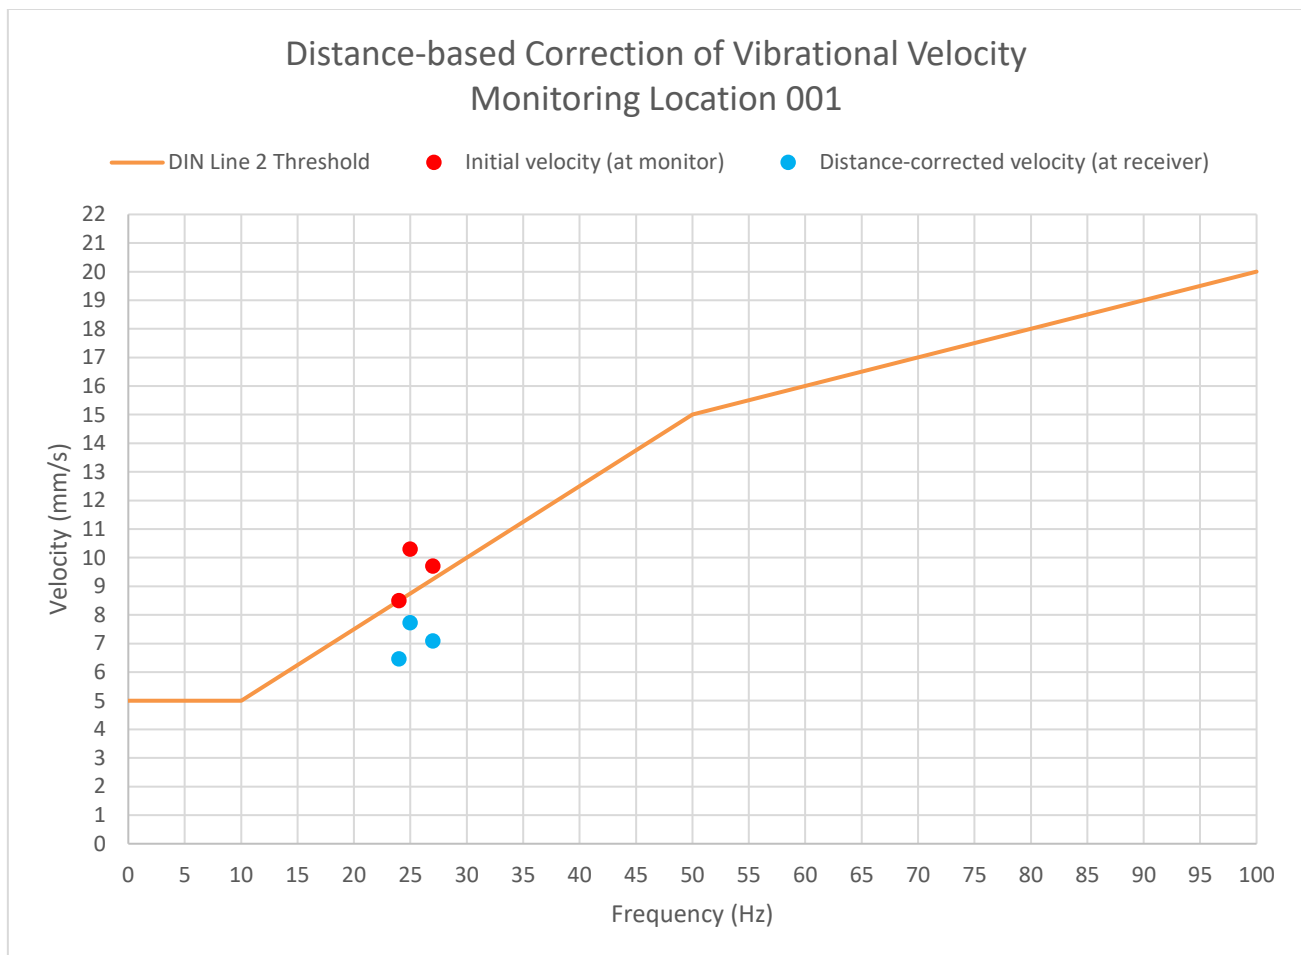
Therefore, the highest vibrational velocity observed at the receiver between 13:05 – 13:15 would be approximately 7.7mm/s, which is below Line 2 (refer to Figure 13 below).

**Figure 13.** Velocity felt at the nearest receiver (after applying distance-based correction of the vibrational velocity), Wednesday 8<sup>th</sup> July 2020, monitoring Location 001 – Adjacent to the carpark.
