Vibration Monitoring Assessment Report (September 2020)

Tweed Valley Hospital Project, Kingscliff NSW

Prepared for: Delta Group

DLT-01-Q1013 | VIB14.V1F | Date: 14/10/2020

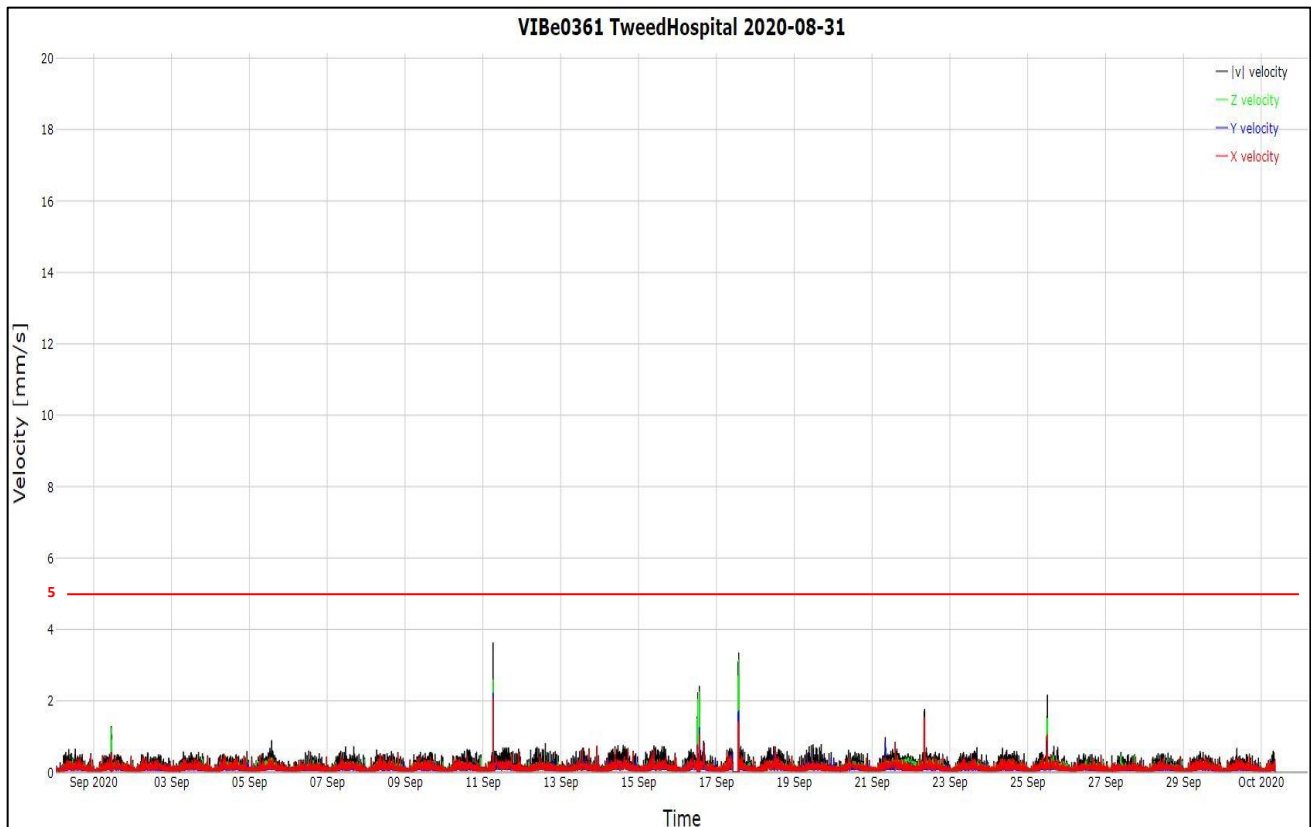
Figure 1. Results of the vibration monitoring from 1st – 30th September 2020 at monitoring location 001 – Adjacent carpark.

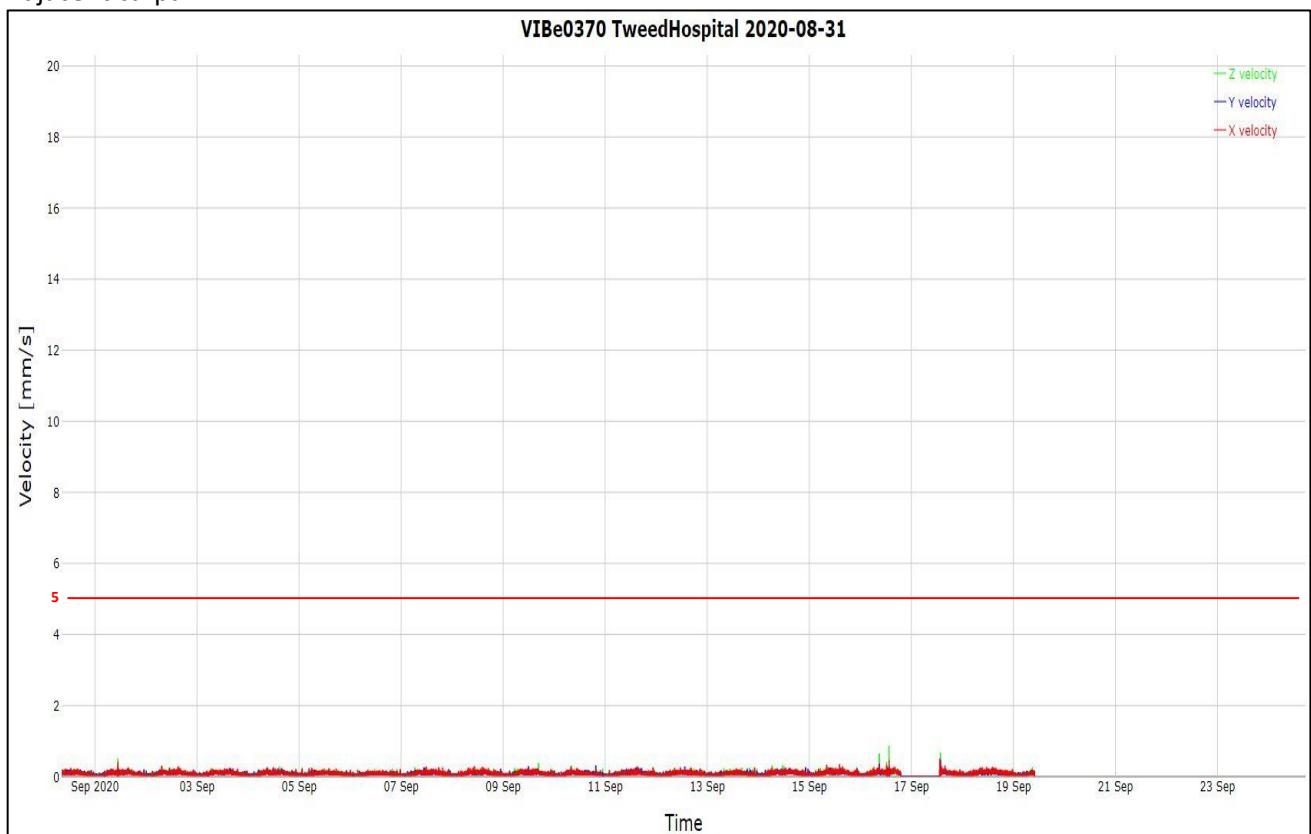
Monitor 002 experienced issues uploading to the telemetry on Wednesday 16/09/2020 @ 1900, see timeline of ADEs actions below:

- Thursday 17/09/2020 – The issue was noted in the daily checks and ADE attended site on the same day to reset the monitor.

Monitor 002 experienced further issues uploading to the telemetry on Saturday 19/09/2020 @ 1000, see timeline of ADEs actions below:

- Saturday 19/09/2020 & Sunday 20/09/2020 – Non-working days.
- Monday 21/09/2020 – The issue was noted in the daily checks, monitored via telemetry and a replacement monitor was requested from the supplier. The monitor was sent from Melbourne on the same day;
- Tuesday 22/09/2020 – New monitor arrives at suppliers office at 11:10am. Monitor is calibrated and assigned to project;
- Wednesday 23/09/2020 – ADE attends site to install new monitor, it was found that the monitor on-site experienced a “Timeout” error during an upload, this data has been sent to the tech company for further investigation/explanation. Data loss recorded from 19th September @ 1000 – 23rd September @ 0945. Rationale for these errors remains unknown and ADE is looking into alternate monitoring options should the issue continue.

Figure 2. Results of the vibration monitoring from 1st – 19th September 2020 at monitoring location 002 – Central monitor.

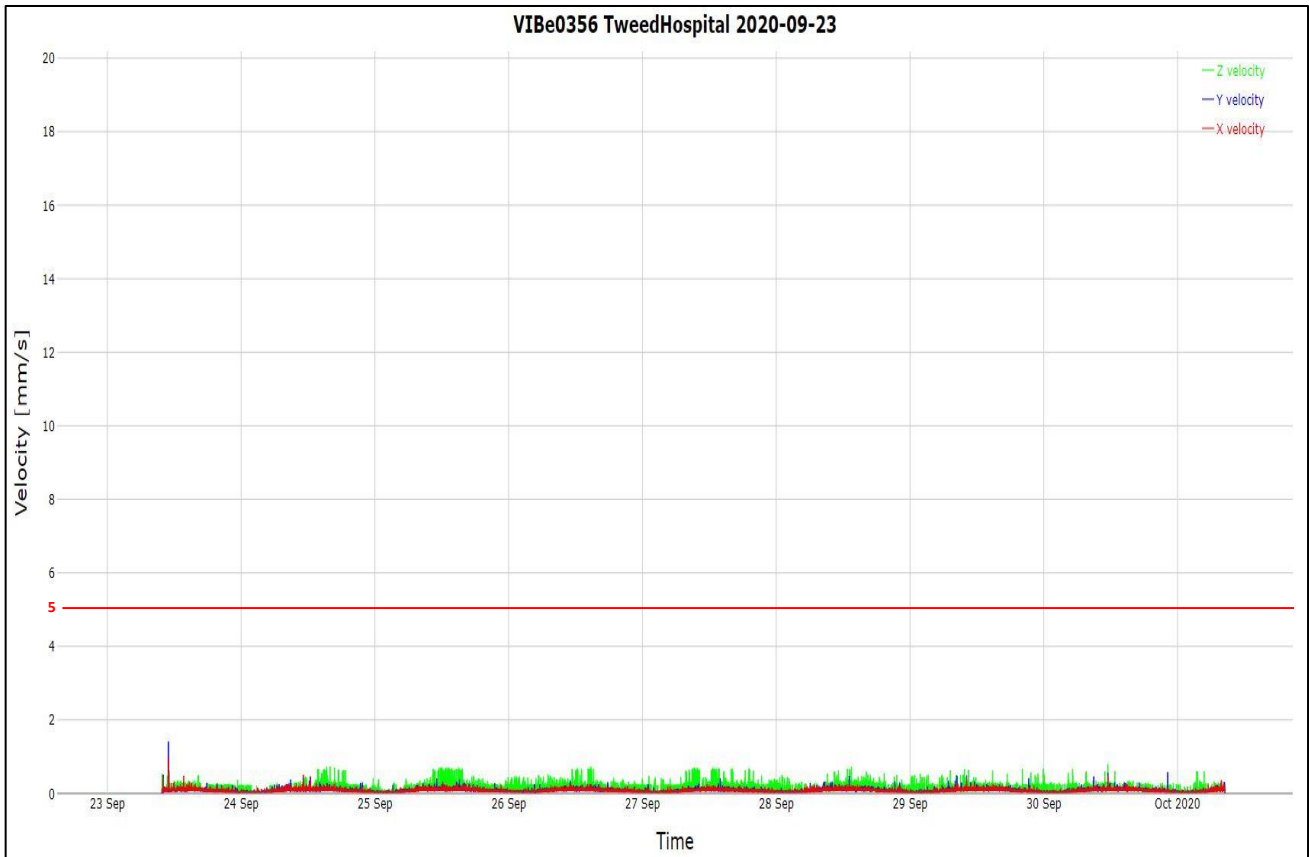
Figure 3. Results of the vibration monitoring from 23rd – 30th September 2020 at monitoring location 002 – Central monitor.

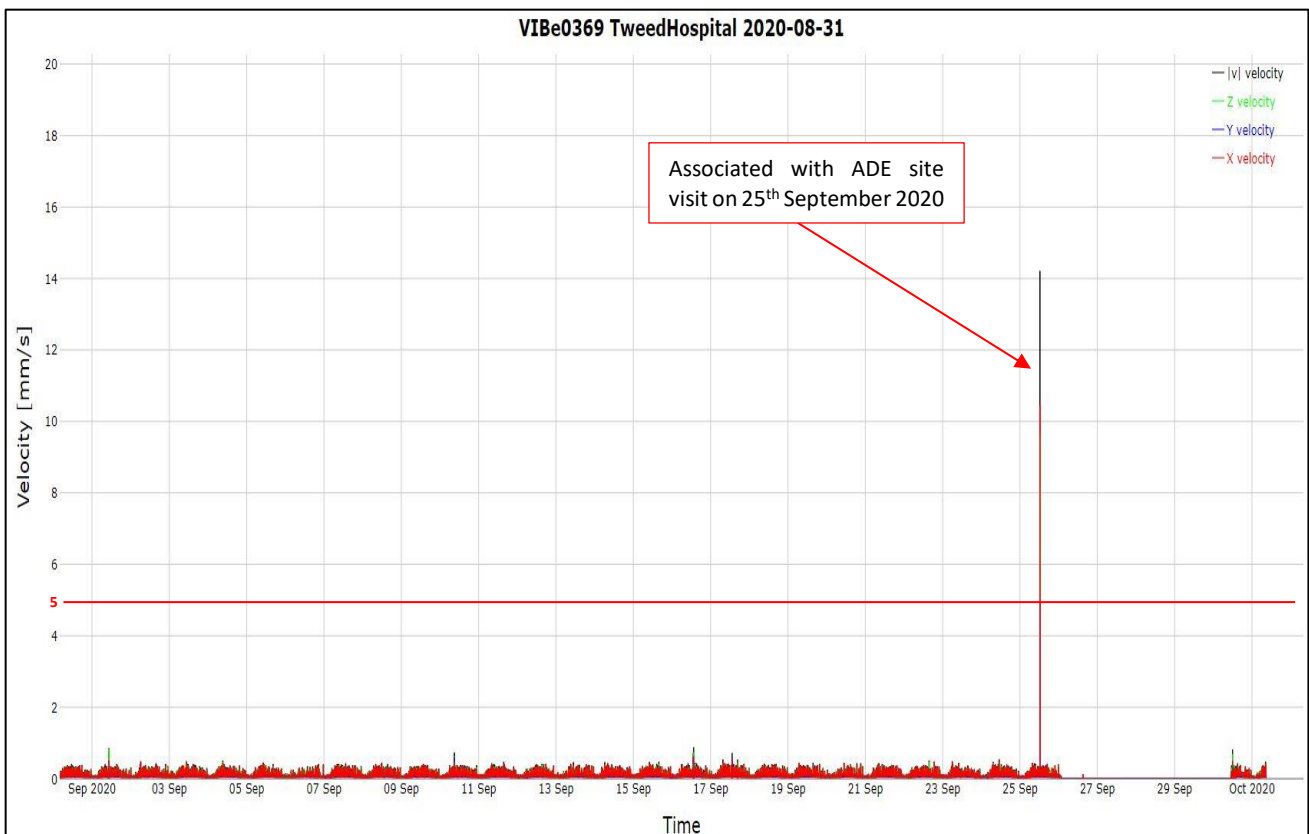
- Location 003
 - 25th of September.

ADE notes that values >5mm/s recorded on the 25th of September coincide with ADE site visits (refer to **Appendix III – ADE Site Time Summary**). ADE visits to monitor the instruments caused false readings not related to construction works and therefore have been omitted from the report.

Monitor 003 experienced issues uploading to the telemetry on Friday 25/09/2020 @ 2159, see timeline of ADEs actions below:

- Monday 28/09/2020 - The issue was noted in the daily checks, monitored via telemetry and ADE attempted to contact the supplier to provide solution;
- Tuesday 29/09/2020 – No remote solution could be determined;
- Wednesday 30/09/2020 – Issues persists and ADE attends site to reset the monitor. ADE is looking into alternate monitoring options should the issue continue.

Figure 4. Results of the vibration monitoring from 1st – 30th September 2020 at monitoring location 003 – Eastern section.
