Vibration Monitoring Assessment Report (April 2020)

771 Cudgen Road, Kingscliff NSW

Prepared for: Delta Group

DLT-01-Q1013 / VIB9 / v1.4f
23rd June 2020

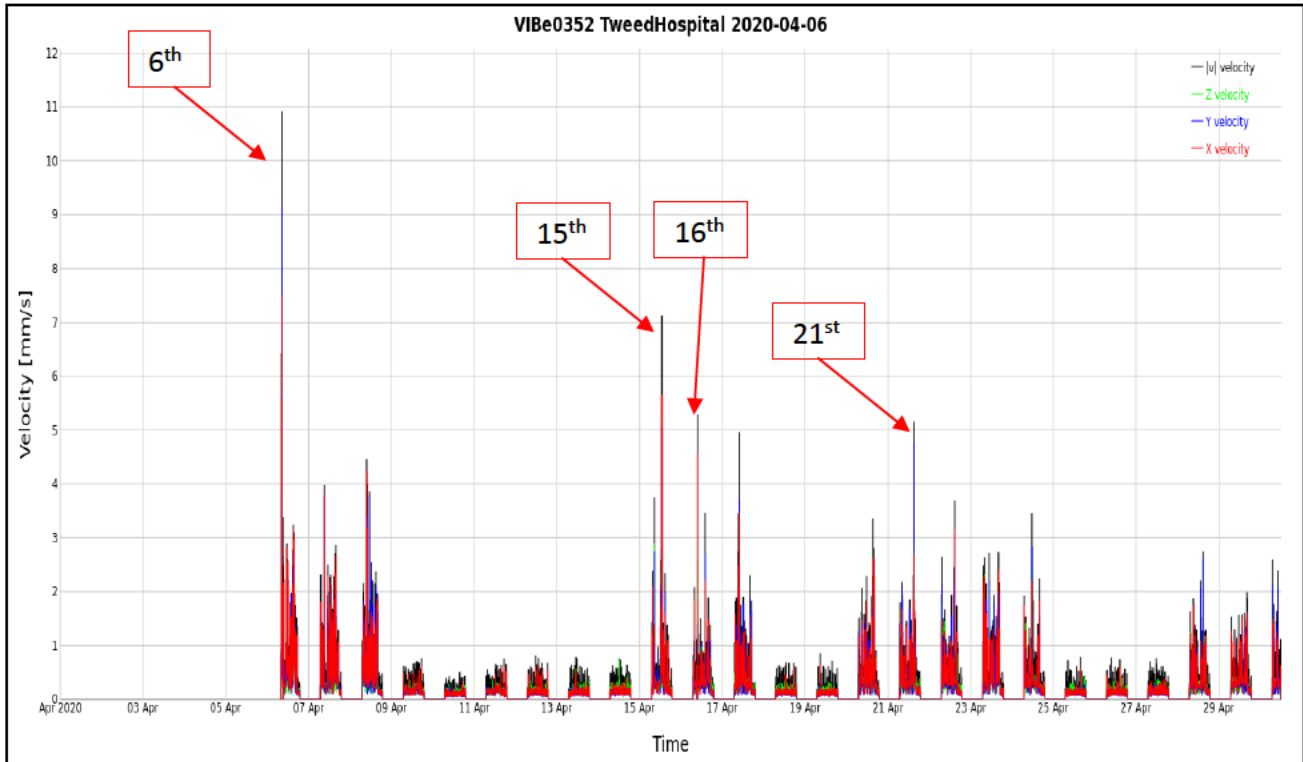
ADE notes that values >5mm/s recorded at Monitoring Location 001 (Figure 1) and Monitoring Location 003 (Figure 3) on the 16th and 23rd can be correlated to ADE site visits (refer to *Appendix B – ADE Site Time Summary*). As such, no comparison against Line 1 and Line 2 from Graph 1 has been completed.

A value >5mm/s on the 6th April 2020 was recorded at location 001 – Adjacent carpark from 0813 to 0830 while ADE was on-site, the cause of the exceedance was a soil roller-compactator operating approximately 10 metres away from the monitor (refer to Figure 4). Values have exceeded Line 2. As per Table 2 of the NSW Government *Construction Noise and Vibration Guideline (2016)*, a vibratory roller above 18 tonnes has a minimum working distance of 25m for cosmetic damage. The distance between the monitor and the sensitive receiver is 36m. Therefore, the vibration at the receiver would be below lines 1 & 2.

Figure 1. Results of the vibration monitoring from Wednesday 1st April 2020 to Thursday 30th April 2020 at monitoring location 001 – Adjacent carpark.

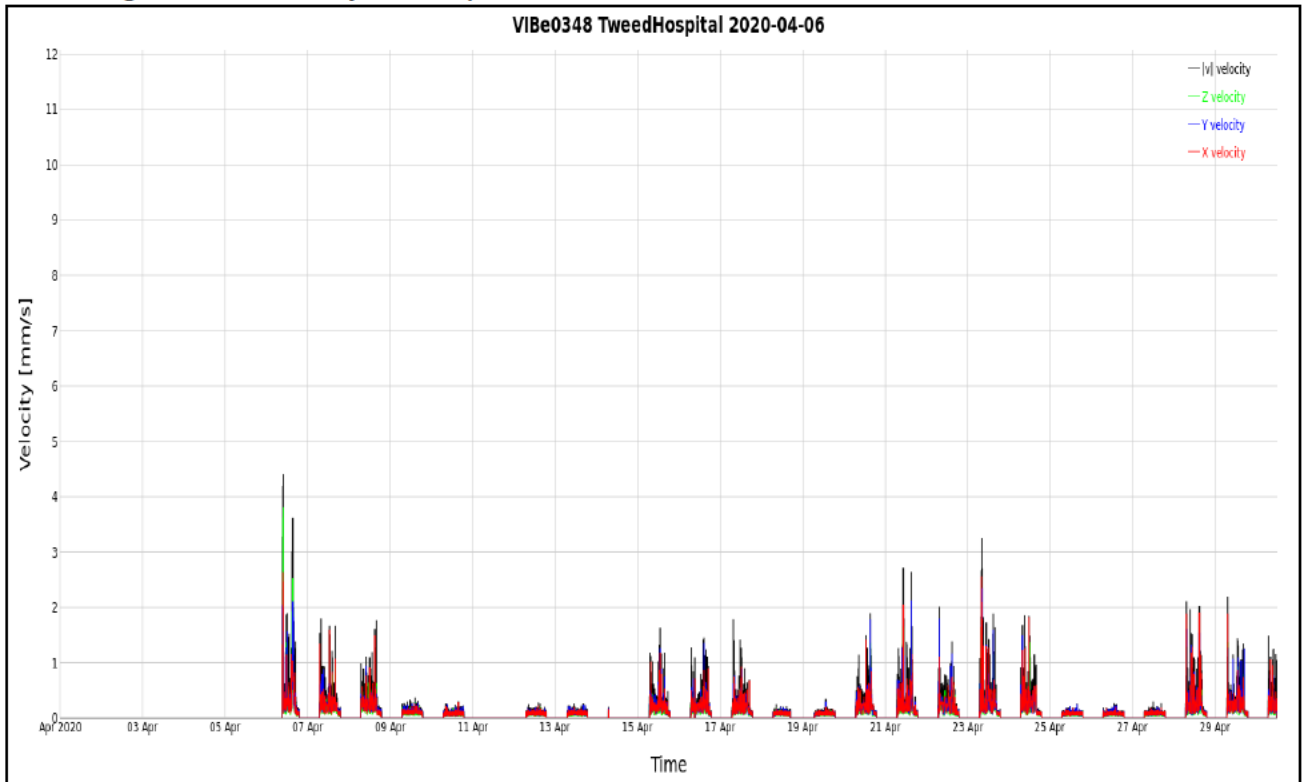
Figure 2. Results of the vibration monitoring from Wednesday 1st April 2020 to Thursday 30th April 2020 at monitoring location 002 – Central monitor.

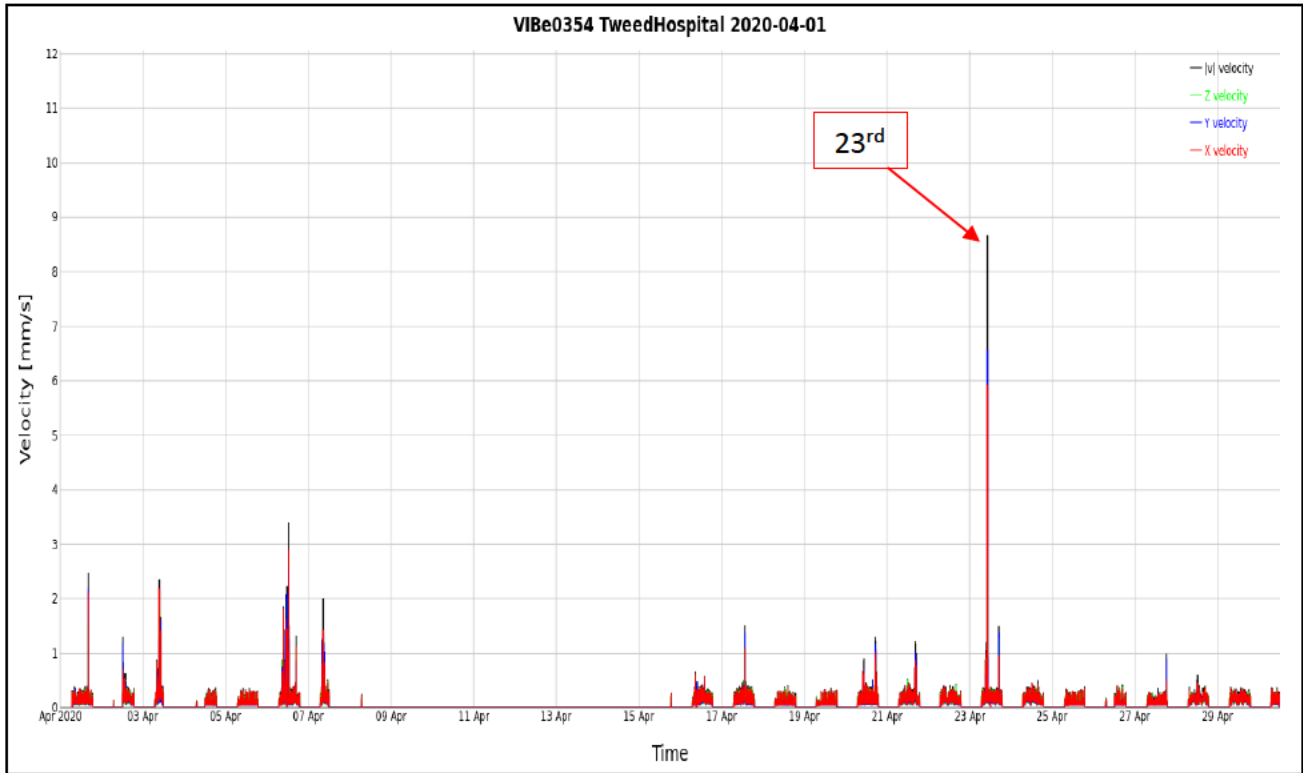
Figure 3. Results of the vibration monitoring from Wednesday 1st April 2020 to Thursday 30th April 2020 at monitoring location 003 – Eastern section of site.

Vibration values >5mm/s on the 16th of April 2020 at monitoring location 001 and the 23rd of April 2020 at monitoring location 003 were caused by ADE performing maintenance on the monitors and are not due to construction works. All other values were below Line 1 and Line 2.

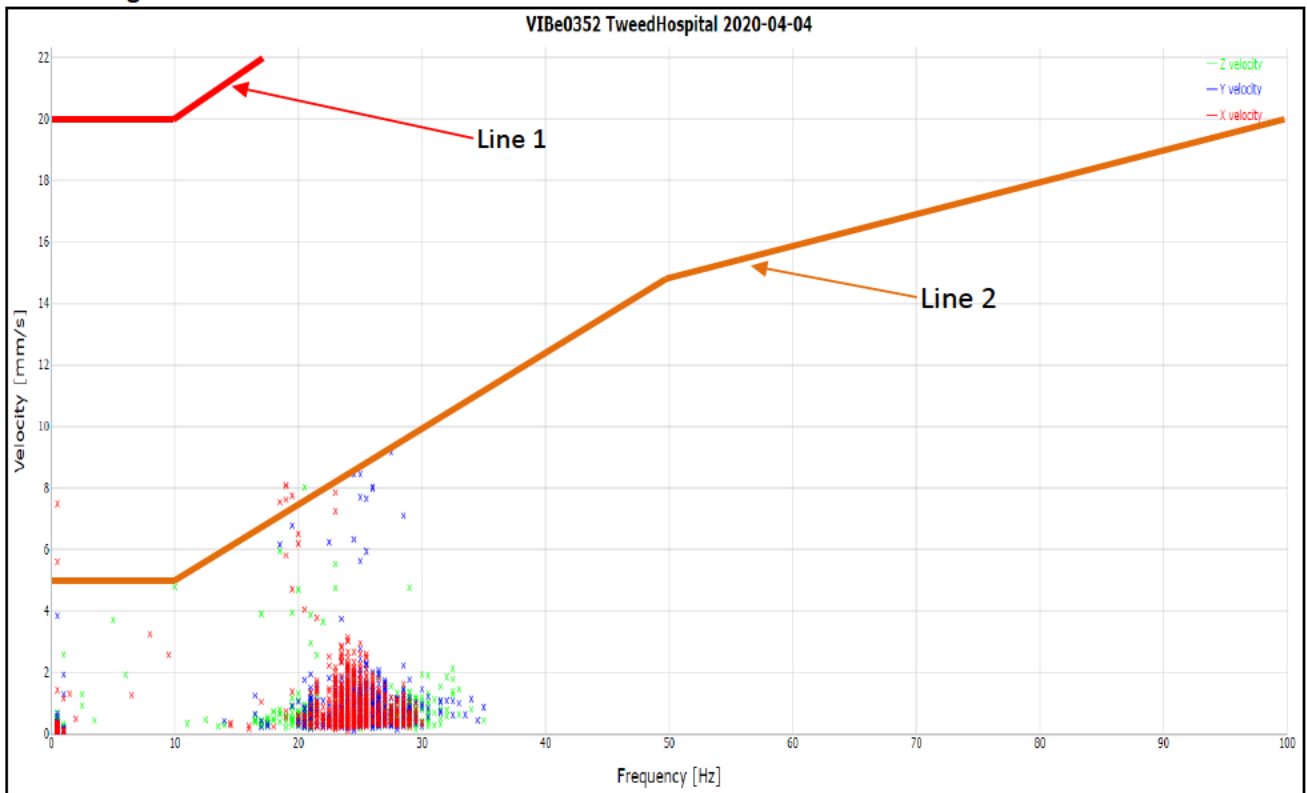
Figure 4. Results of the exceedance on Monday 6th April 2020 at monitoring location 001 – Adjacent carpark.

One exceedance of Line 2 occurred on the 6th of April between 0813 and 0830. The cause of the exceedance was a soil roller-compactor operating approximately 10 metres away from the monitor (refer to Figure 4). Values have exceeded Line 2. As per Table 2 of the NSW Government *Construction Noise and Vibration Guideline (2016)*, a vibratory roller above 18 tonnes has a minimum working distance of 25m for cosmetic damage. The distance between the monitor and the sensitive receiver is 36m. Therefore, the vibration at the receiver would be below lines 1 & 2.

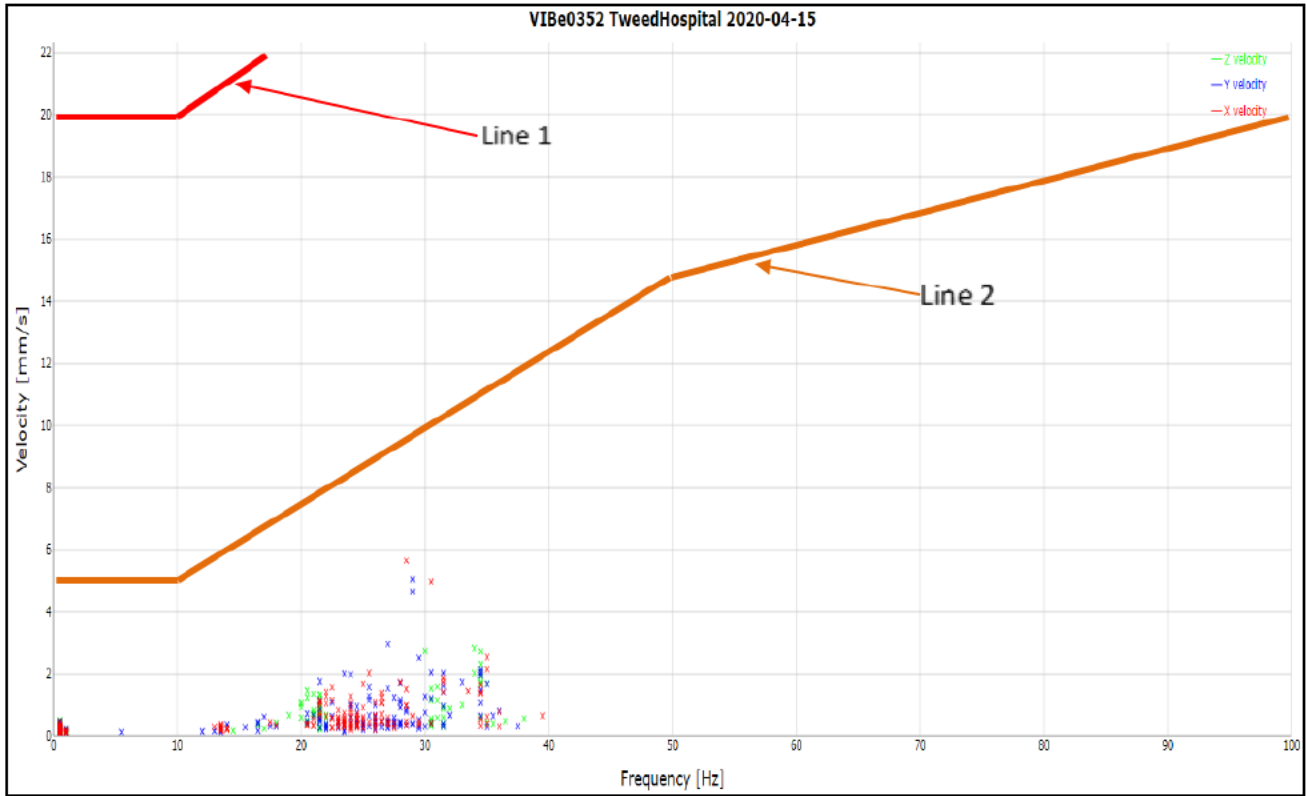
Figure 5. Results of the exceedance on Wednesday 15th April 2020 at monitoring location 001 – Adjacent carpark.

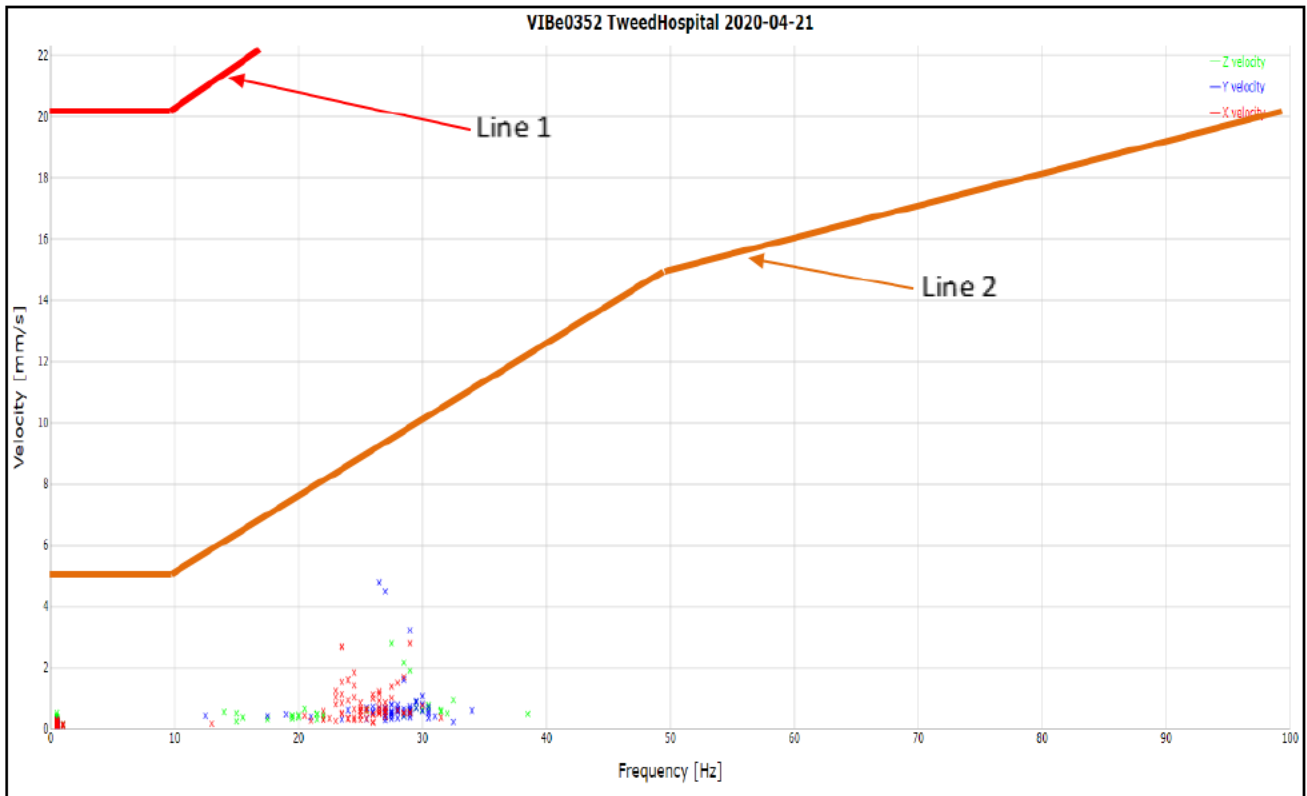
Figure 7. Results of the exceedance on Tuesday 21st April 2020 at monitoring location 001 – Adjacent carpark.

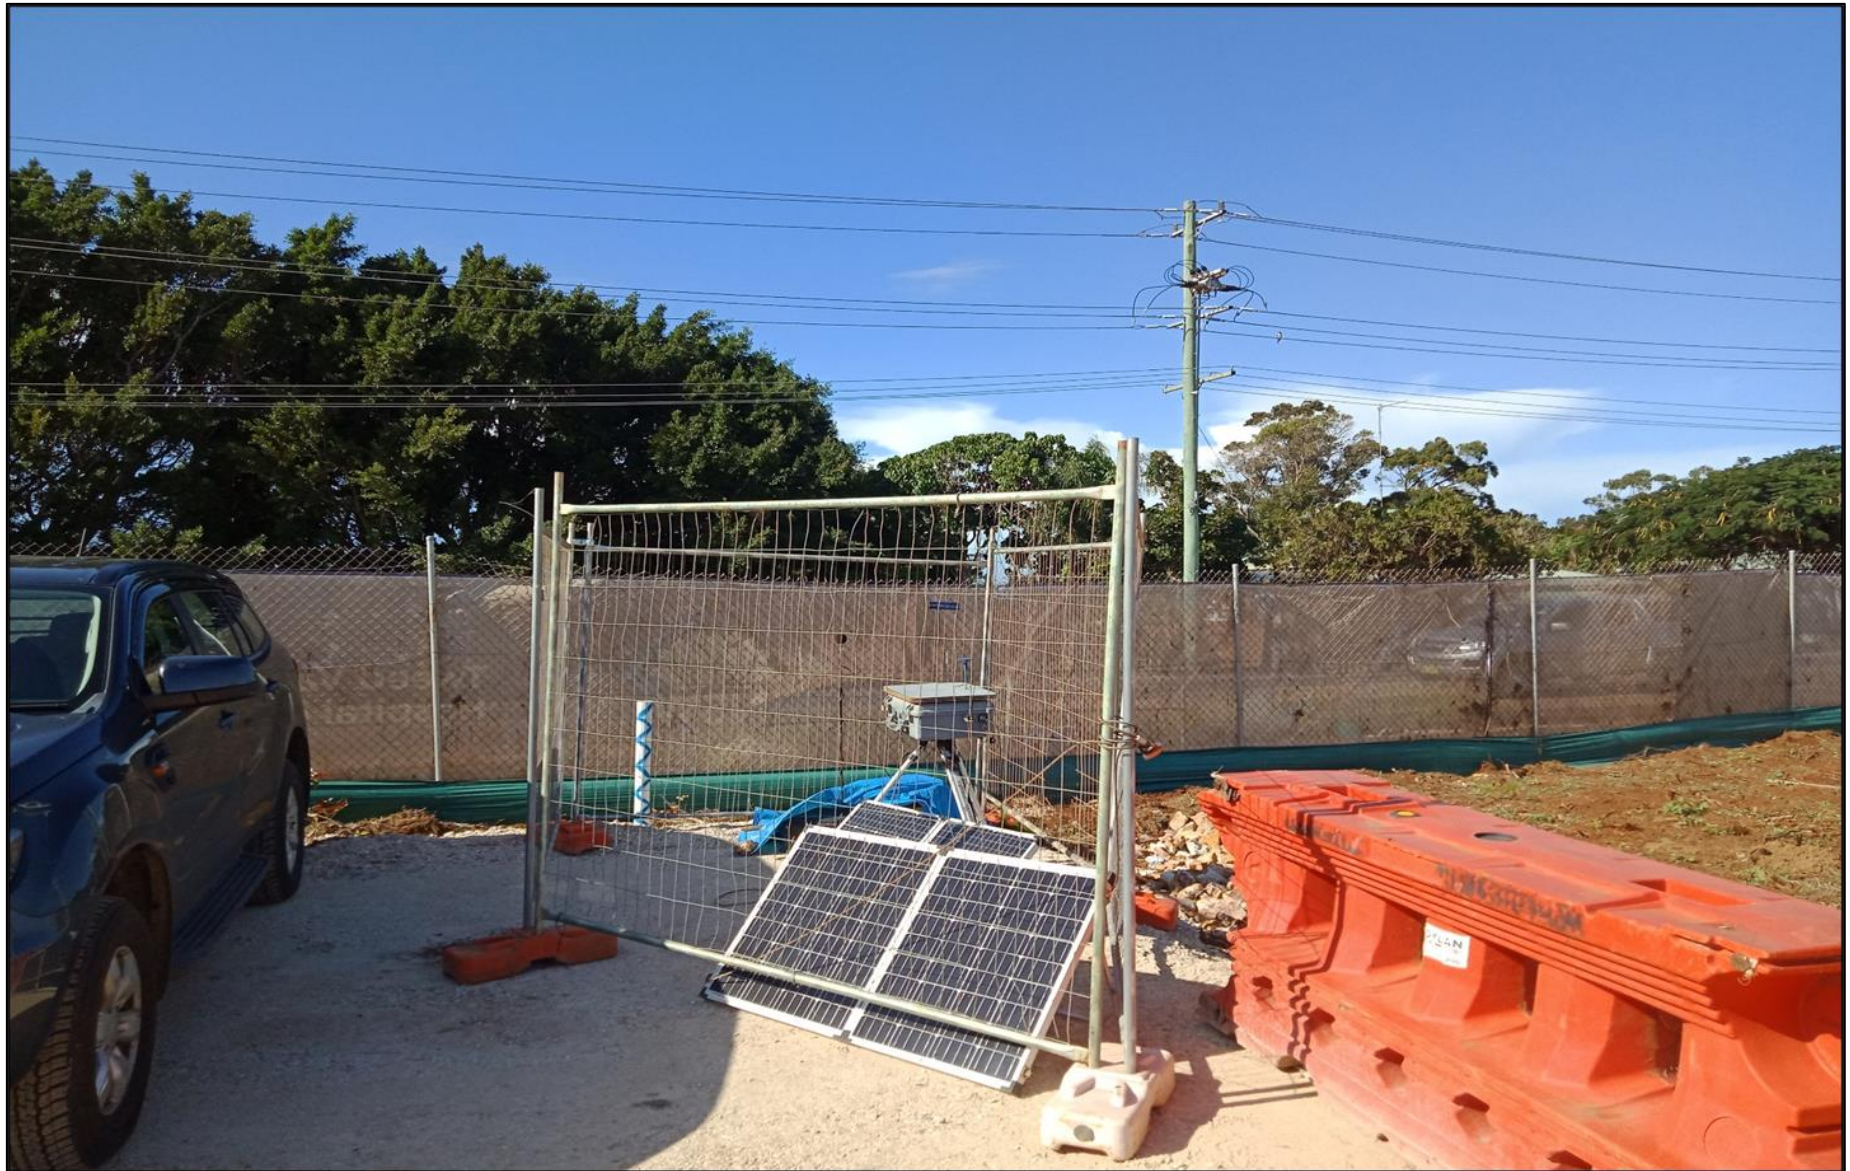
Photograph 1. Representative photo of the monitoring location 001 – Adjacent Carpark location, as observed on the 05.05.2020.

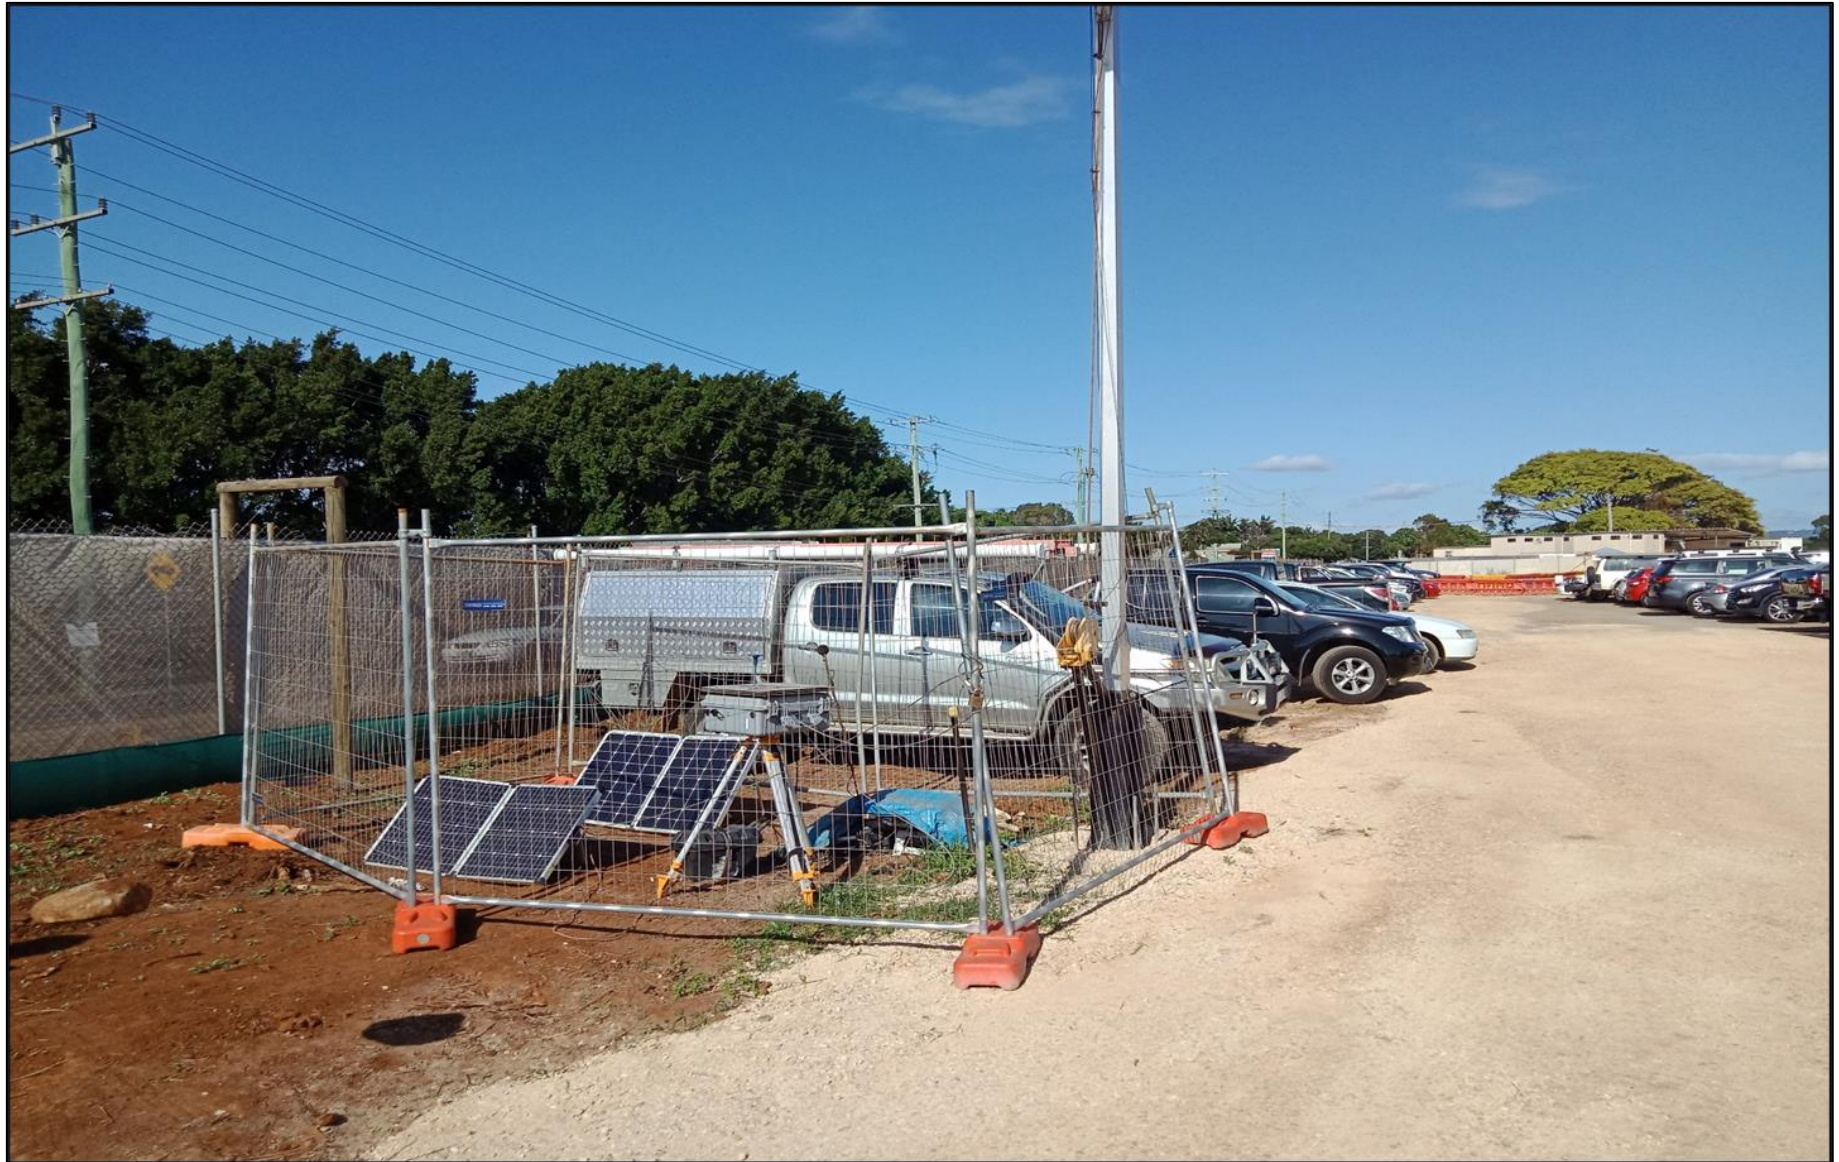
Photograph 2. Representative photo of the monitoring location 002 – Central location, as observed on the 05.05.2020.

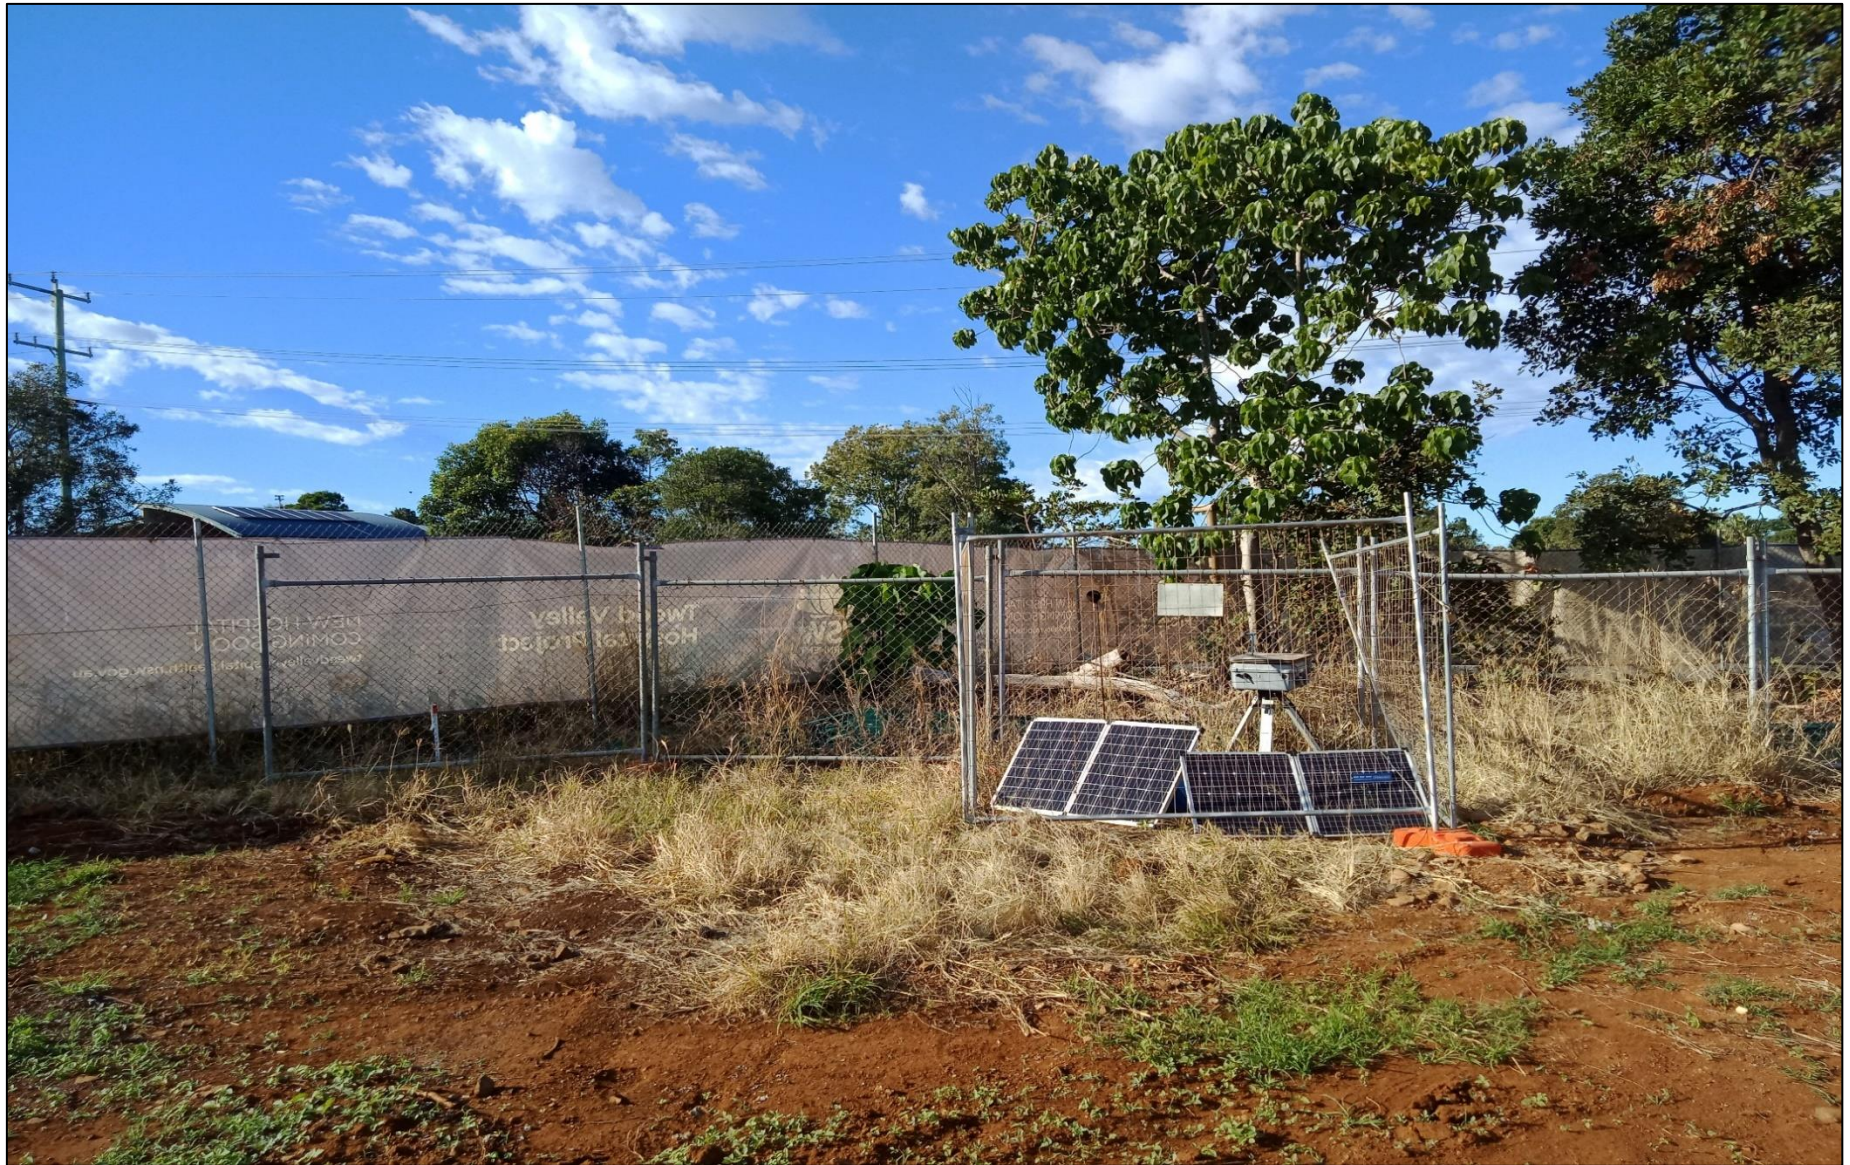
Photograph 3. Representative photo of the monitoring location 003 – Eastern Section of Site, as observed on the 01.05.2020.
