Vibration Monitoring Assessment Report (February 2020)

771 Cudgen Road, Kingscliff NSW

Prepared for: Delta Group

DLT-01-Q1013 / VIB7 / v1.4f
23rd June 2020

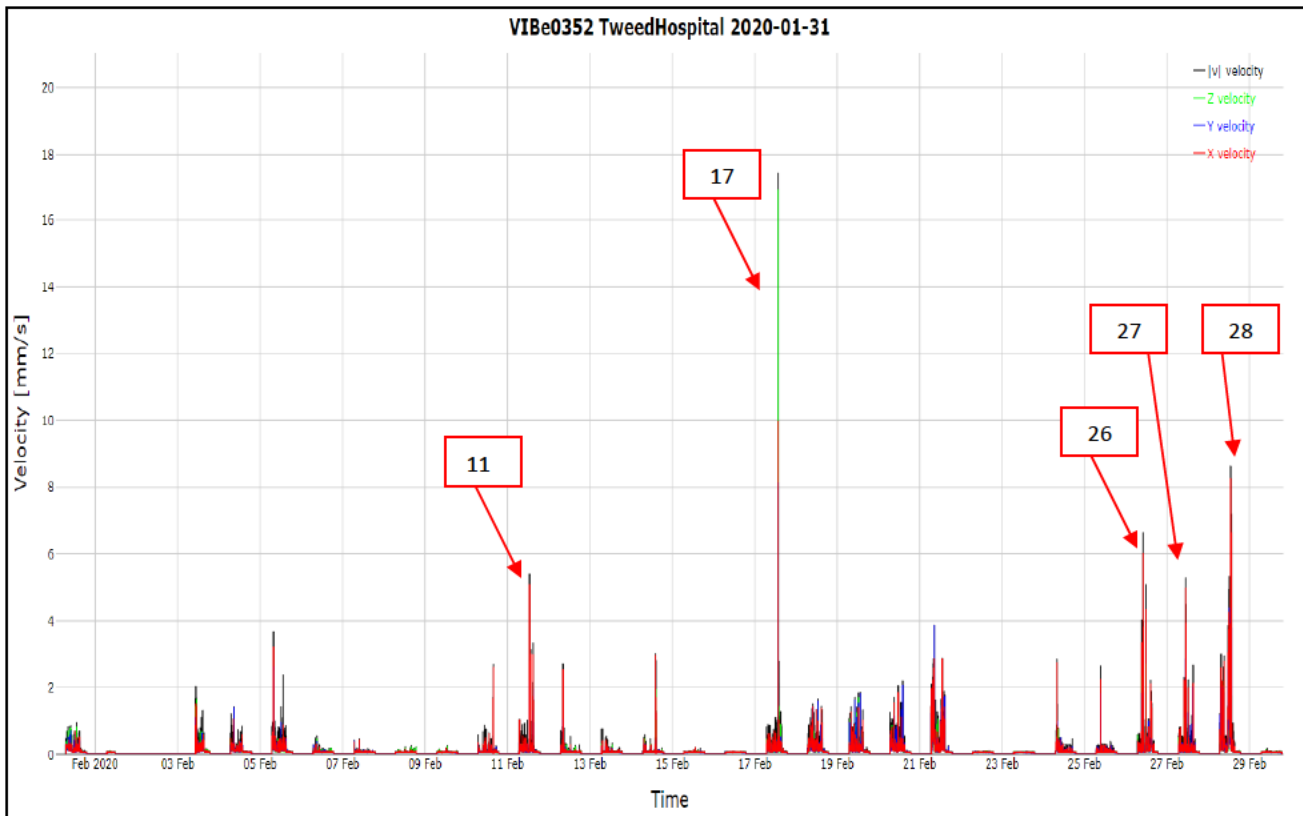
Figure 2. Results of the vibration monitoring from Saturday 1st February 2020 to Saturday 29th February 2020 at monitoring location 001 – Adjacent carpark.

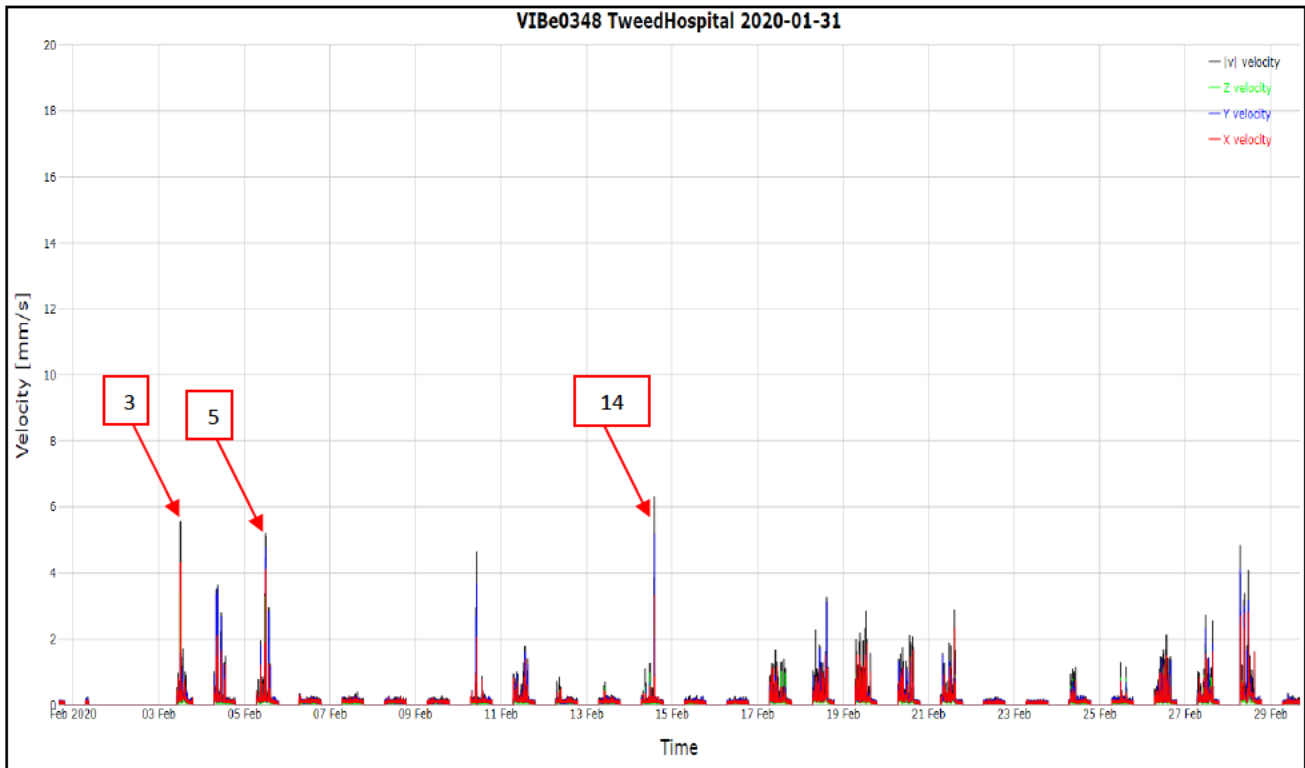
Figure 3. Results of the vibration monitoring from Saturday 1st February 2020 to Saturday 29th February 2020 at monitoring location 002 – Central monitor.

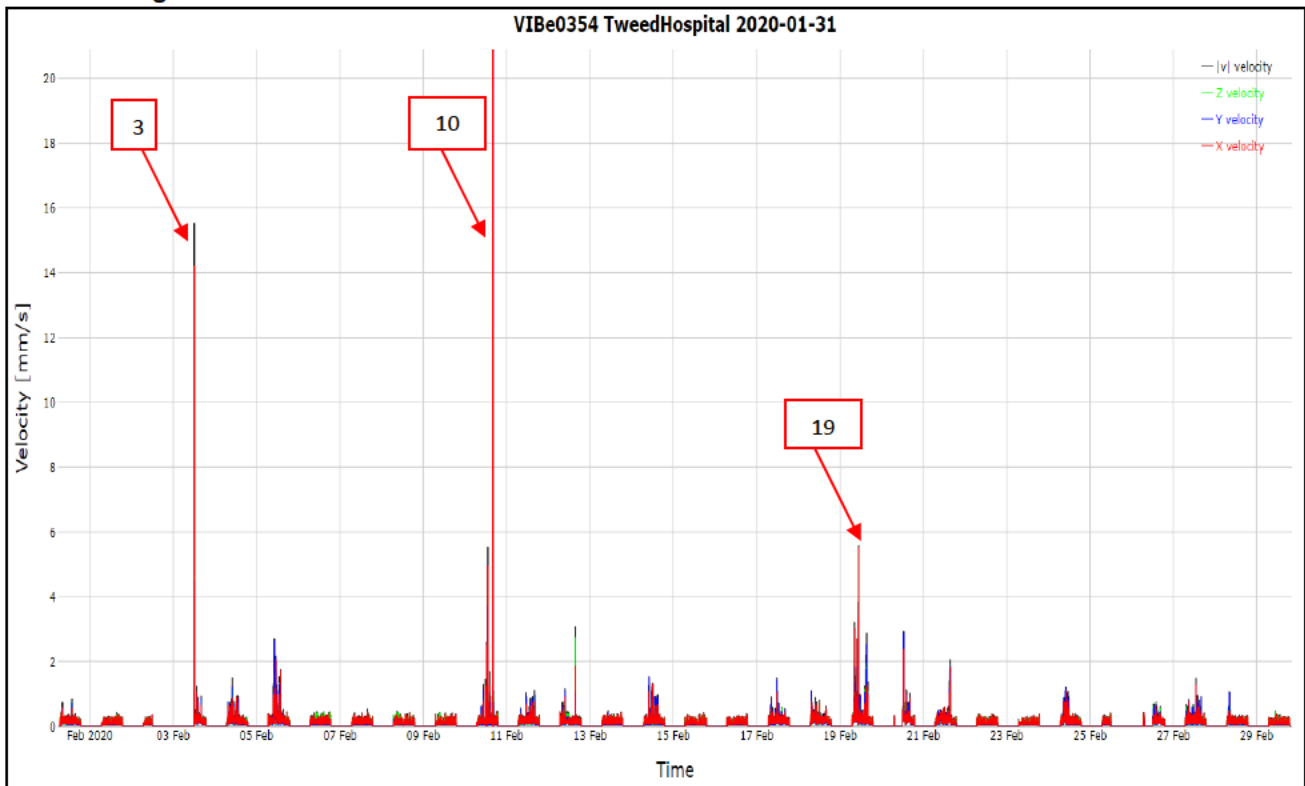
Figure 4. Results of the vibration monitoring from Saturday 1st February 2020 to Saturday 29th February 2020 at monitoring location 003 – Eastern section of site.

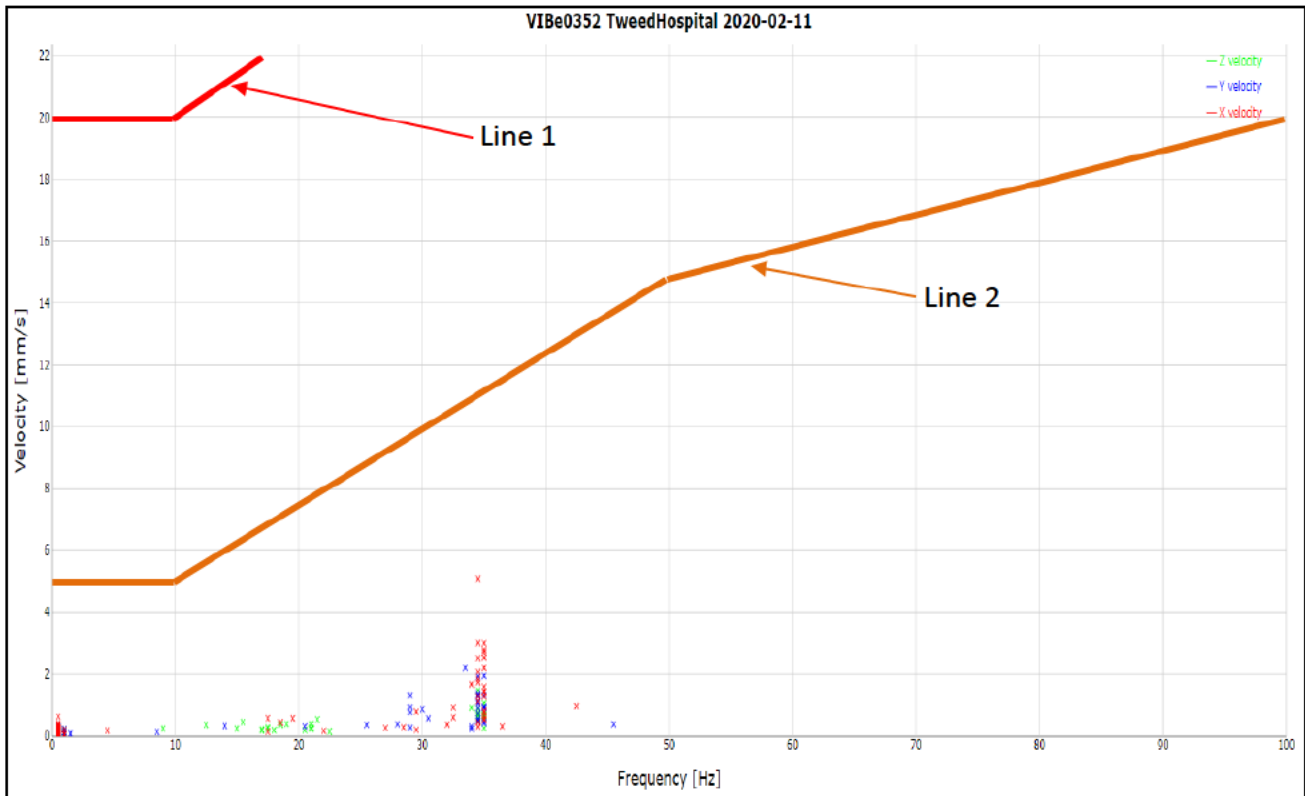
Figure 5. Results of the exceedance on Tuesday 11th February 2020 at monitoring location 001 – adjacent carpark monitor.

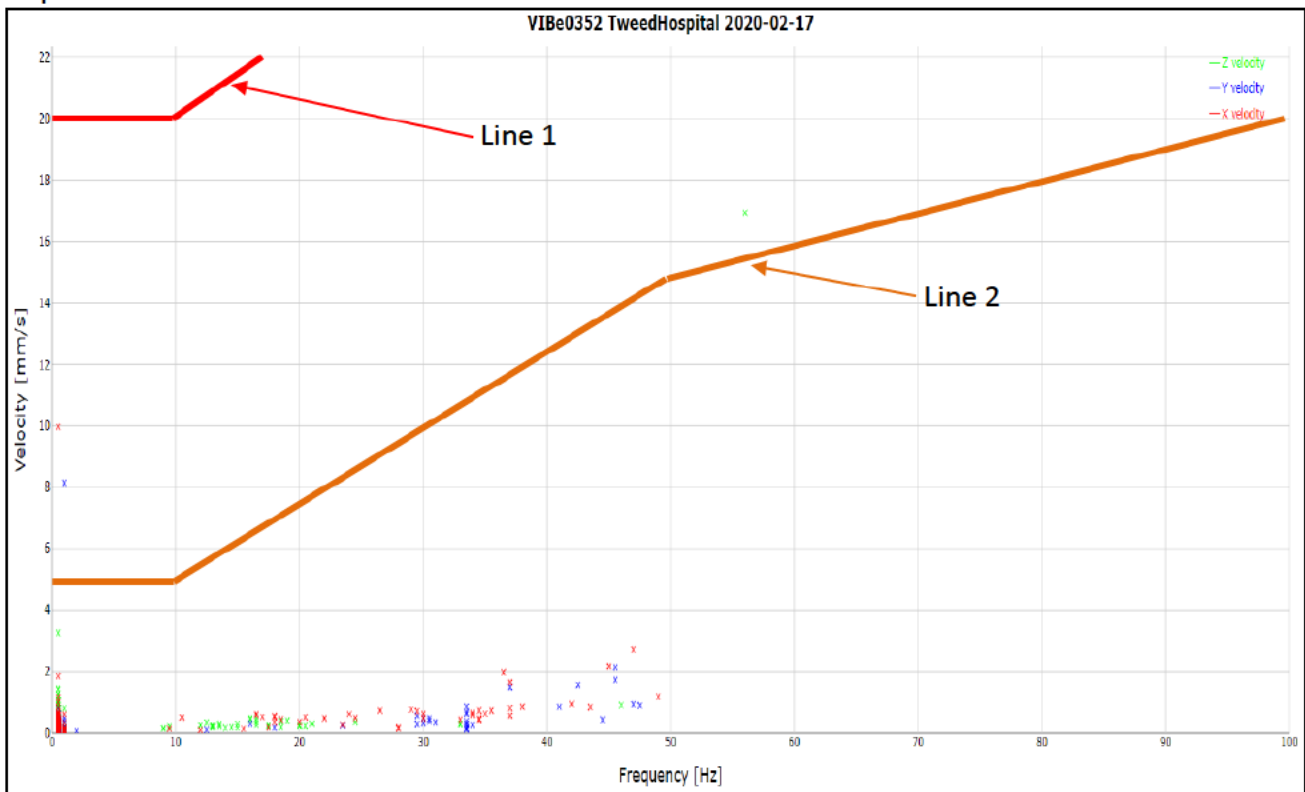
A value >5mm/s on the 17th February 2020 was recorded at location 001 was due to the extension of the sub-contractor carpark. Heavy machinery was operating within 10 metres of the monitor. Values have exceeded Line 2. It is noted that the exceedance on the 17th of February was caused by a 'one off' activity and will not occur again. All other results from vibration monitoring undertaken during the monitoring period [February 2020] were **below** the threshold used to assess the effects of short-term vibration on structures according to DIN 4150-3.

Figure 6. Results of the exceedance on Monday 17th February 2020 at monitoring location 001 – adjacent carpark monitor.

One (1) exceedance of Line 2 occurred on the 17th of February at monitoring location 001 due to the extension of the sub-contractor carpark. The cause of the exceedance was a vibratory roller operating within 10 metres of the monitor. As per Table 2 of the NSW Government *Construction Noise and Vibration Guideline (2016)*, a vibratory roller above 18 tonnes has a minimum working distance of 25m for cosmetic damage. The distance between the monitor and the sensitive receiver is 36m. Therefore, the vibration at the receiver would be below lines 1 & 2.

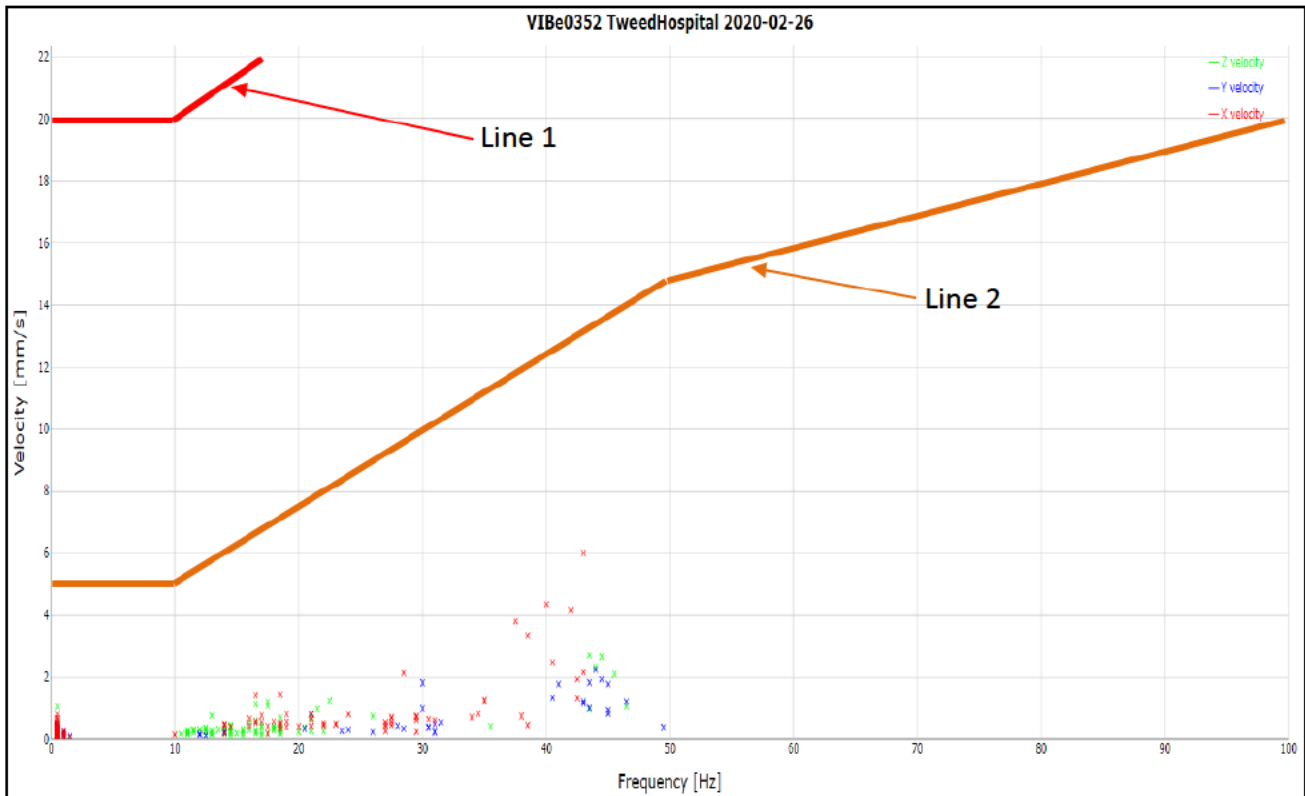
Figure 7. Results of the exceedance on Wednesday 26th February 2020 at monitoring location 001 – adjacent carpark monitor.

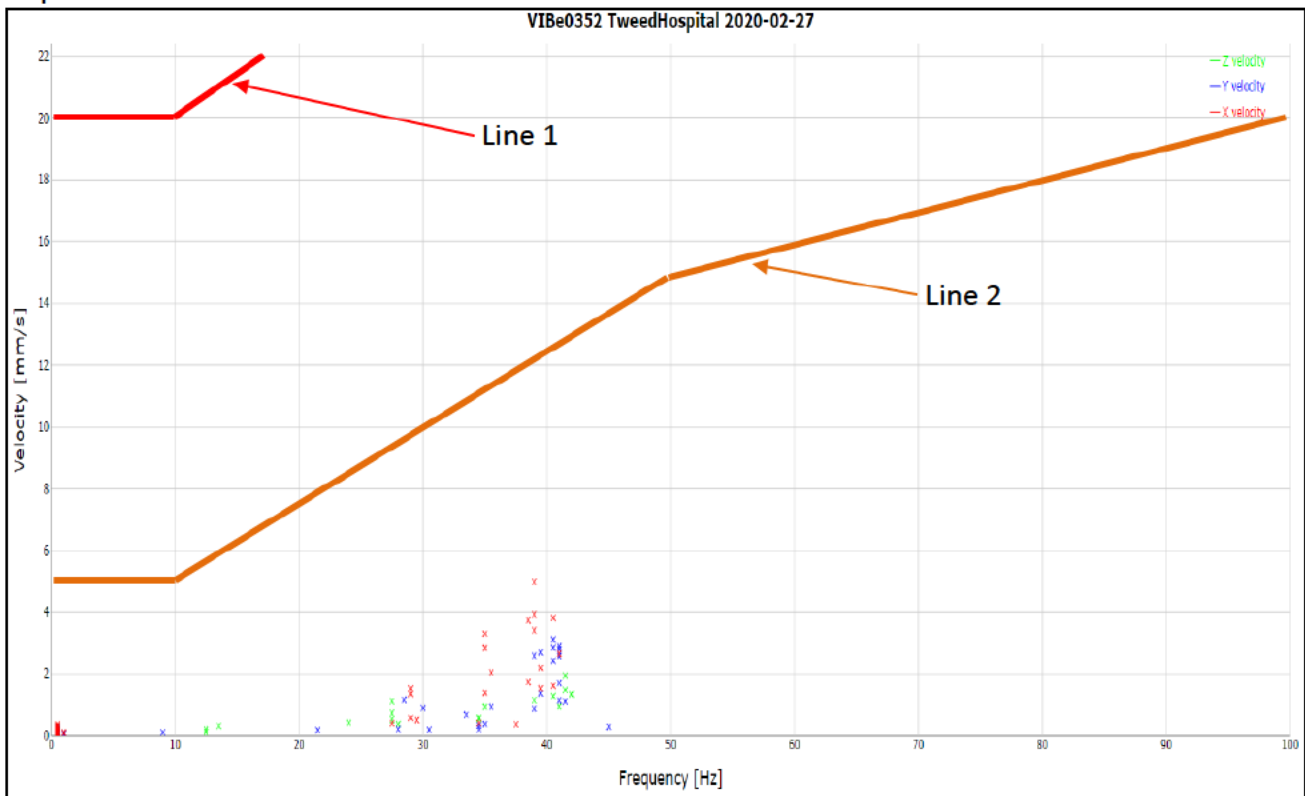
Figure 8. Results of the exceedance on Thursday 27th February 2020 at monitoring location 001 – adjacent carpark monitor.

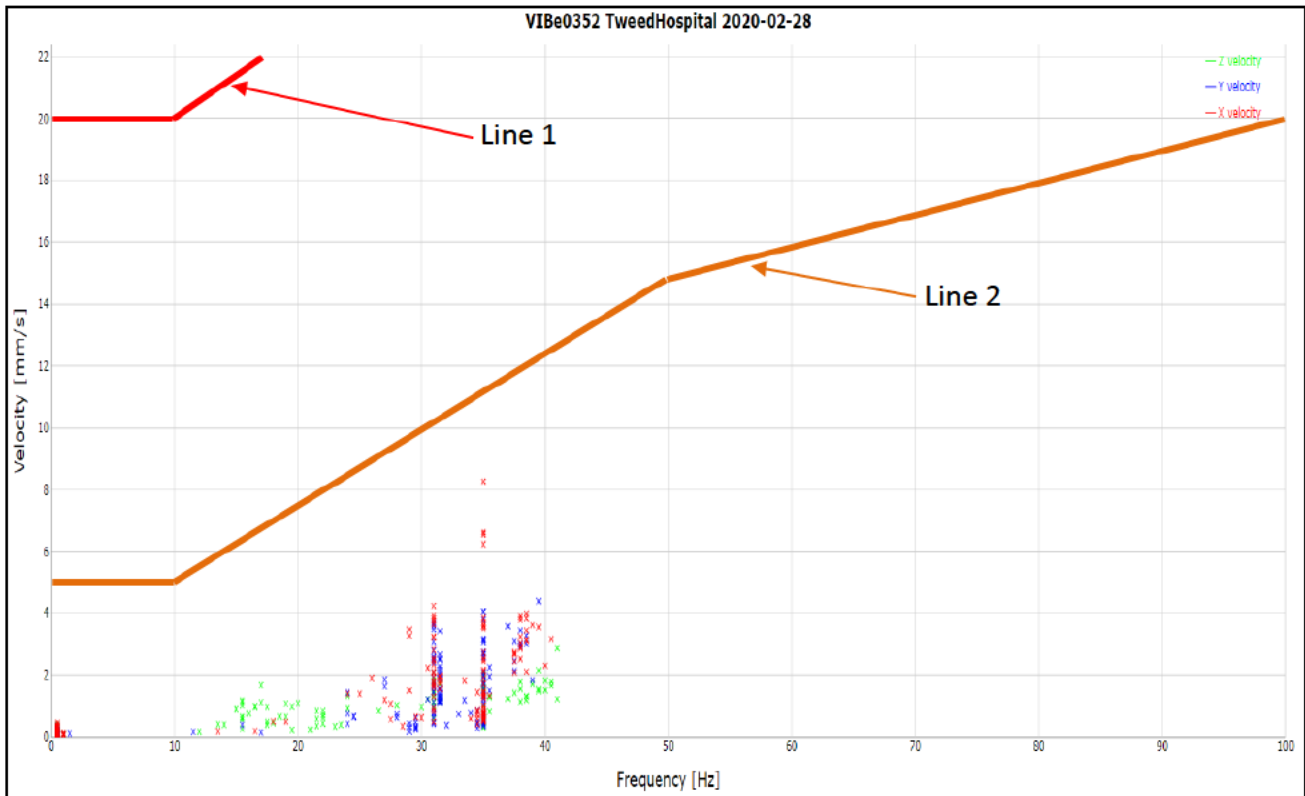
Figure 9. Results of the exceedance on Friday 28th February 2020 at monitoring location 001 – adjacent carpark monitor.

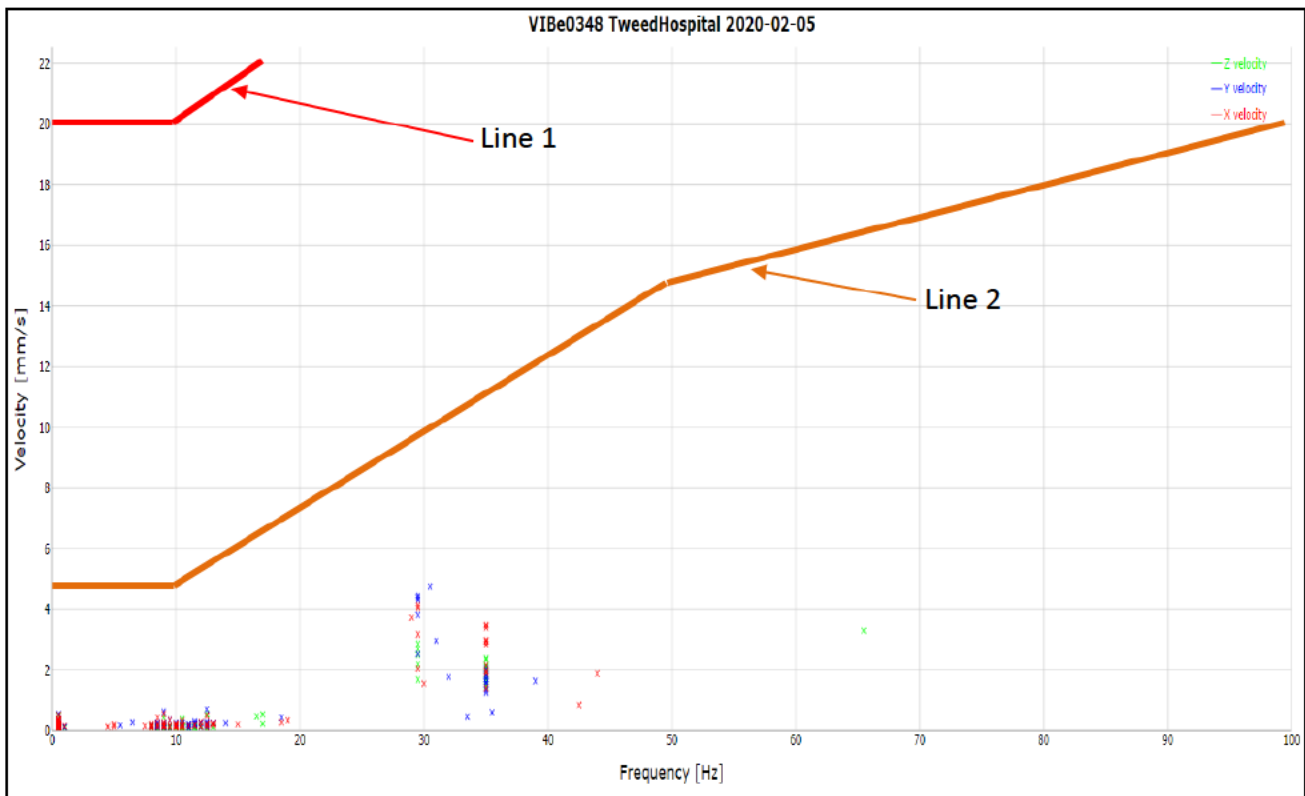
Figure 10. Results of the exceedance on Wednesday 5th February 2020 at monitoring location 002 – Central monitor.

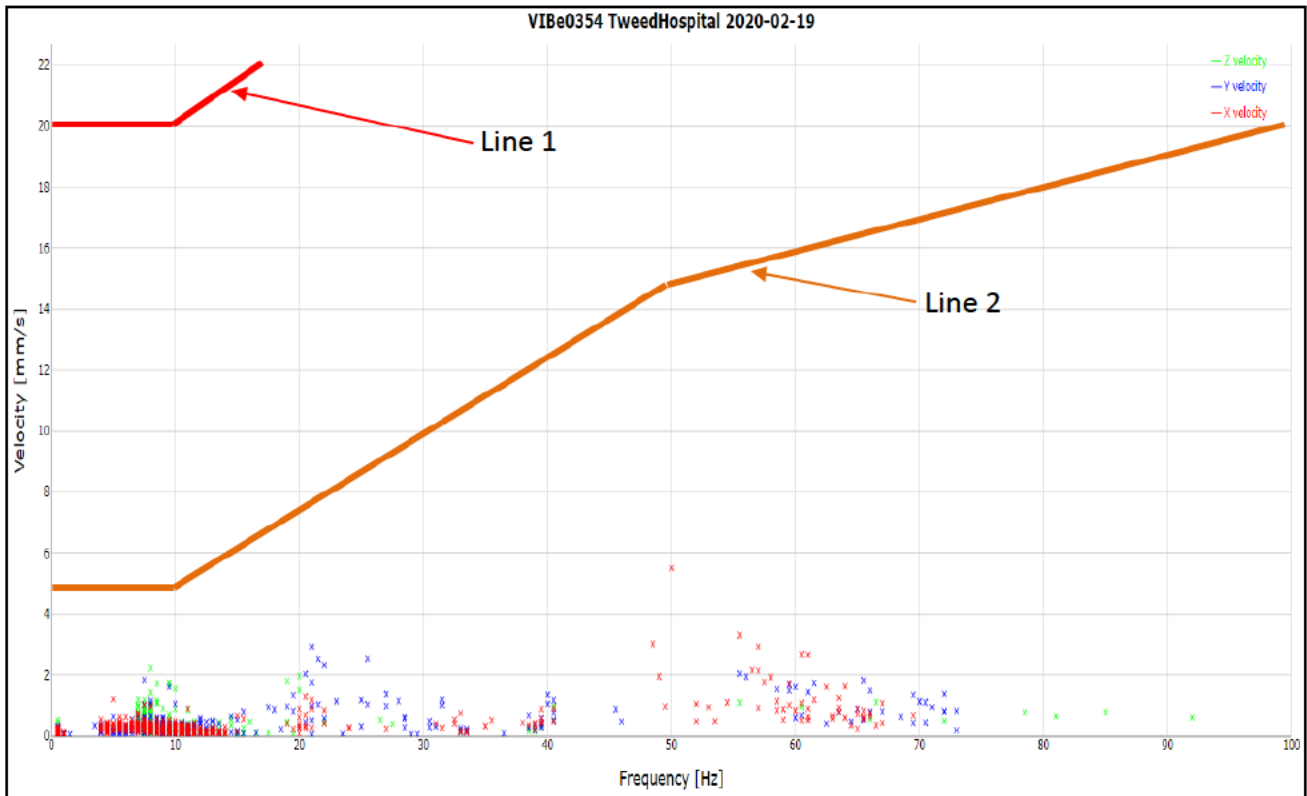
Figure 11. Results of the exceedance on Wednesday 19th February 2020 at monitoring location 003 – Eastern section of site.
