Environmental Dust Assessment Report (August 2021)

Tweed Valley Hospital Project, Cudgen NSW

Prepared for: Lendlease Building Pty Ltd

LND-01-Q1299 | EDM25.V1F | Date: 10/09/2021

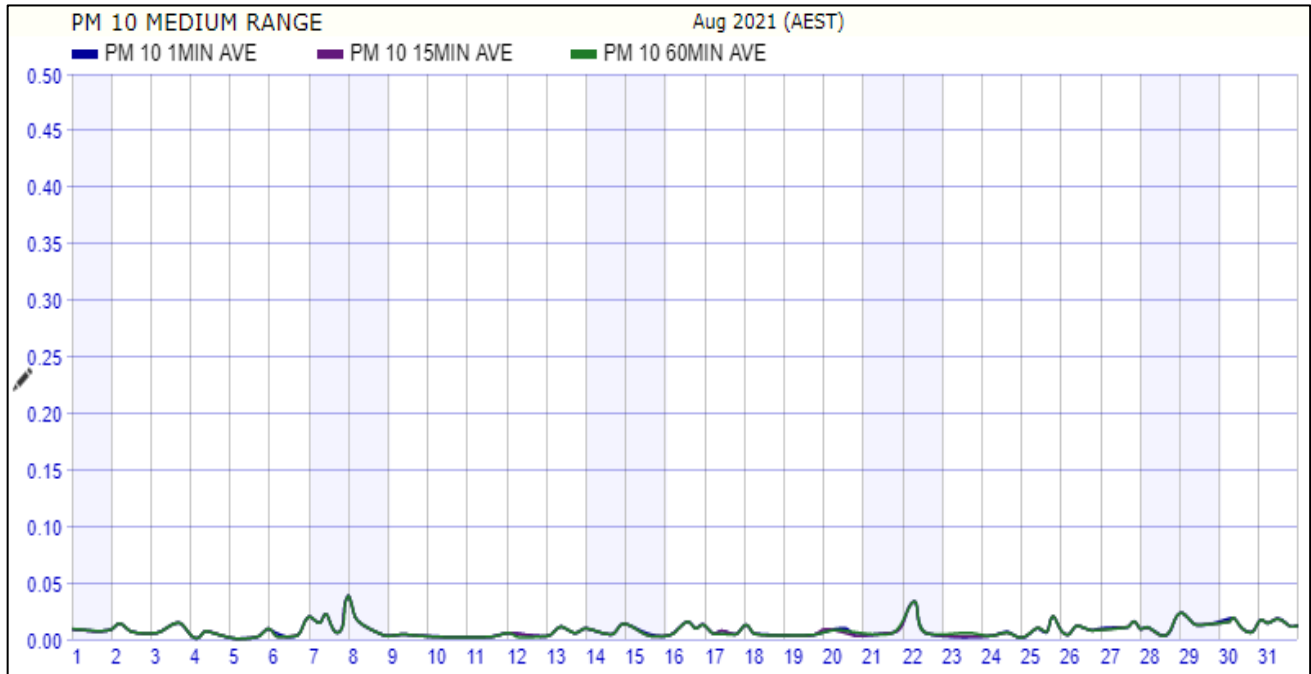
Figure 1. Summary of PM10 from the real time monitoring at location 001 – Adjacent to the carpark for the month of August 2021.

All dust levels remained below 0.5 mg/m^3 during the month of August 2021 (*refer to Section 3*).

Ensure adequate dust control measures continue to be implemented as per the Tweed Valley Hospital Management Plan – Air Quality and continue monitoring of PM10 for the duration of the project. If the action limit of 2.5 mg/m^3 (8-hour time weighted average) is exceeded, cease works and review and implement additional dust prevention techniques.

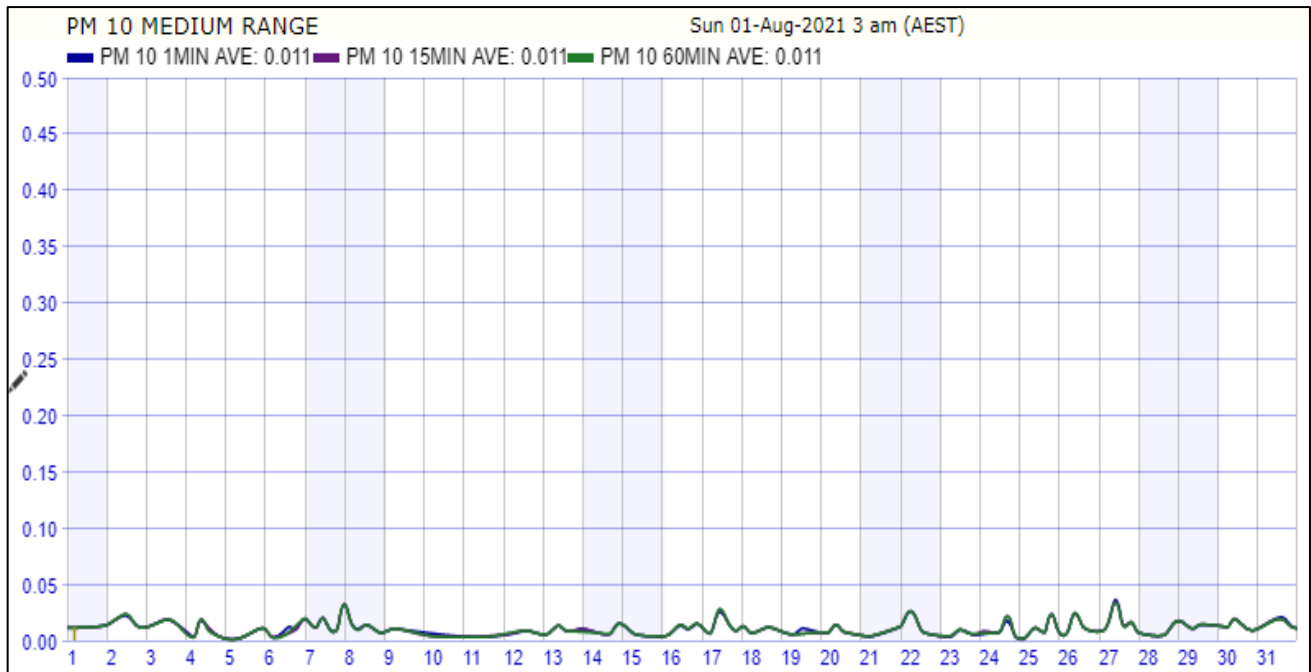
Figure 2. Summary of PM10 from the real time monitoring at location 002 – Central location for the month of August 2021.

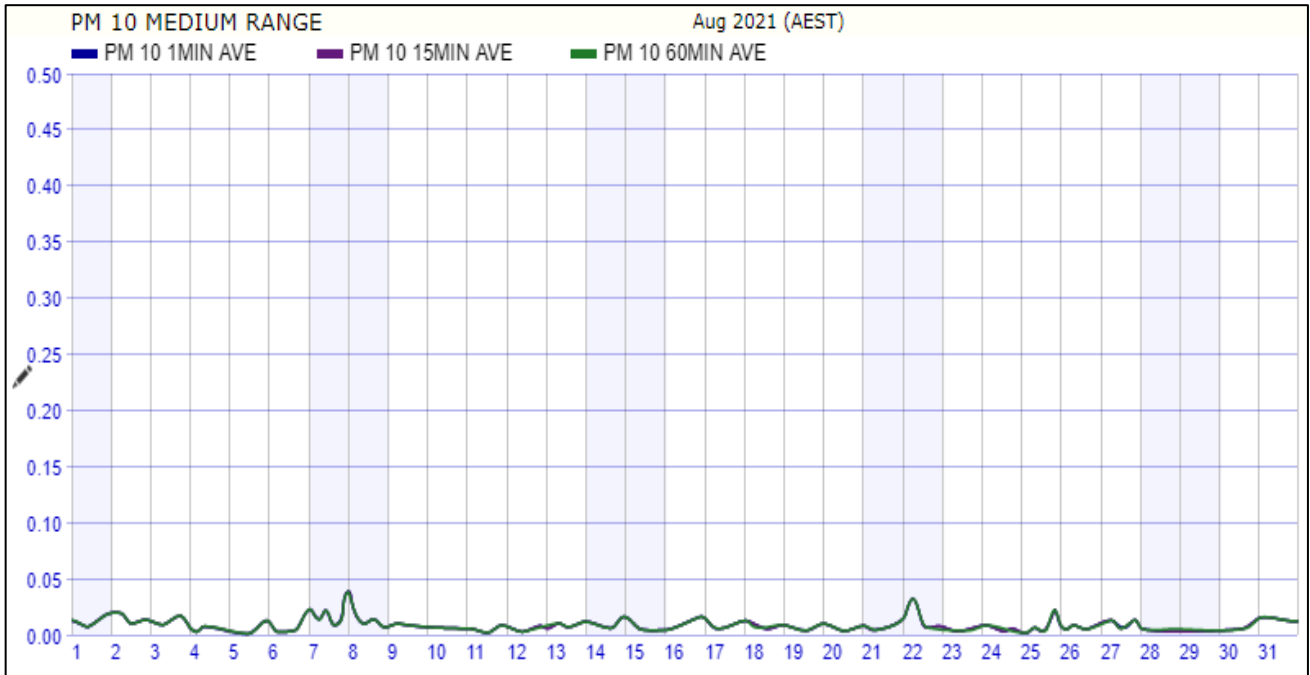
Figure 3. Summary of PM10 from the real time monitoring at location 003 – Eastern Section of site for the month of August 2021.

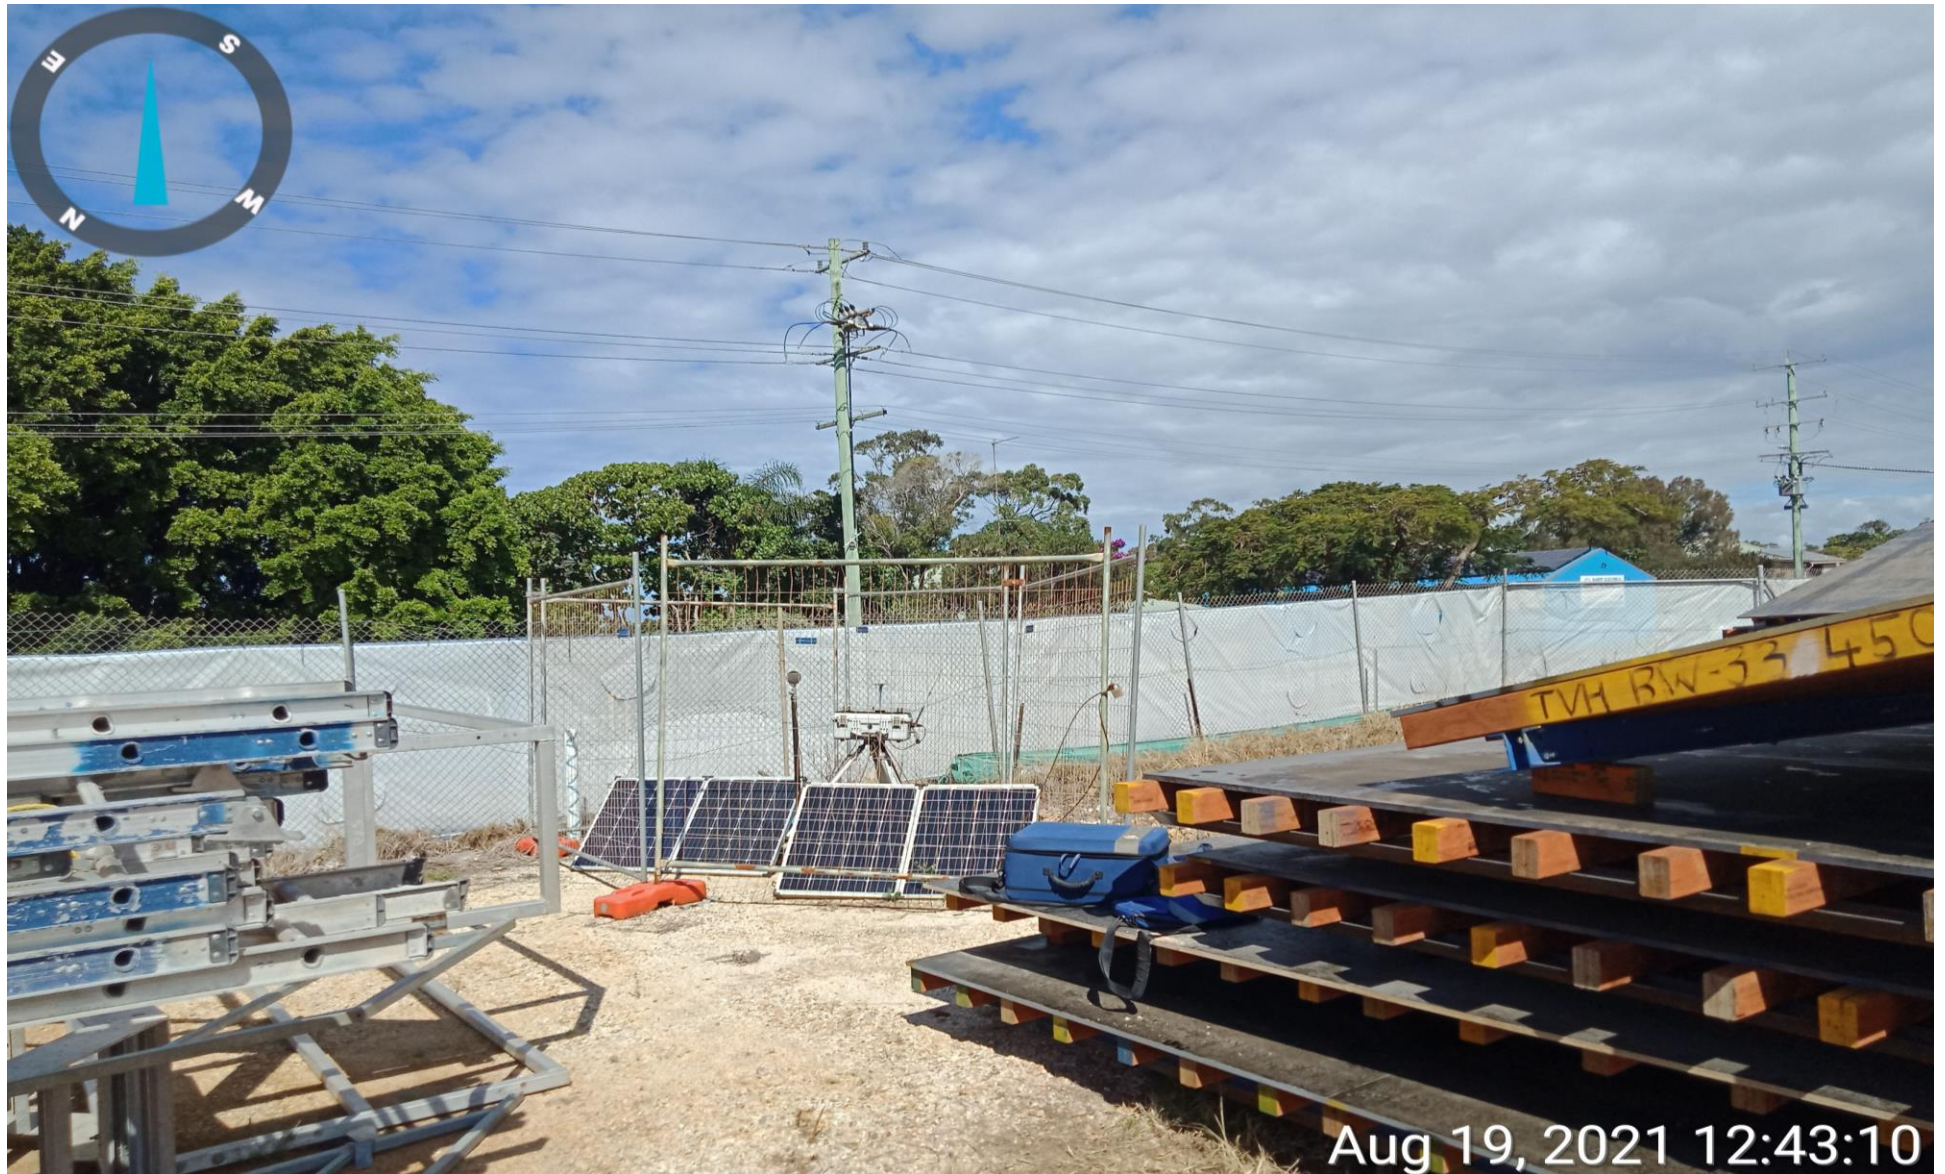
Photograph 1 Representative photograph of monitoring location 001 – Adjacent Carpark location, as observed 19/08/2021

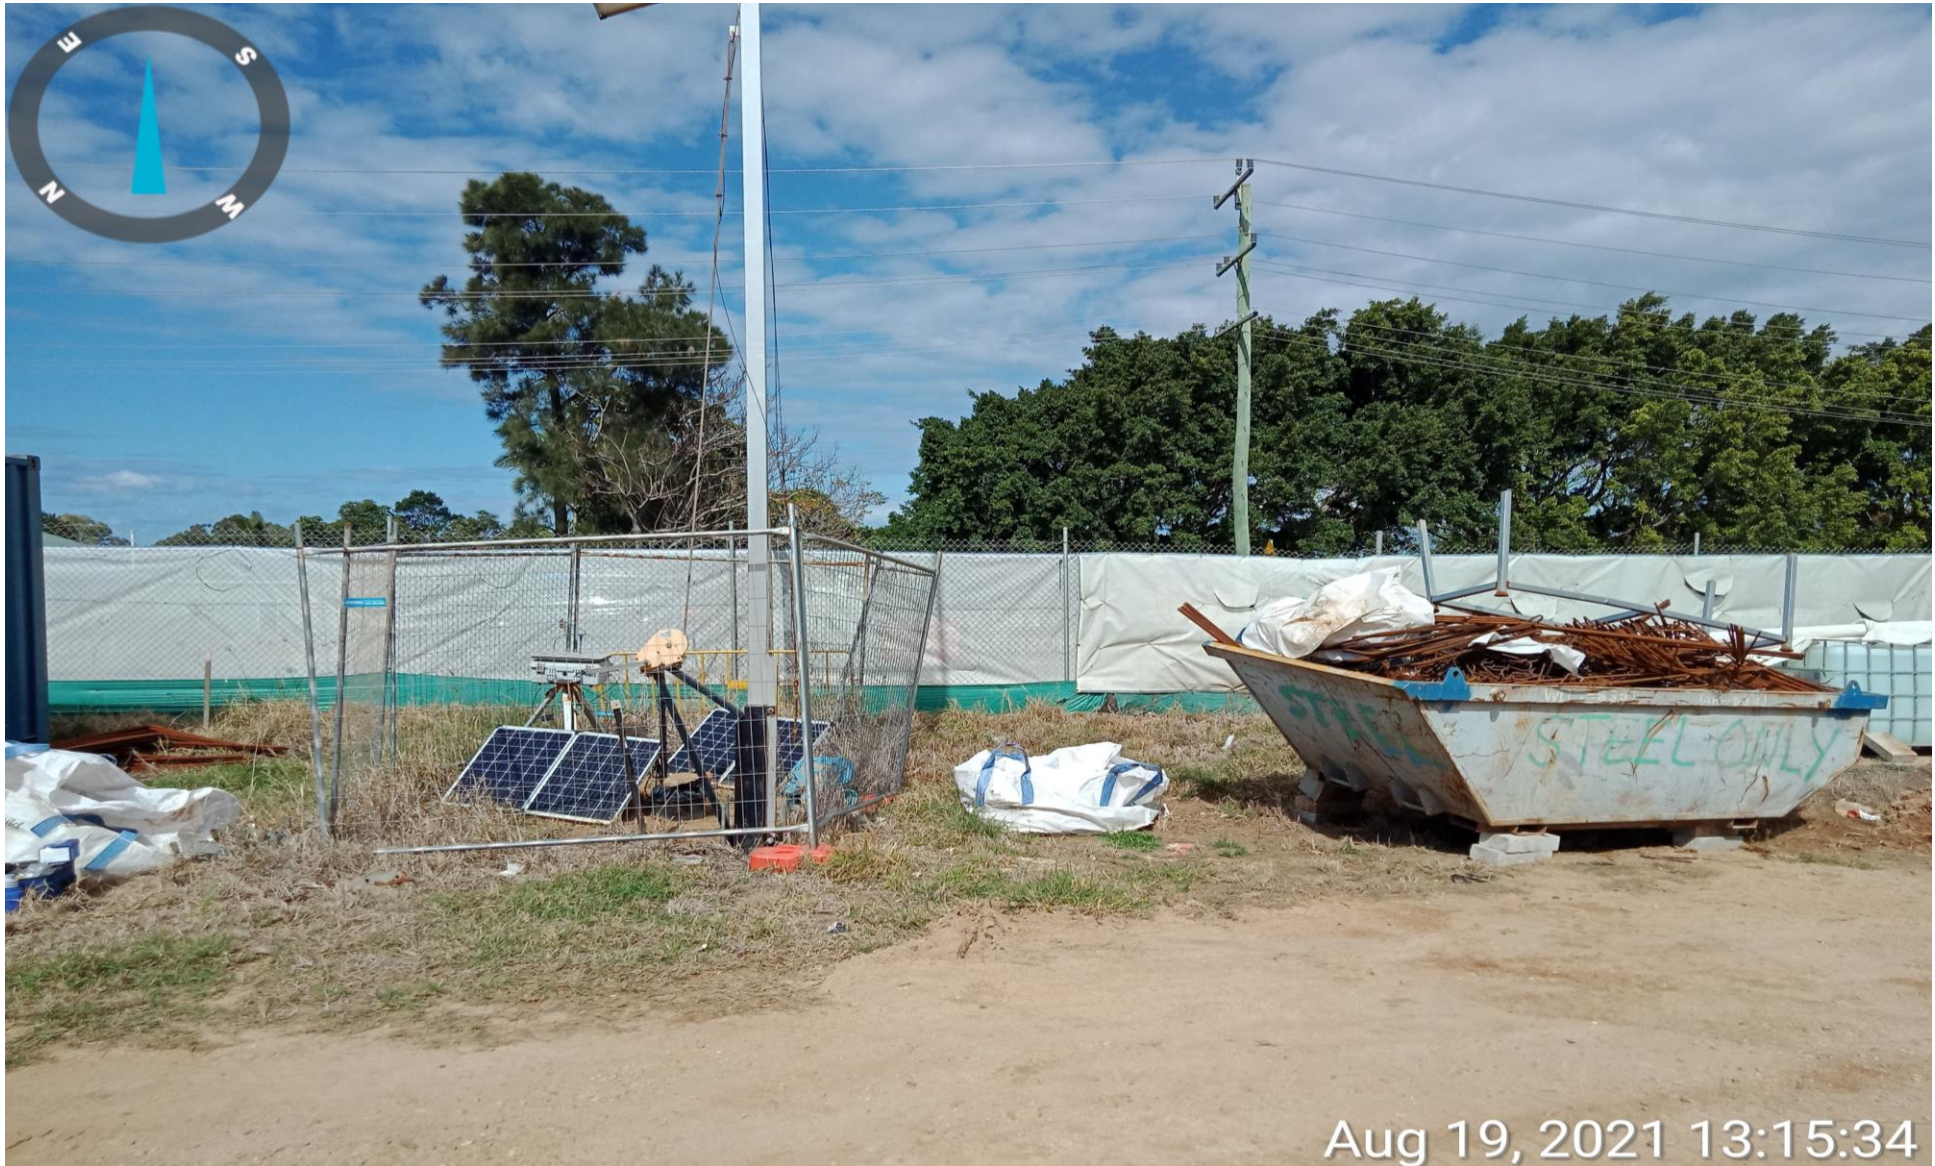
Photograph 2 Representative photograph of monitoring location 002 – Central location, as observed 19/08/2021

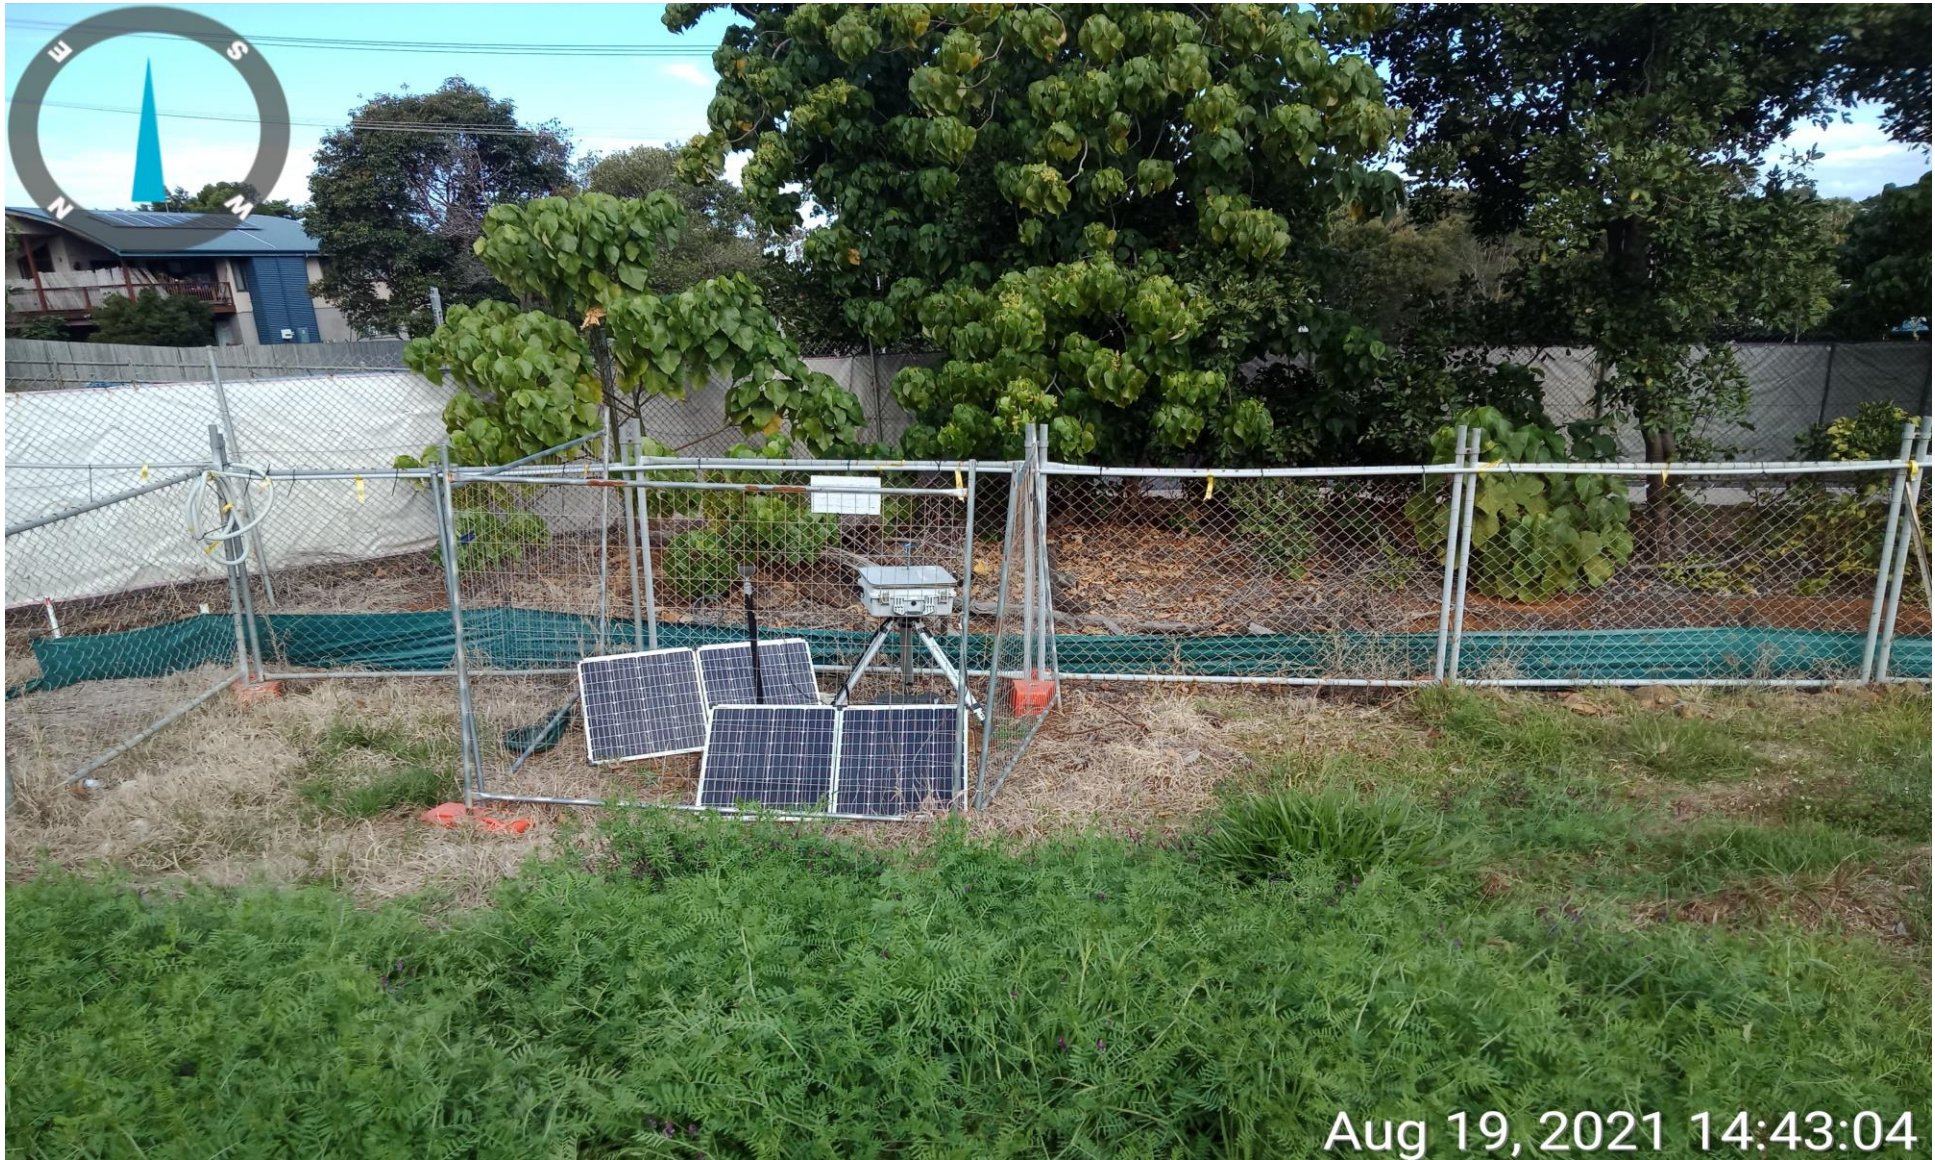
Photograph 3 Representative photograph of monitoring location 003 – Eastern Section of Site, as observed 19/08/2021
