Environmental Dust Assessment Report (September 2021)

Tweed Valley Hospital Project, Cudgen NSW

Prepared for: Lendlease Building Pty Ltd

LND-01-Q1299 | EDM26.V1F | Date: 15/10/2021

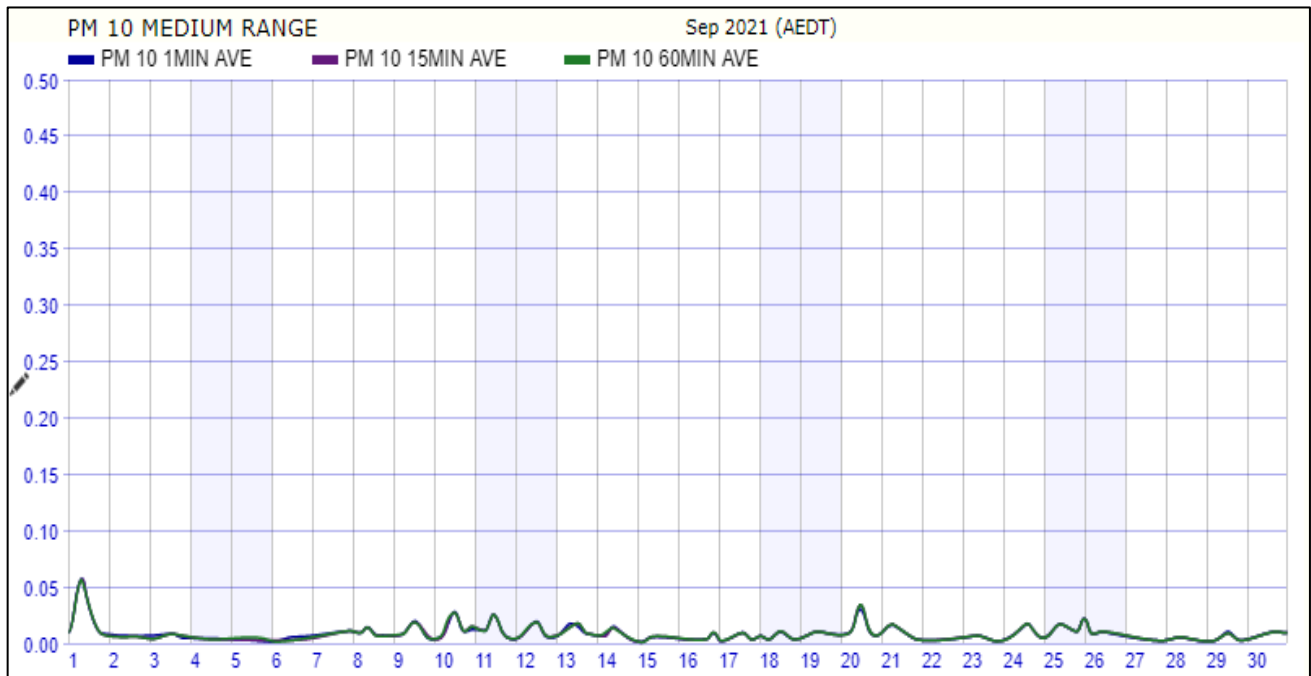
Figure 1. Summary of PM10 from the real time monitoring at location 001 – Adjacent the carpark for the month of September 2021.

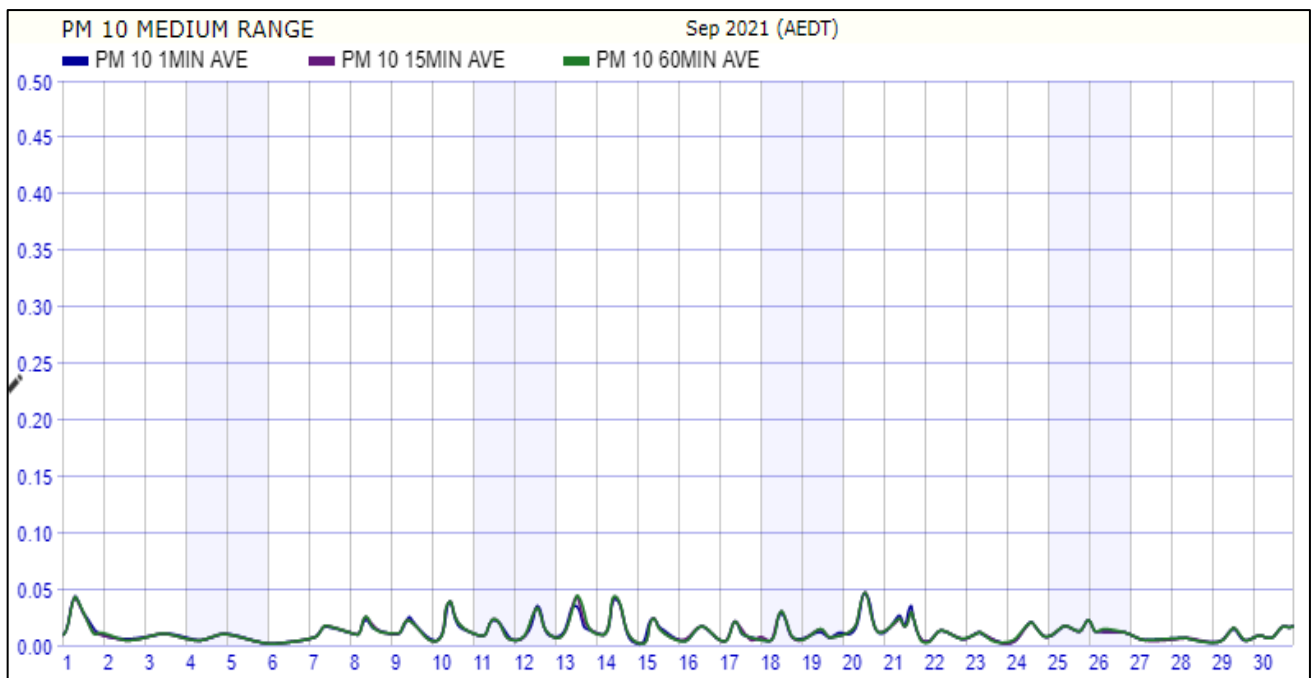
Figure 2. Summary of PM10 from the real time monitoring at location 002 – Central location for the month of September 2021.

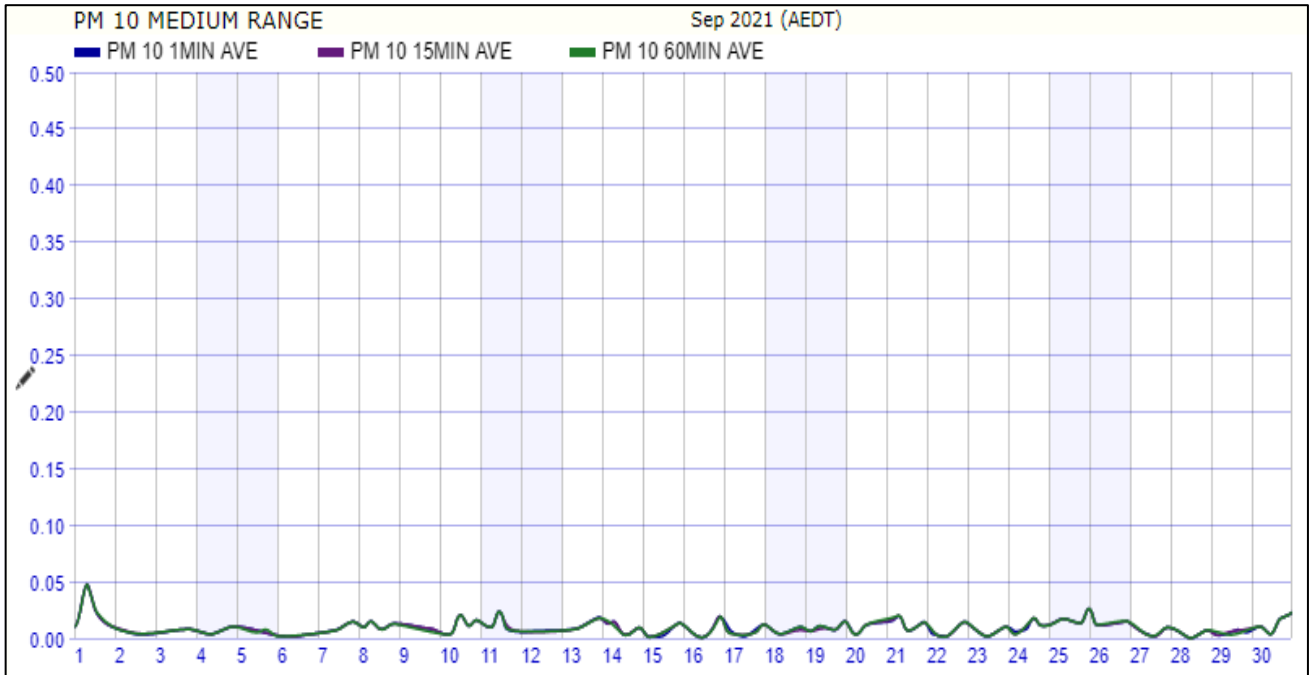
Figure 3. Summary of PM10 from the real time monitoring at location 003 – Eastern Section of site for the month of September 2021.

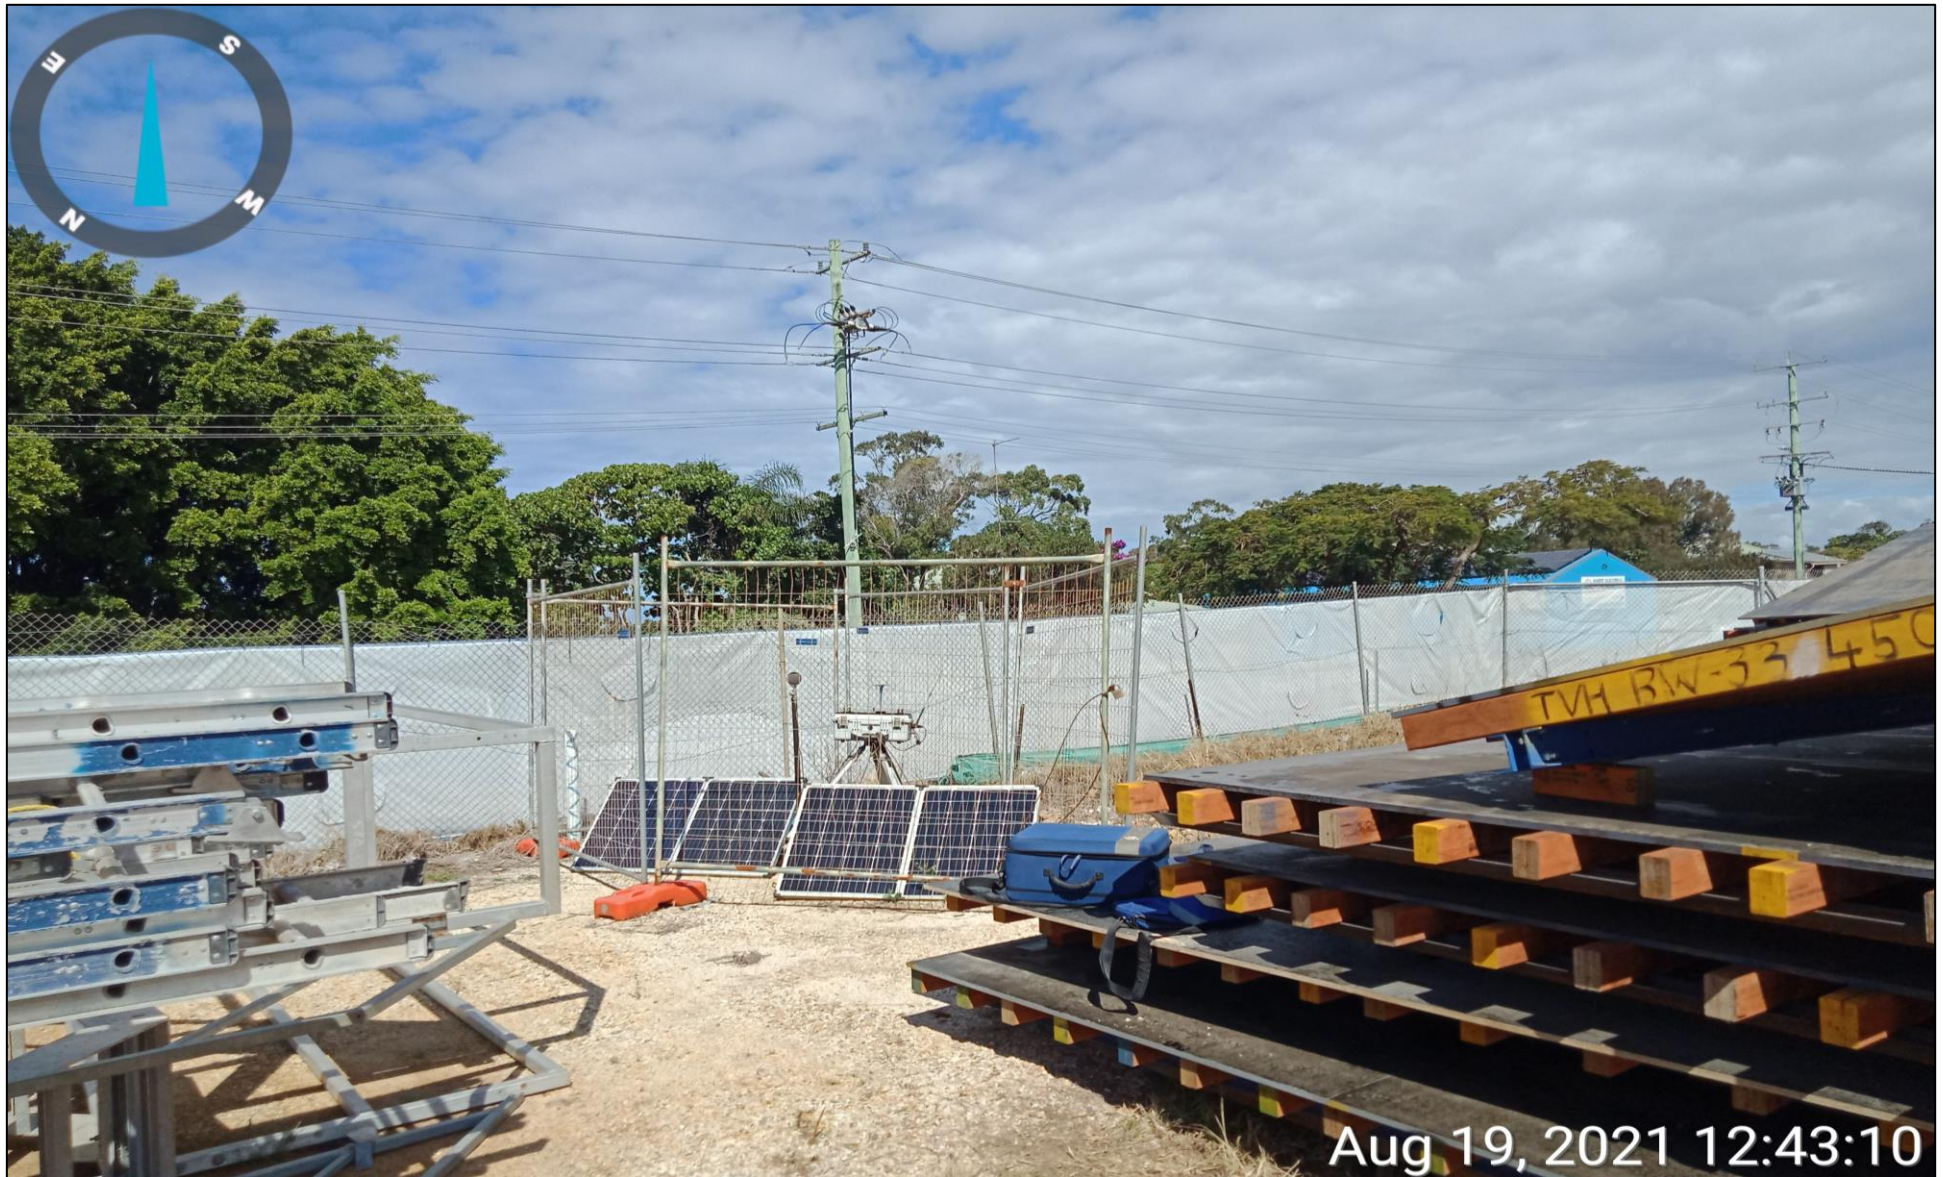
Photograph 1 Representative photograph of monitoring location 001 – Adjacent Carpark location, as observed 19/08/2021

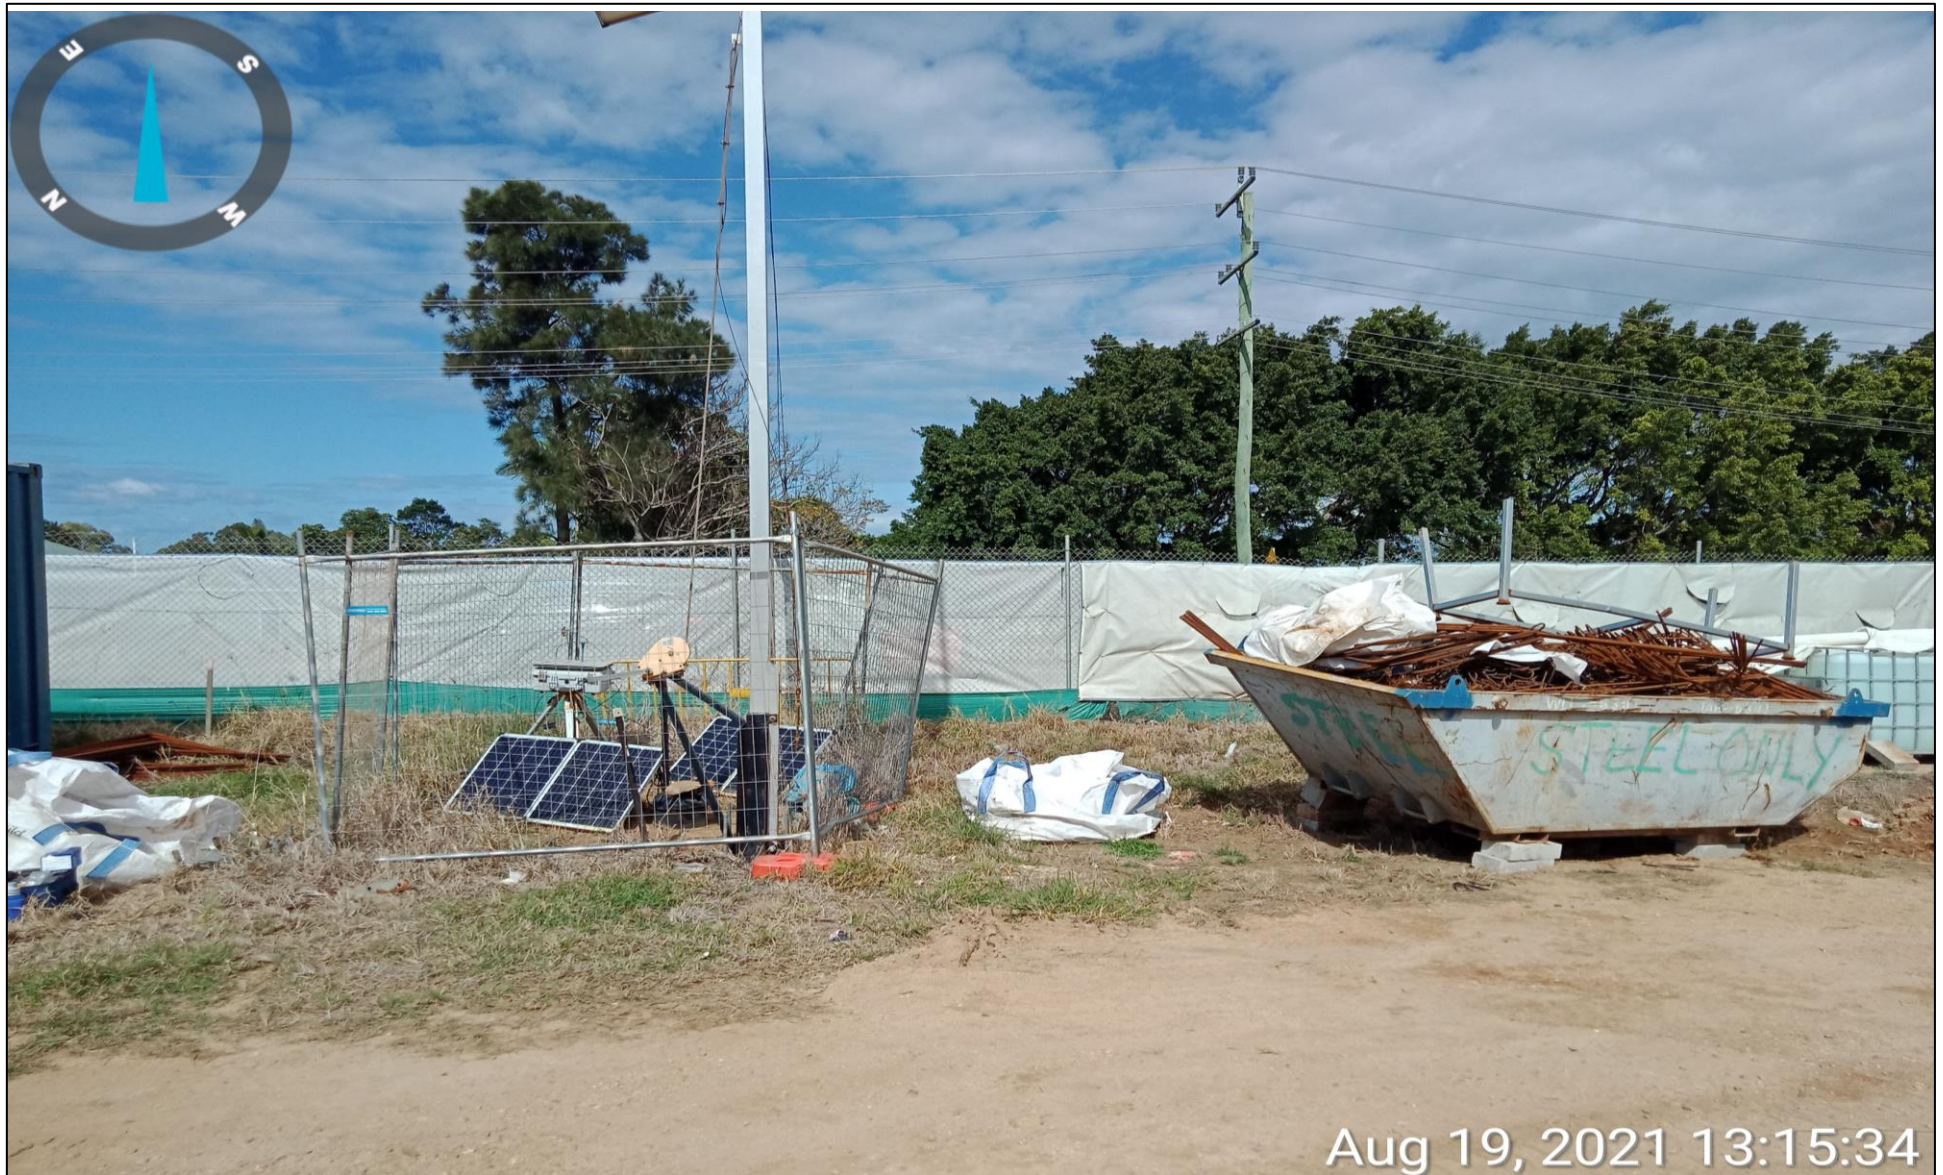
Photograph 2 Representative photograph of monitoring location 002 – Central location, as observed 19/08/2021

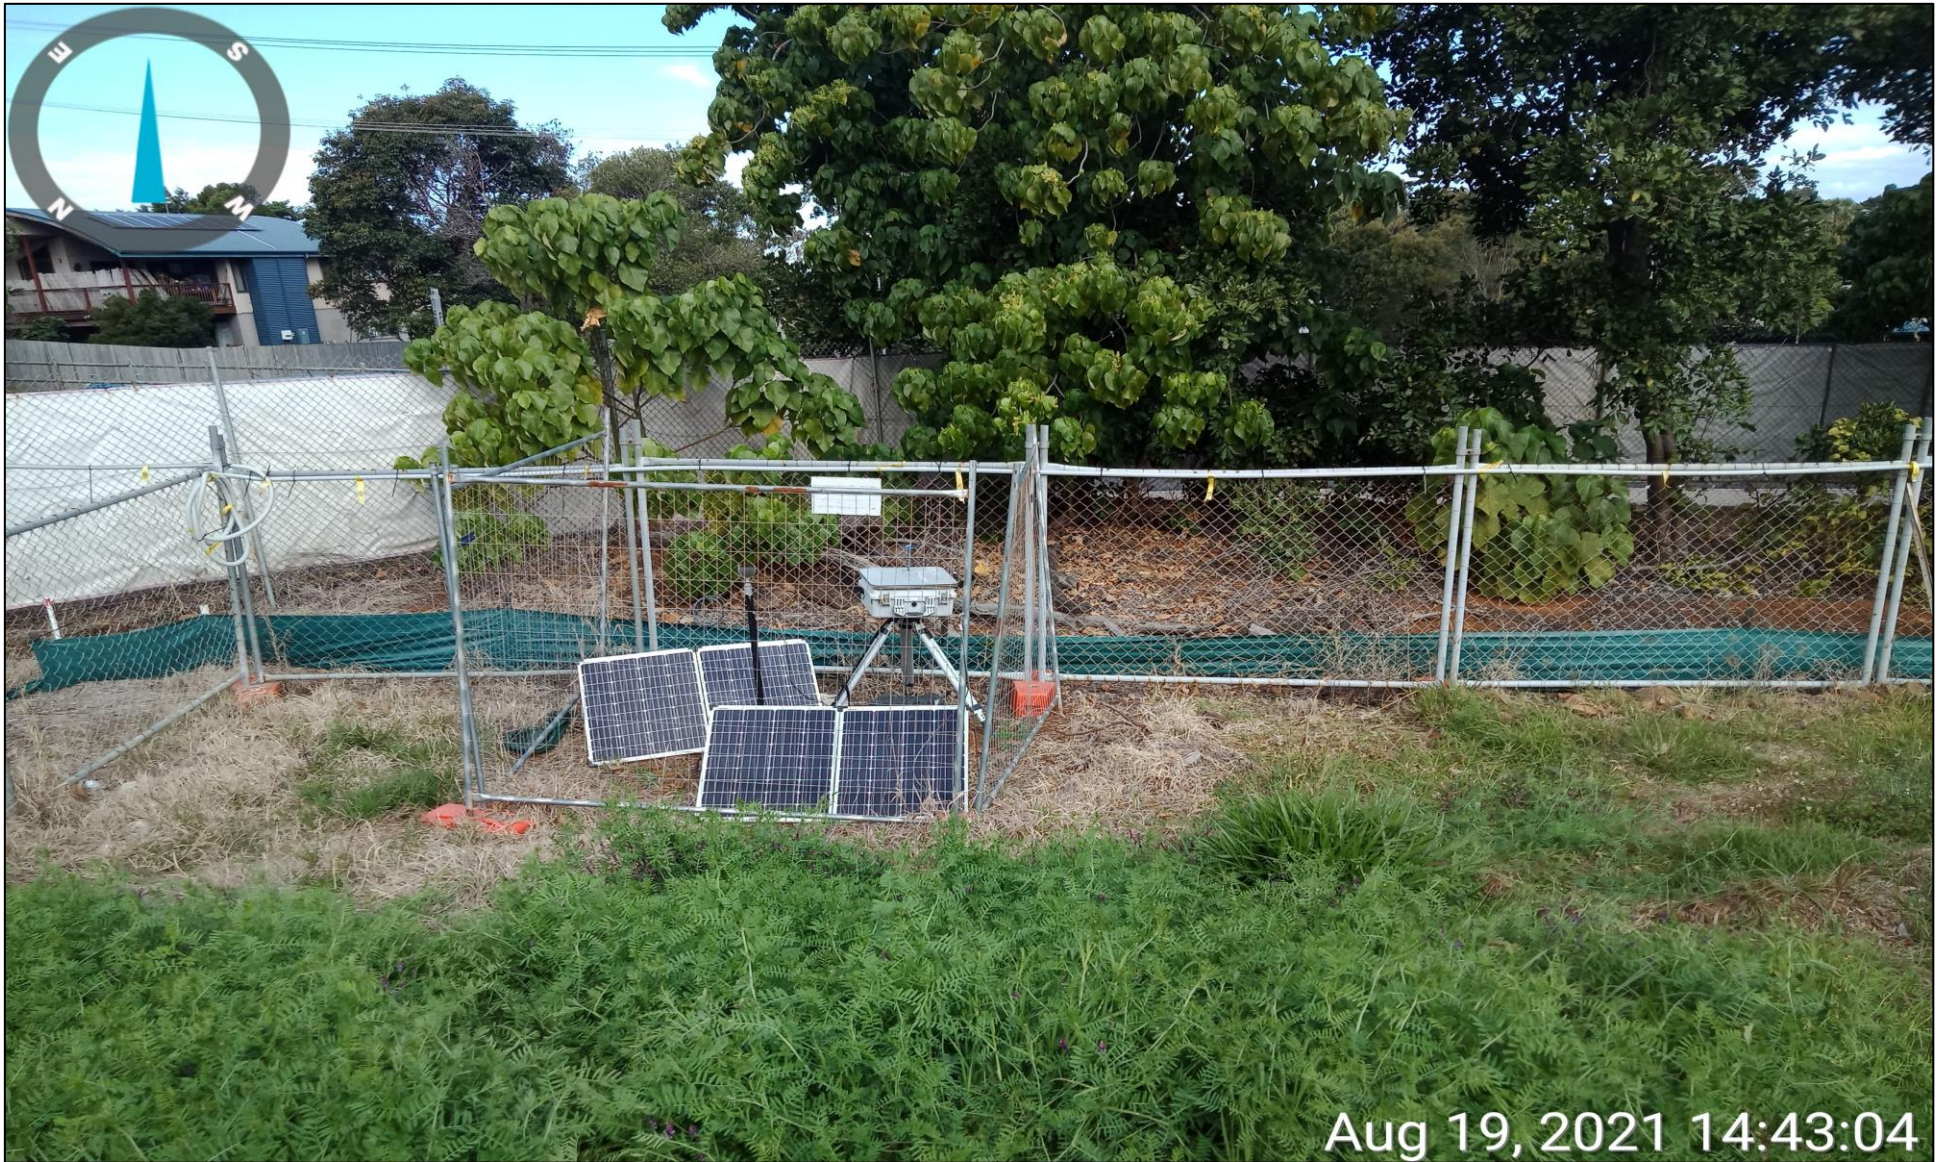
Photograph 3 Representative photograph of monitoring location 003 – Eastern Section of Site, as observed 19/08/2021
