Vibration Monitoring Assessment Report (July 2021)

Tweed Valley Hospital Project, Cudgen NSW

Prepared for: Lendlease Building Pty Ltd

LND-01-Q1299 | VIB24.V1F | Date: 6/08/2021

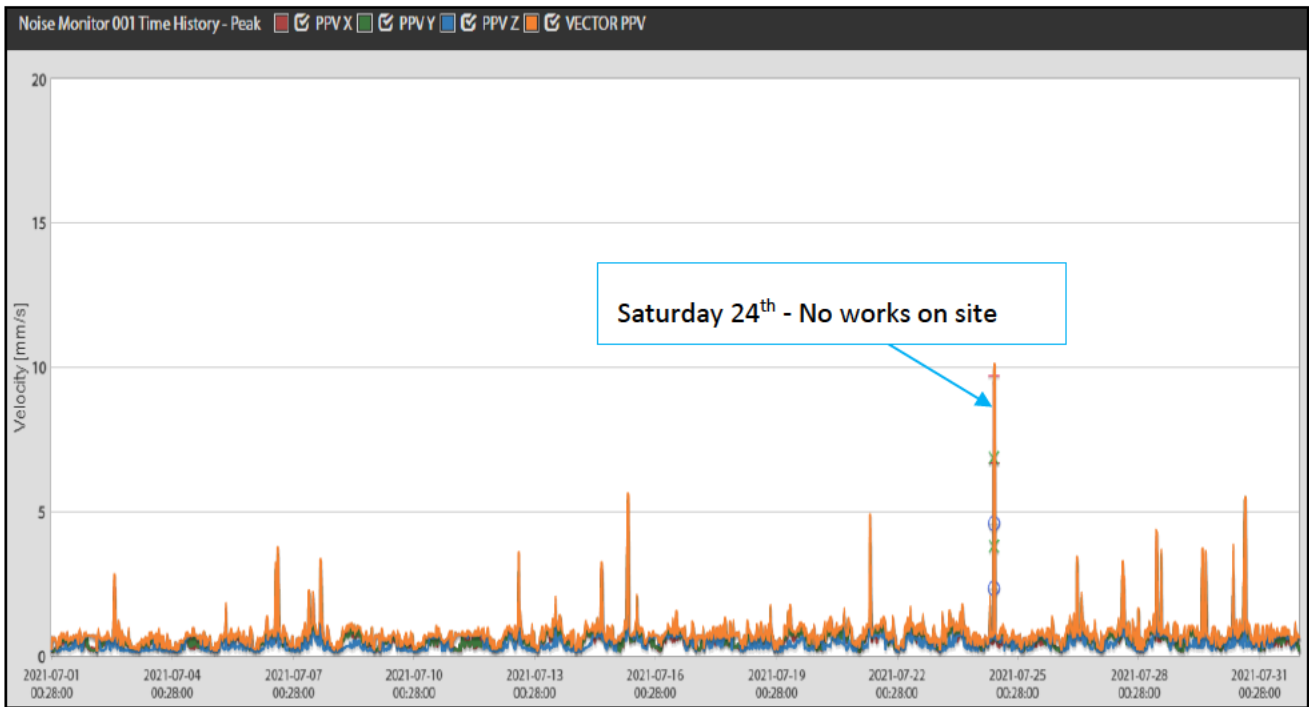
Data measured at location 001 is presented below in **Figure 1**.

Figure 1 Vibration data at location 001 | Adjacent carpark | July 2021

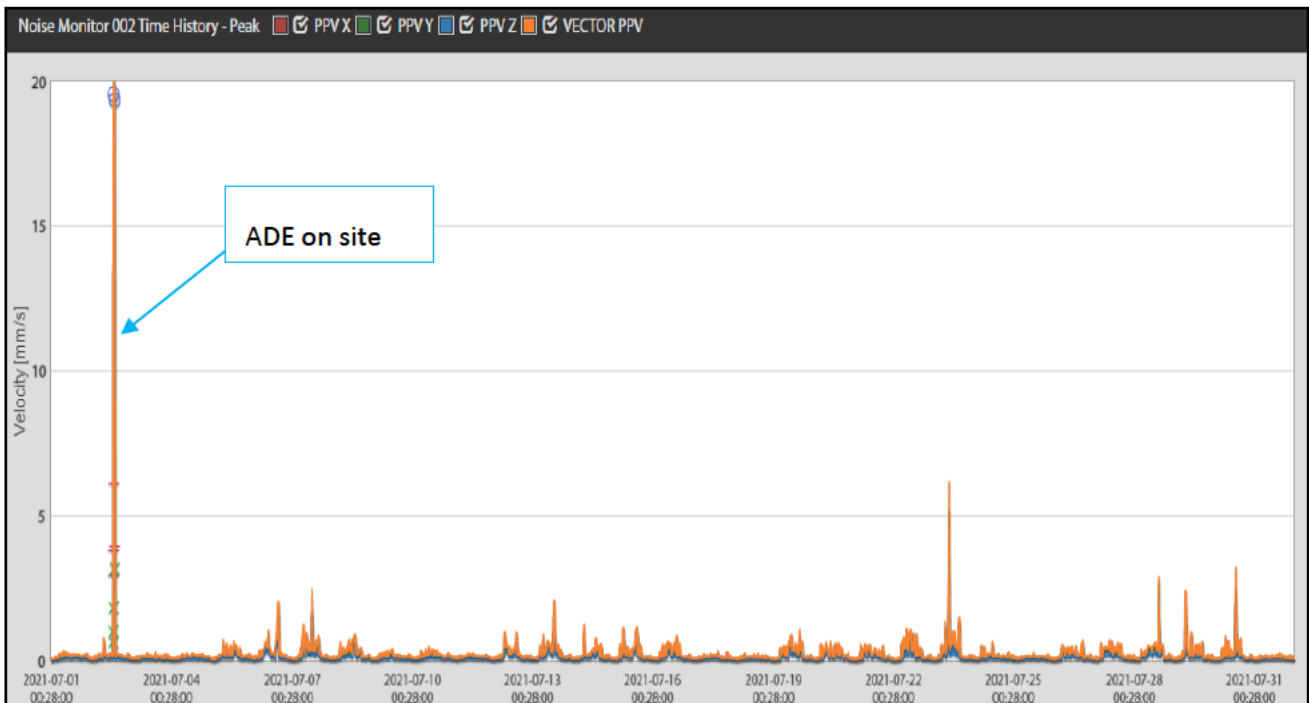
Data measured at location 002 is presented below **Figure 2**.

Figure 2 Vibration data at location 002 | Central monitor | July 2021

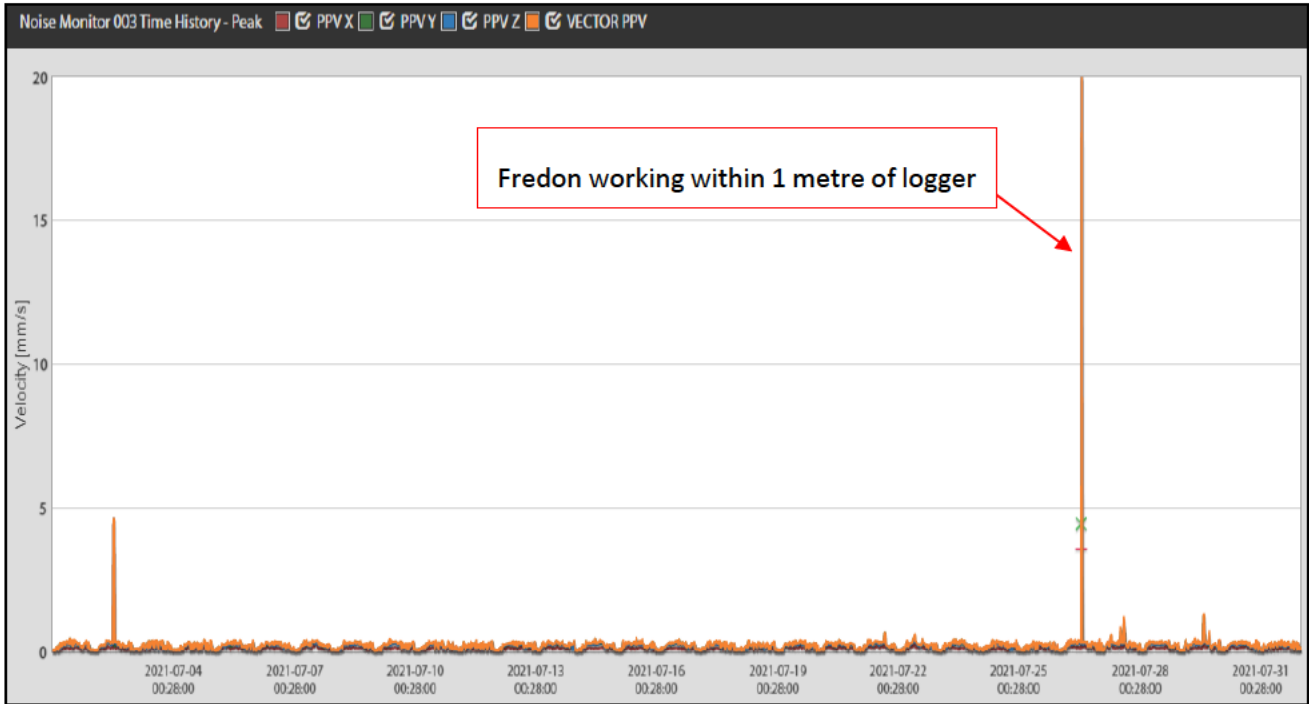
Data measured at location 003 is presented below Figure 3.

Figure 3 Vibration data at location 003 | Eastern section | July 2021

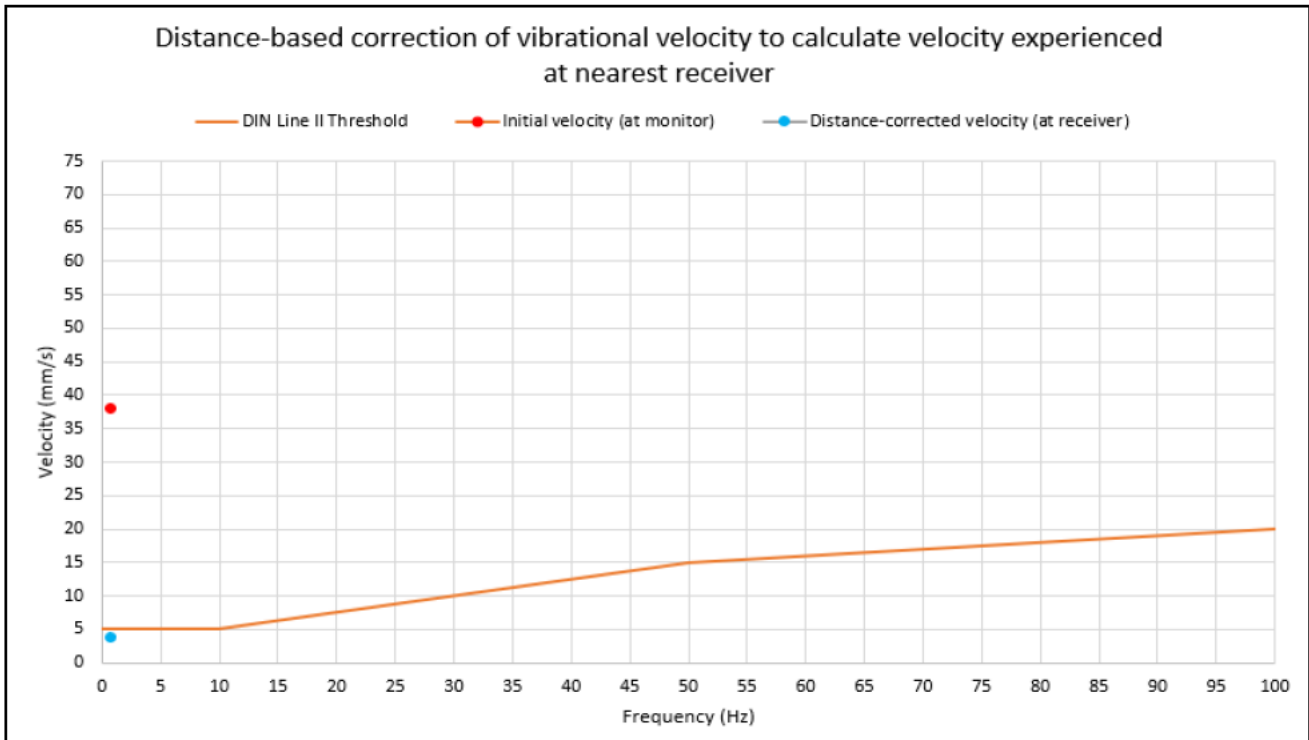
Figure 4 below shows the one (1) value measured at the logger above DIN4150 Line 2 and the distance corrected velocity (at receiver) values. The distance corrected value was below line 2.

Figure 4 Distance corrected PPV values (monitoring location 003)

During the monitoring period (1 to 31 July 2021) there was one (1) value measured at the logger that exceeds DIN4150 Line 2 criteria. Once distance correction calculations are performed to calculate the value experienced at the receiver the value is below DIN 4150 Line 2 (refer to Figure 4 above).

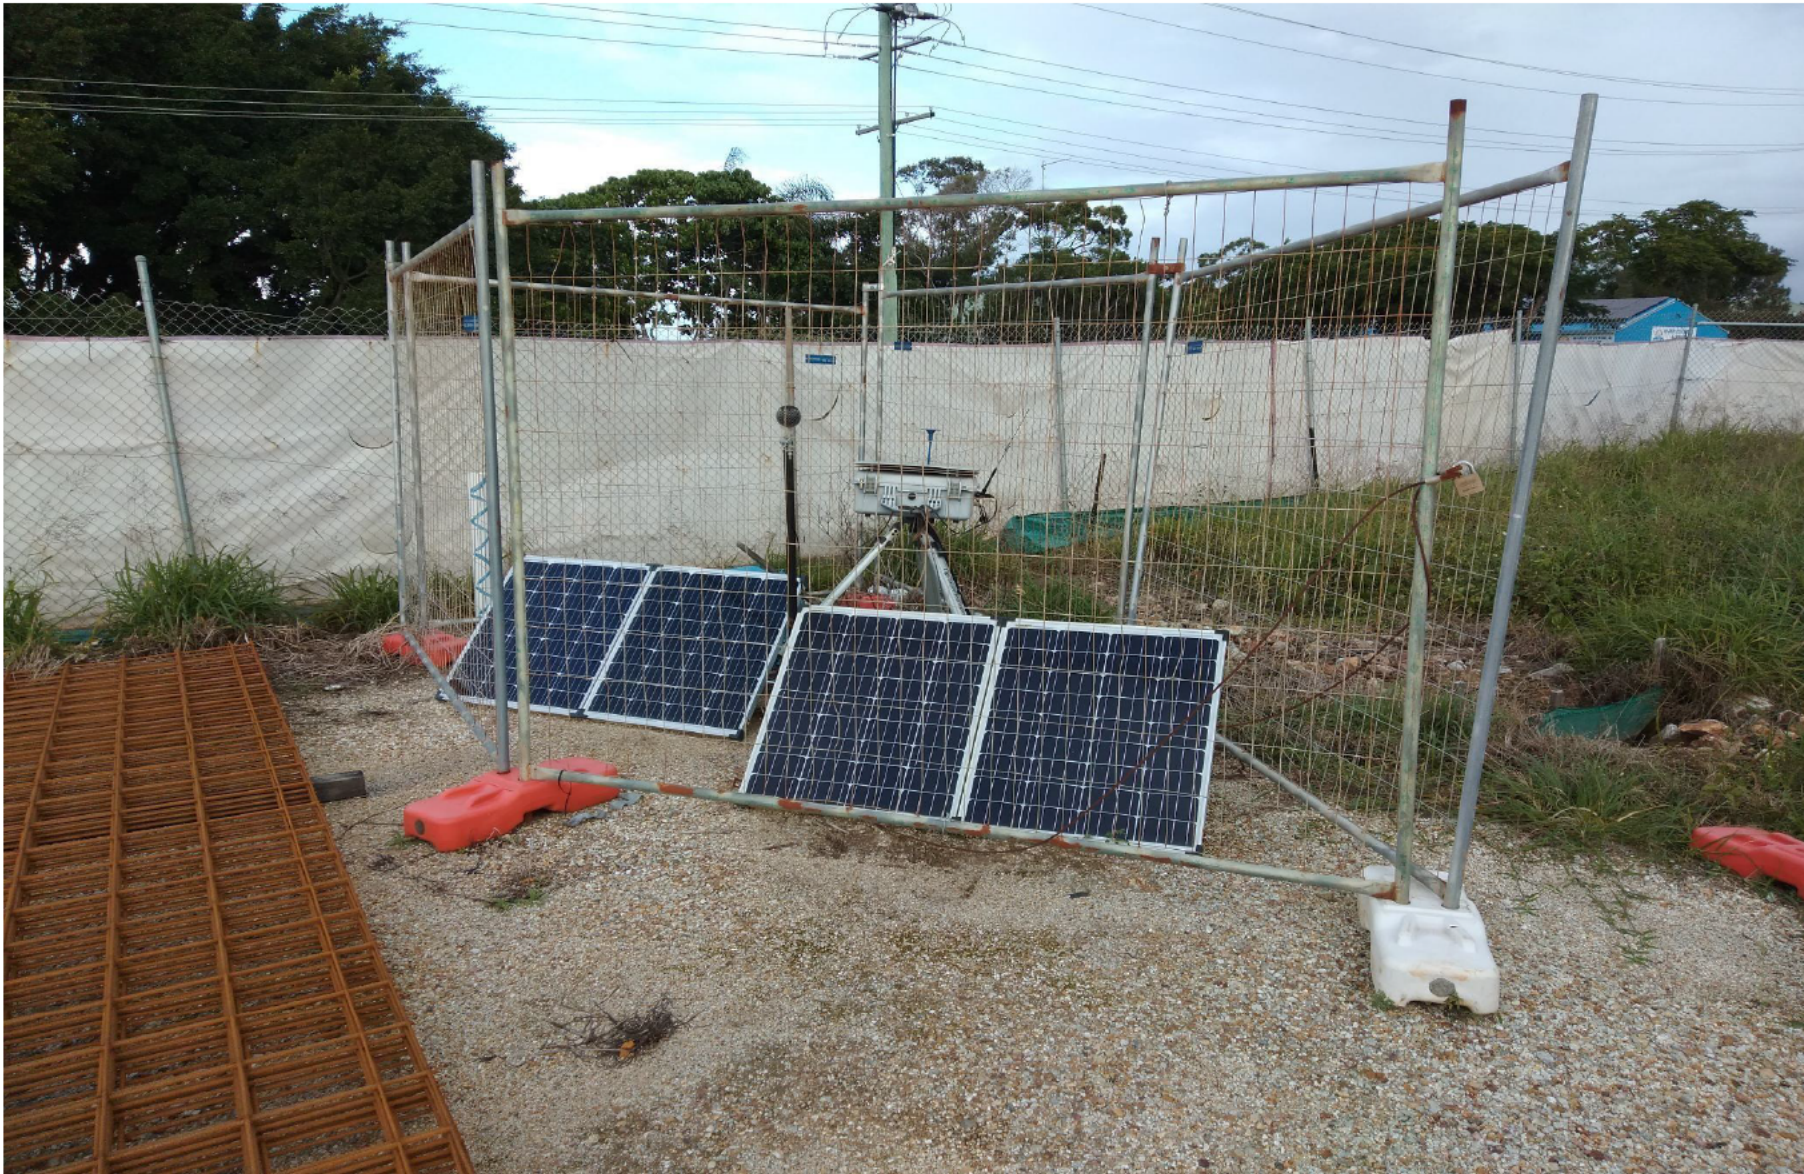
Photograph 1 Representative photograph of monitoring location 001 – Adjacent Carpark location, as observed 02/07/2021

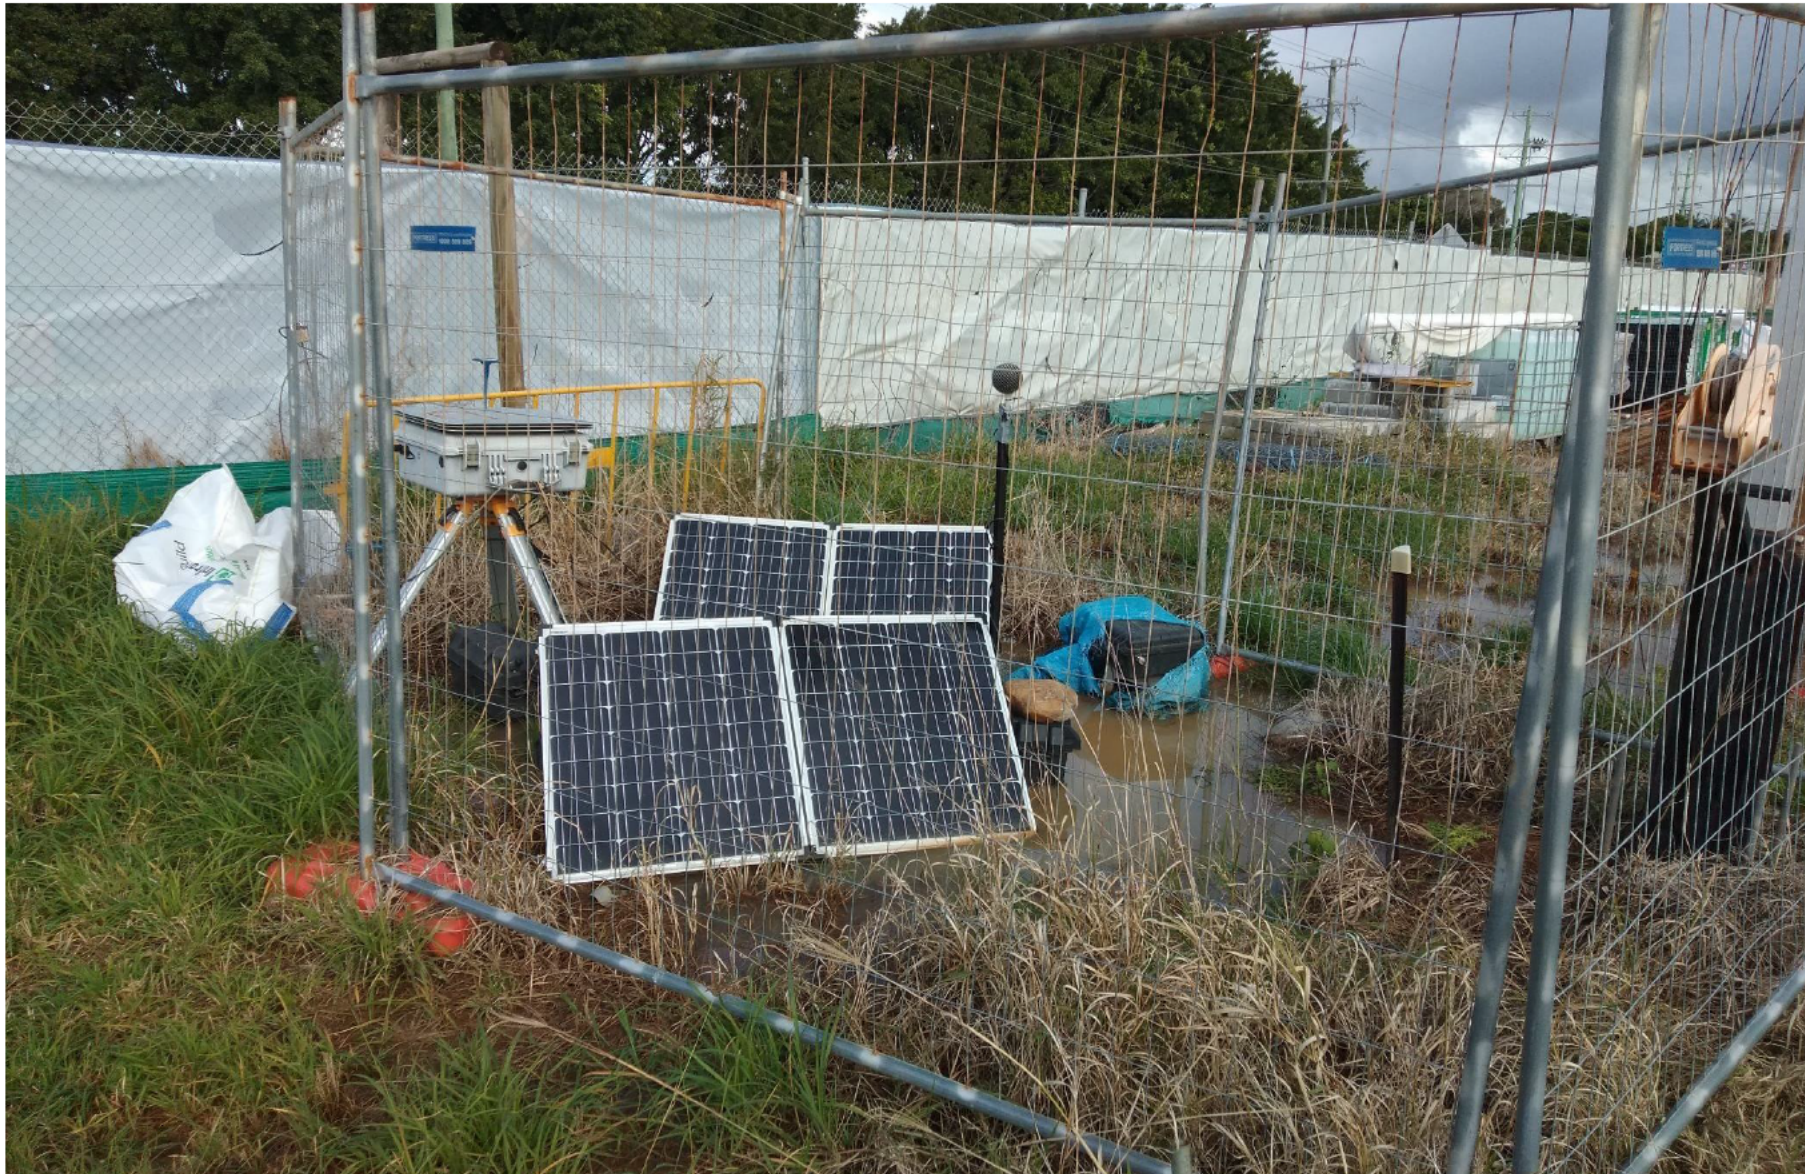
Photograph 2 Representative photograph of monitoring location 002 – Central location, as observed 02/07/2021

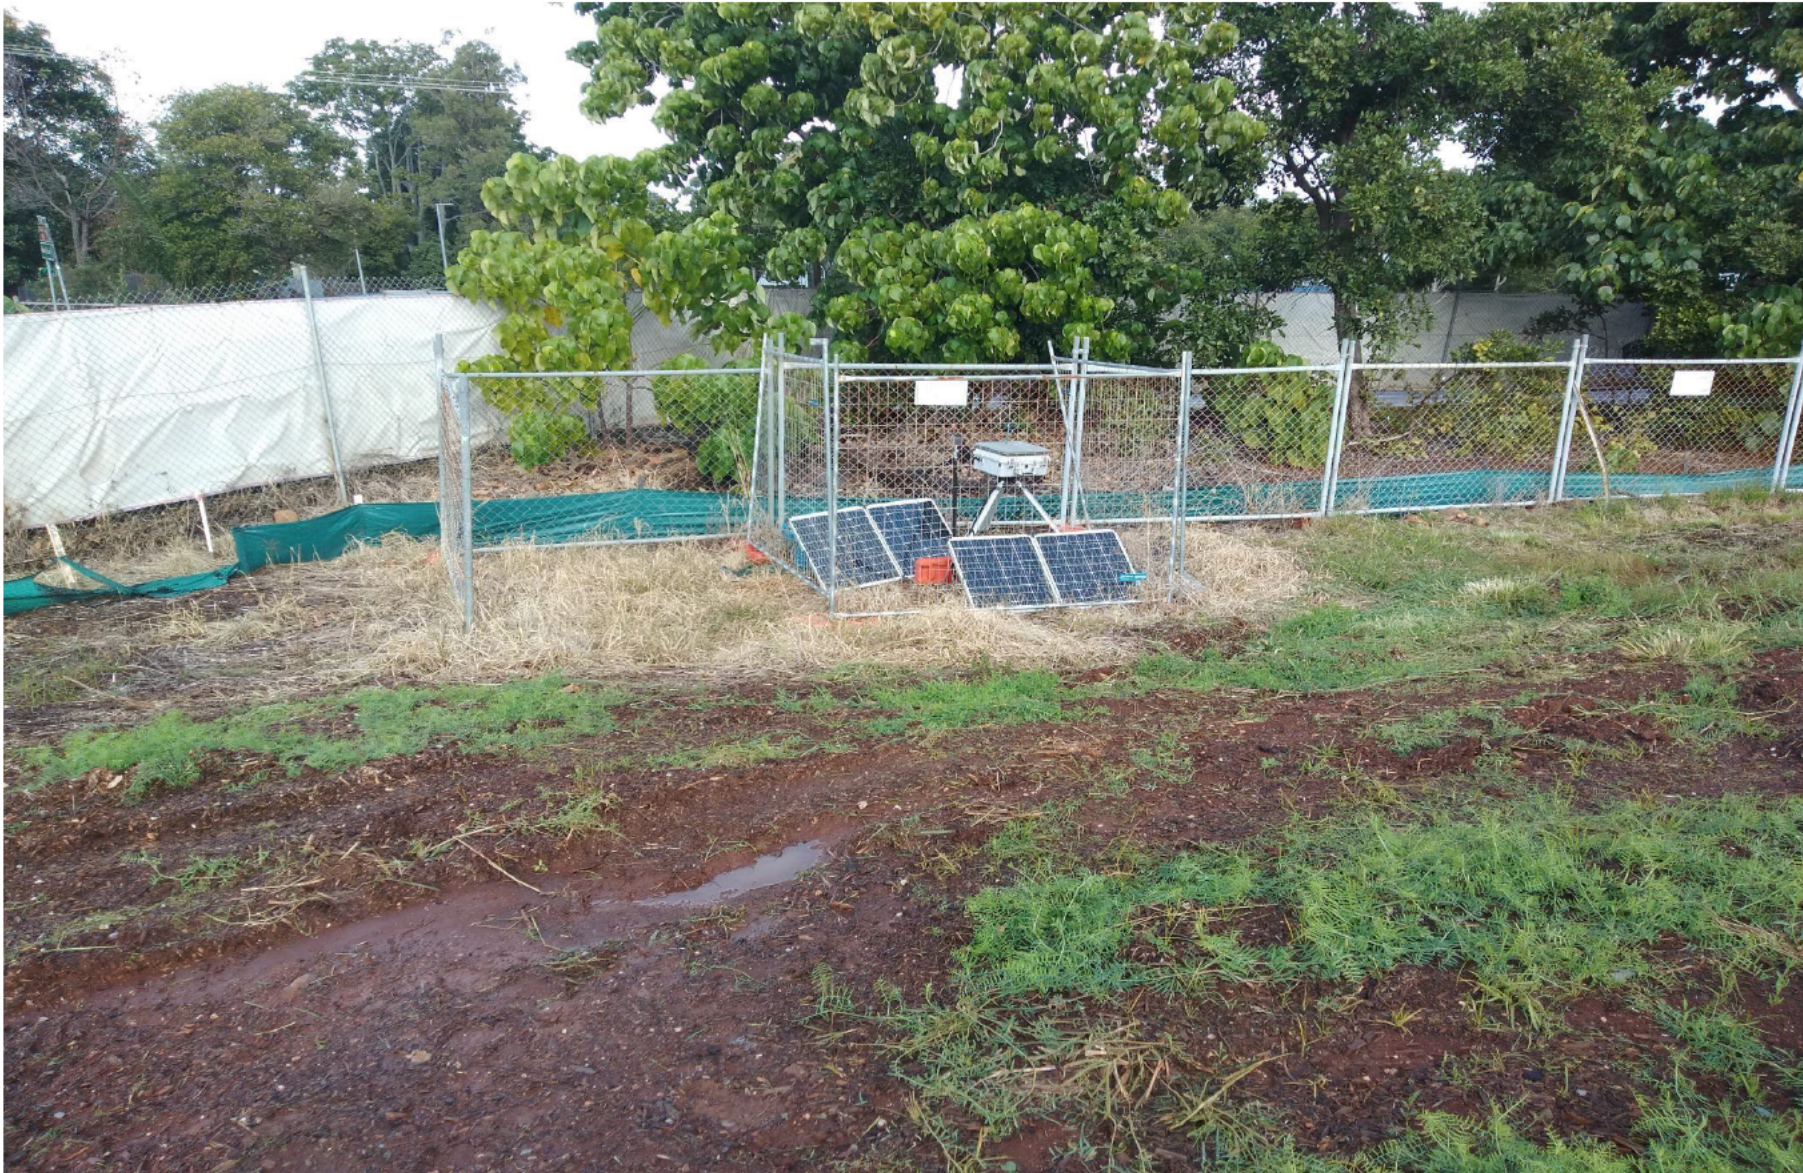
Photograph 3 Representative photograph of monitoring location 003 – Eastern Section of Site, as observed 02/07/2021
