# Vibration Monitoring Assessment Report (May 2021)

**Tweed Valley Hospital Project, Cudgen NSW**

Prepared for: Lendlease Building Pty Ltd

LND-01-Q1299 | VIB22.V1.2F | Date: 14/07/2021

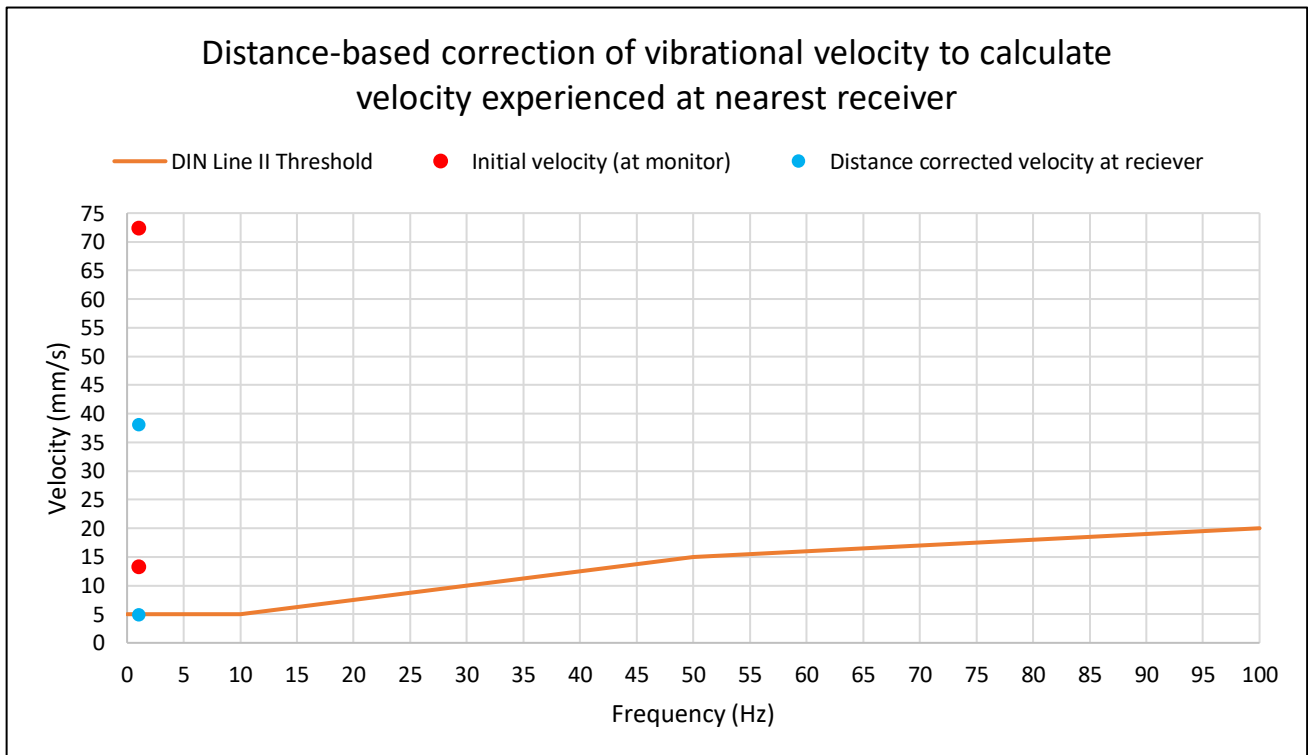
**Figure 4** Distance corrected PPV values (monitoring location 001)

**Figure 4** below shows the two (2) values measured at the logger above DIN4150 Line 2 and the distance corrected velocity (at receiver) values. One (1) distance corrected value was above Line 2 and One (1) distance corrected value was below line 2.

During the monitoring period 1 May - 31 May 2021 there were two (2) values measured at the logger that exceed DIN4150 Line 2 criteria. Once distance correction calculations are performed to calculate the values experienced at the receiver one (1) value remains above Line 2 (refer to **Figure 4** above).

The DIN4150 Line 2 criteria was exceeded once during this reporting period on 19/05/2021 @ 10:32am. ADE understands that works were in close proximity to the monitor and recommend that works be distanced from the vibration sensors as much as practicable.
