Vibration Monitoring Assessment Report (March 2021)

Tweed Valley Hospital Project, Cudgen NSW

Prepared for: Lendlease Building Pty Ltd

LND-01-Q1299 | VIB20.V1.4F | Date: 01/07/2021

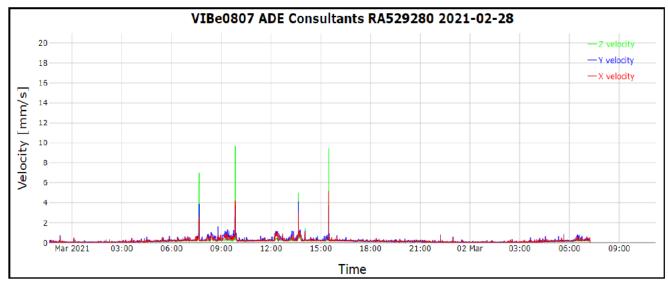
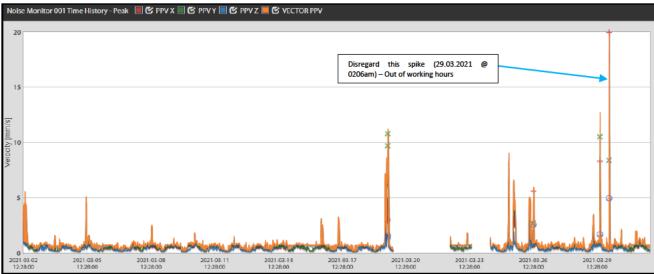
Figure 1 Vibration data at location 001 | Adjacent carpark | March 2021

Data measured at location 001 is presented below in Figure 1.

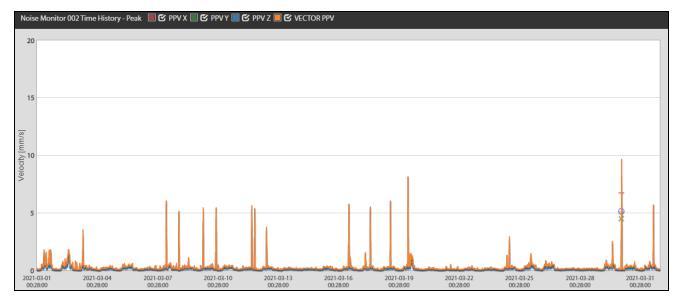
Figure 2 Vibration data at location 002 | Central monitor | March 2021

Data measured at location 002 is presented below in Figure 2.

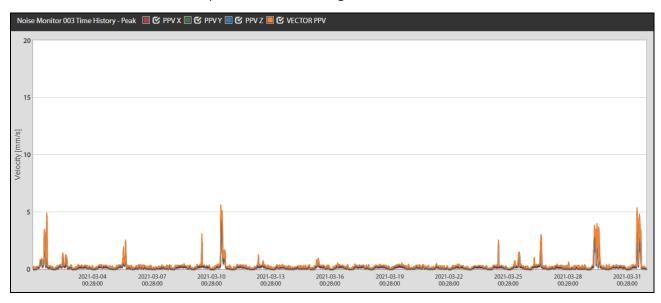
Figure 3 Vibration data at location 003 | Eastern section | March 2021

Data measured at location 003 is presented below in Figure 3.

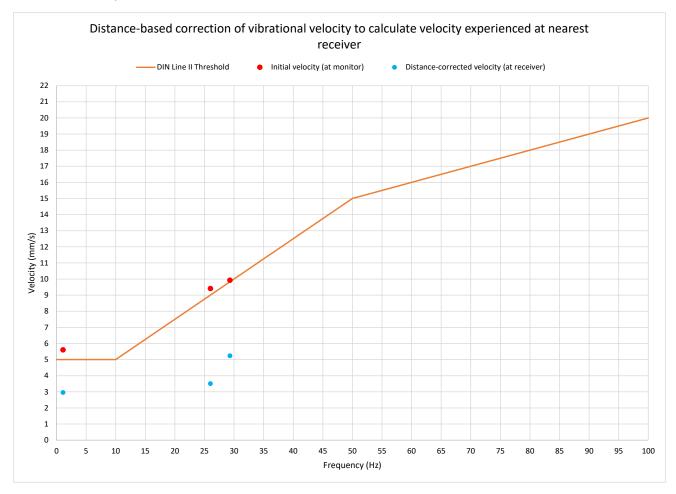
Figure 4 Distance corrected PPV values (monitoring location 001)

Figure 4 below shows the three (3) values measured at the logger above DIN4150 Line 2 and the distance corrected velocity (at receiver) values all below Line 2.

During the monitoring period (1 March to 31 March 2021) there was three (3) values measured at the logger that exceed DIN4150 Line 2 criteria. However, once distance correction calculations are performed to calculate the values experienced at the receiver, all values are below line 2 (refer to **Figure 4** above). Therefore no exceedance of DIN 4150 Line 1 or Line 2 PPV guideline values was observed.
