Environmental Dust Assessment Report (June 2023)

Tweed Valley Hospital Project, Cudgen NSW

A101021.0286.00 | EDM47.Rev0 | Date: 2/08/2023

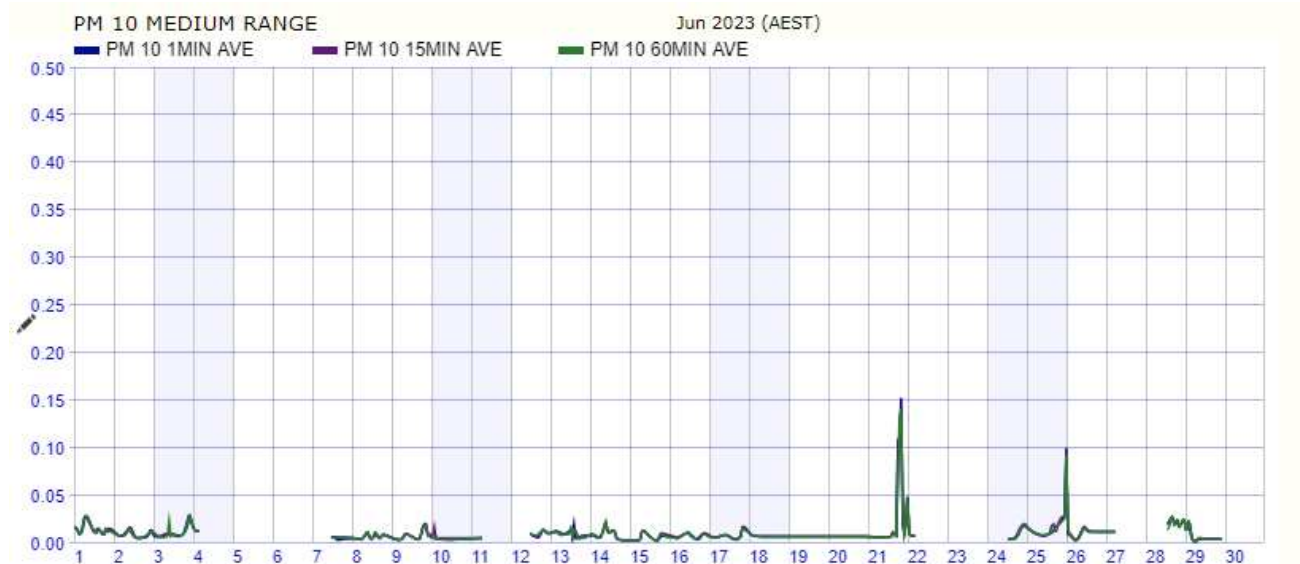
Dust Monitor 005 was observed to be offline during the daily checks on 5 June 2023. The monitor came back online 7 June 2023. Dust Monitor 005 was observed to be offline during the daily checks on 22 June 2023. ADE attended site on 22 June 2023 checking connections, status of the battery and repositioning of the solar panels. The monitor came back online 24 June 2023.

Figure 1. Summary of PM10 from the real time monitoring at location 005 – Solar Industry for the month of June 2023.

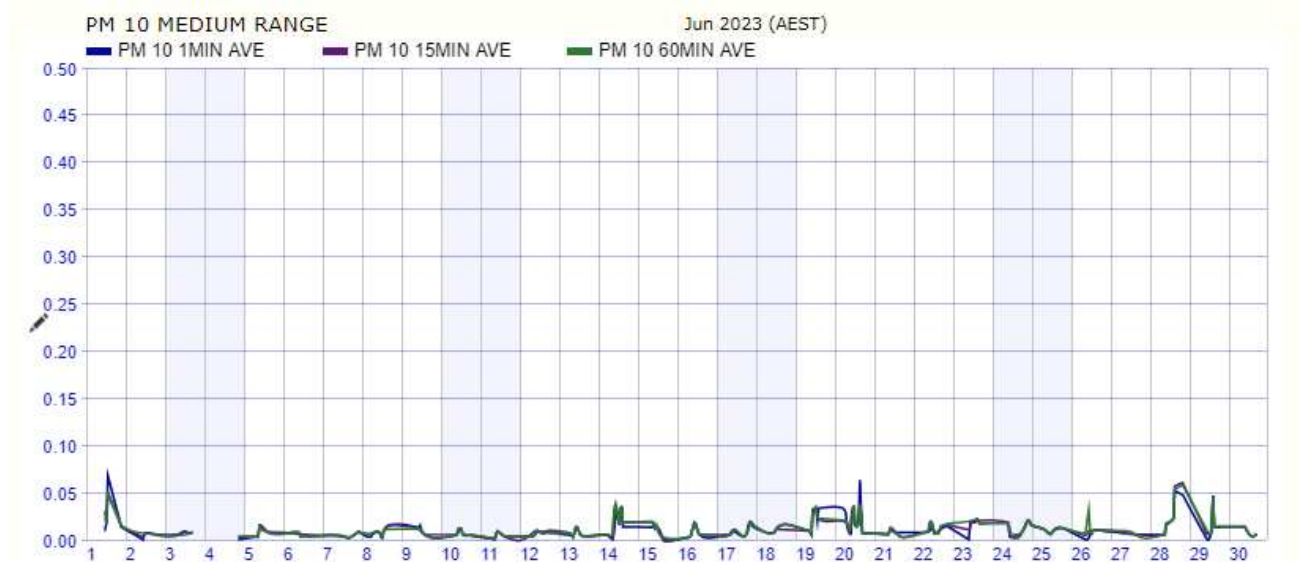
Figure 2. Summary of PM10 from the real time monitoring at location 006 – Mate and Matts for the month of June 2023.

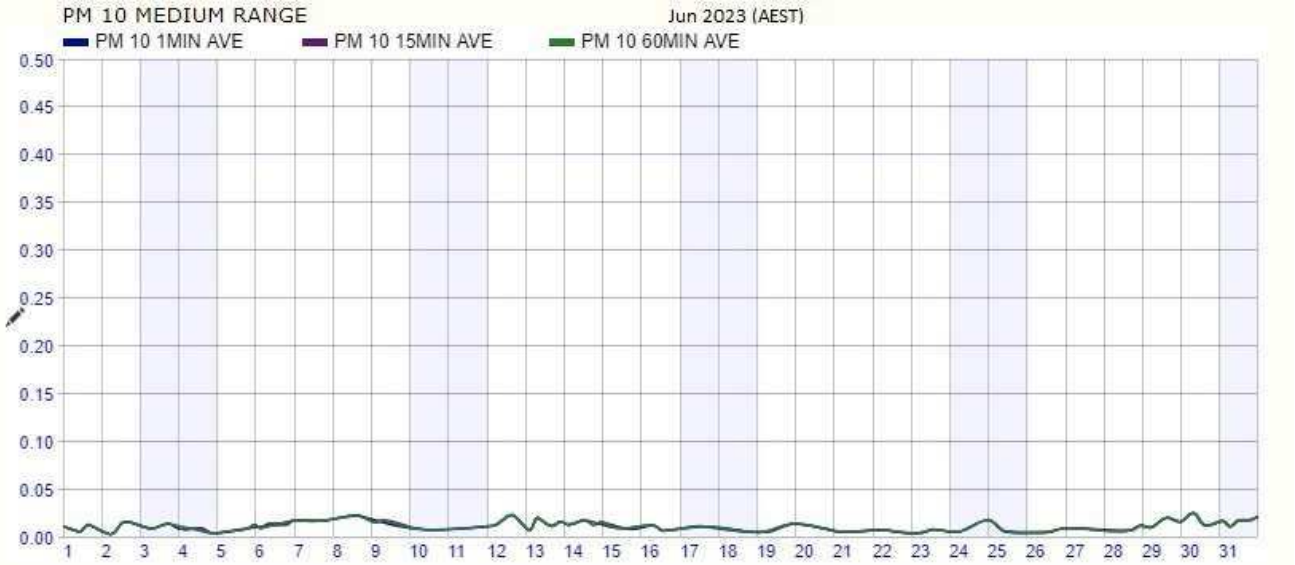
Figure 3. Summary of PM10 from the real time monitoring at location 007 – Residential for the month of June 2023.

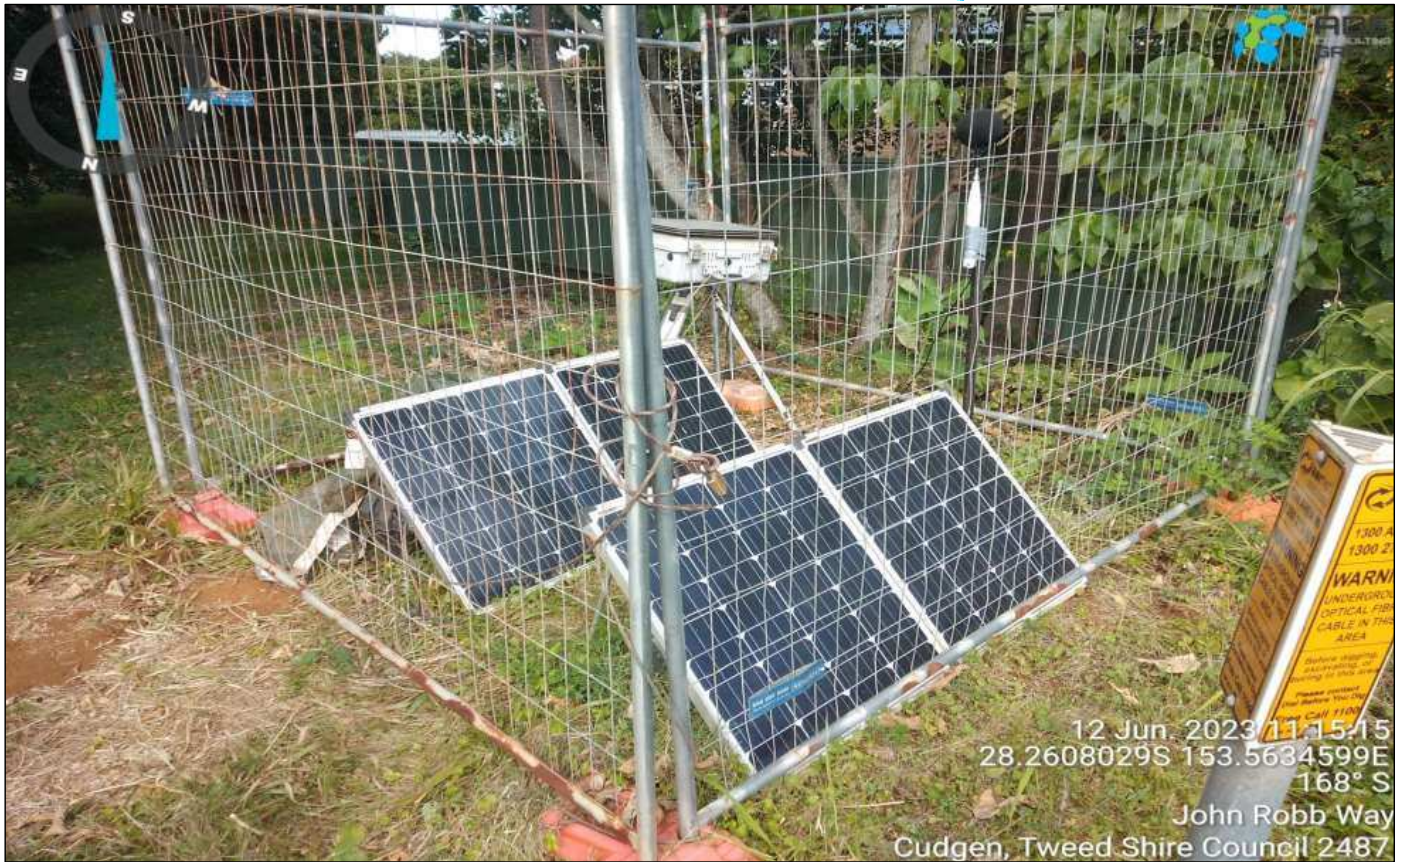
Photograph 1: Representative photograph of monitoring location 005 – Solar Industry, as observed 12/06/2023

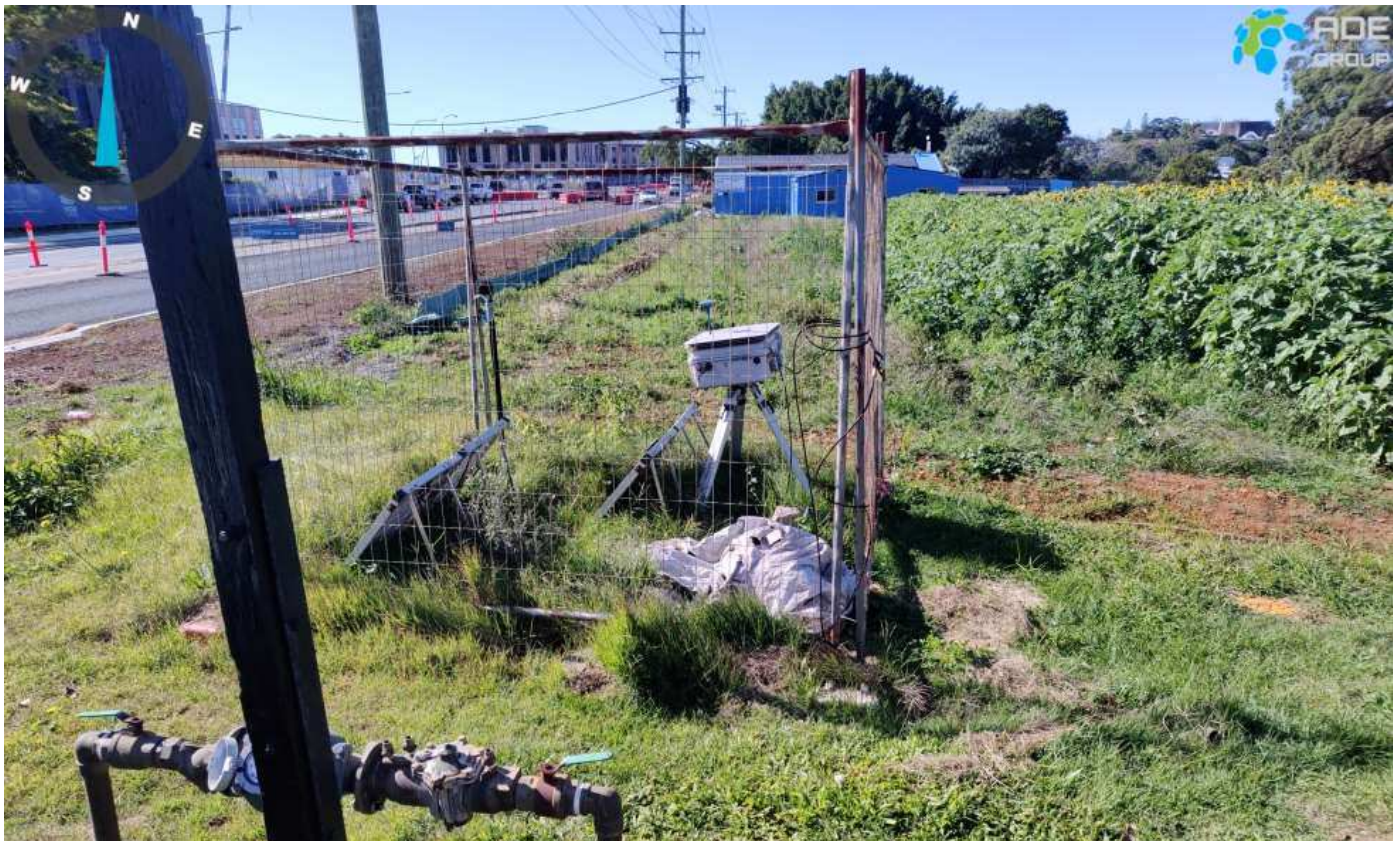
Photograph 2: Representative photograph of monitoring location 006 – Mate and Matts, as observed 12/06/2023

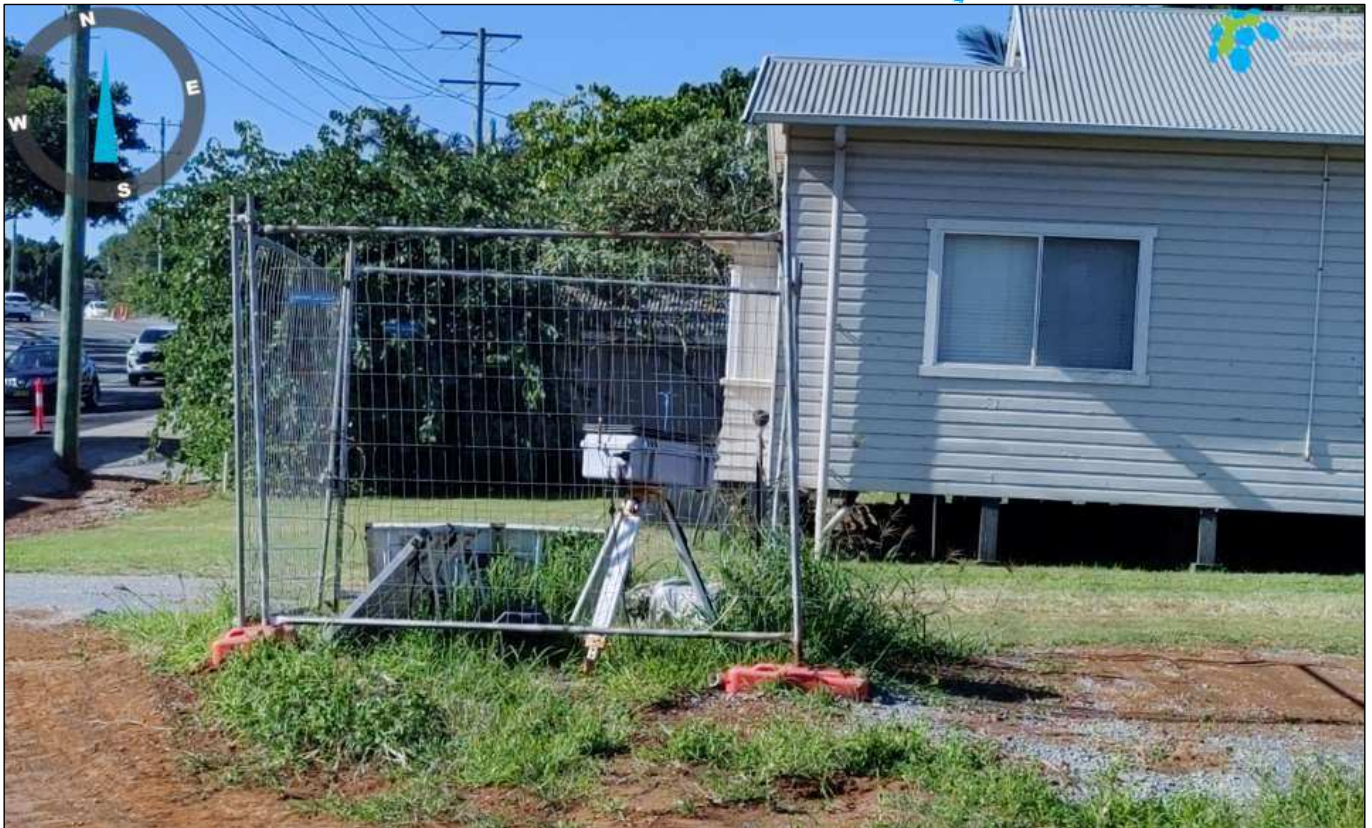
Photograph 3: Representative photograph of monitoring location 007 – Residential, as observed 12/06/2023
