Environmental Dust Assessment Report (December 2021)

Tweed Valley Hospital Project, Cudgen NSW

Prepared for: Lendlease Building Pty Ltd

A101021.0286.00 | EDM29.Rev1 | Date: 19/01/2022

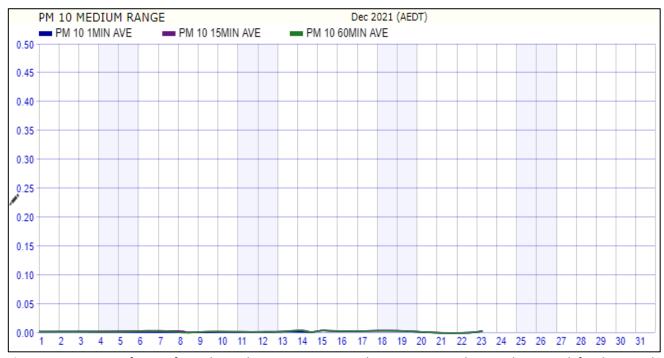
Figure 1. Summary of PM10 from the real time monitoring at location 001 – Adjacent the carpark for the month of December 2021.

All dust levels remained below 0.5 mg/m³ during the month of December 2021 (refer to Section 3).

Dust concentrations across all monitoring locations remained below the action limit of 2.5 mg/m³.

Ensure adequate dust control measures continue to be implemented as per the Tweed Valley Hospital Management Plan – Air Quality and continue monitoring of PM10 for the duration of the project. If the action limit of 2.5 mg/m^3 (8-hour time weighted average) is exceeded, cease works and review and implement additional dust prevention techniques.

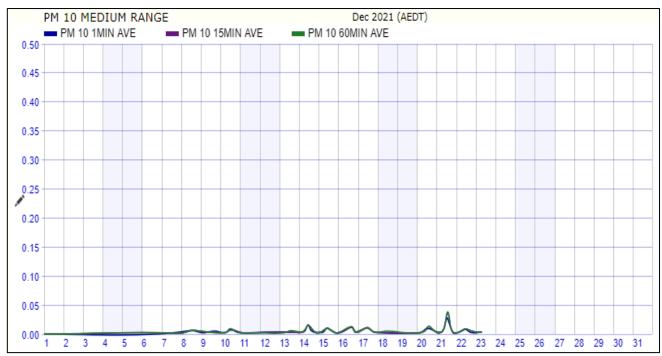
Figure 2. Summary of PM10 from the real time monitoring at location 002 – Central location for the month of December 2021.

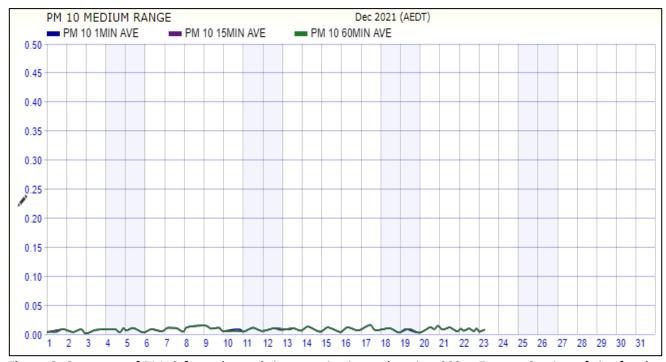
Figure 3. Summary of PM10 from the real time monitoring at location 003 – Eastern Section of site for the month of December 2021.
