# **Environmental Dust Assessment Report (February 2023)**

**Tweed Valley Hospital Project, Cudgen NSW**

Prepared for: Lendlease Building Pty Ltd

A101021.0286.00 | EDM43.Rev0 | Date: 23/03/2023

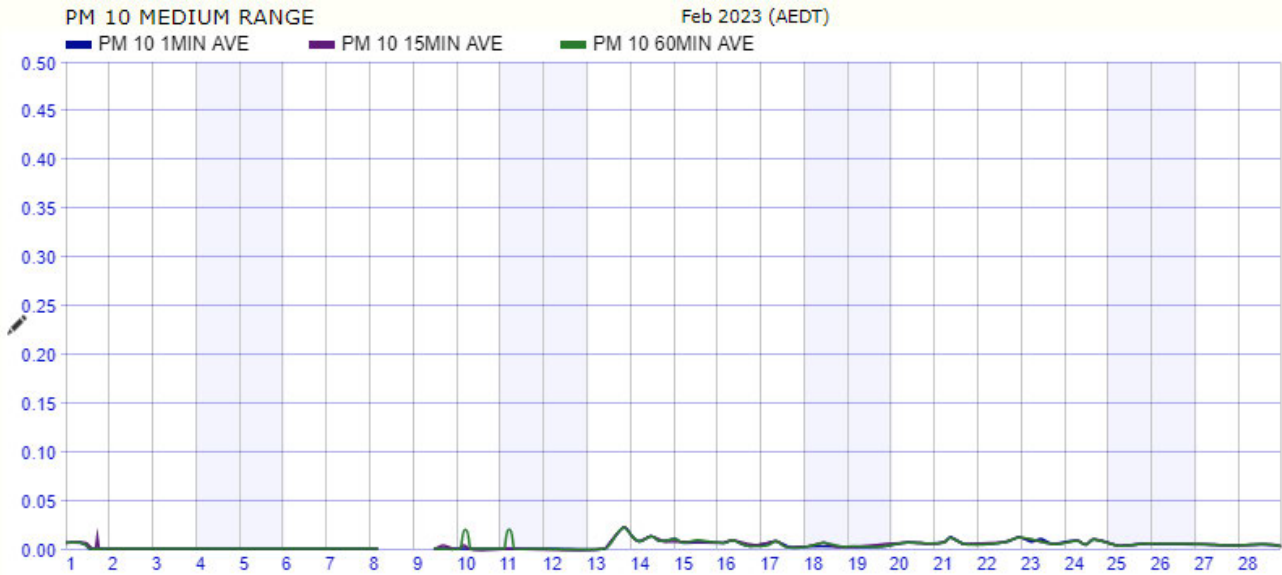
**Figure 1.** Summary of PM10 from the real time monitoring at location 005 – Solar Industry for the month of February 2023.

All measured PM<sub>10</sub> dust levels remained below 0.5 mg/m<sup>3</sup> during the month of February 2023 (*refer to Section 3*) at Monitoring Locations 005, 006 and 007. Recorded data from all monitoring locations were below the Action Limit of 2.5 mg/m<sup>3</sup>. It should be noted that the DustTrak records a minimum concentration reading of 0.001 mg/m<sup>3</sup> and values of lower concentration were recorded as zero.

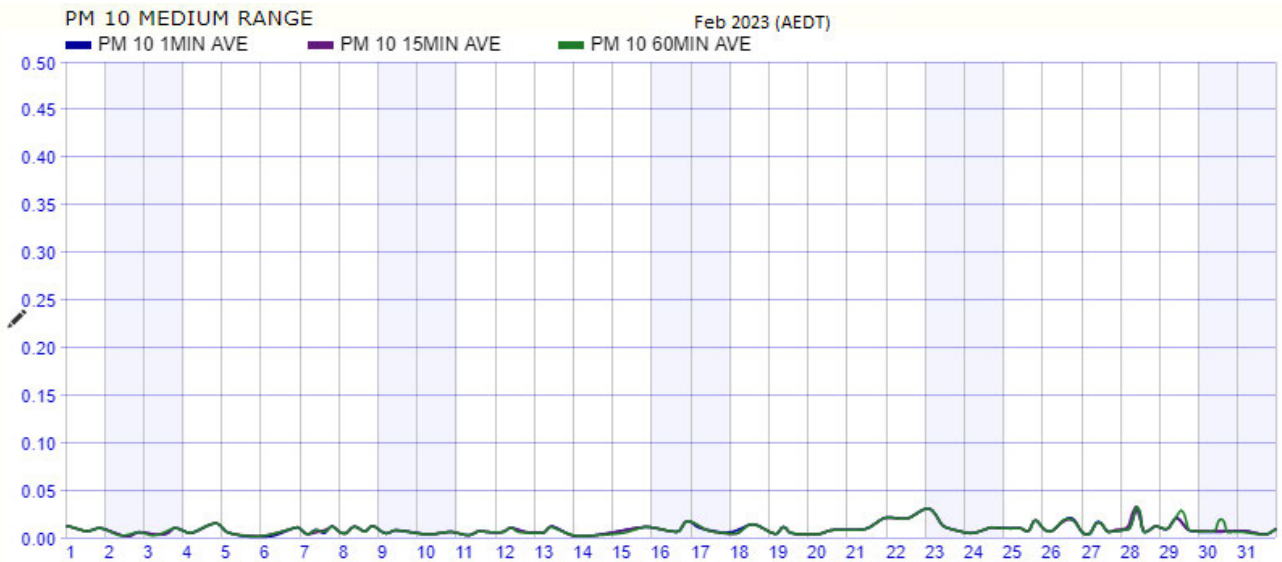
**Figure 2.** Summary of PM10 from the real time monitoring at location 006 – Mate and Matts for the month of February 2023.

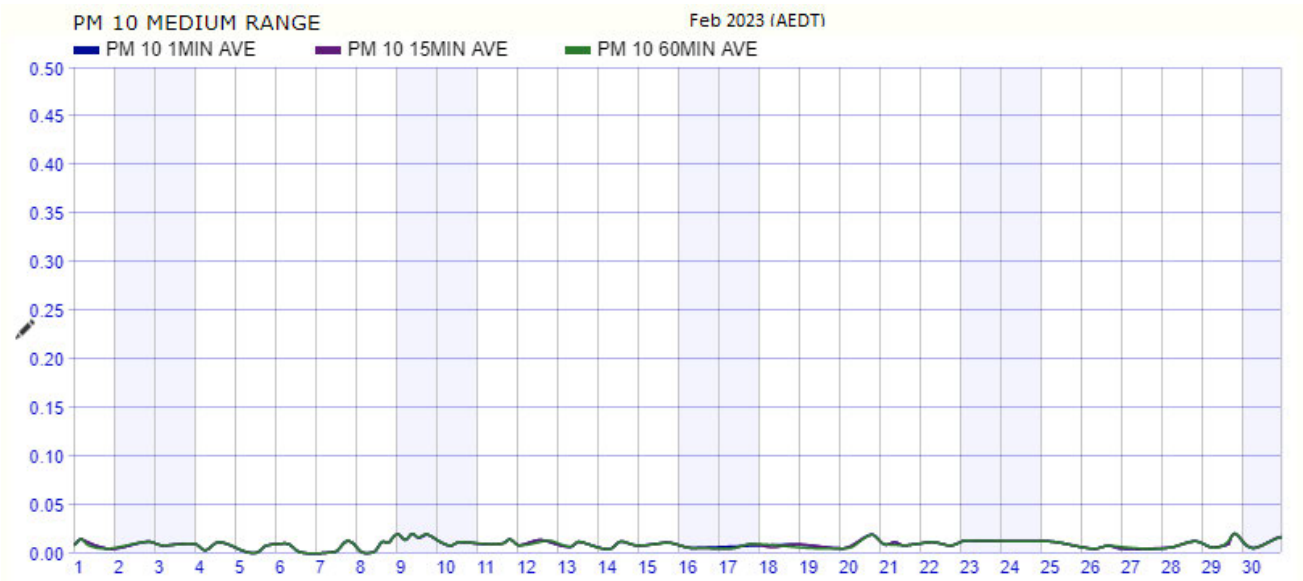
**Figure 3.** Summary of PM10 from the real time monitoring at location 007 – Residential for the month of February 2023.

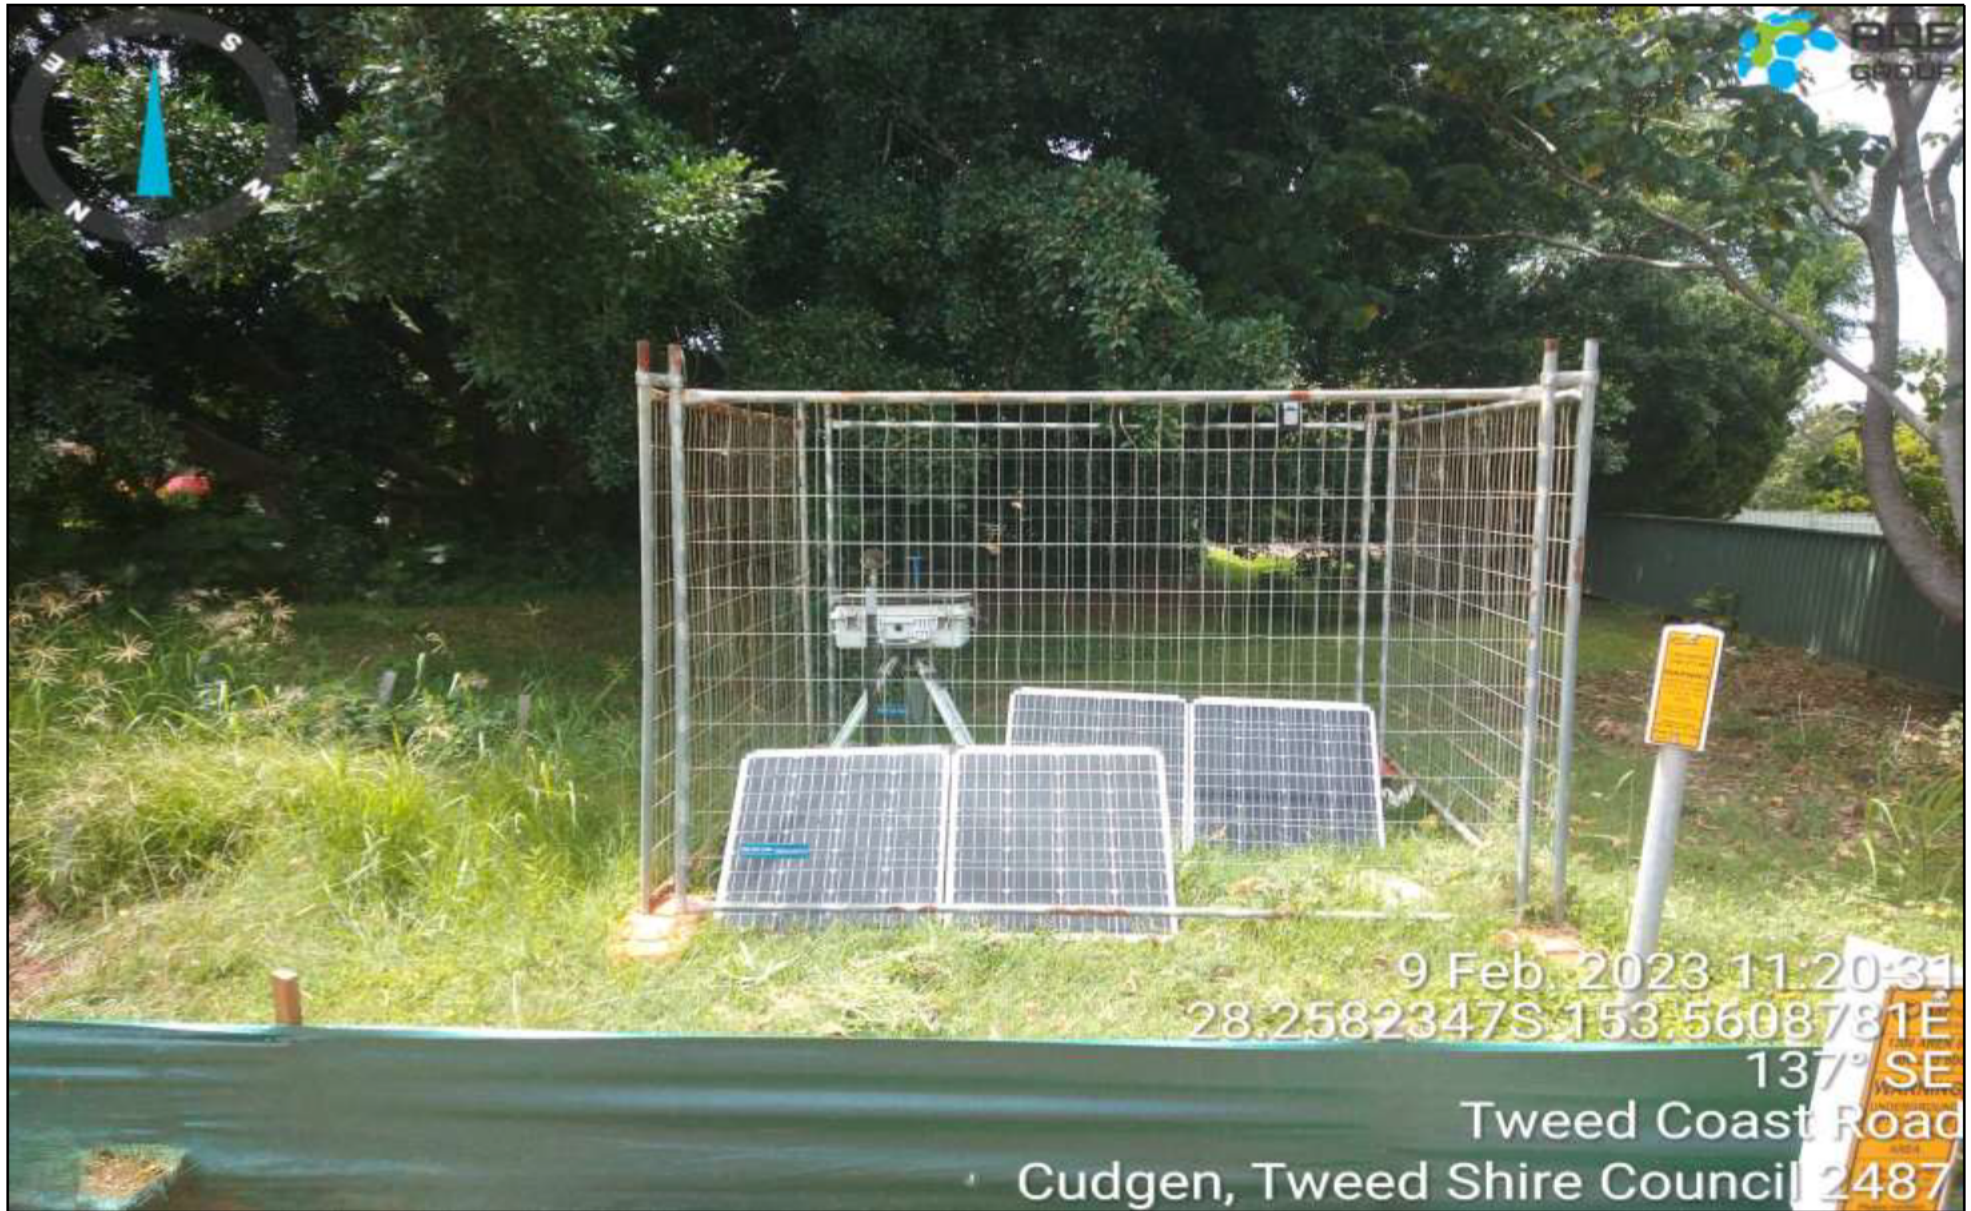
Dust Monitor 005 was observed to be offline during the daily checks on 8 February 2023. ADE attended site on 9 February 2023 checking connections, status of the battery and repositioning of the solar panels. A power supply and connectivity issue was identified and resolved. The monitor came back online on 9 February 2023.

Photograph 1: Representative photograph of monitoring location 005 – Solar Industry, as observed 9/02/2023

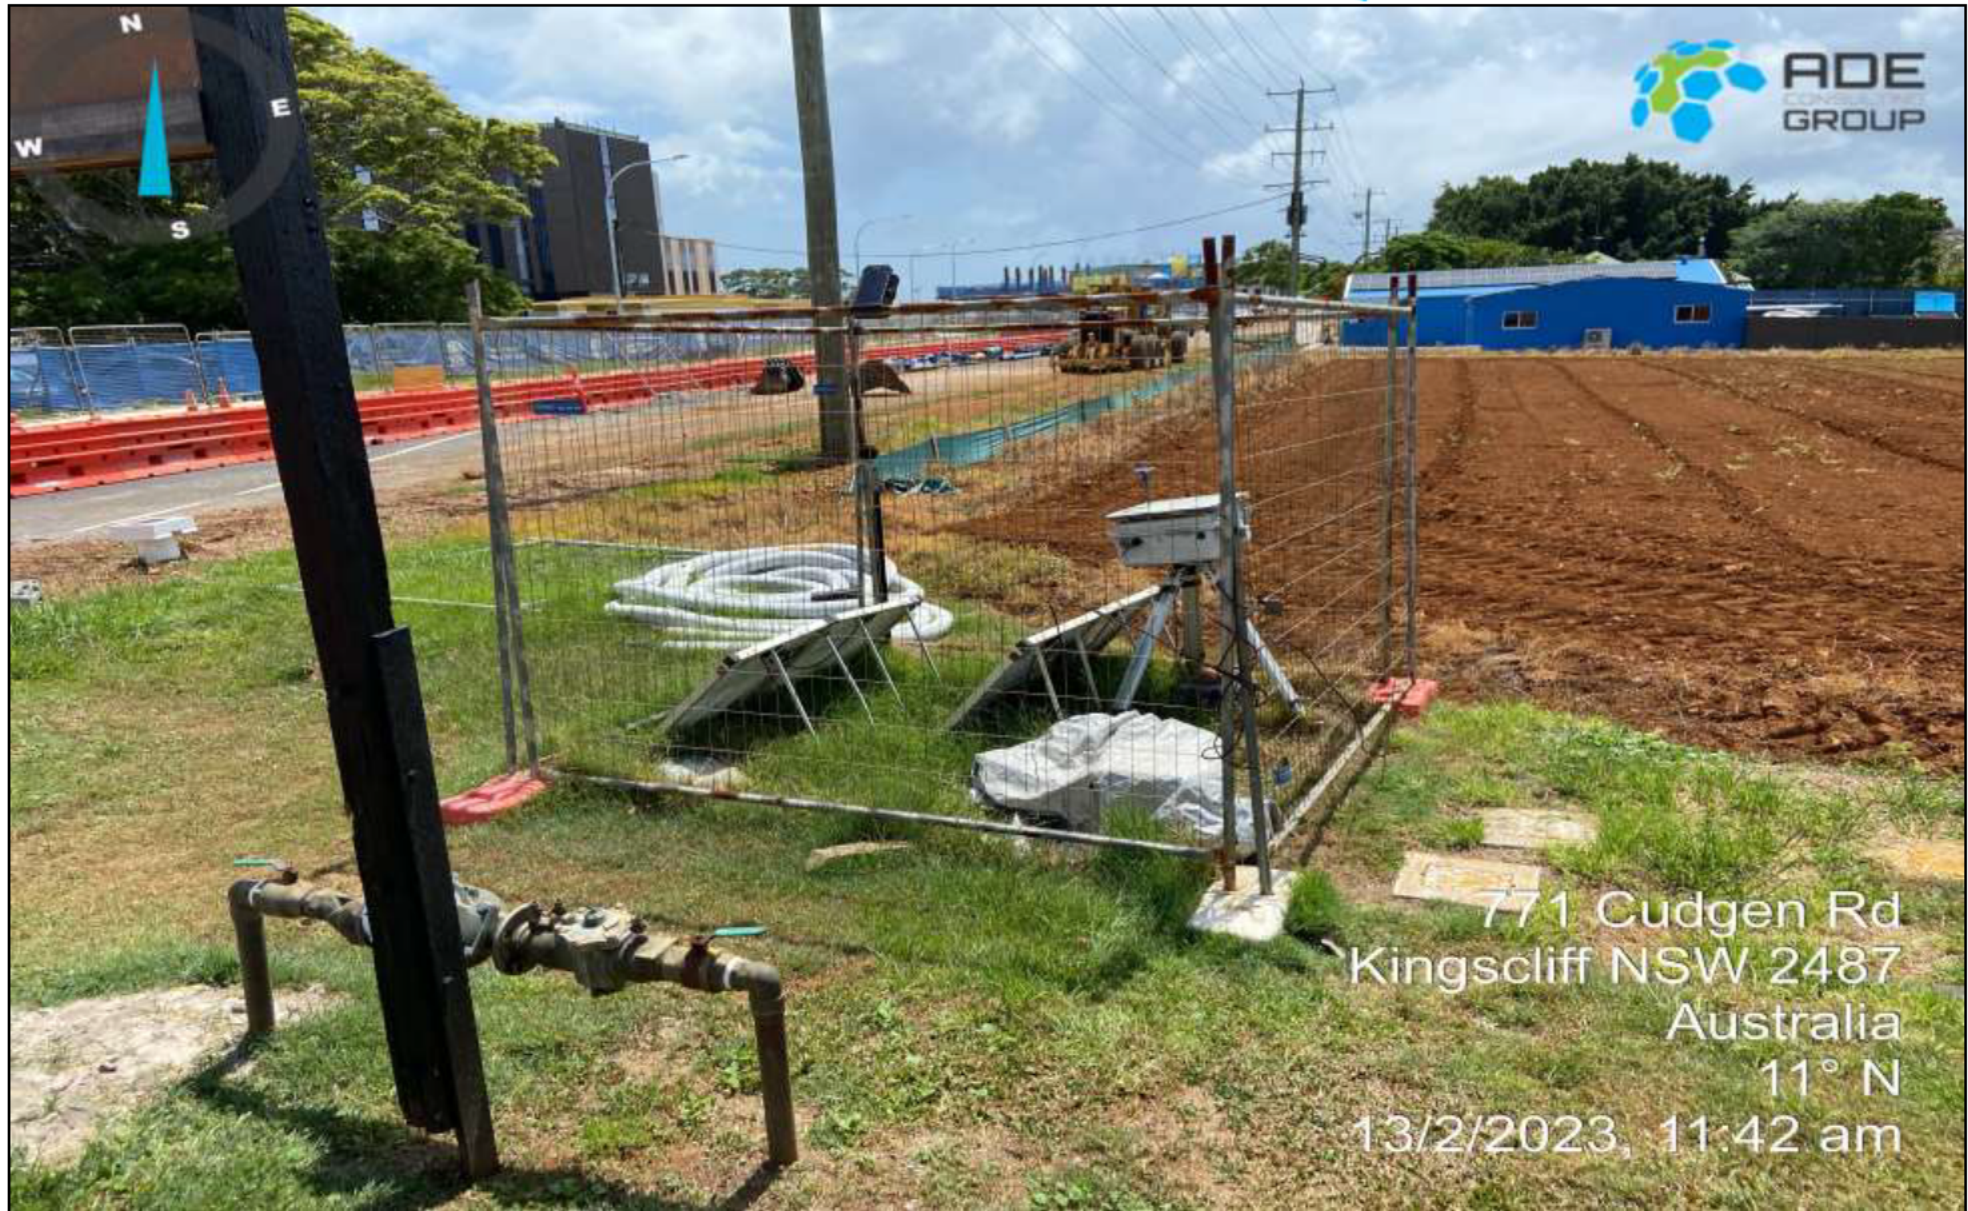
Photograph 2: Representative photograph of monitoring location 006 – Mate and Matts, as observed 13/02/2023

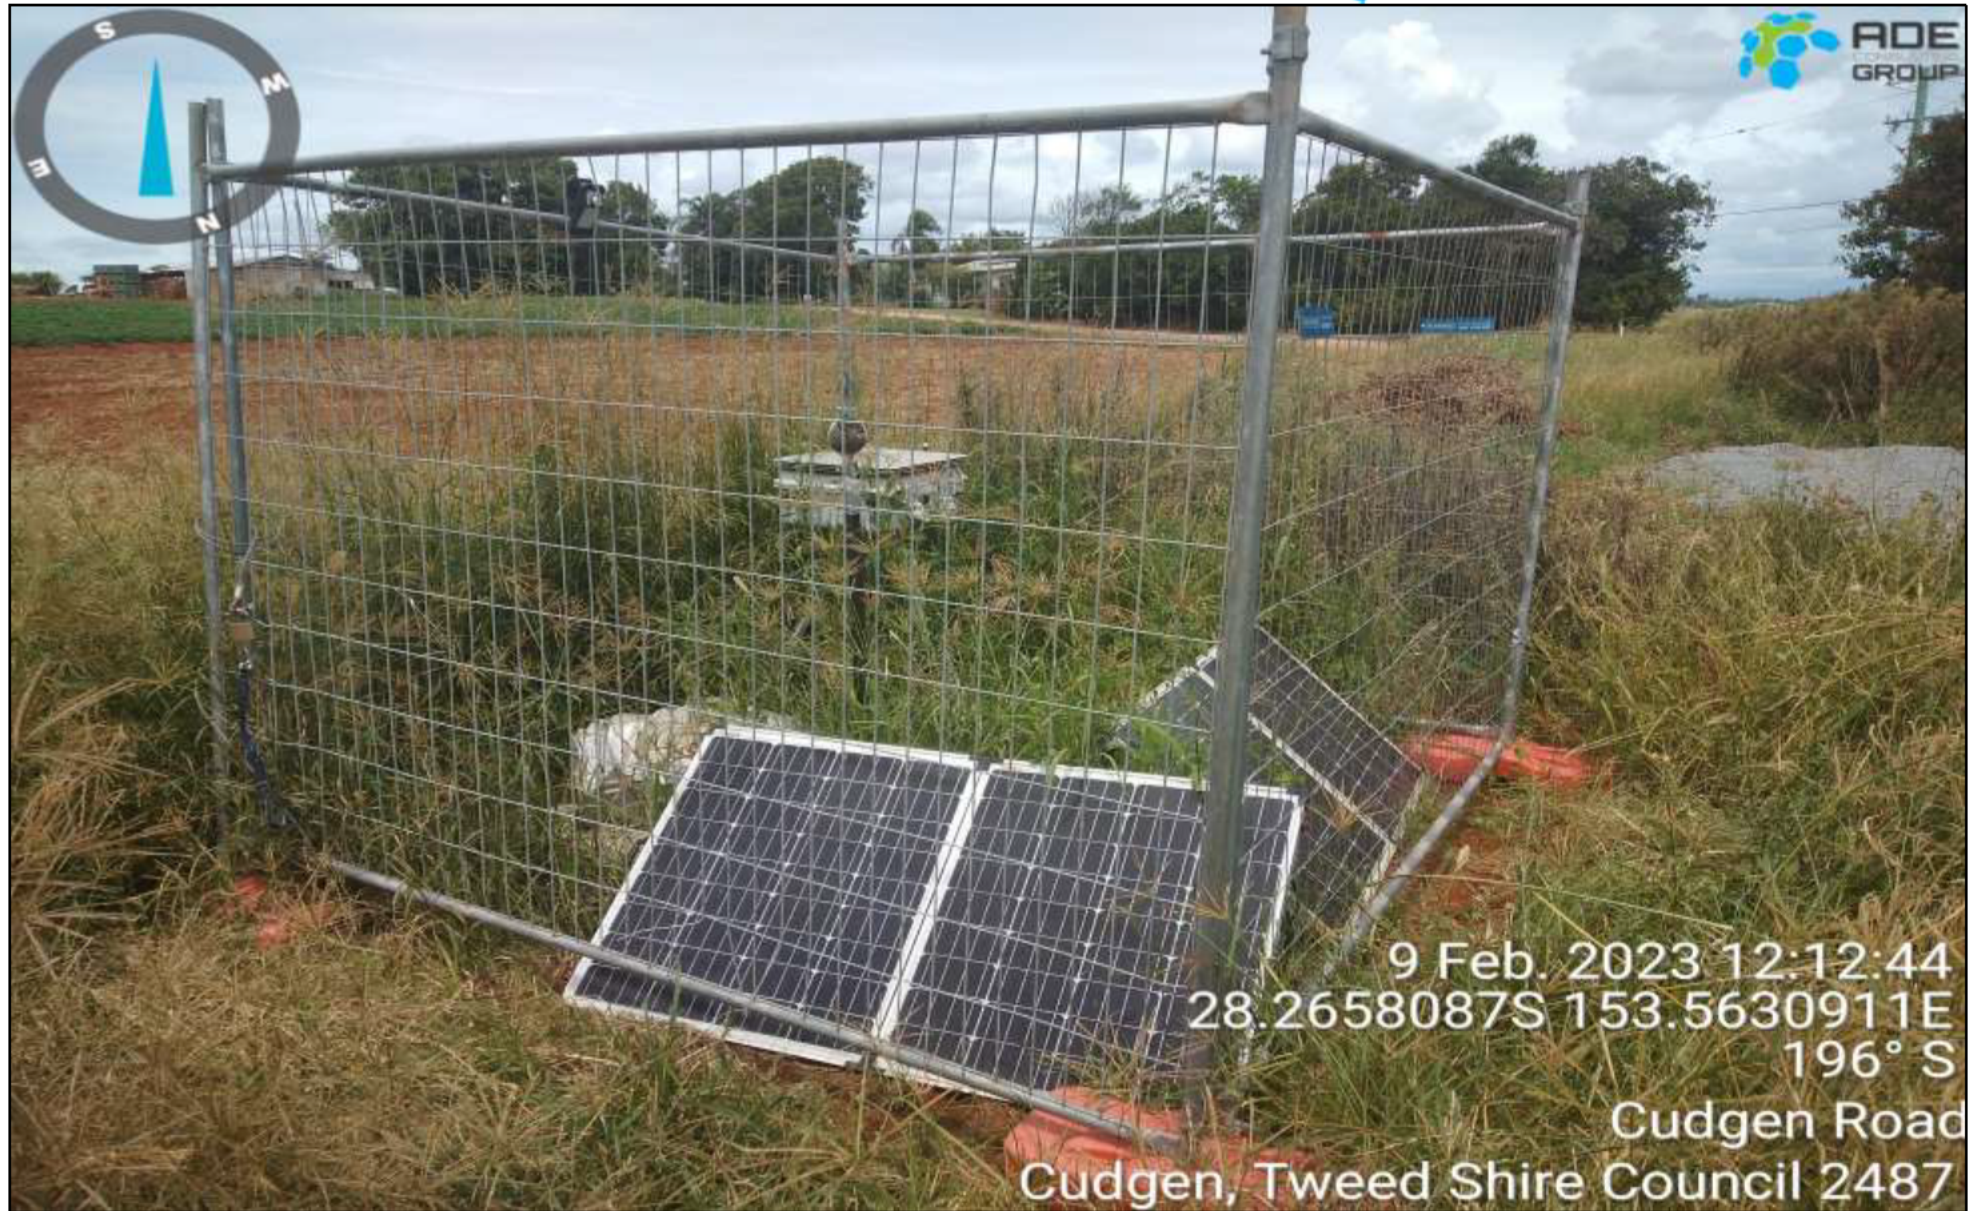
Photograph 2: Representative photograph of monitoring location 007 – Residential, as observed 09/02/2023
