# Vibration Monitoring Assessment Report (September 2022)

Tweed Valley Hospital Project, Cudgen NSW

A101021.0286.00 | VIB38.Rev0 | Date: 17/10/2022

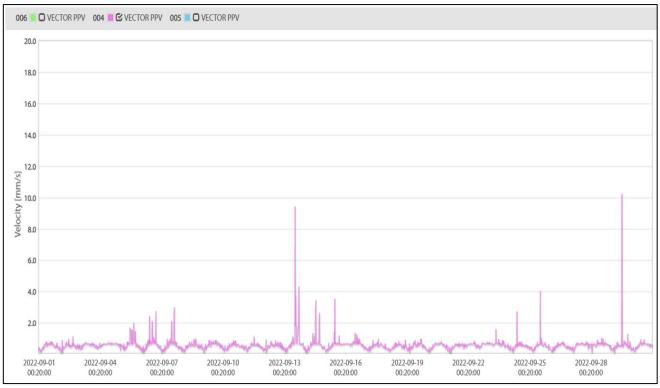
Figure 1. Vibration data at location 004 | TAFE East | September 2022

During the monitoring period (September 2022) no exceedance of DIN 4150 Line 1 or Line 2 PPV guideline values was observed. The results presented in Figures 1-3 do not include a distance correction.

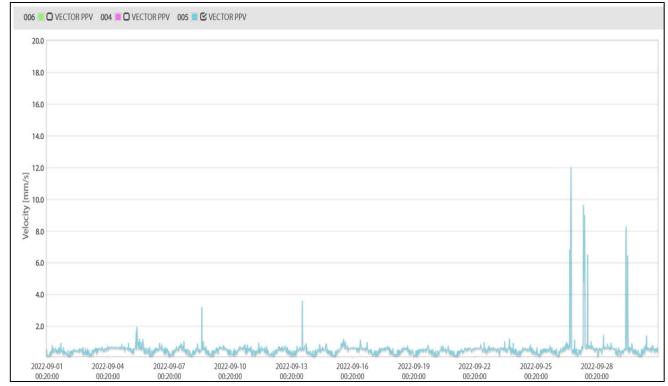
Figure 2. Vibration data at location 005 | TAFE West | September 2022

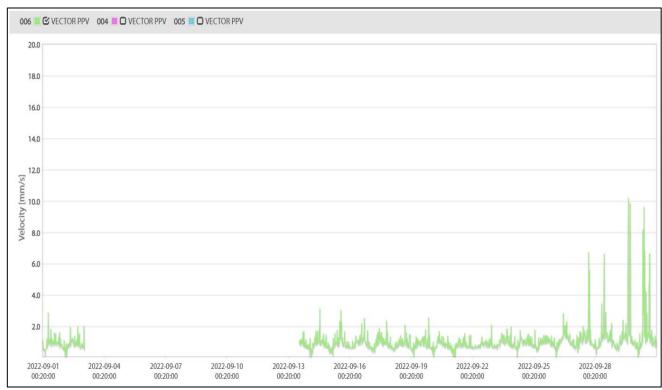
Monitor 006 was noted to be offline during the daily checks on 5 September 2022. ADE attended site on 8 September 2022 to remove the monitor for detailed inspection. The monitor was reinstalled on site 13 September 2022.

Figure 3. Vibration data at location 006 | Mate and Matt's | September 2022
