# Environmental Dust Assessment Report (June 2022) Tweed Valley Hospital Project, Cudgen NSW

Prepared for: Lendlease Building Pty Ltd

A101021.0286.00 | EDM5.Rev0| Date: 21/07/2022

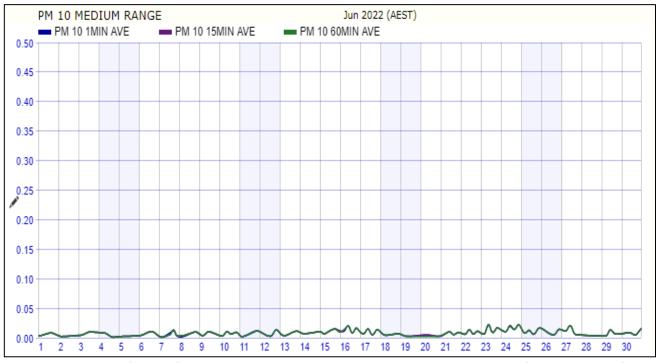
**Figure 1.** Summary of PM10 from the real time monitoring at location 004 – TAFE East for the month of June 2022.

All dust levels remained below 0.5 mg/m<sup>3</sup> during the month of June 2022 (*refer to Section 3*).

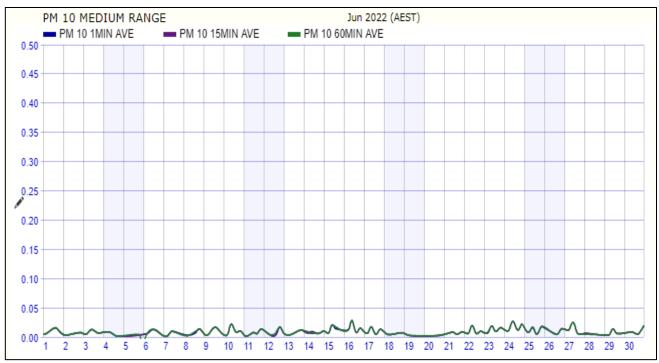
**Figure 2.** Summary of PM10 from the real time monitoring at location 005 – TAFE West for the month of June 2022.

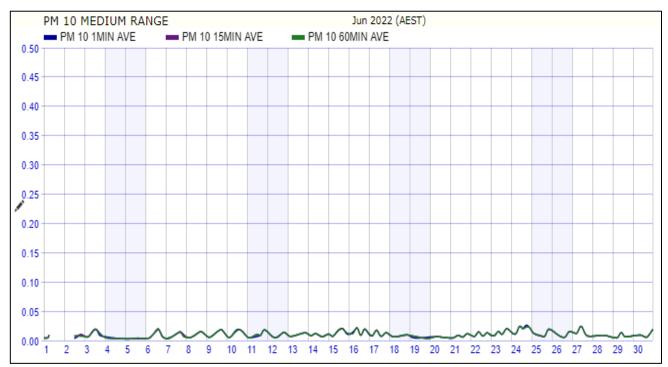
Dust monitor 006 was noted to be offline during the daily checks 01 June 2022. The monitor came back online 02 June 2022.

**Figure 3.** Summary of PM10 from the real time monitoring at location 006 – Mate and Matts for the month of June 2022.
