# Environmental Dust Assessment Report (December 2022)

**Tweed Valley Hospital Project, Cudgen NSW**

Prepared for: Lendlease Building Pty Ltd

A101021.0286.00 | EDM41.Rev0 | Date: 7/02/2023

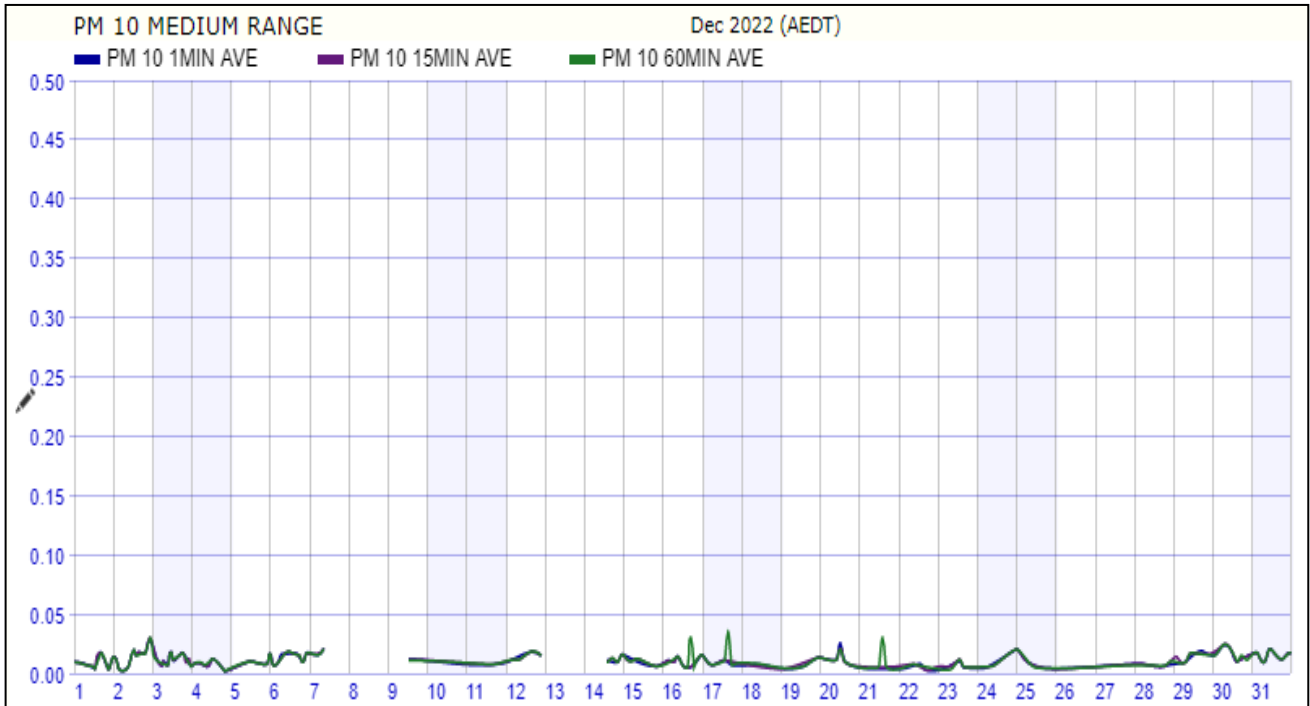
Dust monitor 005 was noted to be offline during the daily checks on 7 December 2022. ADE attended site on 8 December 2022 to check connections and solar panels. The monitor came back online on 9 December 2022. The monitor was noted to be offline during the daily checks on 13 December 2022. The monitor came back online on 14 December 2022.

**Figure 1.** Summary of PM10 from the real time monitoring at location 005 – Solar Industry for the month of December 2022.

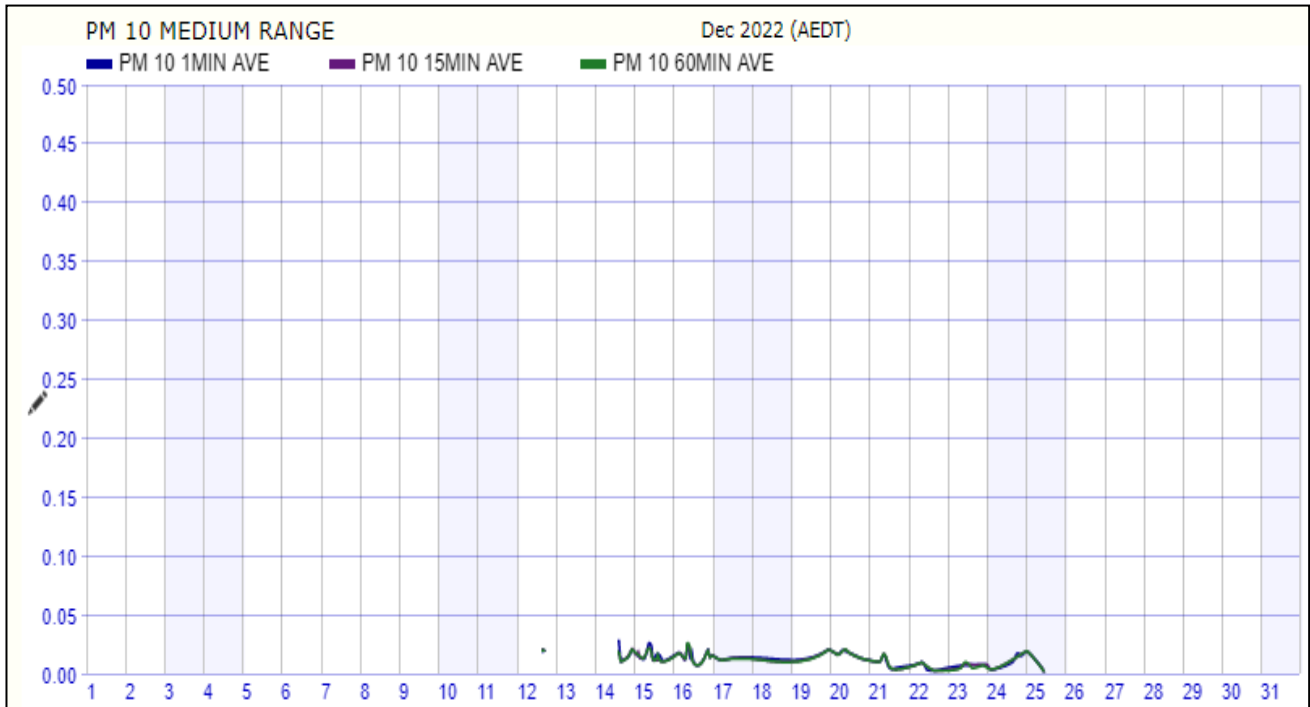
Dust monitor 006 was noted to be offline during the daily checks on 24 November 2022. ADE attended site on 01 December 2022 to check connections and reposition solar panels. The monitor was removed from site for repair on 08 December 2022. Following diagnostics and repair, the monitor was reinstalled on site on 14 December 2022. The monitor went offline again on 25 December 2022 and came back online 01 January 2023.

**Figure 2.** Summary of PM10 from the real time monitoring at location 006 – Mate and Matts for the month of December 2022.

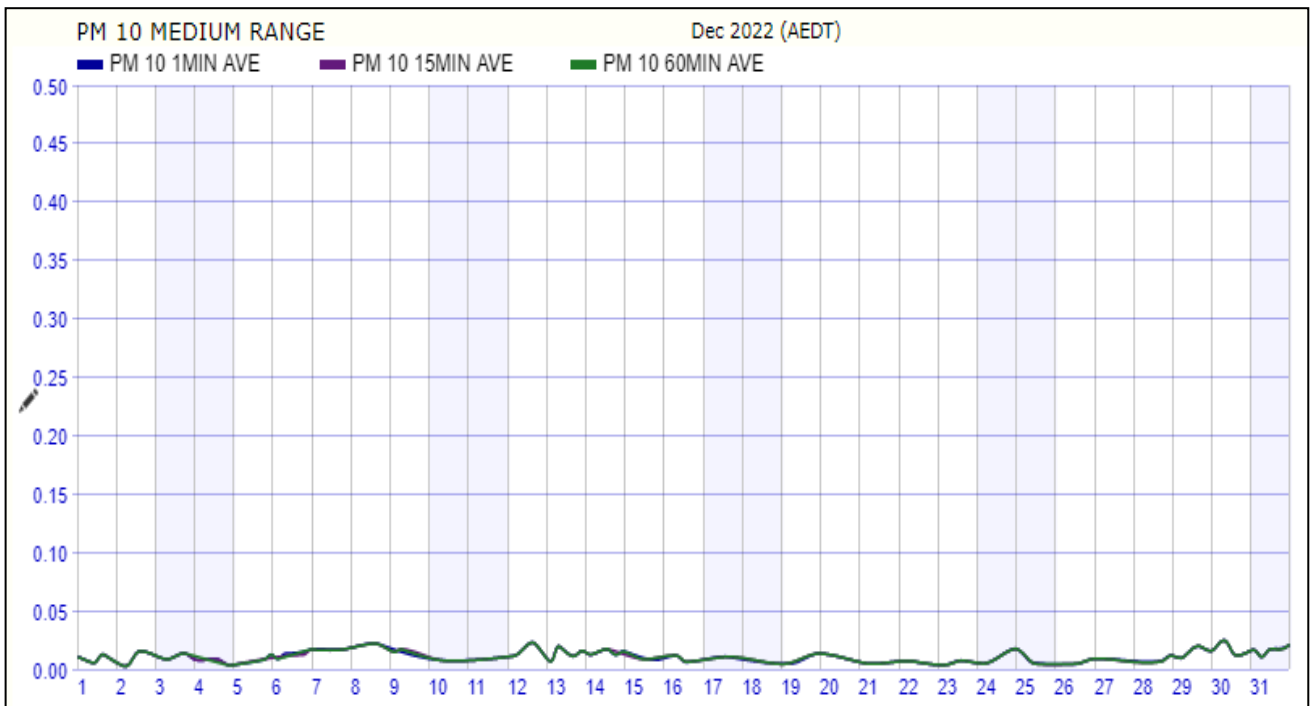
All data from dust monitor 007 were correctly collected.

**Figure 3.** Summary of PM10 from the real time monitoring at location 007 – Residential for the month of December 2022.

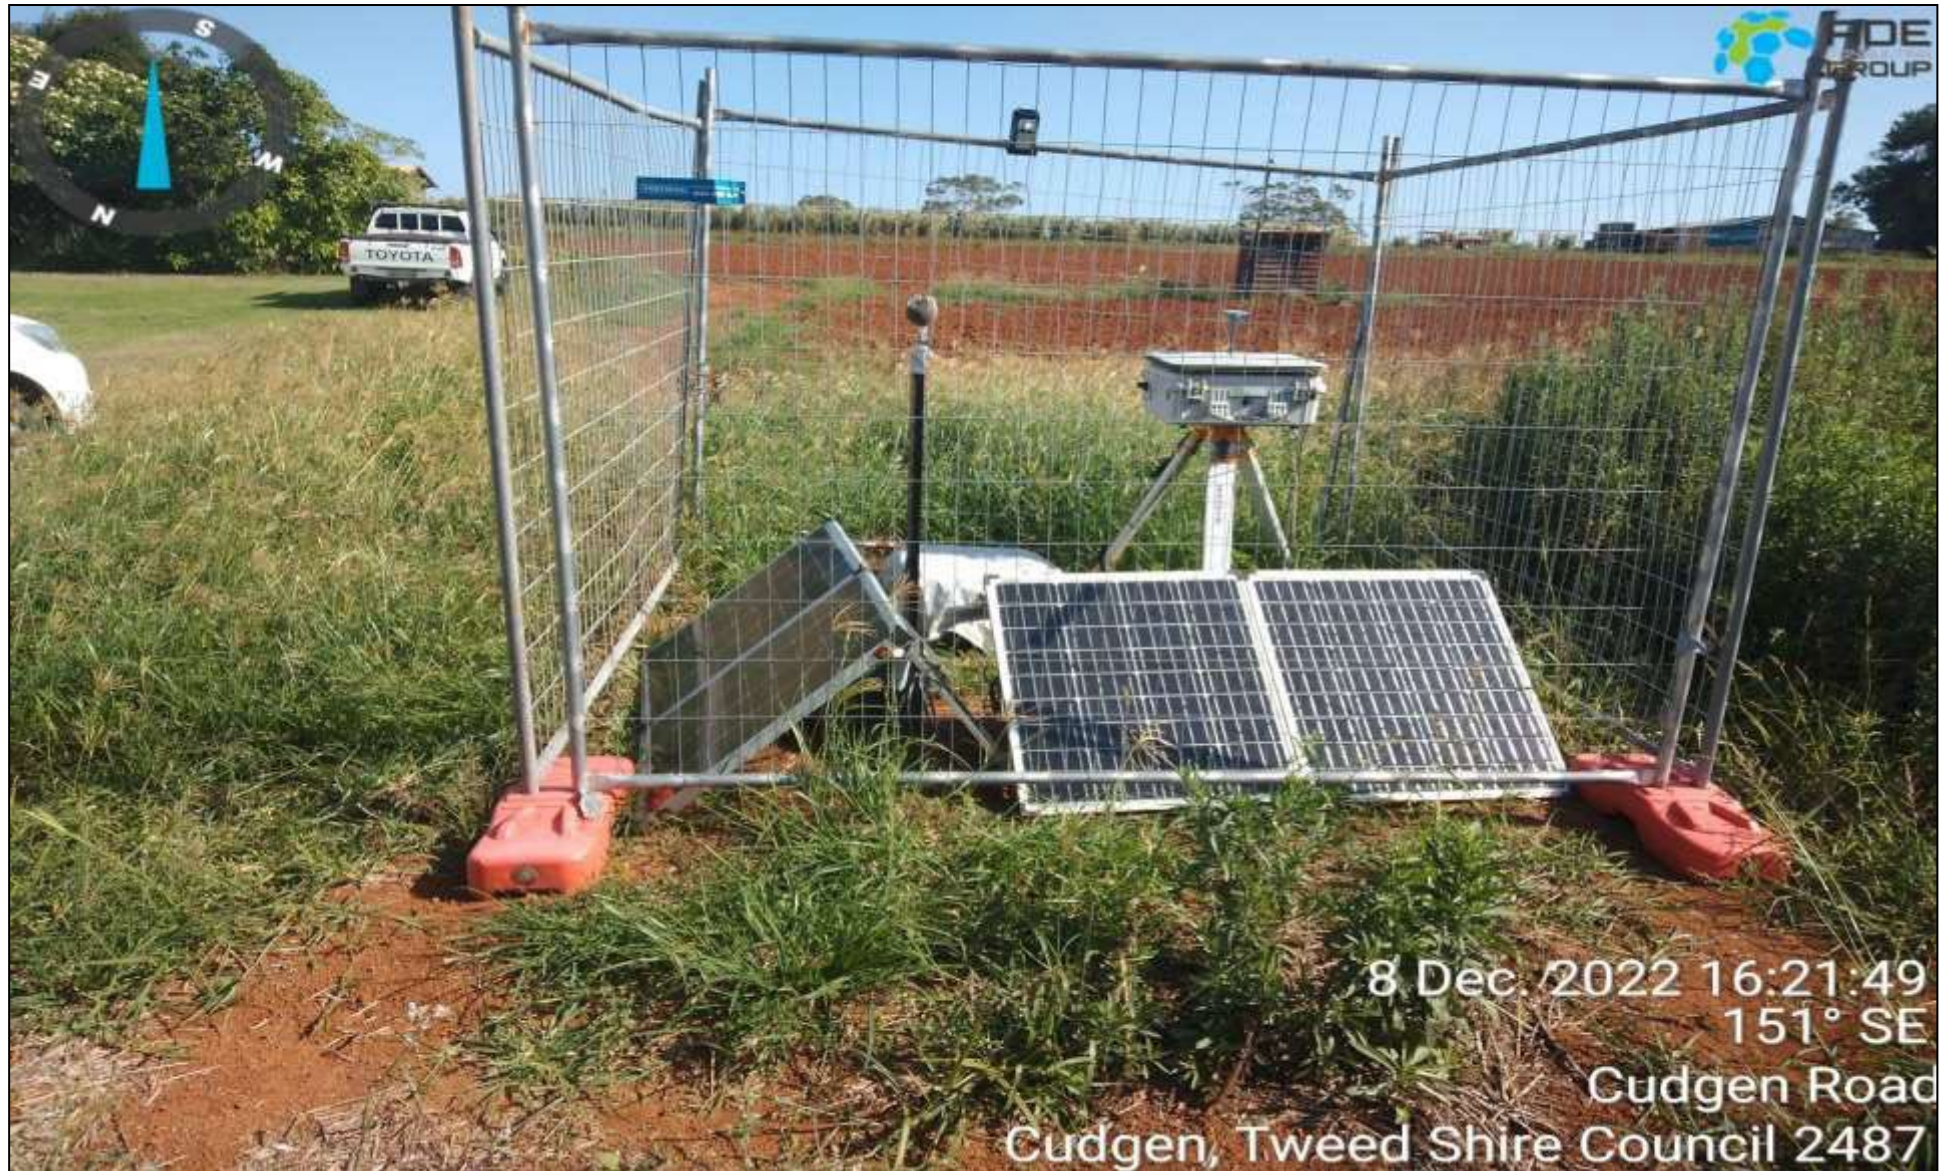
Photograph 1 Representative photograph of monitoring location 007 – Residential, as observed 08/12/2022

Photograph 2 Representative photograph of monitoring location 005 – Solar Industry, as observed 08/12/2022

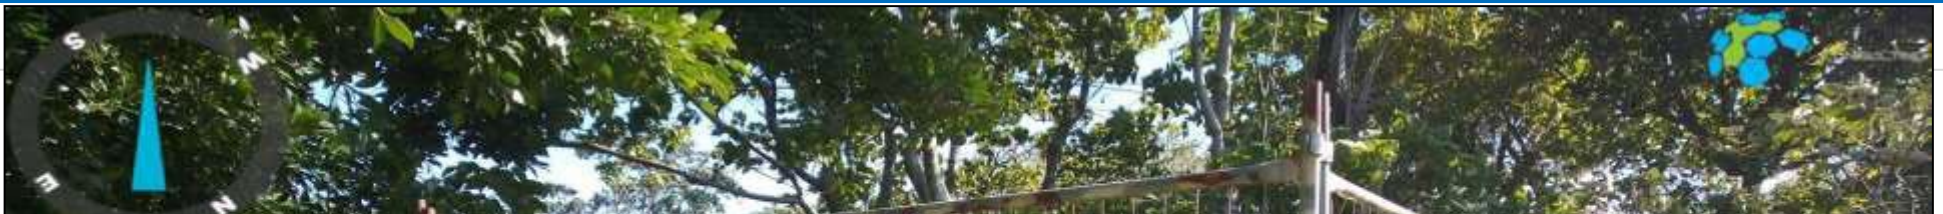
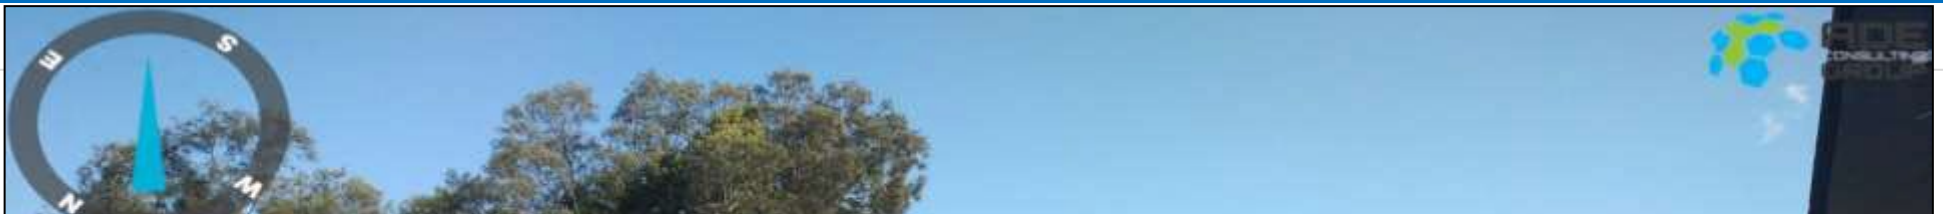
Photograph 3 Representative photograph of monitoring location 006 – Mate and Matts, as observed 08/12/2022
