# **Environmental Dust Assessment Report** (May 2022)

Tweed Valley Hospital Project, Cudgen NSW

Prepared for: Lendlease Building Pty Ltd

A101021.0286.00 | EDM34.Rev0 | Date: 21/06/2022

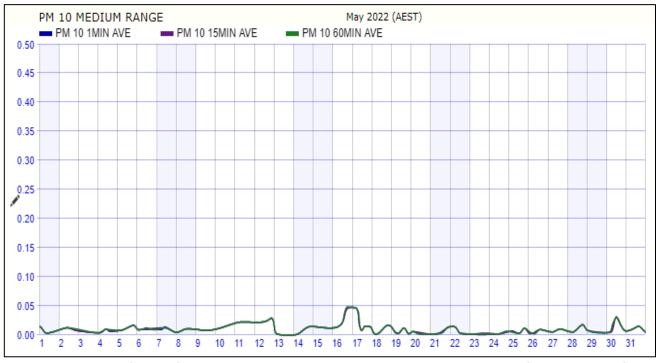
**Figure 1.** Summary of PM10 from the real time monitoring at location 004 – TAFE East for the month of May 2022.

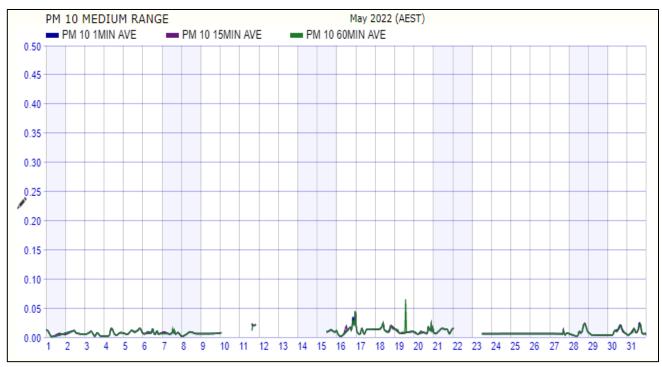
Dust monitor 005 was noted to be offline during the daily checks on 10 May 2022. The monitor came back online 11 May 2022. It was again noted to be offline during the daily checks on 12 May 2022. The monitor came back online 15 May 2022. ADE attended site to check power connections and optimise the angle of the solar panels on 16 May 2022.

**Figure 2.** Summary of PM10 from the real time monitoring at location 005 – TAFE West for the month of May 2022.

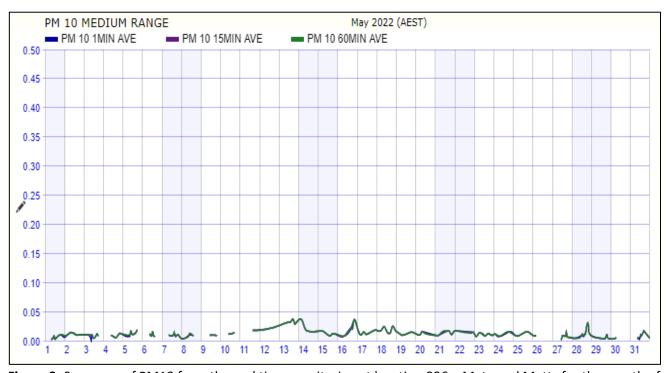
Dust monitor 006 was noted to be experiencing upload difficulties during the weekly graphs 06 May 2022. ADE attended site to check power connections on 11 May 2022. The monitor ran normally again until the 26 May 2022 when it was again noted to be offline during the daily checks. ADE attended site to check power connections again on 27 May 2022. The monitor was noted to be offline again during the daily checks on 30 May 2022. ADE attended site to optimise the angle of the solar panels on 31 May 2022.

**Figure 3.** Summary of PM10 from the real time monitoring at location 006 – Mate and Matts for the month of May 2022.

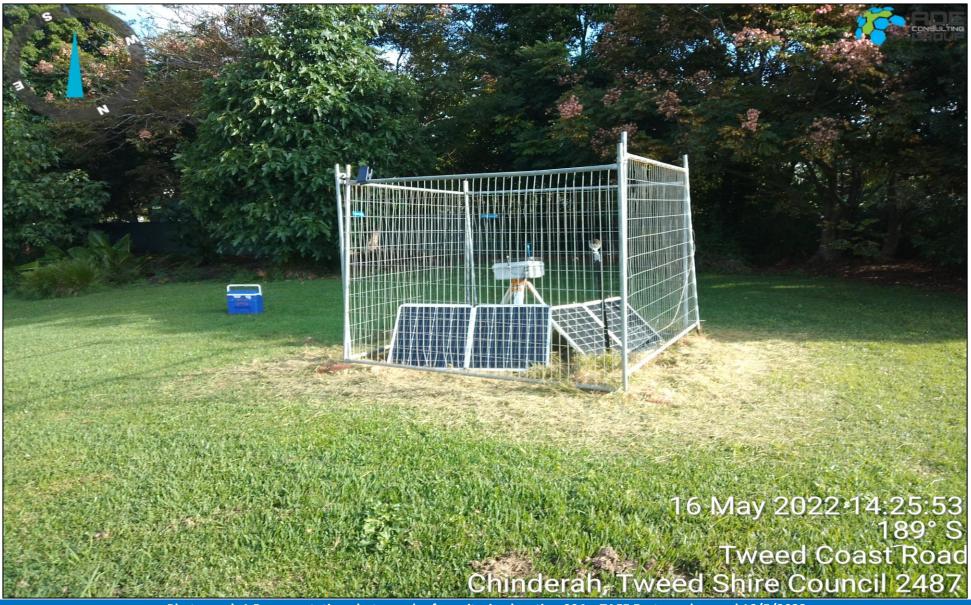
Photograph 1 Representative photograph of monitoring location 004 – TAFE East, as observed 16/5/2022

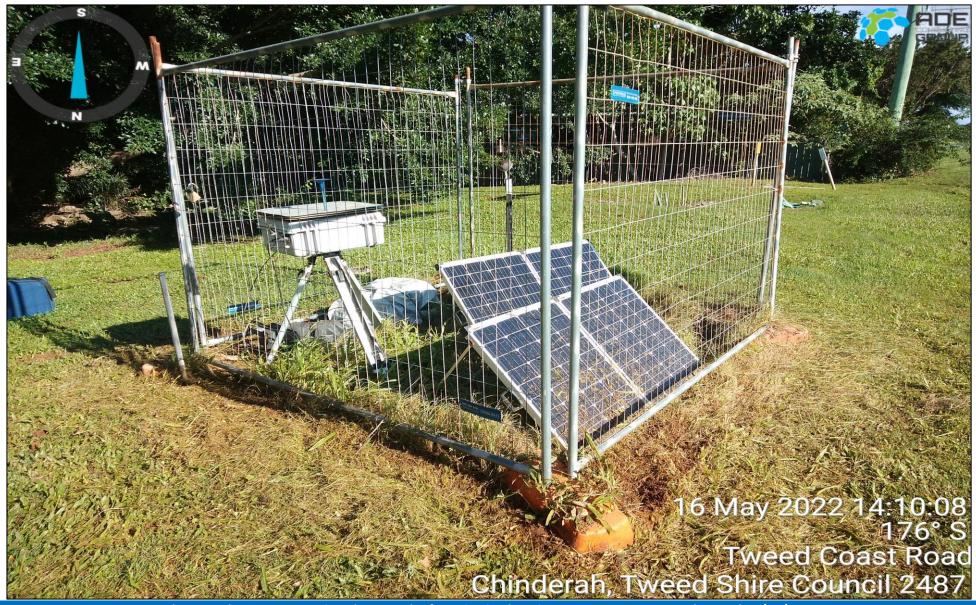
Photograph 2 Representative photograph of monitoring location 005 – TAFE West, as observed 16/05/2022

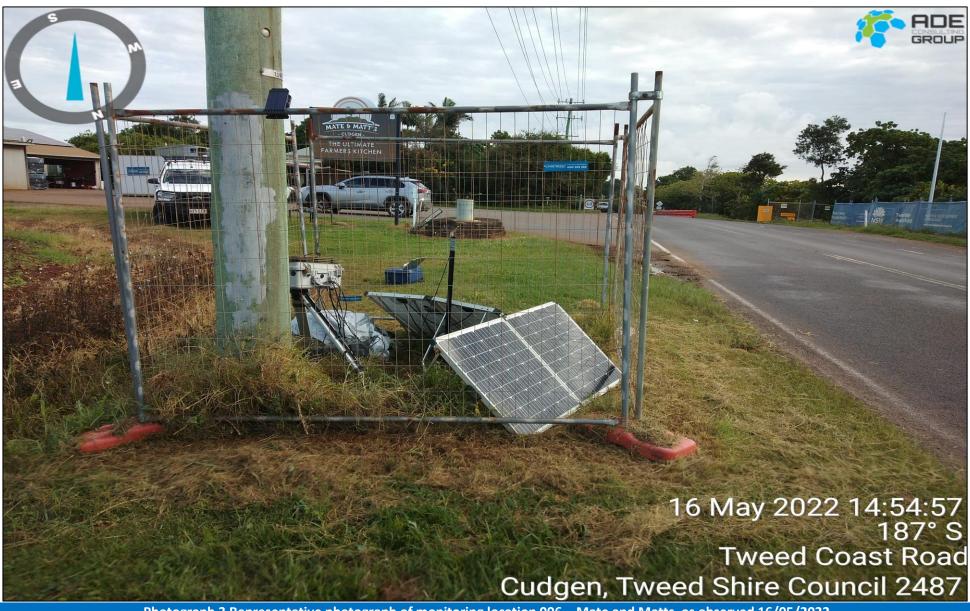
Photograph 3 Representative photograph of monitoring location 006 – Mate and Matts, as observed 16/05/2022
