# **Environmental Dust Assessment Report (May 2023)**

**Tweed Valley Hospital Project, Cudgen NSW**

Prepared for: Lendlease Building Pty Ltd

A101021.0286.00 | EDM46.Rev0 | Date: 2/08/2023

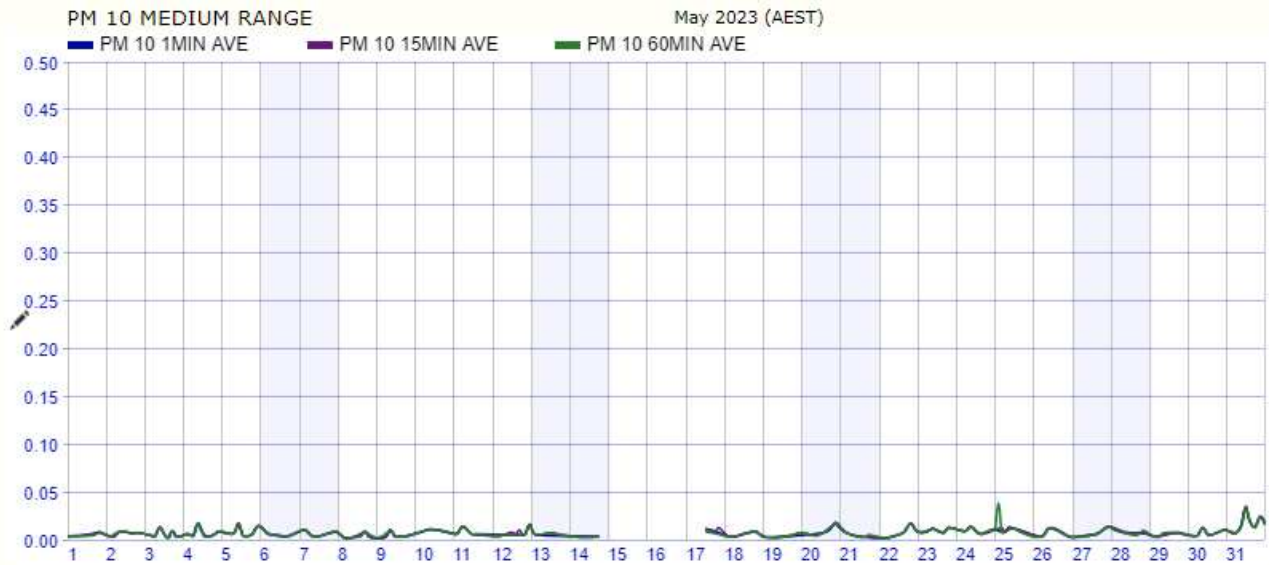
**Figure 1.** Summary of PM10 from the real time monitoring at location 005 – Solar Industry for the month of May 2023.

All measured PM<sub>10</sub> dust levels remained below 0.5 mg/m<sup>3</sup> during the month of May 2023 (*refer to Section 3*) at Monitoring Locations 005, 006 and 007. Recorded data from all monitoring locations were below the Action Limit of 2.5 mg/m<sup>3</sup>. It should be noted that the DustTrak records a minimum concentration reading of 0.001 mg/m<sup>3</sup> and values of lower concentration were recorded as zero.

Consistent with previous reports, recommendations are to ensure adequate dust control measures continue to be implemented as per the Tweed Valley Hospital Management Plan – Air Quality and continue monitoring PM<sub>10</sub> for the duration of the project. If the action limit of 2.5 mg/m<sup>3</sup> (8-hour time weighted average) is exceeded, it is recommended that works are to cease and appropriate dust prevention techniques are to be identified and implemented. To reduce the likelihood of data gaps, daily on-site visual checks are to be undertaken by Lendlease accompanied by daily checks of the online telemetry by ADE.

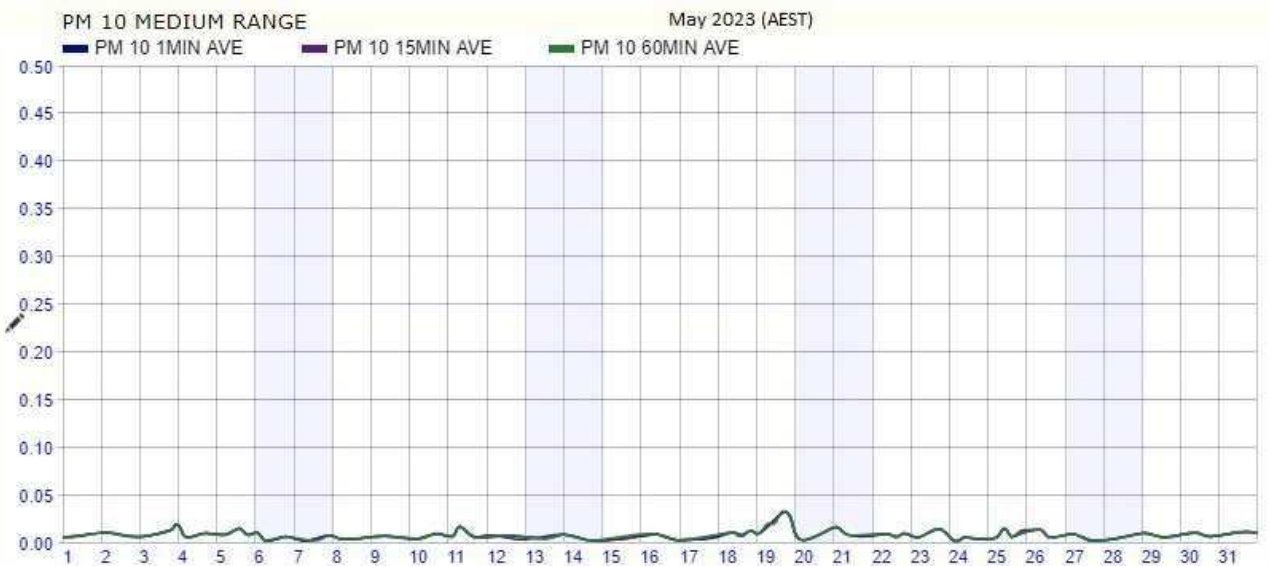
**Figure 2.** Summary of PM10 from the real time monitoring at location 006 – Mate and Matts for the month of May 2023.

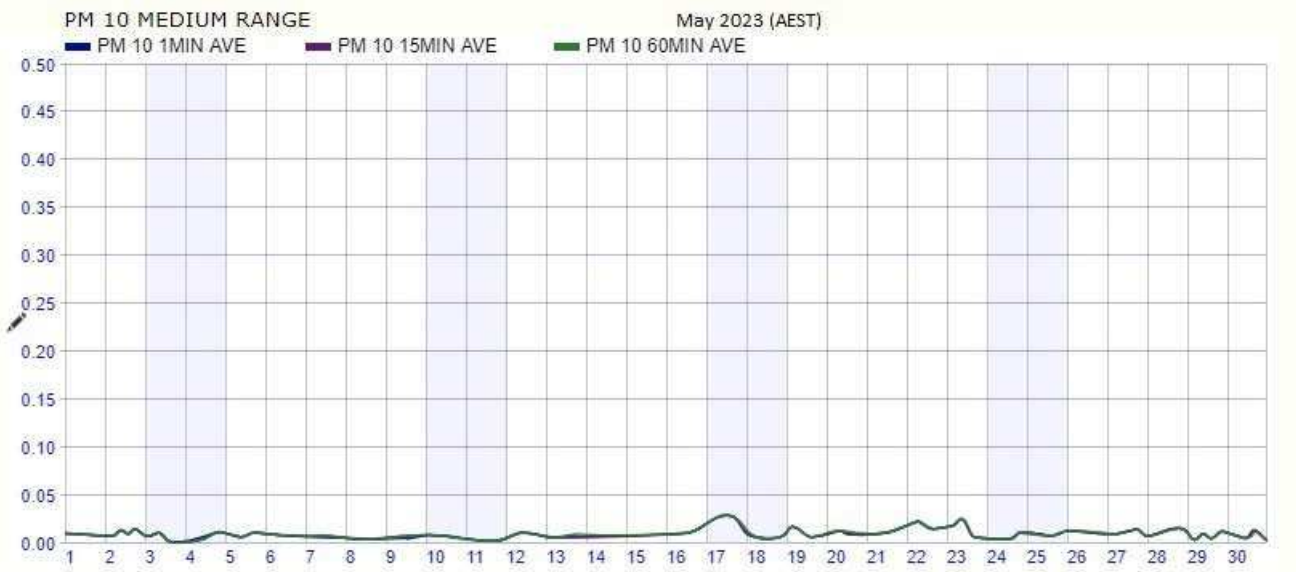
**Figure 3.** Summary of PM10 from the real time monitoring at location 007 – Residential for the month of May 2023.

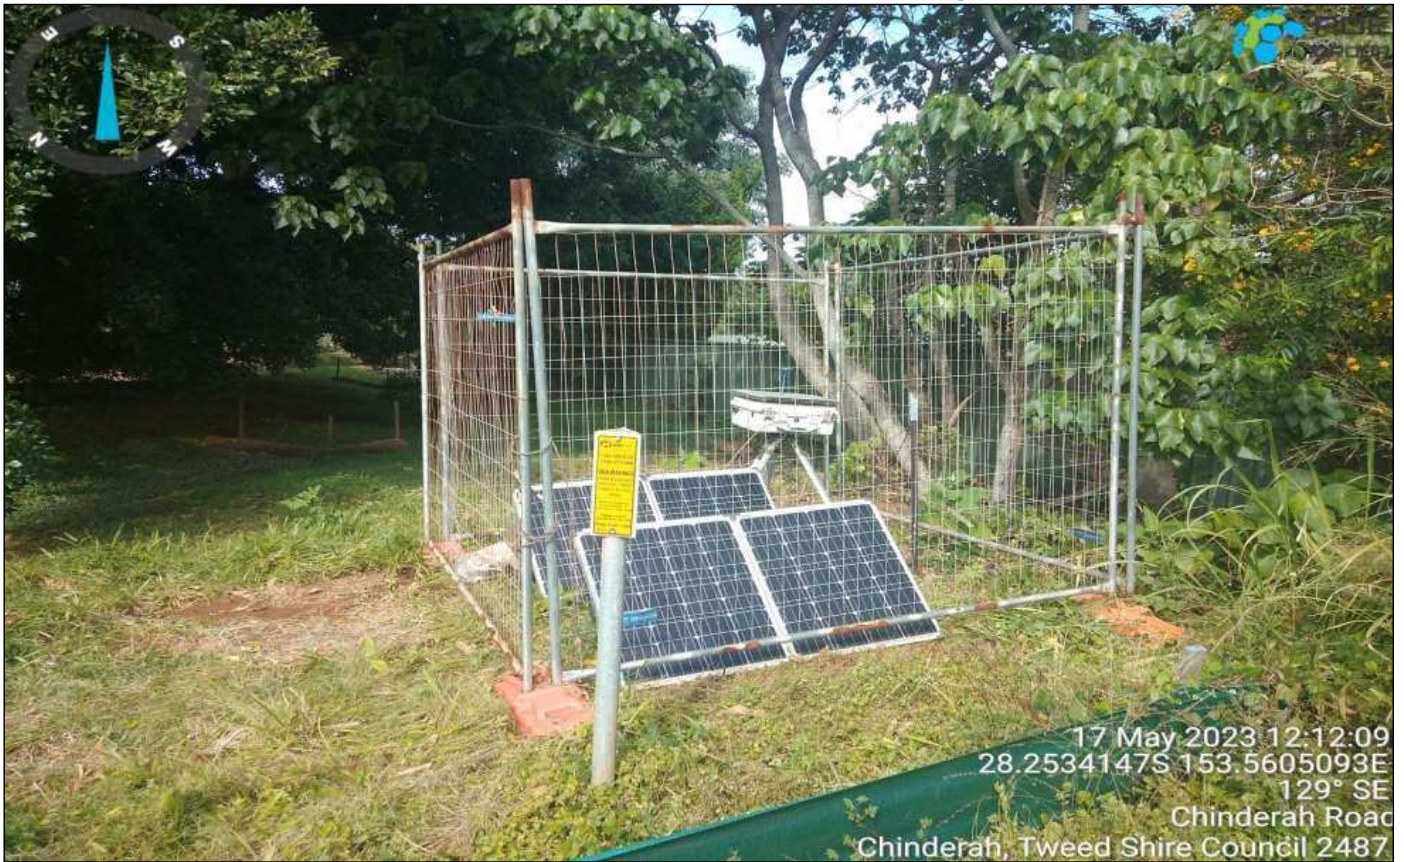
Dust Monitor 005 was observed to be offline during the daily checks on 15 May 2023. ADE attended site on 17 May 2023 checking connections, status of the battery and repositioning of the solar panels. A power supply and connectivity issue was identified and resolved. The monitor came back online 17 May 2023.

Data gaps were identified at Monitoring Location 005 on the following dates (14 – 17 May 2023) due to insufficient power supply and poor connectivity and confirmed on-site when inspected by field personnel. Based on field observations recorded with the current works, historical data at the monitoring location and the absence of dust exceedances at surrounding dust monitoring locations during current works, ADE considers the likelihood of dust exceedances to have occurred at Monitoring Location 005 is very low to negligible. Restoration of continuous power supply and other measures have been undertaken to improve monitoring performance for the instrument at Monitoring Location 005. In-field testing has confirmed that the equipment at Monitoring Location 005 is online and operating correctly within the assigned parameters.

Photograph 1: Representative photograph of monitoring location 005 – Solar Industry, as observed 17/05/2023
