Vibration Monitoring Assessment Report (December 2021)

Tweed Valley Hospital Project, Cudgen NSW

Prepared for: Lendlease Building Pty Ltd

A101021.0286.00 | VIB29.Rev1 | Date: 19/01/2022

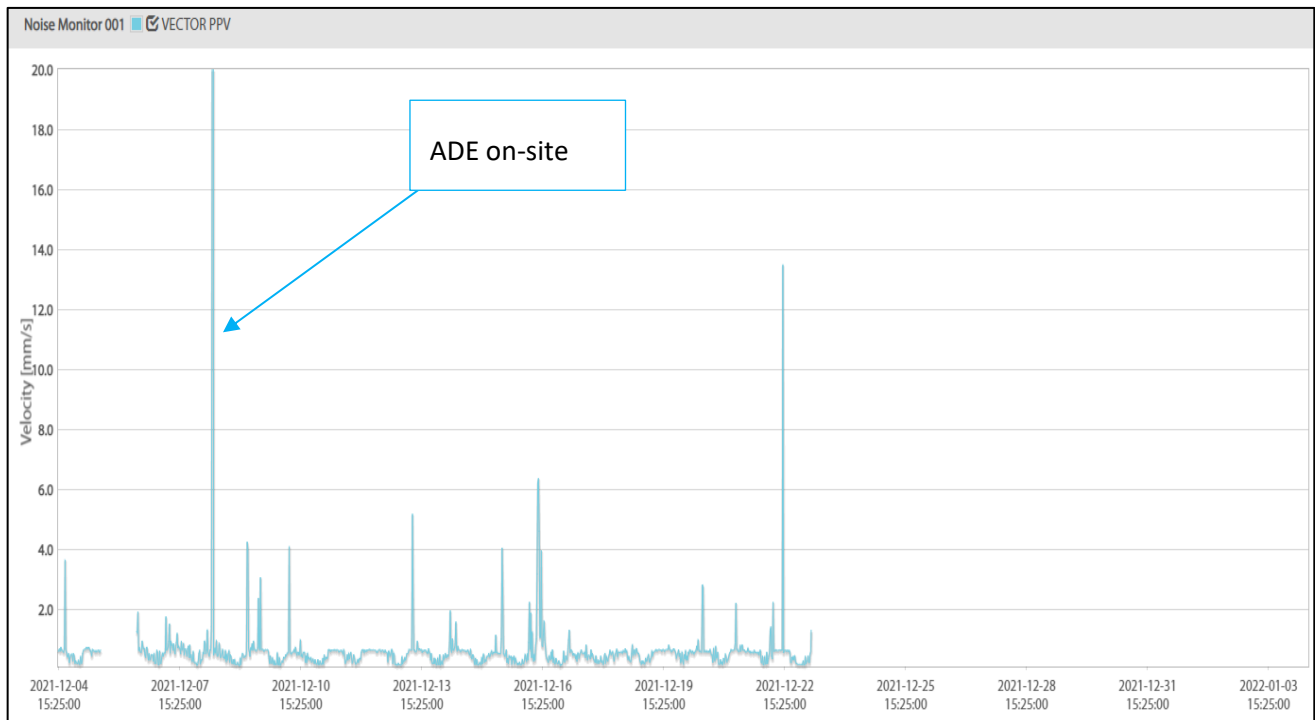
Figure 1. Vibration data at location 001 | Adjacent carpark | December 2021.

During a routine telemetry check on Monday 6 December 2021, ADE noticed that the Noise/Vibration monitor at monitoring location 001 was not online and had stopped recording on Sunday 5 December 2021. ADE attended site on 6 December 2021 and reset the monitor.

Data measured at location 001 is presented below in **Figure 1**.

During the monitoring period (December 2021) no exceedance of DIN 4150 Line 1 or Line 2 PPV guideline values was observed. The results presented in Figure 1 – 3 do not include a distance correction.

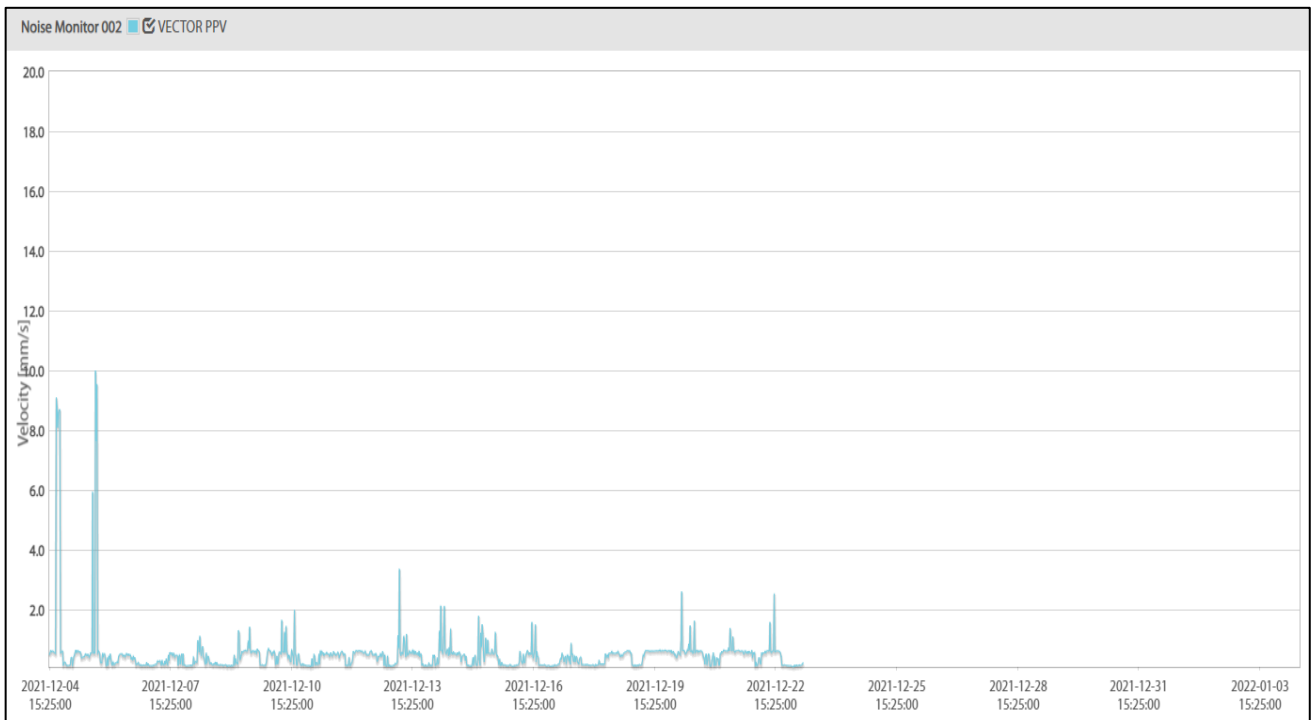
Figure 2. Vibration data at location 002 | Central monitor | December 2021

Data measured at location 002 is presented below **Figure 2**.

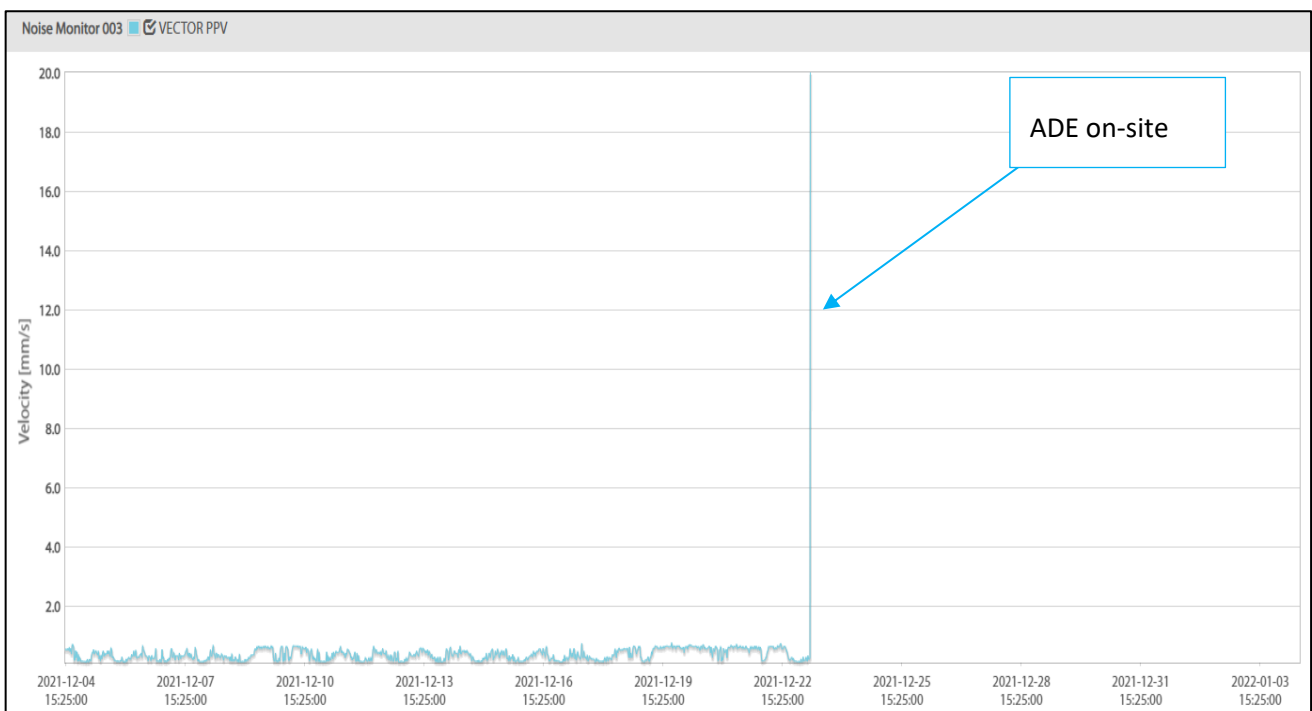
Figure 3. Vibration data at location 003 | Eastern section | December 2021

Data measured at location 003 is presented below **Figure 3**.

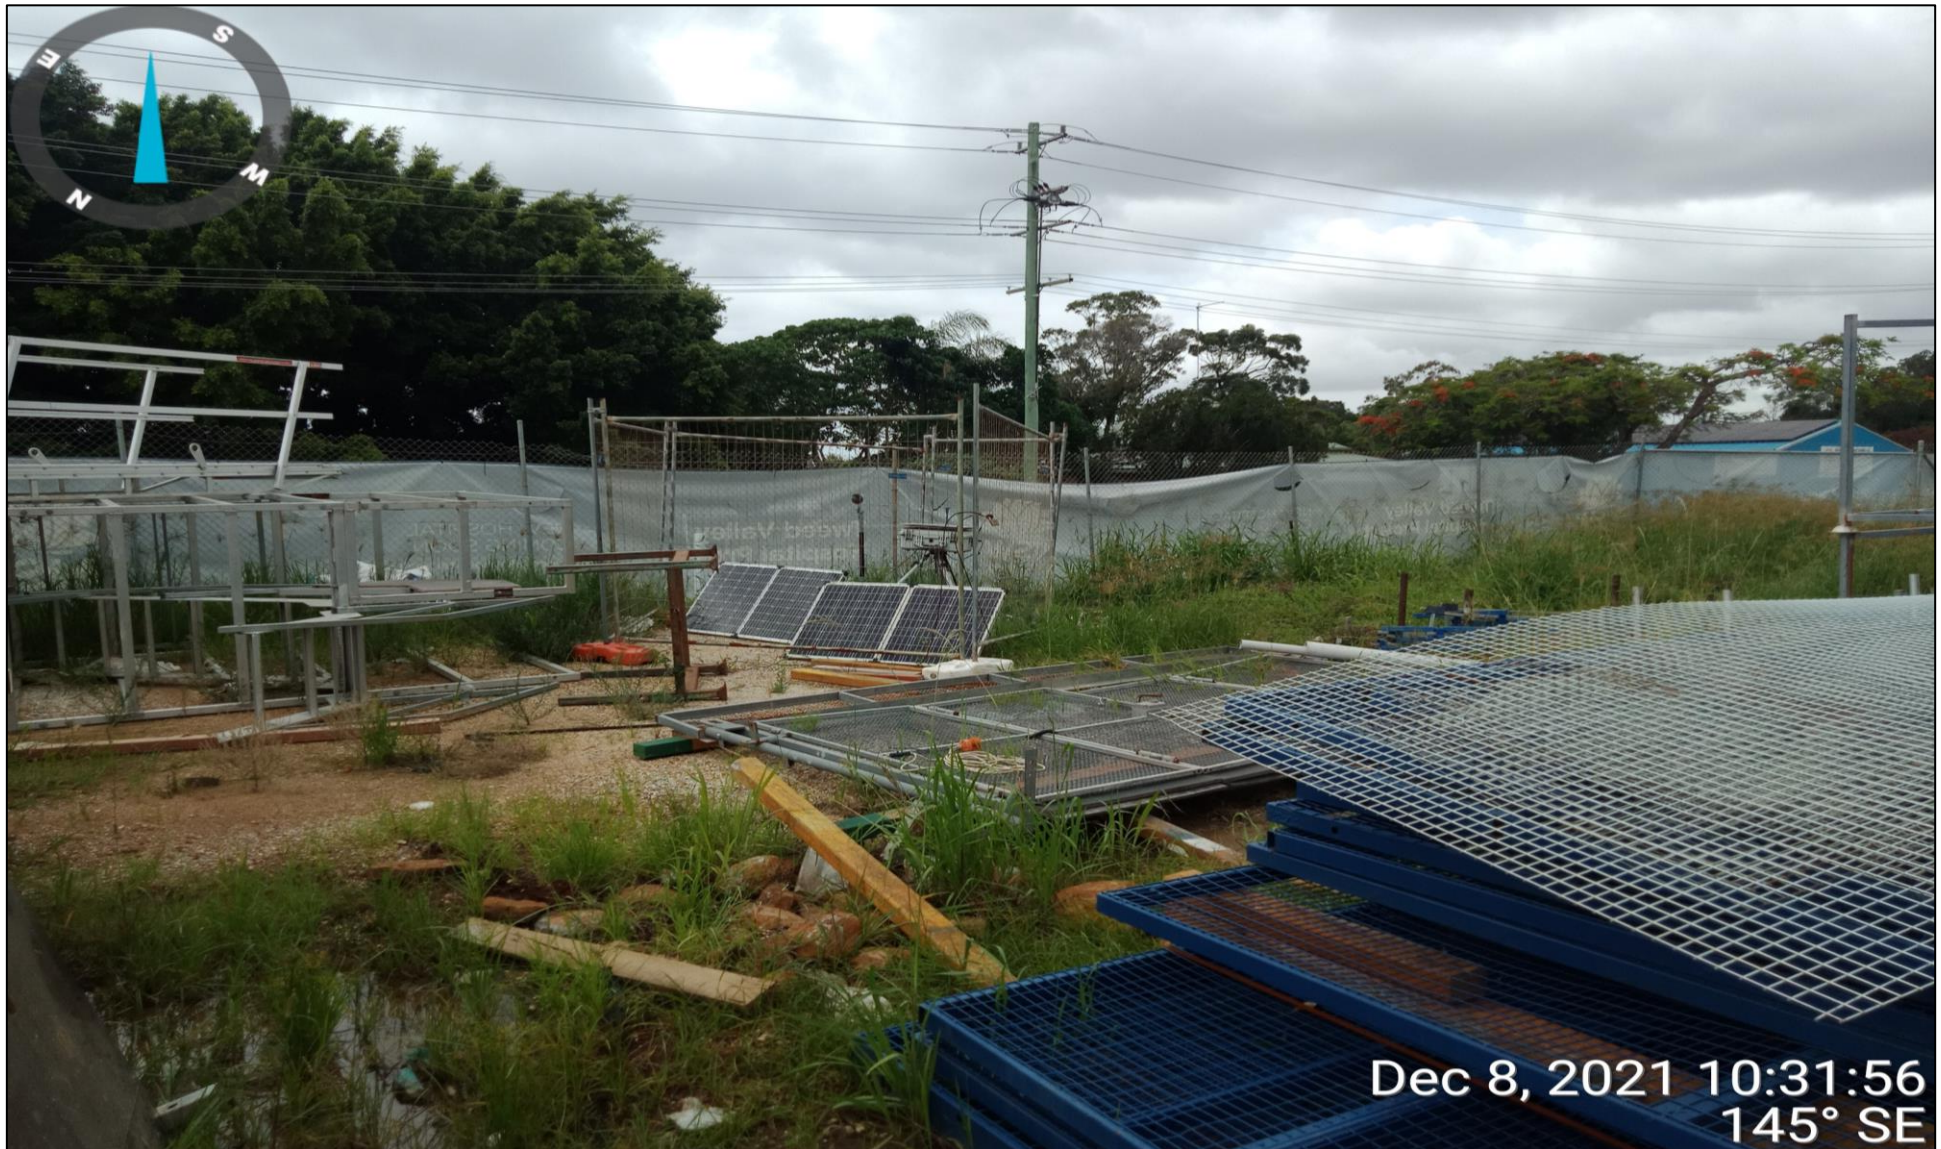
Photograph 1 Representative photograph of monitoring location 001 – Adjacent Carpark location, as observed 08/12/2021

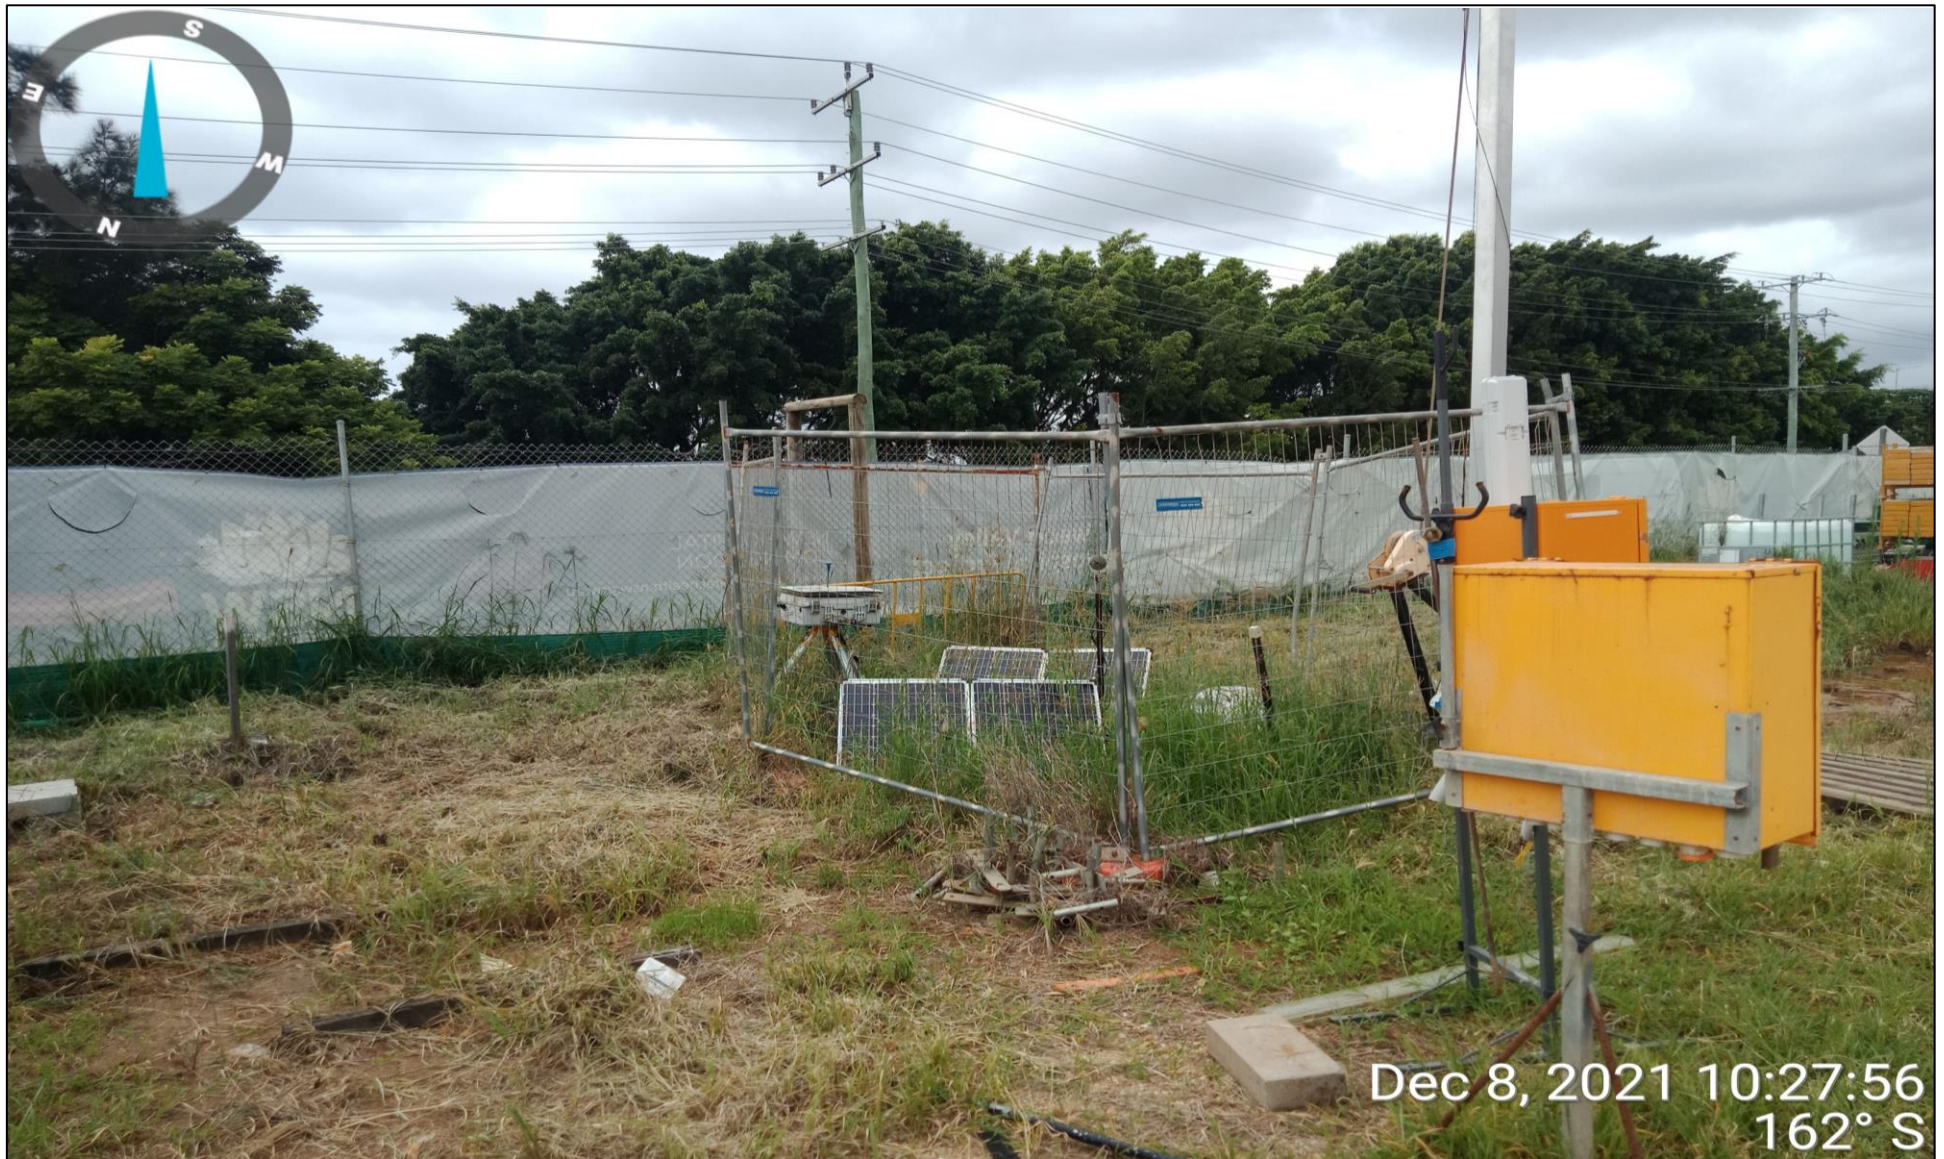
Photograph 2 Representative photograph of monitoring location 002 – Central location, as observed 08/12/2021

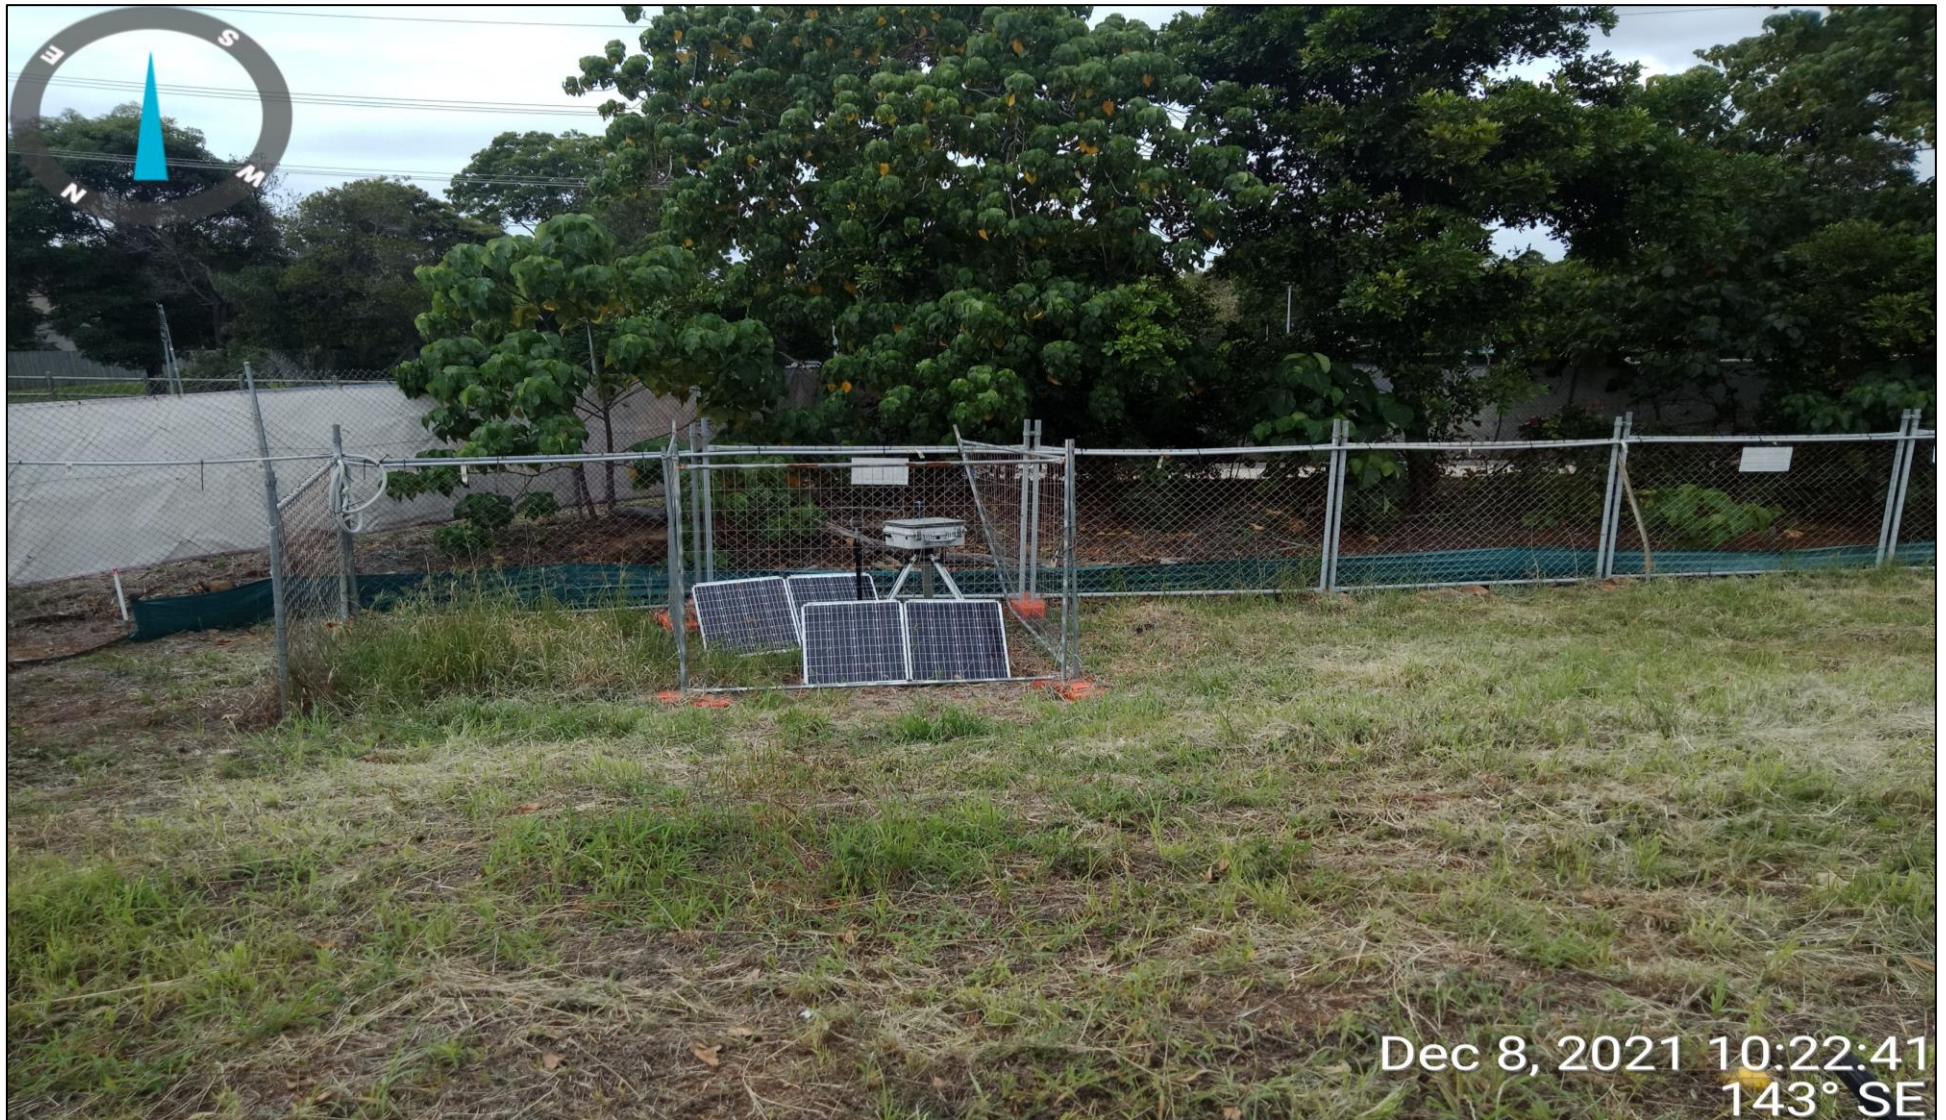
Photograph 3 Representative photograph of monitoring location 003 – Eastern Section of Site, as observed 08/12/2021
