# **Environmental Dust Assessment Report (November 2022)**

**Tweed Valley Hospital Project, Cudgen NSW**

Prepared for: Lendlease Building Pty Ltd

A101021.0286.00 | EDM40.Rev0 | Date: 19/12/2022

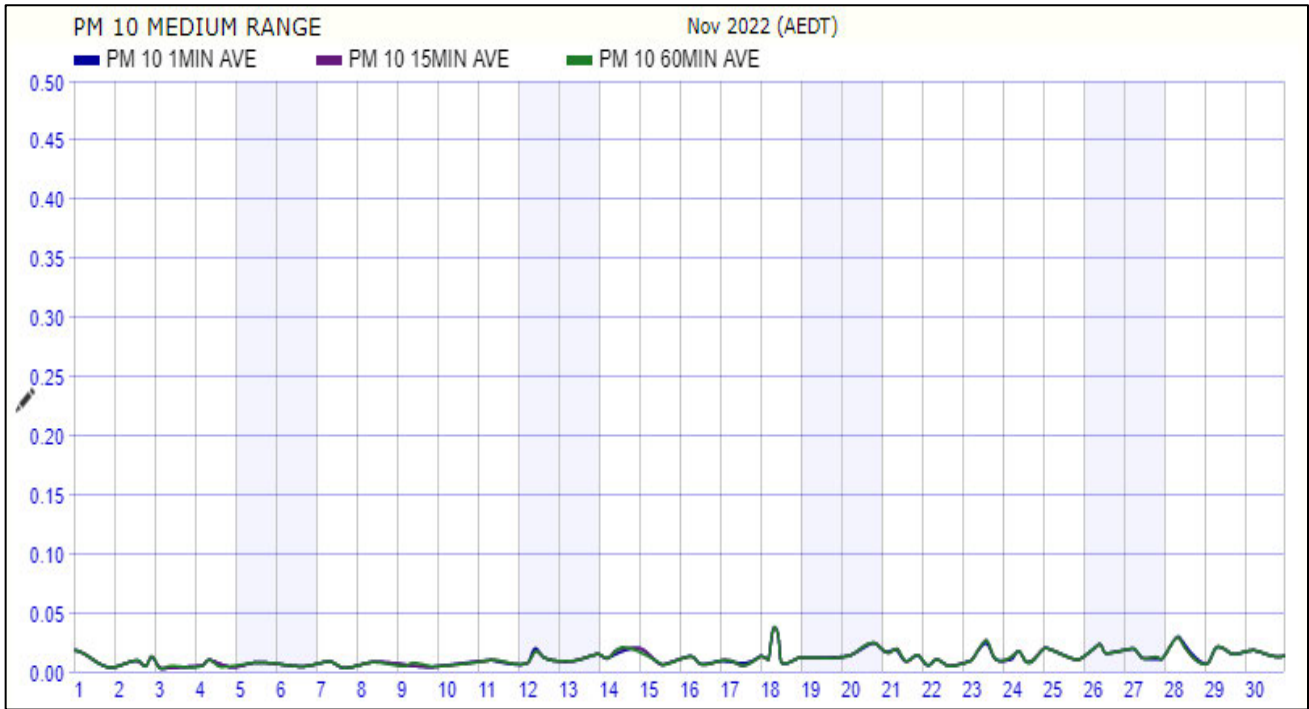
**Figure 1.** Summary of PM10 from the real time monitoring at location 005 – Solar Industry for the month of November 2022.

All dust levels remained below  $0.5 \text{ mg/m}^3$  during the month of November 2022 (*refer to Section 3*).

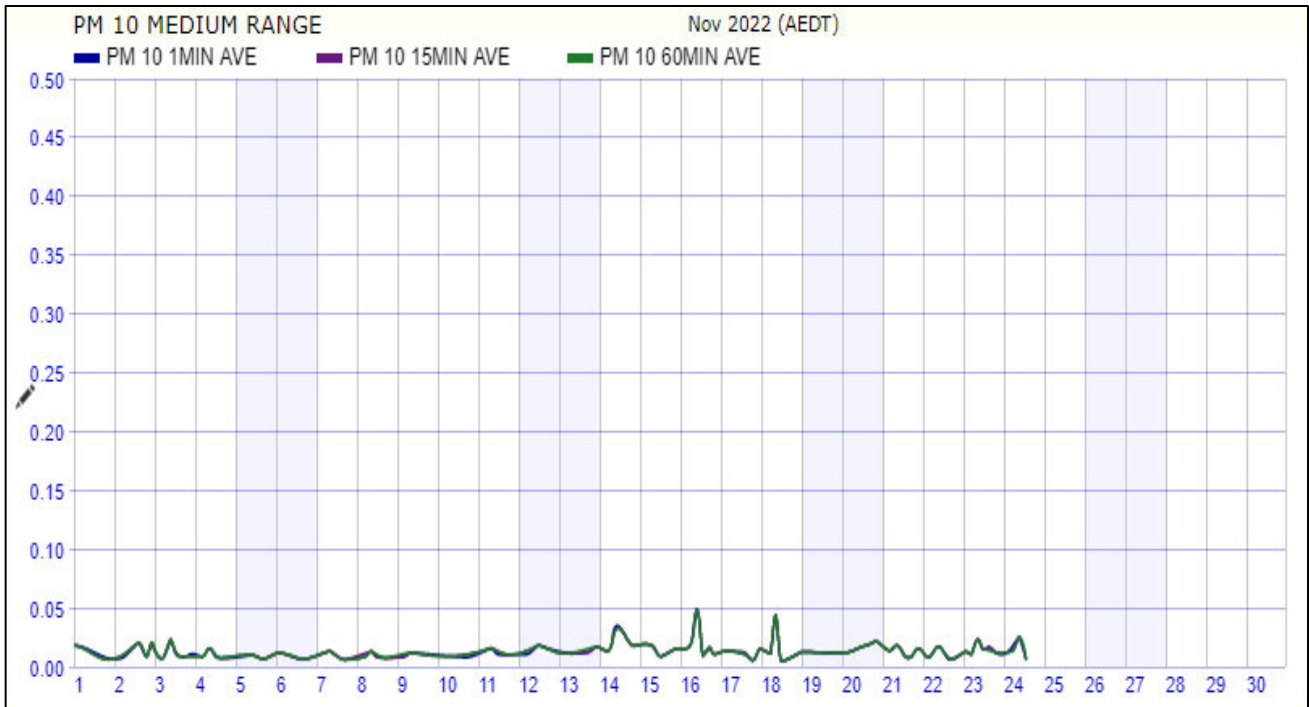
Dust monitor 006 was noted to be offline during the daily checks on 24 November 2022. The monitor was removed from site for repair on 01 December 2022.

**Figure 2.** Summary of PM10 from the real time monitoring at location 006 – Mate and Matts for the month of November 2022.

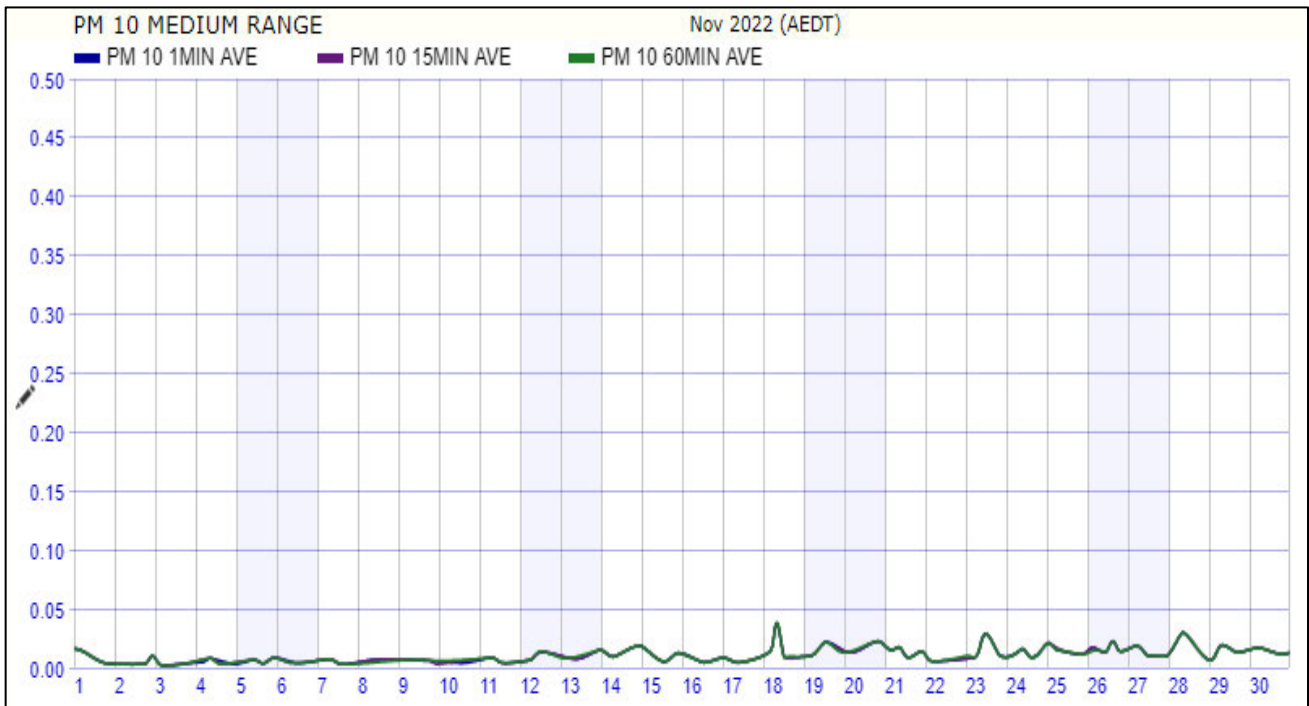
**Figure 3.** Summary of PM10 from the real time monitoring at location 007 – Residential for the month of November 2022.
