# **Environmental Dust Assessment Report (August 2022)**

**Tweed Valley Hospital Project, Cudgen NSW**

Prepared for: Lendlease Building Pty Ltd

A101021.0286.00 | EDM37.Rev0 | Date: 17/10/2022

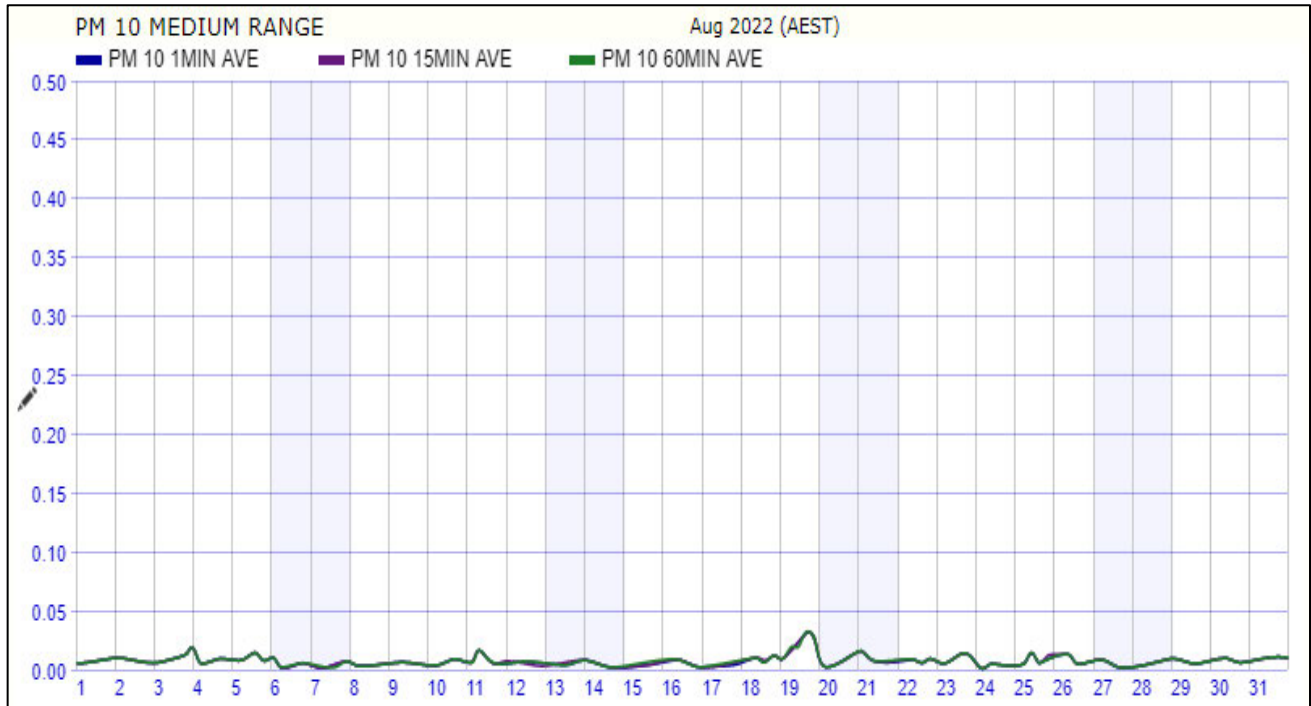
**Figure 1.** Summary of PM10 from the real time monitoring at location 004 – TAFE East for the month of August 2022.

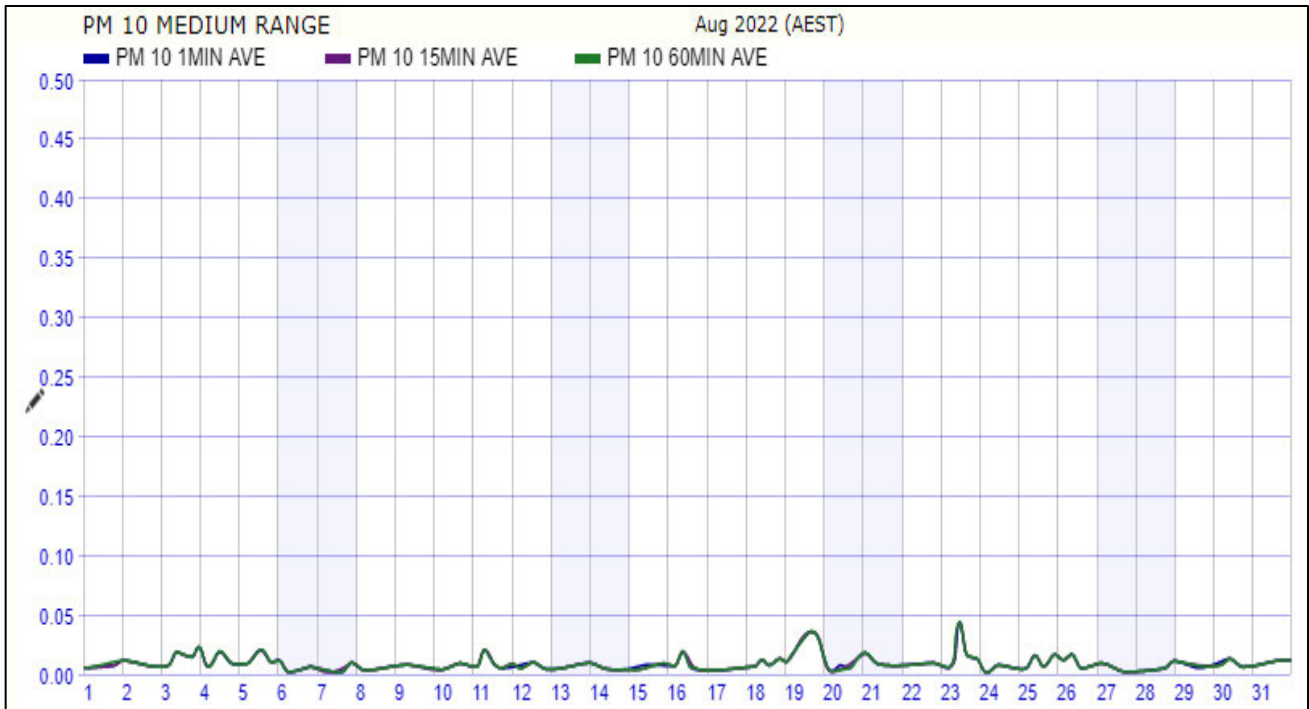
**Figure 2.** Summary of PM10 from the real time monitoring at location 005 – TAFE West for the month of August 2022.

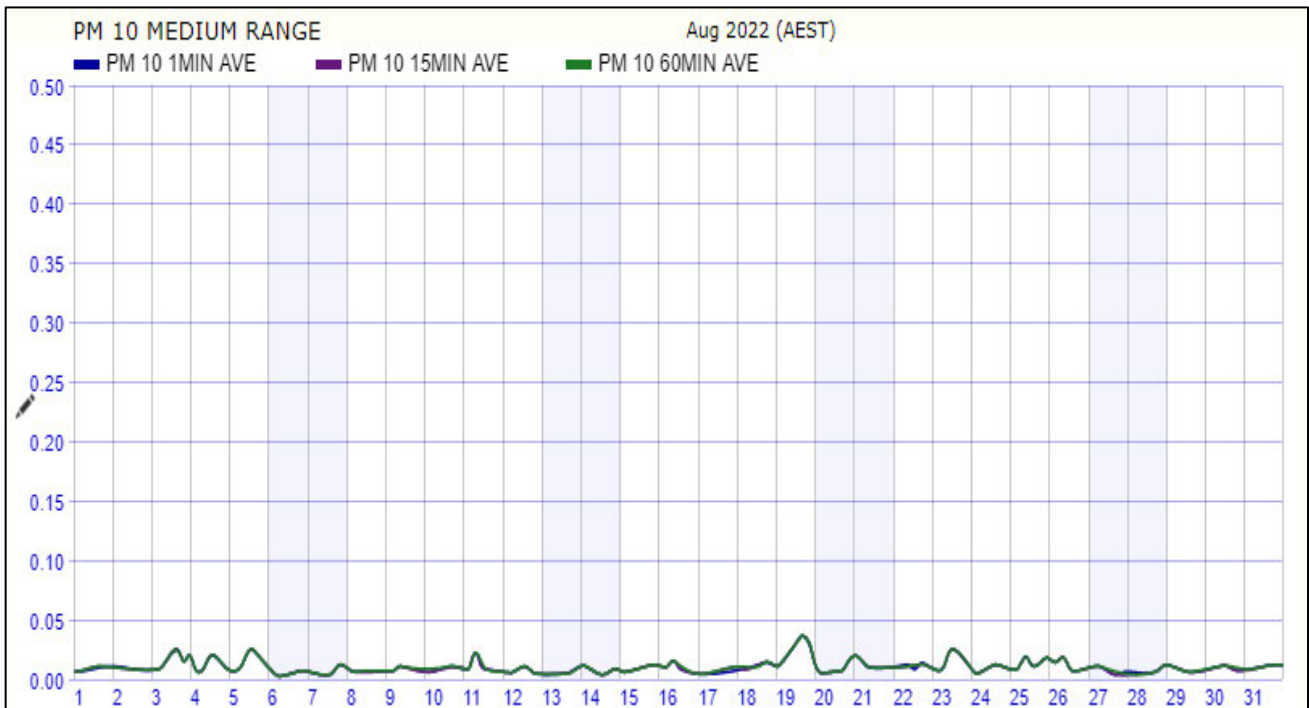
**Figure 3.** Summary of PM10 from the real time monitoring at location 006 – Mate and Matts for the month of August 2022.
