# Environmental Dust Assessment Report (January 2023)

Tweed Valley Hospital Project, Cudgen NSW

Prepared for: Lendlease Building Pty Ltd

A101021.0286.00 | EDM42.Rev0 | Date: 23/02/2023

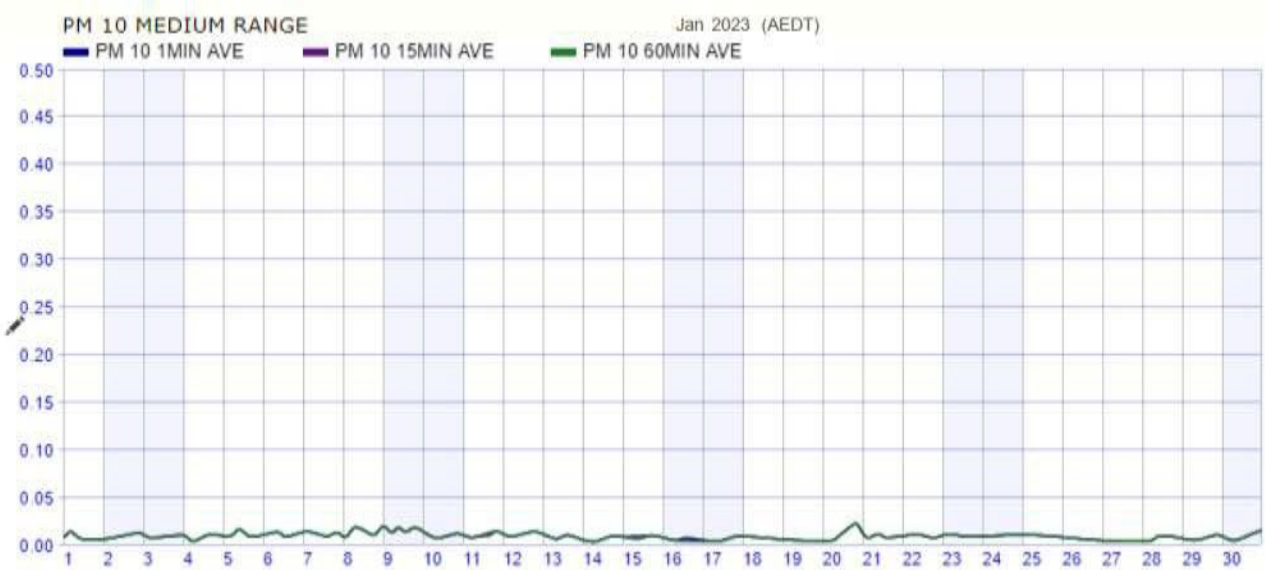
**Figure 1.** Summary of PM10 from the real time monitoring at location 005 – Solar Industry for the month of January 2023.

All measured PM<sub>10</sub> dust levels remained below 0.5 mg/m<sup>3</sup> during the month of January 2023 (*refer to Section 3*) at locations 005, 006 and 007 and consequently below the Action Limit of 2.5 mg/m<sup>3</sup>. It should be noted that the DustTrak minimum concentration reading is 0.001 mg/m<sup>3</sup> and values of lower concentration will be recorded as zero.

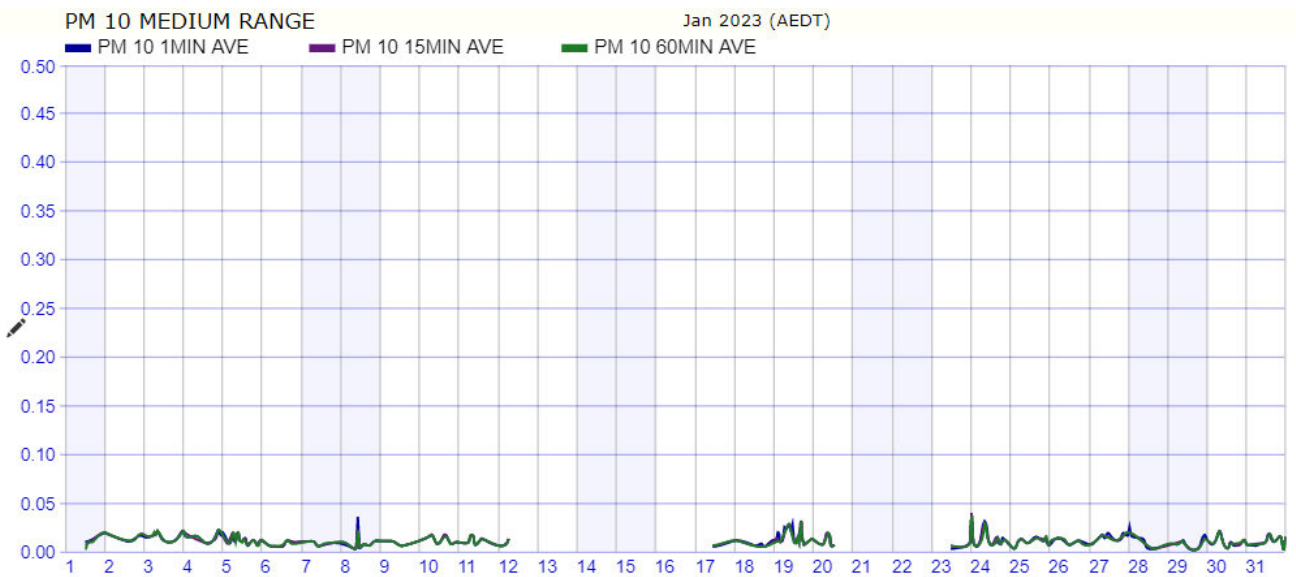
Dust monitor 006 was noted to be offline during the daily checks on 12 January 2023. ADE attended site on 13 January 2023 to check connections and reposition solar panels. The monitor remained offline. ADE again attended site on the 17 January to diagnose and repair a solar issue. The monitor came back online 17 January 2023.

Data gaps were identified at monitoring location 006. Based on field observations, historical data and the absence of residential dust complaints, ADE considers the potential for dust exceedances to be unlikely. Rectification measures have been undertaken to improve monitoring performance for the instrument at Monitoring Location 006.

**Figure 2.** Summary of PM10 from the real time monitoring at location 006 – Mate and Matts for the month of January 2023.

Consistent with previous reports, recommendations are to ensure adequate dust control measures continue to be implemented as per the Tweed Valley Hospital Management Plan – Air Quality and continue monitoring of PM<sub>10</sub> for the duration of the project. If the action limit of 2.5 mg/m<sup>3</sup> (8-hour time weighted average) is exceeded, works are to cease and appropriate dust prevention techniques are to be implemented. To reduce the likelihood of data gaps, daily on-site visual checks are to be undertaken by Lendlease accompanied by daily checks of the online telemetry by ADE. Rectification measures have been undertaken to improve the overall data collection at monitoring location 006.

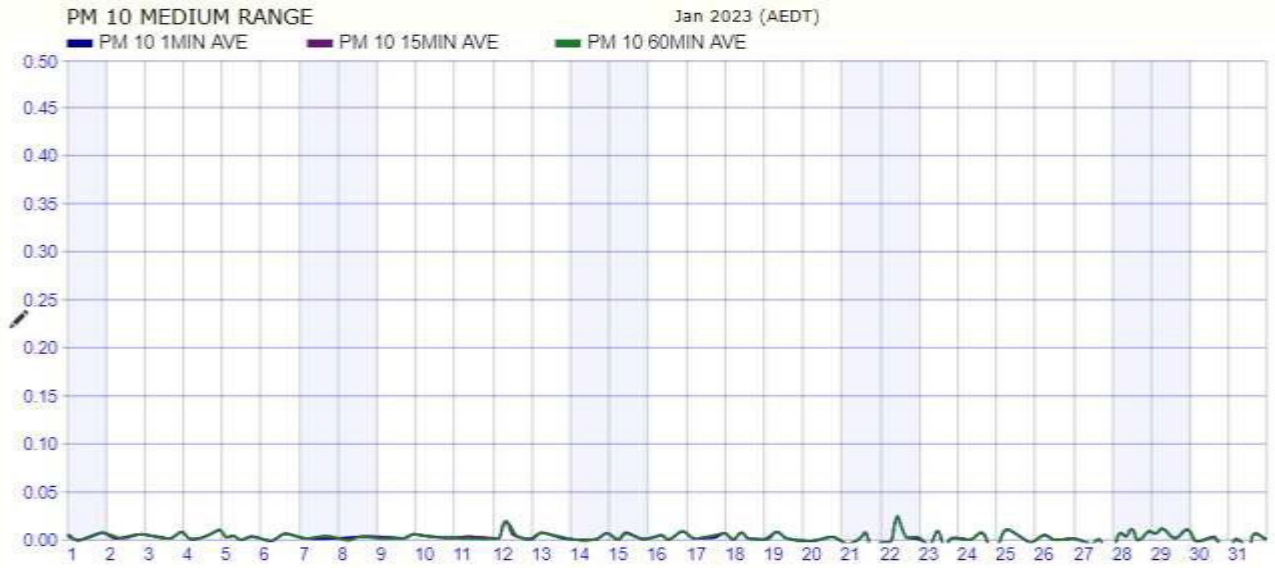
**Figure 3.** Summary of PM10 from the real time monitoring at location 007 – Residential for the month of January 2023.

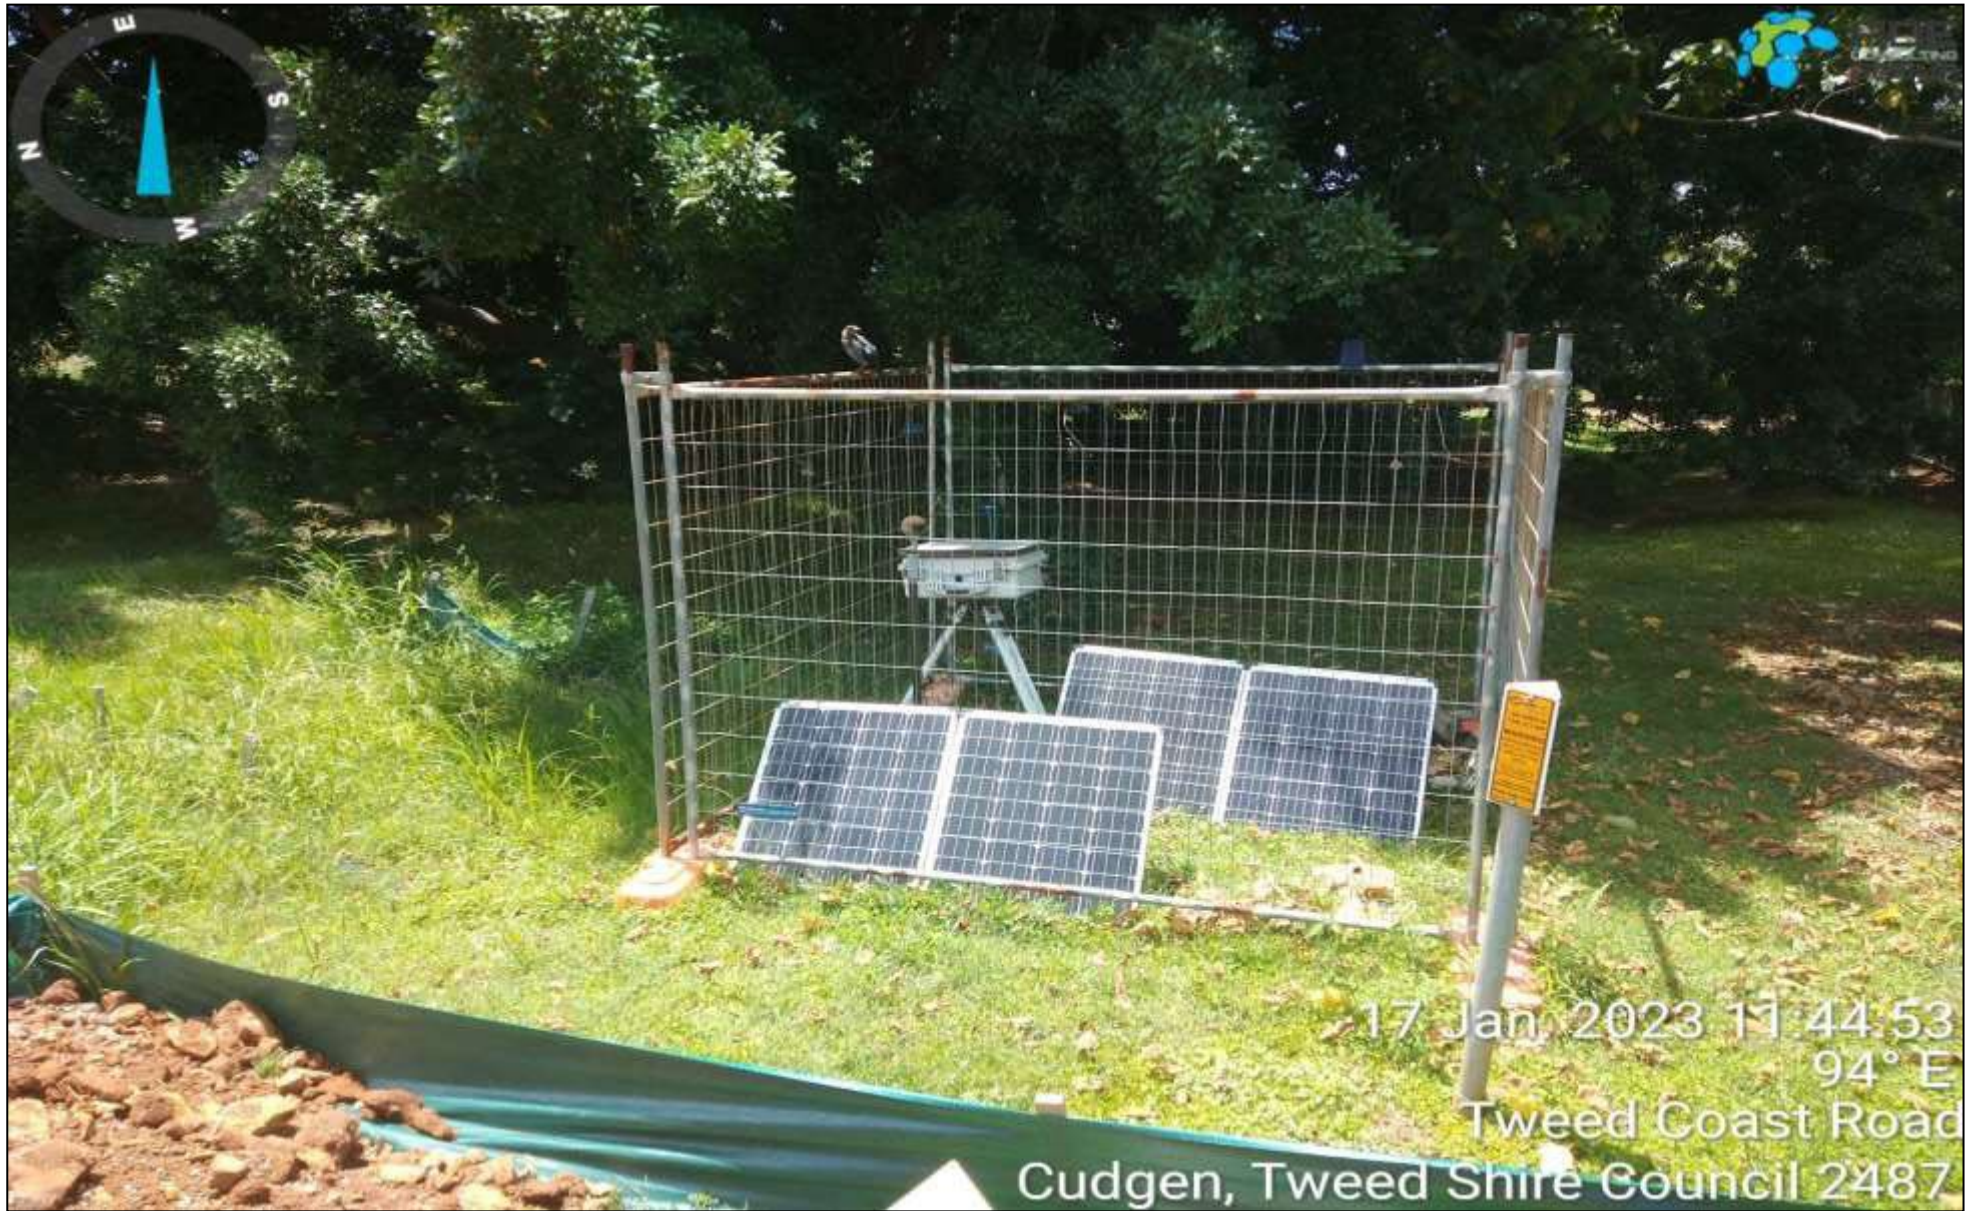
Photograph 1: Representative photograph of monitoring location 005 – Solar Industry, as observed 17/01/2023

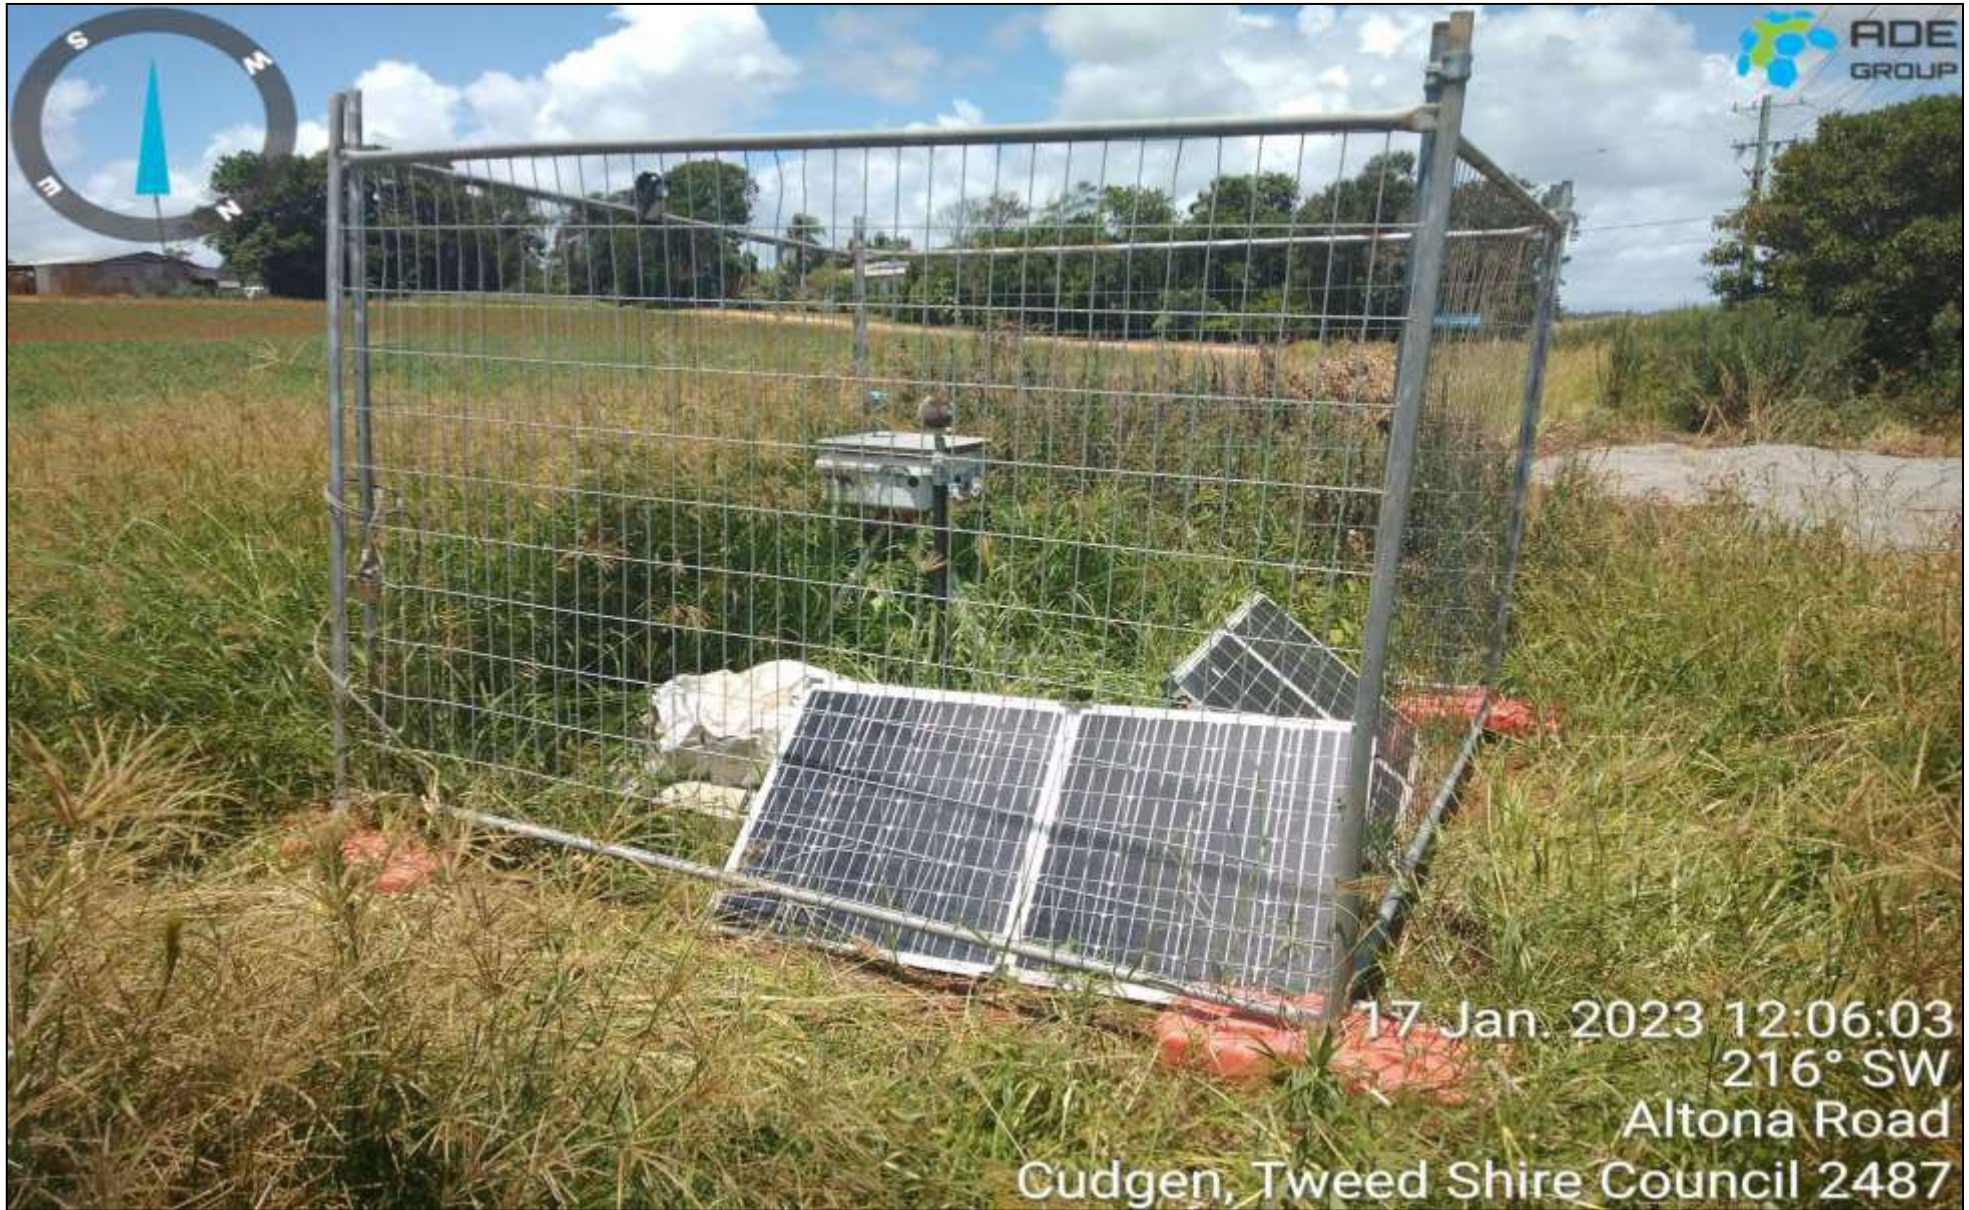
Photograph 2: Representative photograph of monitoring location 007 – Residential, as observed 17/01/2023

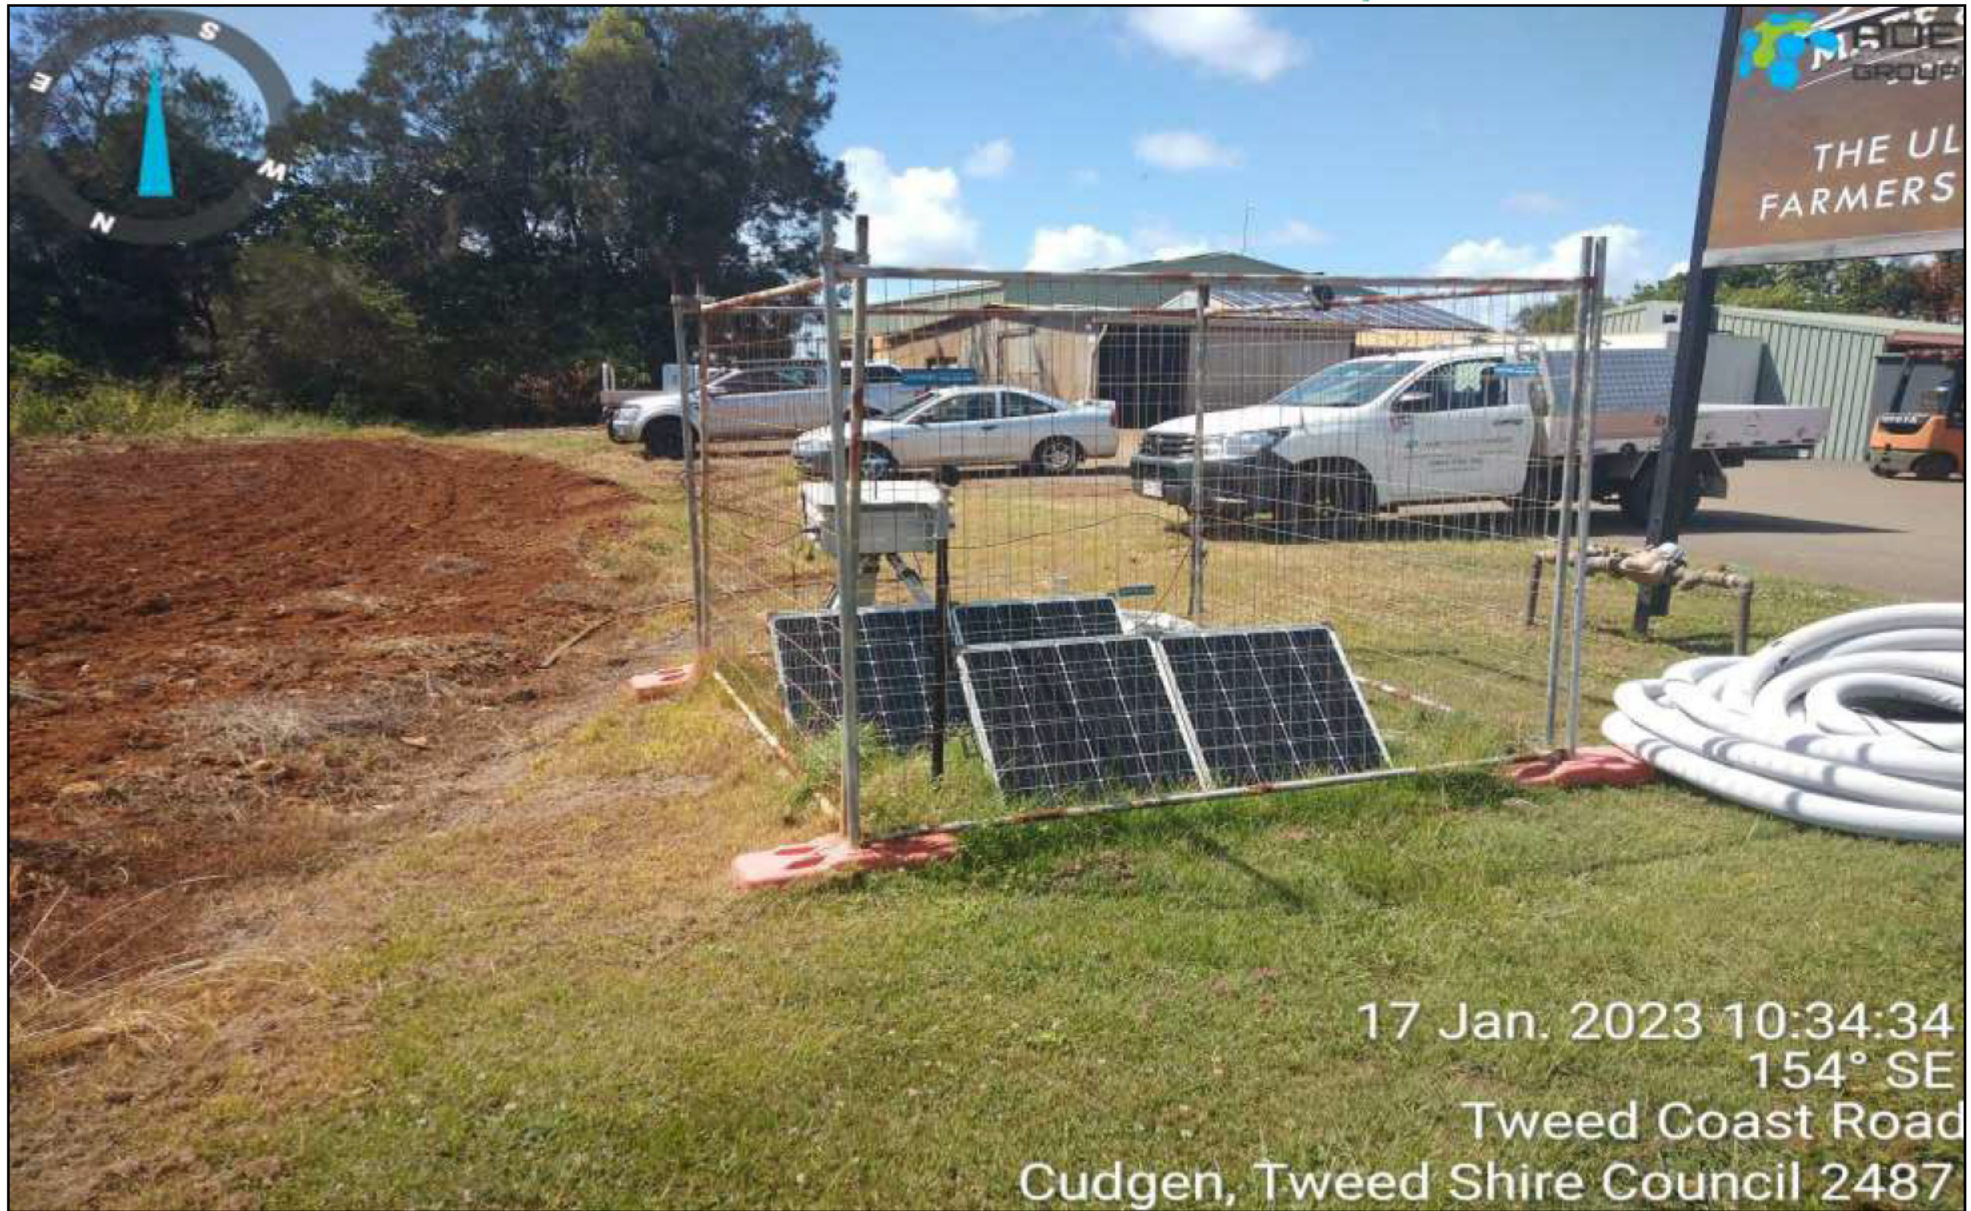
Photograph 3: Representative photograph of monitoring location 006 – Mate and Matts, as observed 17/01/2023

Date of site visit	Time of site visit	Observations/Actions
13/01/2023	1100 – 1300	<ul style="list-style-type: none"> <li>▪ Noise/Vibration monthly calibrations</li> <li>▪ Dust monitor 006 - check connections/reposition solar panels</li> </ul>
17/01/2023	1000 – 1230	<ul style="list-style-type: none"> <li>▪ Monitoring location 005 - repositioning of solar panels;</li> <li>▪ Dust monitor 006 – solar panel repair</li> </ul>
