Vibration Monitoring Assessment Report

771 Cudgen Road, Kingscliff NSW

Prepared for: Delta Group

DLT-01-Q1013 / VIB2
v1. final
4th October 2019

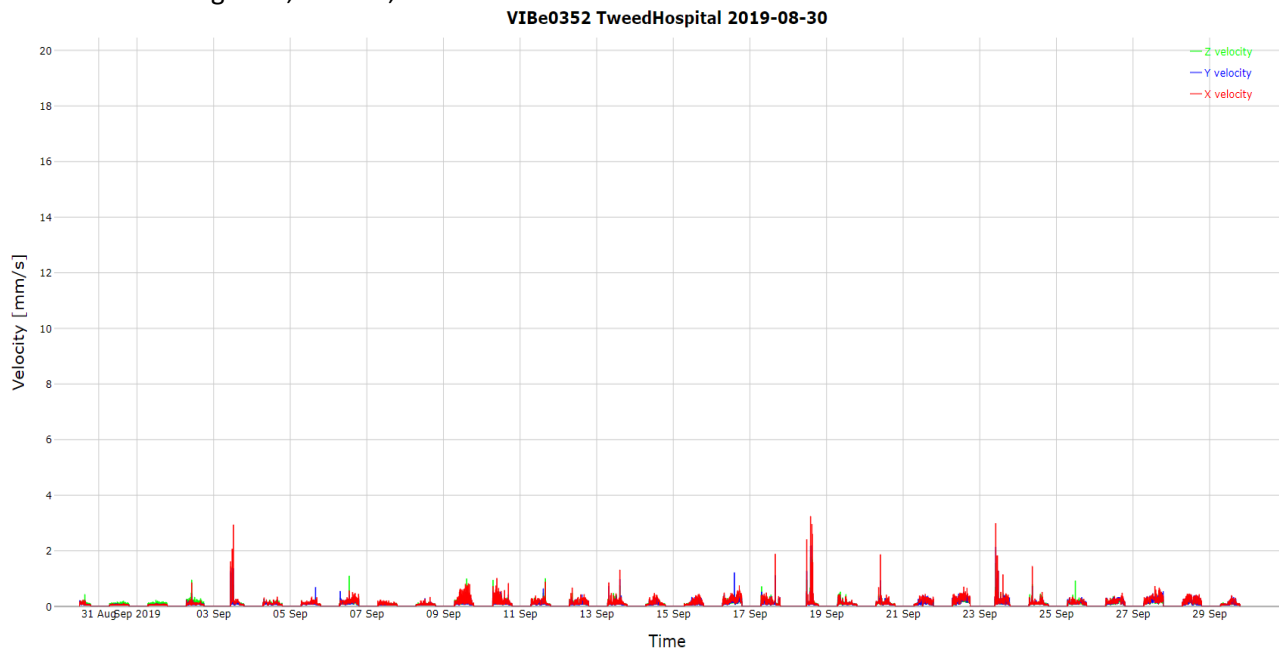
Figure 2 – Results of the vibration monitoring from 1st September 2019 to 30th September 2019 at monitoring location 001 – Adjacent carpark.

*Note all results >5mm/s in figures 2, 3 and 4 can be correlated with ADE site visits. These values directly correlate with ADE attending site to perform maintenance on the monitors and these exceedances should be disregarded (refer to *Appendix B – ADE Site Time Summary*).

ADE site visits on the 3rd, 18th and 23rd of October 2019 had results >5mm/s as can be seen in figures 2, 3 and 4 of this report. The activities undertaken by ADE included manoeuvring within close proximity to the vibration sensors in the enclosure and can be correlated with the peaks on these particular days (refer to *Appendix B – ADE Site Time Summary*).

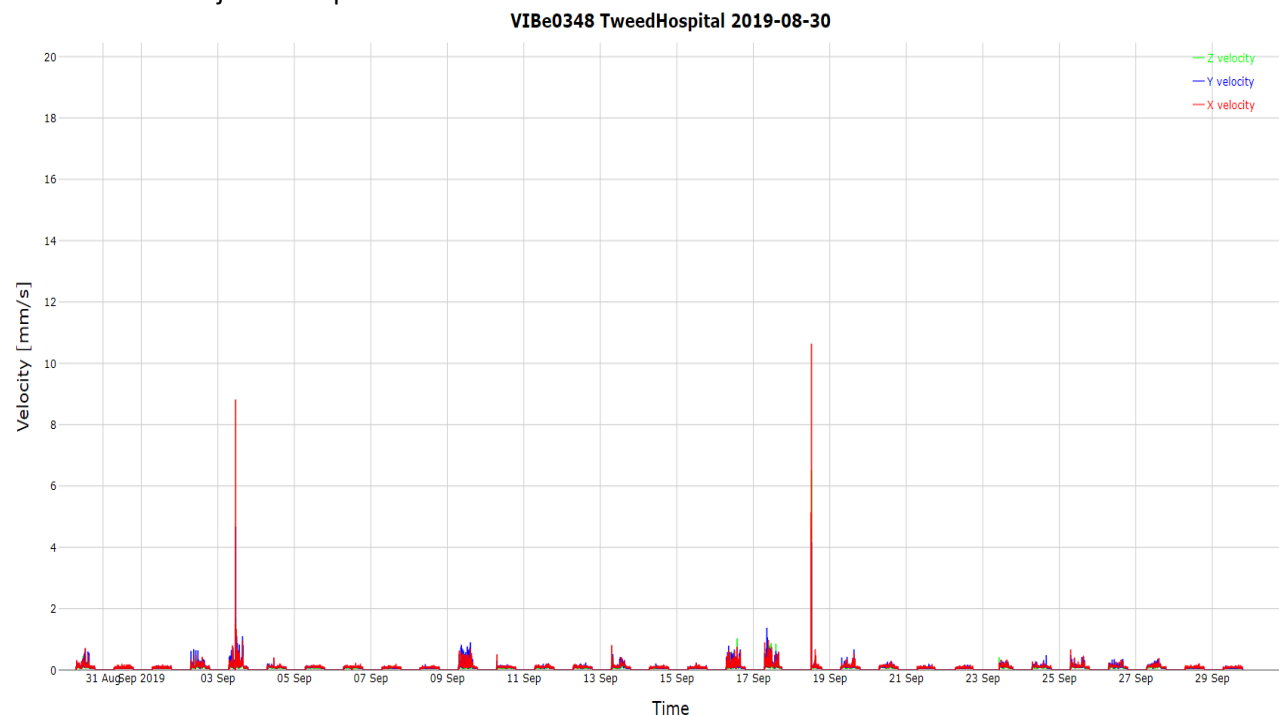
Figure 3 – Results of the vibration monitoring from 1st September 2019 to 30th September 2019 at monitoring location 002 – Central monitor.

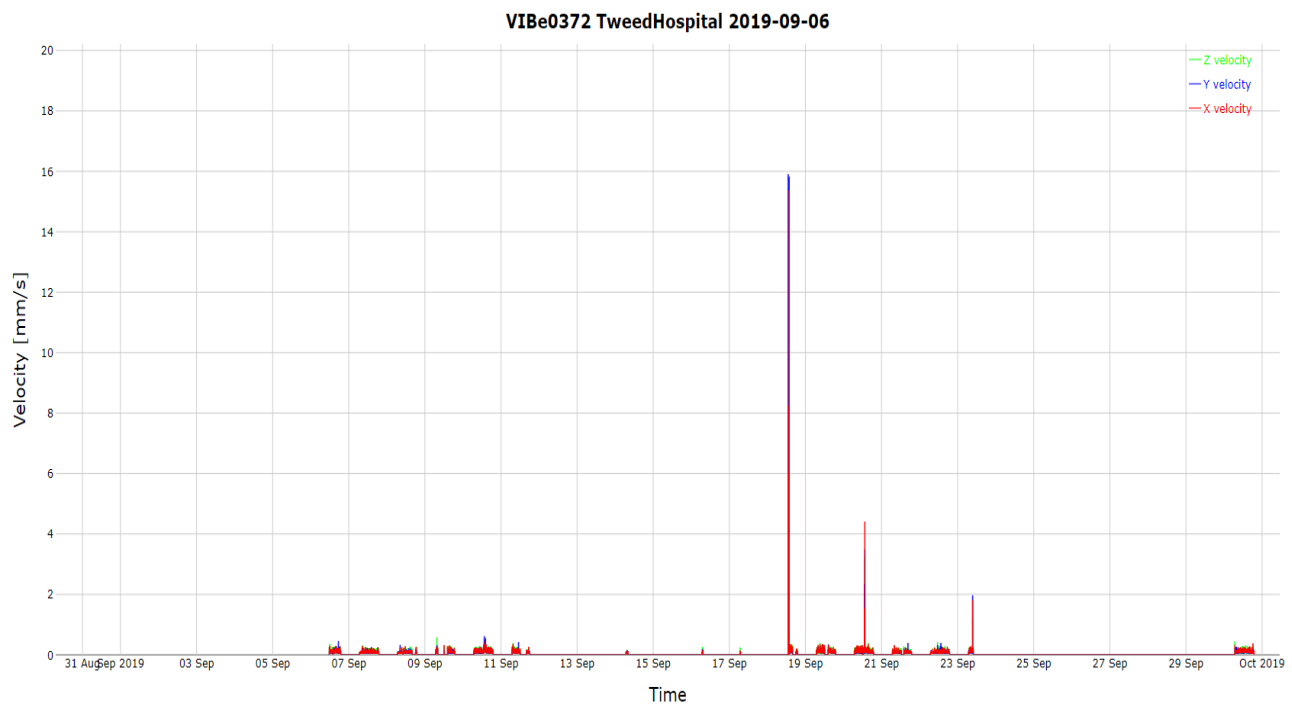
Figure 4 – Results of the vibration monitoring from 1st September 2019 to 30th September 2019 at monitoring location 003 – Eastern section of site.

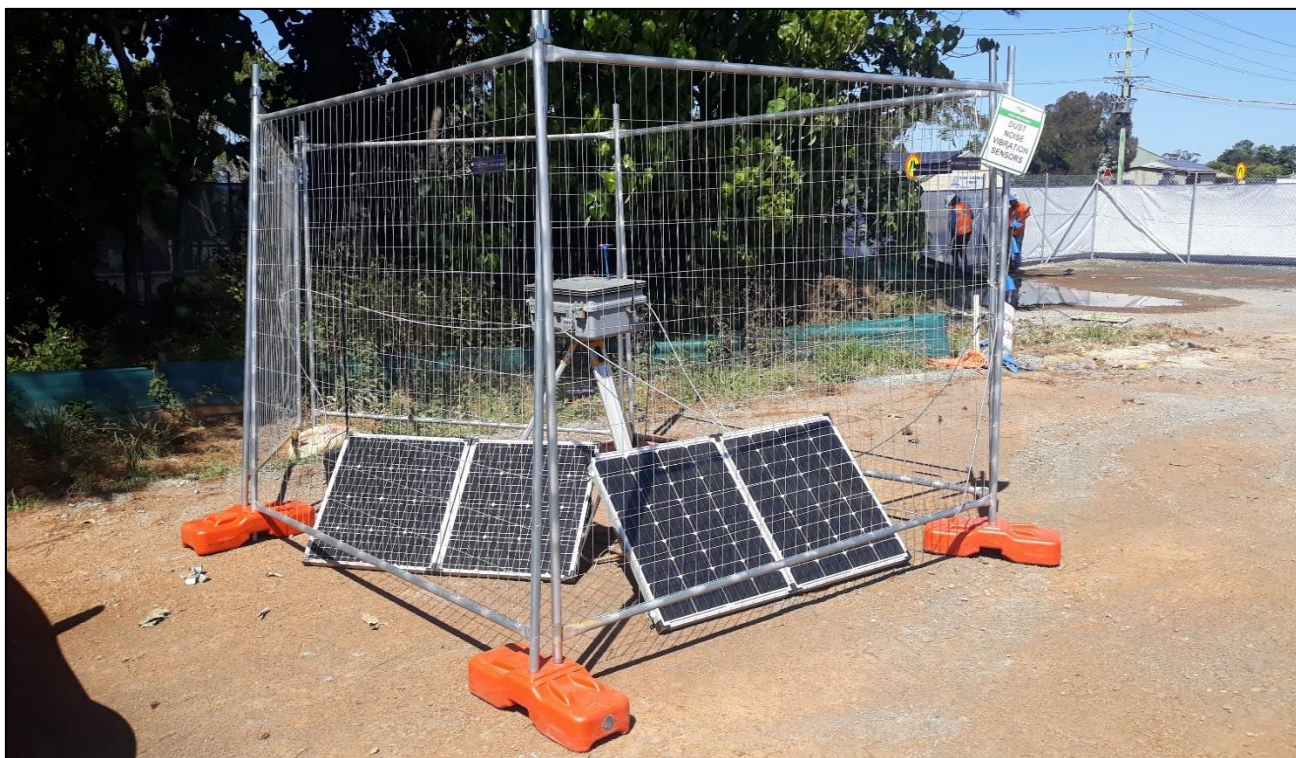
Photograph 1 – Representative photo of the monitoring location 001 – adjacent carpark, as observed on the 03.09.2019.

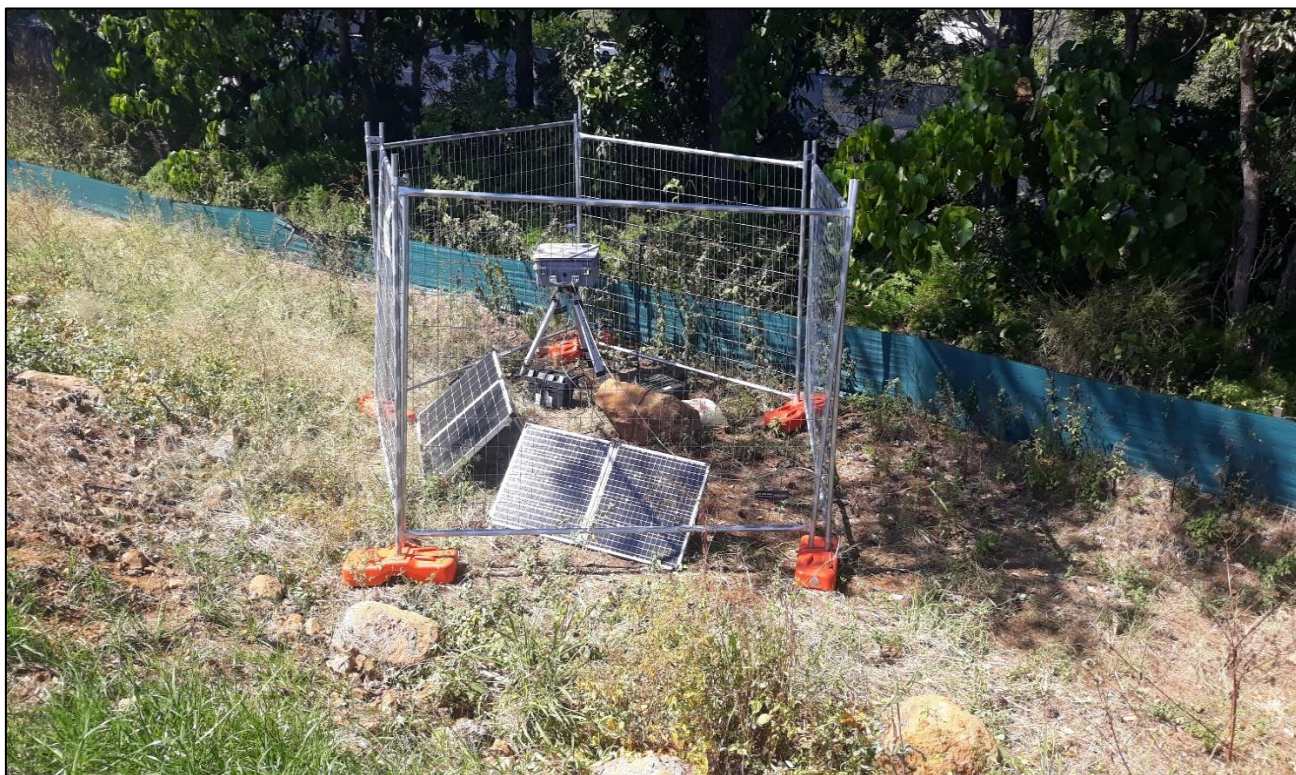
Photograph 2 – Representative photo of the monitoring location 002 – central location, as observed on the 03.09.2019.

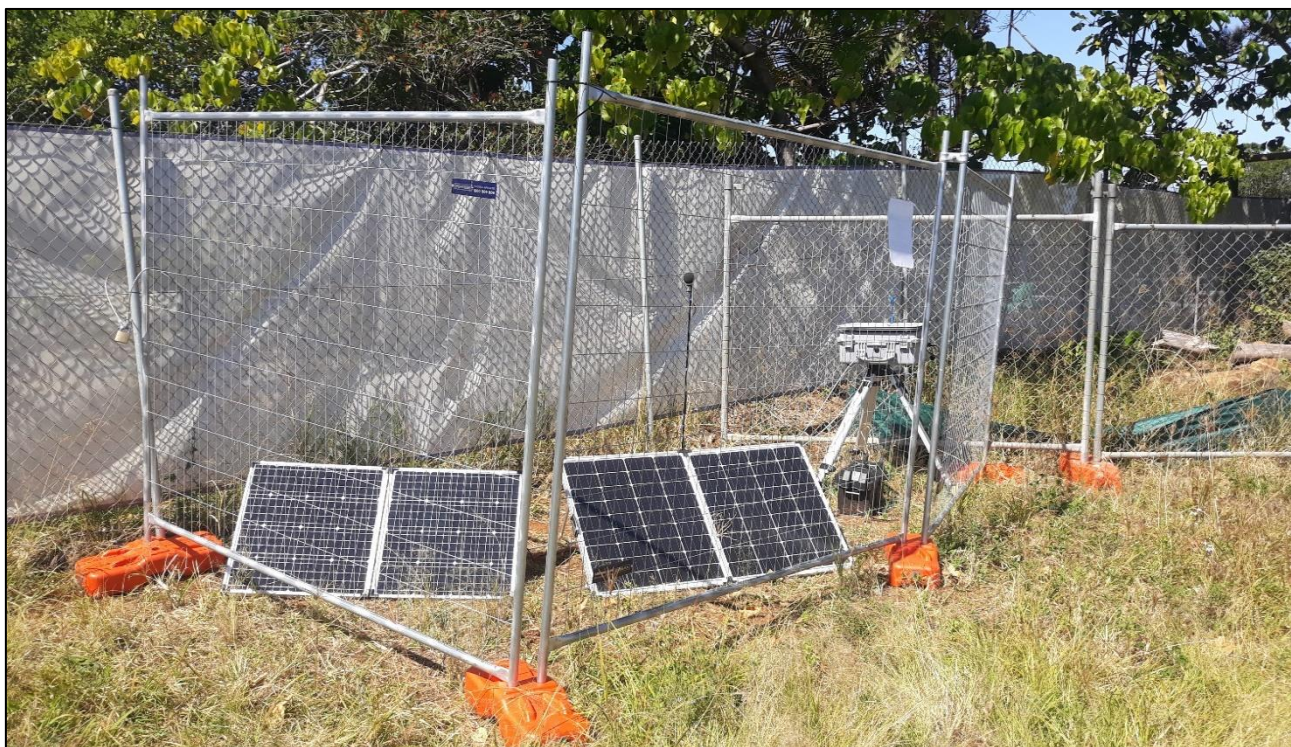
Photograph 3 – Representative photo of the monitoring location 003 – eastern section of site, as observed on the 03.09.2019.
