Vibration Monitoring Assessment Report

771 Cudgen Road, Kingscliff NSW

DLT-01-Q1013 / VIB5 / v1.2f
15th January 2020

Vibration Monitoring Assessment Report
771 Cudgen Road, Kingscliff NSW

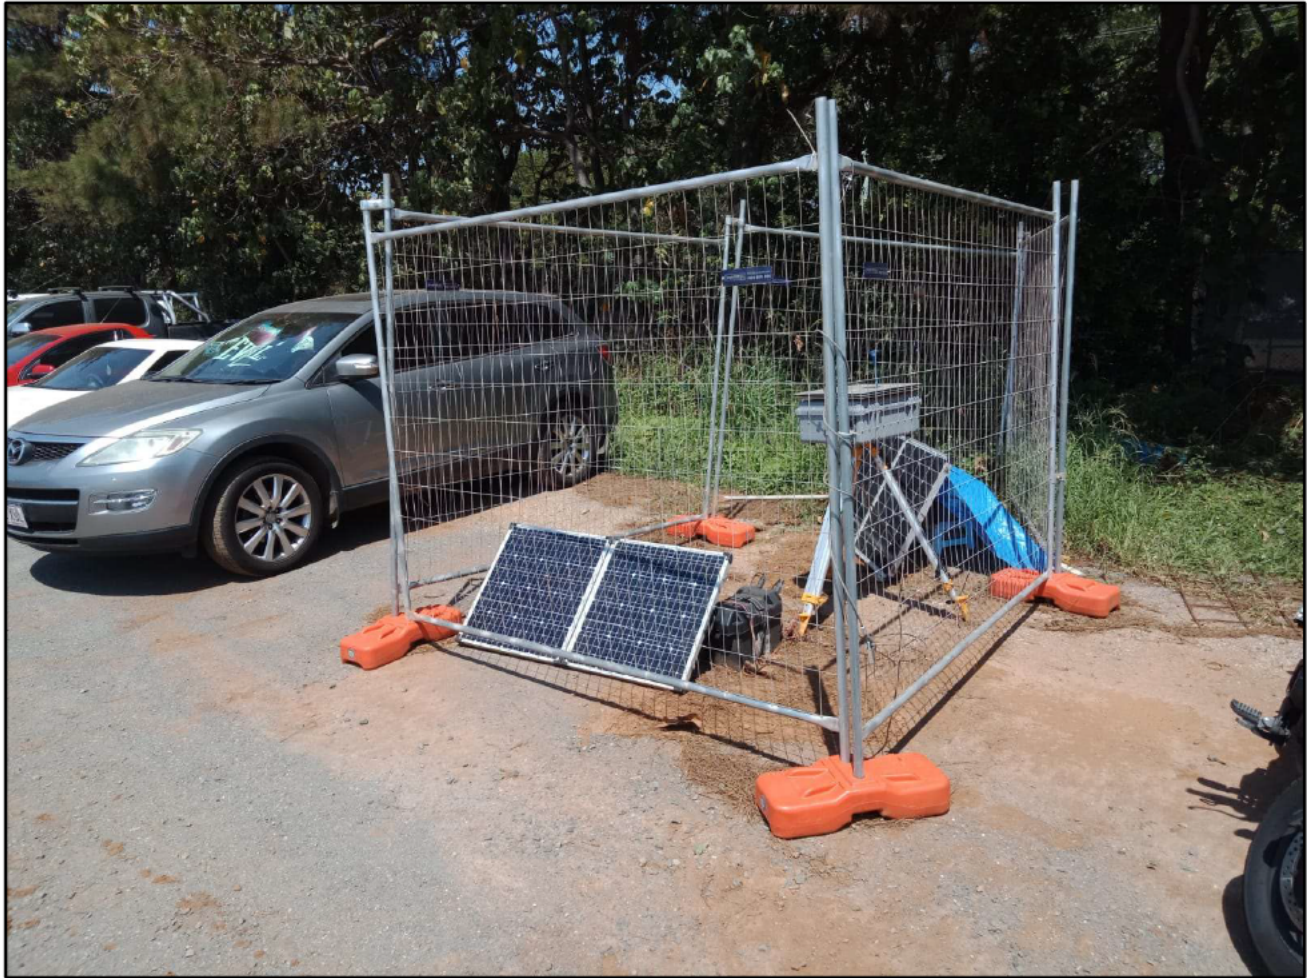
Photograph 1. Representative photo of the monitoring location 001 – adjacent carpark, as observed on the 04.12.2019

During ADEs site visit on the 4th of December, the cases that contain the vibration monitors were raised above the ground and covered with a tarp to aid in keeping temperatures below 60°C and ensure continuous monitoring.

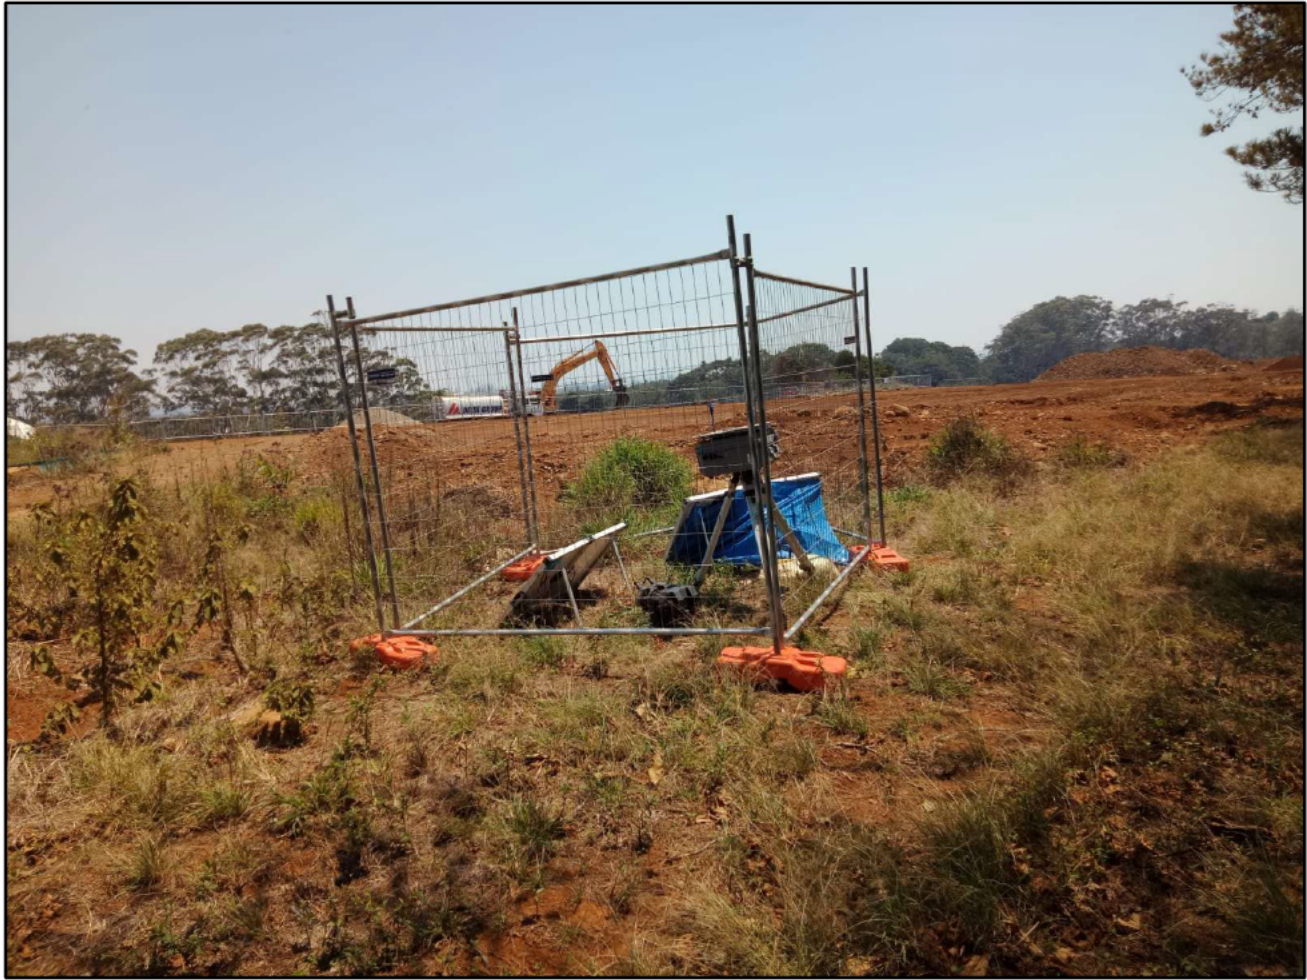
Photograph 2. Representative photo of the monitoring location 002 – central location, as observed on the 04.12.2019

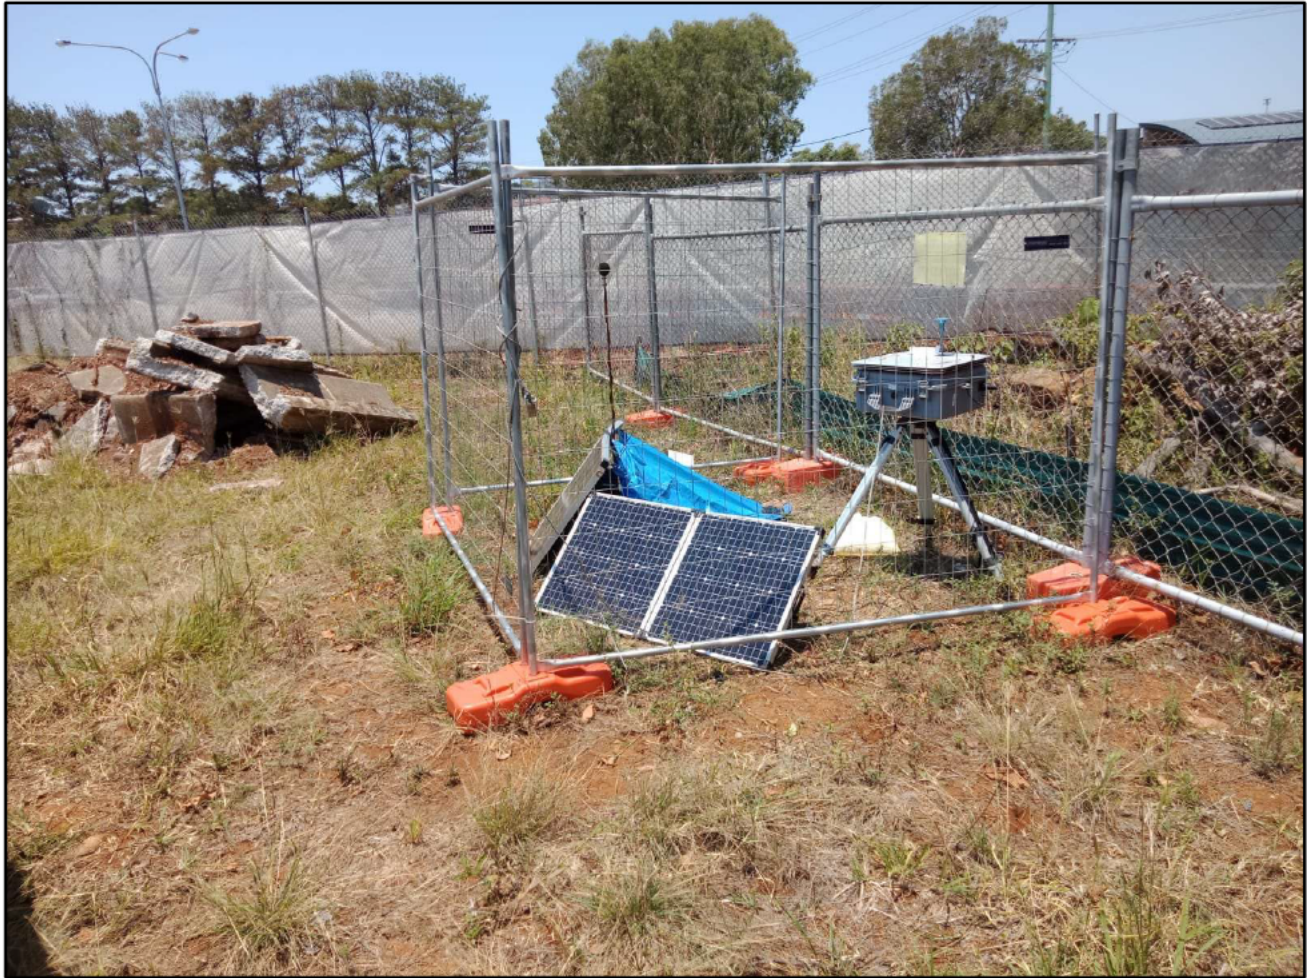
Photograph 3. Representative photo of the monitoring location 003 – eastern section of site, as observed on the 04.12.2019.

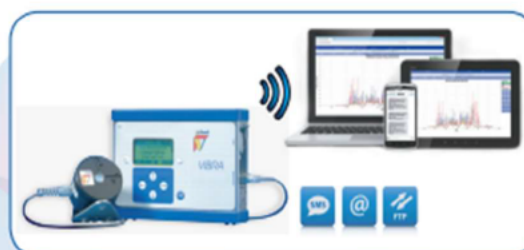
Profound VIBRA-series

The VIBRA's robust aluminium housing is IP65 watertight. The system is easily portable, lightweight and battery-operated which allows for up to 4 weeks of continuous and unmanned operation.

Setting up the system on site is easy: attach the 3-dimensional sensor to the structure to be monitored, switch on the system and start measuring. While measuring the VIBRA displays date, time, time interval and the current peak vibration values including frequency in all 3 directions. In advance an alarm level can be set.
