Vibration Monitoring Assessment Report

771 Cudgen Road, Kingscliff NSW

DLT-01-Q1013 / VIB1
v1. final
6th September 2019

Delta Group are undertaking Earthworks for the Tweed Valley Hospital Project located at 771 Cudgen Road, Kingscliff NSW, hereafter referred to as 'The Site'. The Site was previously agricultural land and has been cleared of vegetation for soft mobilisation and preparation of the site.

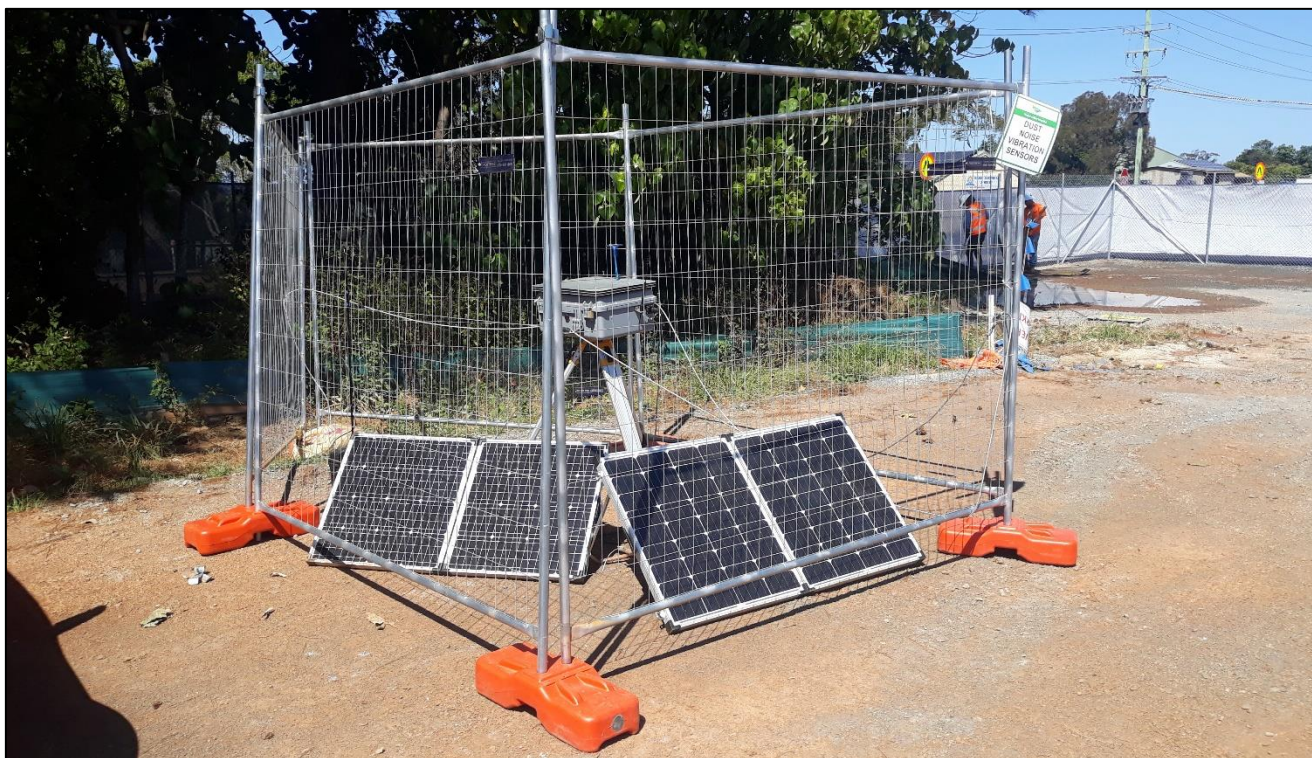
Photograph 1 – Representative photo of the monitoring location 001 – adjacent carpark, as observed on the 02.09.2018.

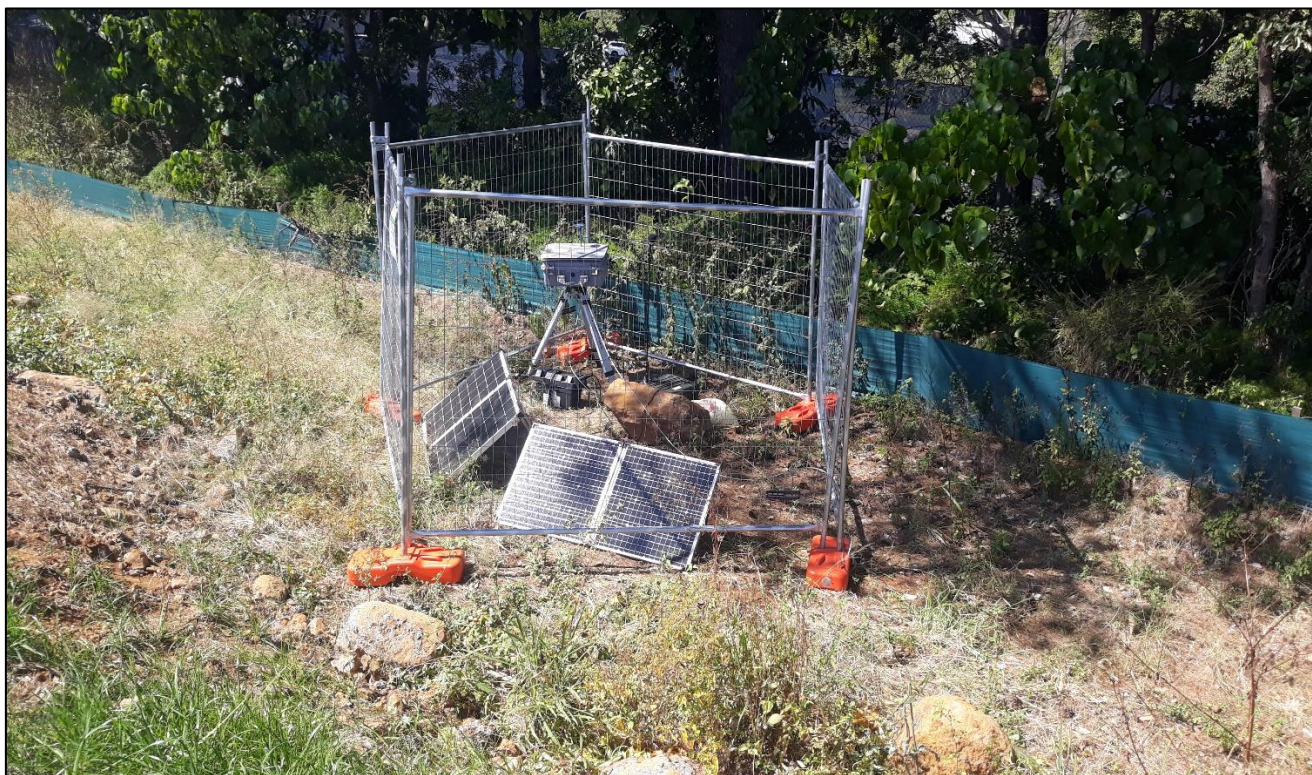
Photograph 2 – Representative photo of the monitoring location 002 – central location, as observed on the 02.09.2018.

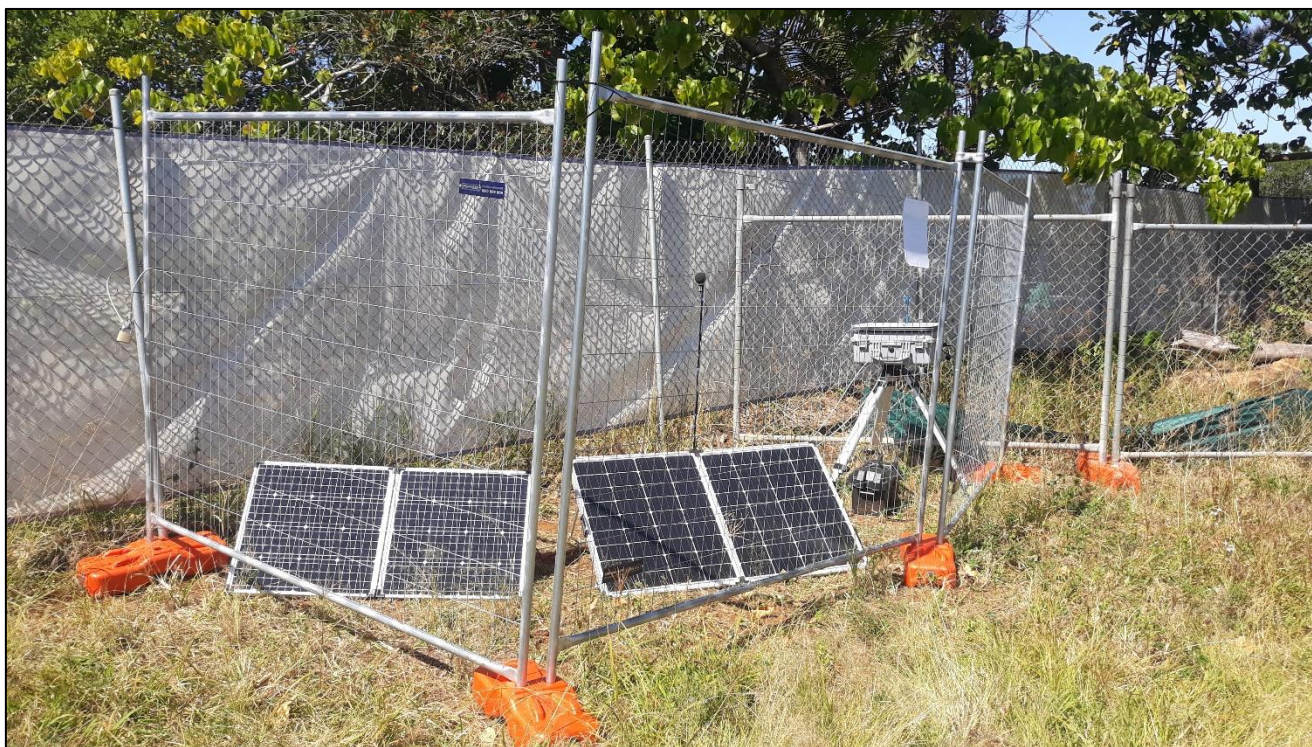
Photograph 3 – Representative photo of the monitoring location 003 – eastern section of site, as observed on the 02.09.2018.
