# Vibration Monitoring Assessment Report (January 2020)

771 Cudgen Road, Kingscliff NSW

Prepared for: Delta Group

DLT-01-Q1013 / VIB6 / v1.3f  
23<sup>rd</sup> June 2020

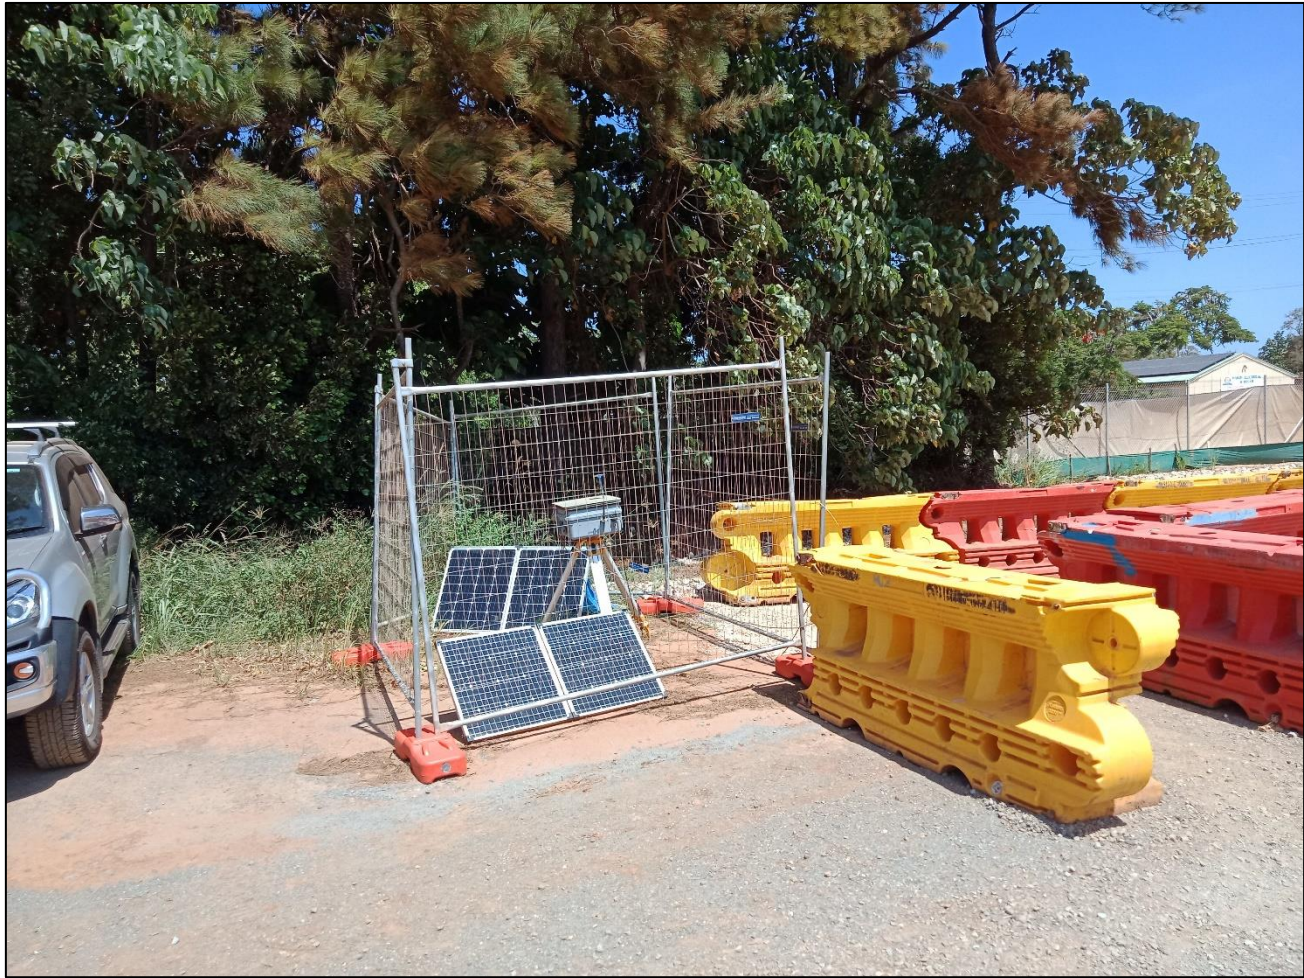
**Photograph 1.** Representative photo of the monitoring location 001 – western location, as observed on the 04.02.2020

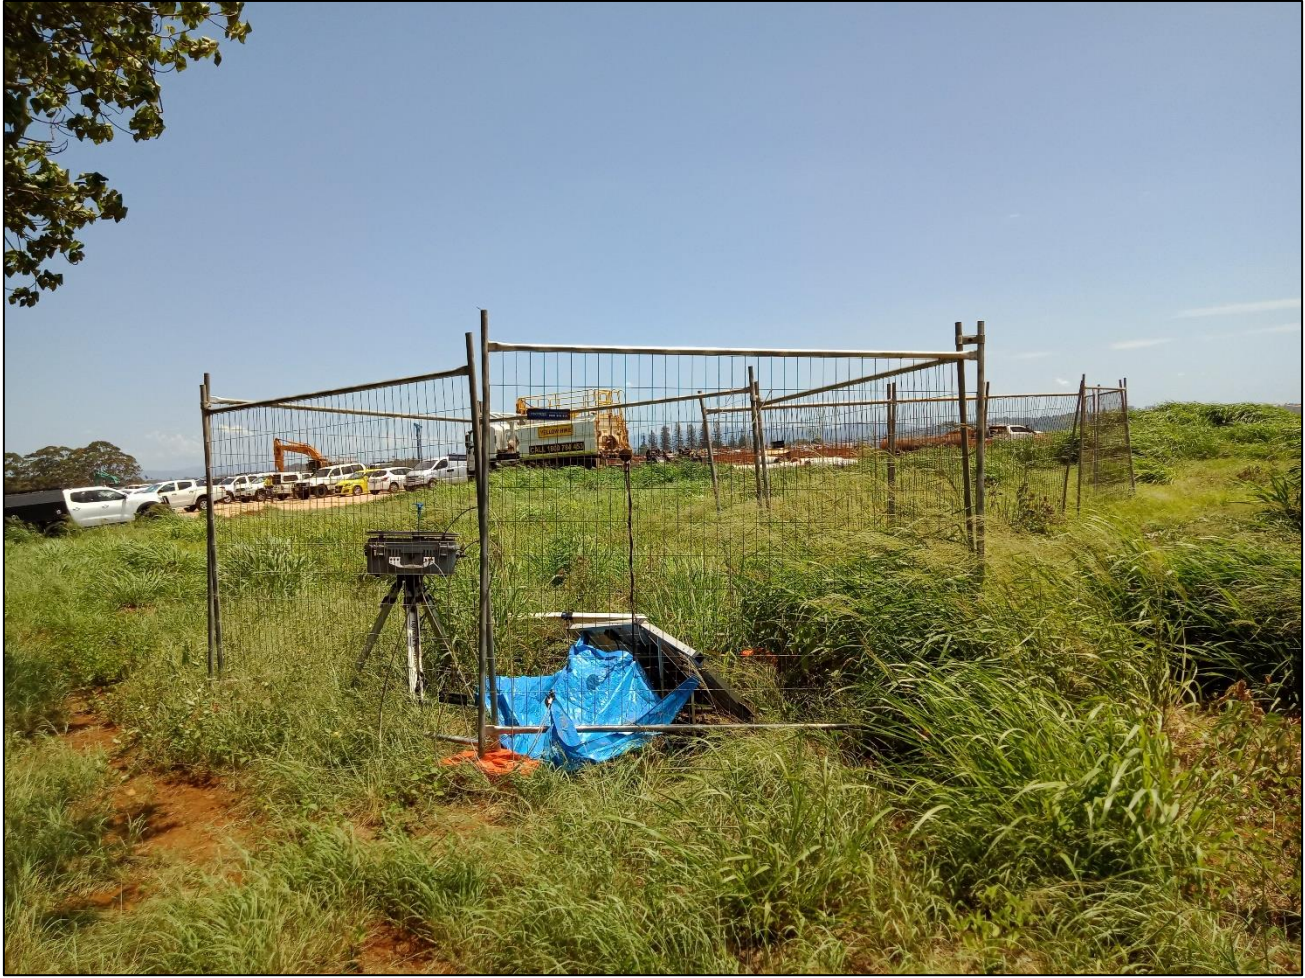
**Photograph 2.** Representative photo of the monitoring location 002 – central location, as observed on the 04.02.2020

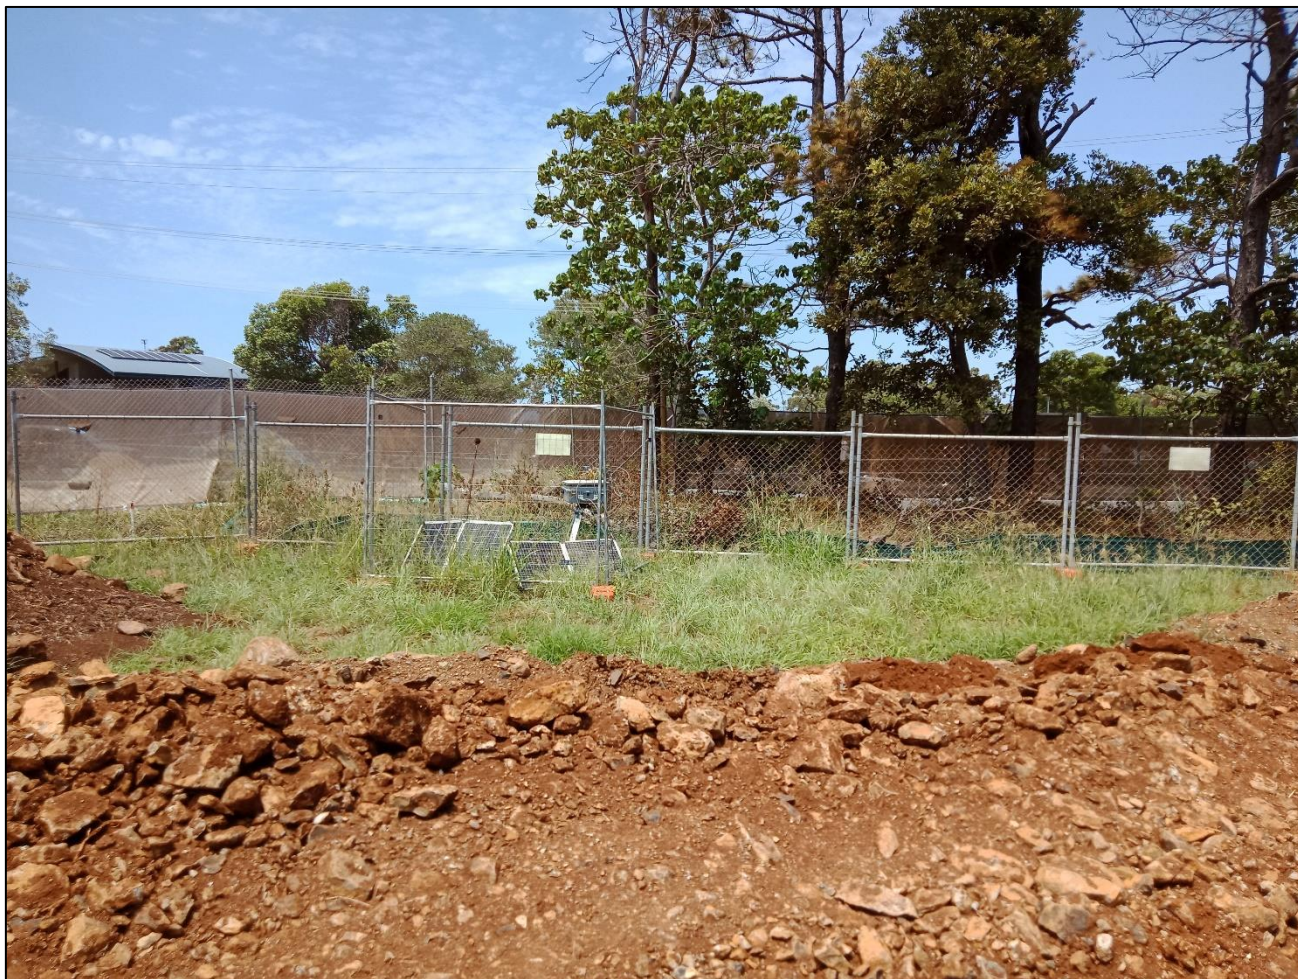
**Photograph 3.** Representative photo of the monitoring location 003 – eastern section of site, as observed on the 04.02.2020
