# Environmental Dust Assessment Report

Tweed Valley Hospital Project

DLT-01-Q1013 / EDM6 / v1.1f

7<sup>th</sup> February 2020

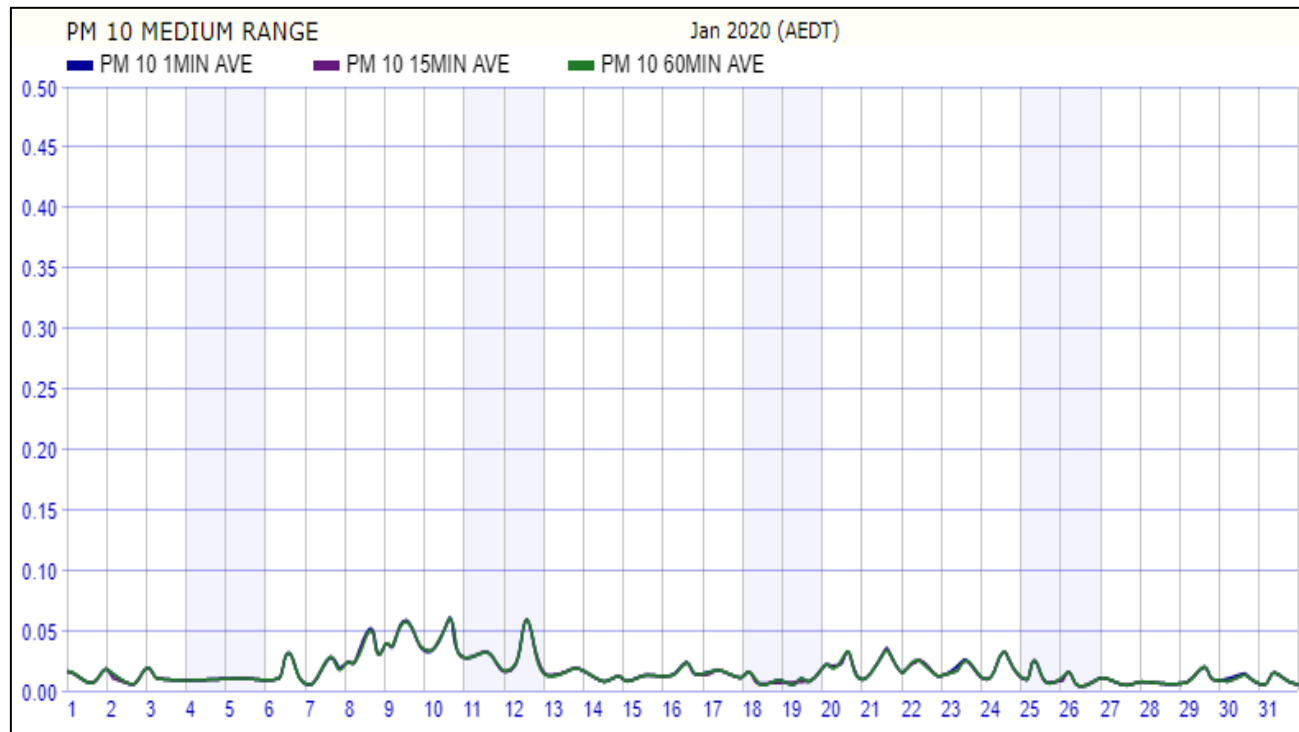
**Figure 2.** Summary of PM10 from the real time monitoring at location 001 – Adjacent the carpark.

The peak dust concentration of 0.359mg/m<sup>3</sup> recorded at monitoring location 001 occurred over a one-minute period on the 9<sup>th</sup> of January at 11:01am.

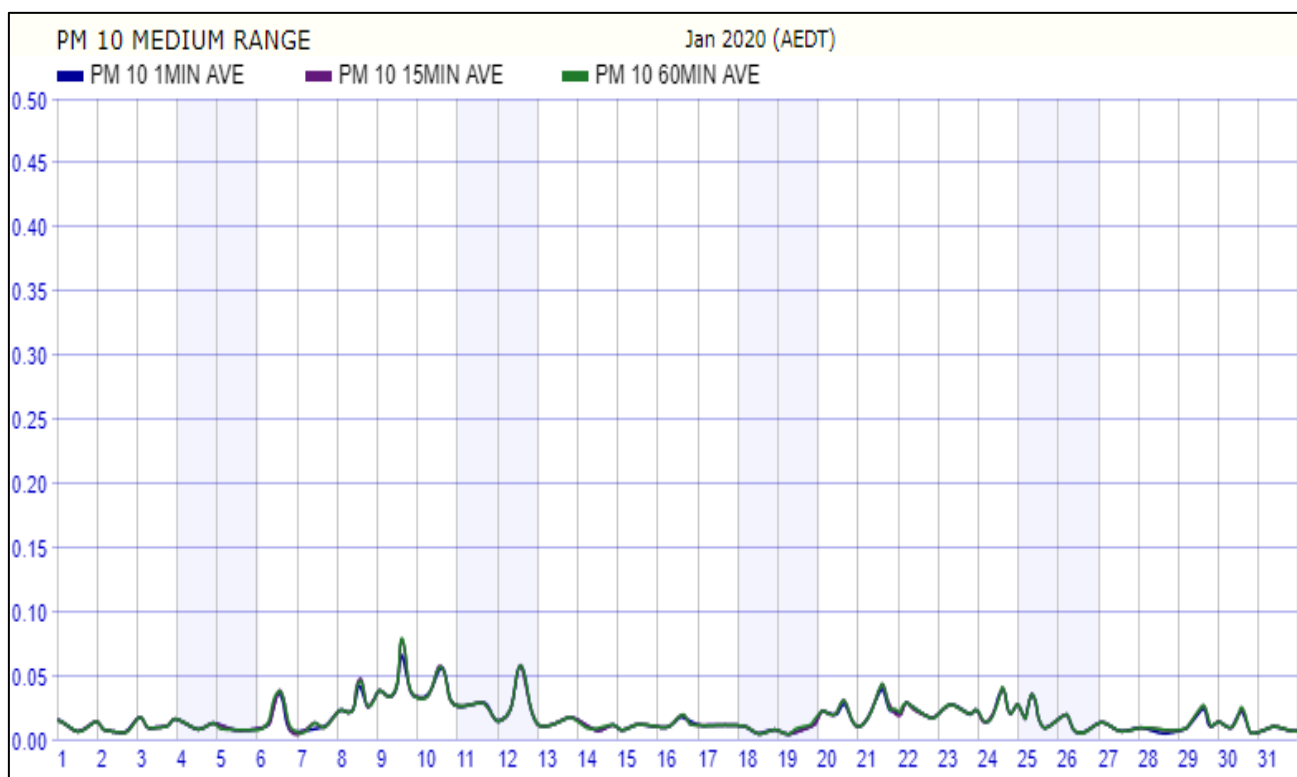
**Figure 4.** Summary of PM10 from the real time monitoring at location 003 – Eastern end of site.

The peak dust concentration of 3.036 mg/m<sup>3</sup> recorded at monitoring location 003 occurred over a one-minute period on the 9<sup>th</sup> of January at 14:39pm. ADE was advised that C&D Excavations was loading mulch with an excavator near the monitor
