**Re: Surface Water Quality Monitoring Results & Report for the Tweed Valley Hospital Project**

*Reporting period: 21<sup>st</sup> November 2019 to 18<sup>th</sup> December 2019*

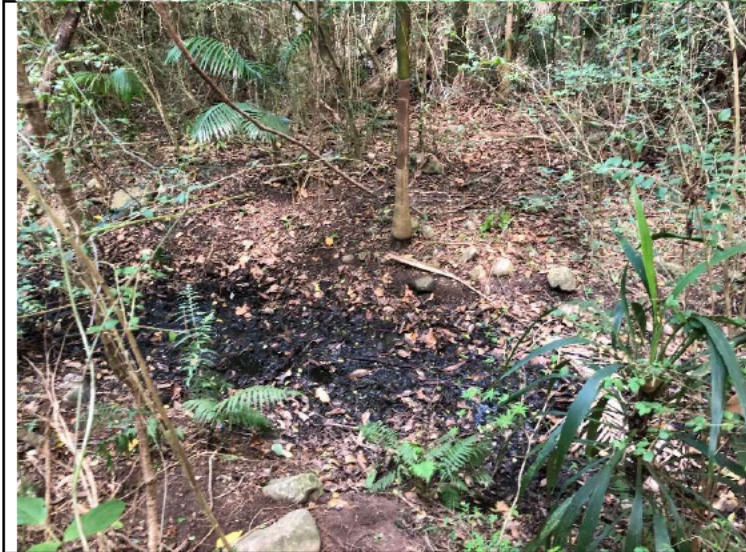
**Site 005 – Dam Drain  
(18/12/2019)**

In situ physico-chemical sampling results with comparison to WQOs are shown in **Table 2**. There were no surface sheens visible which may indicate presence of Oil and Grease. A surface sheen was visible at Site 005 which was potentially of microbial origin. Water was visibly stagnant due to low rainfall and an organic odour was especially apparent at site 005.
