Vibration Monitoring Assessment Report (October 2020)

Tweed Valley Hospital Project, Kingscliff NSW

Prepared for: Lendlease Group

DLT-01-Q1013 | VIB15.V1.1F | Date: 06/11/2020

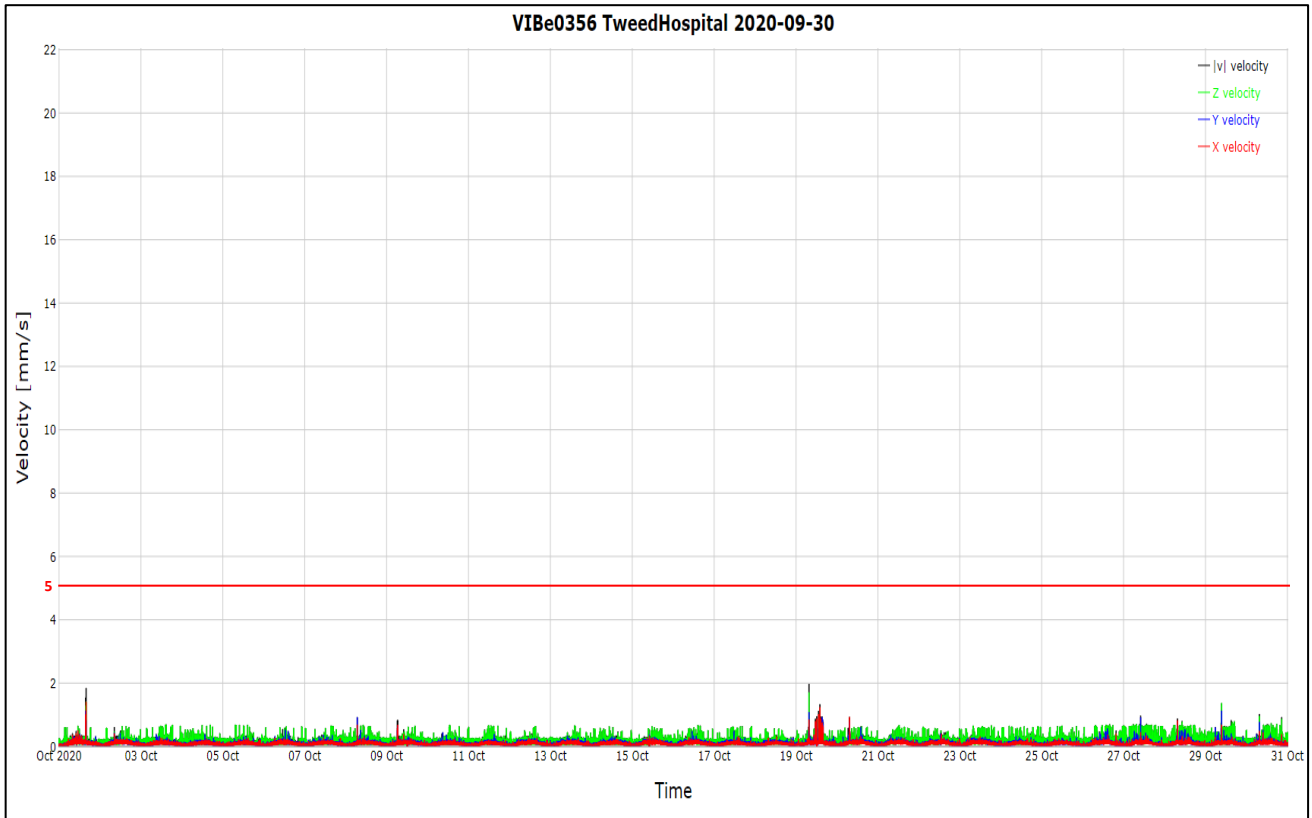
Figure 2. Results of the vibration monitoring from 1 – 31 October 2020 at monitoring location 002 – Central monitor.

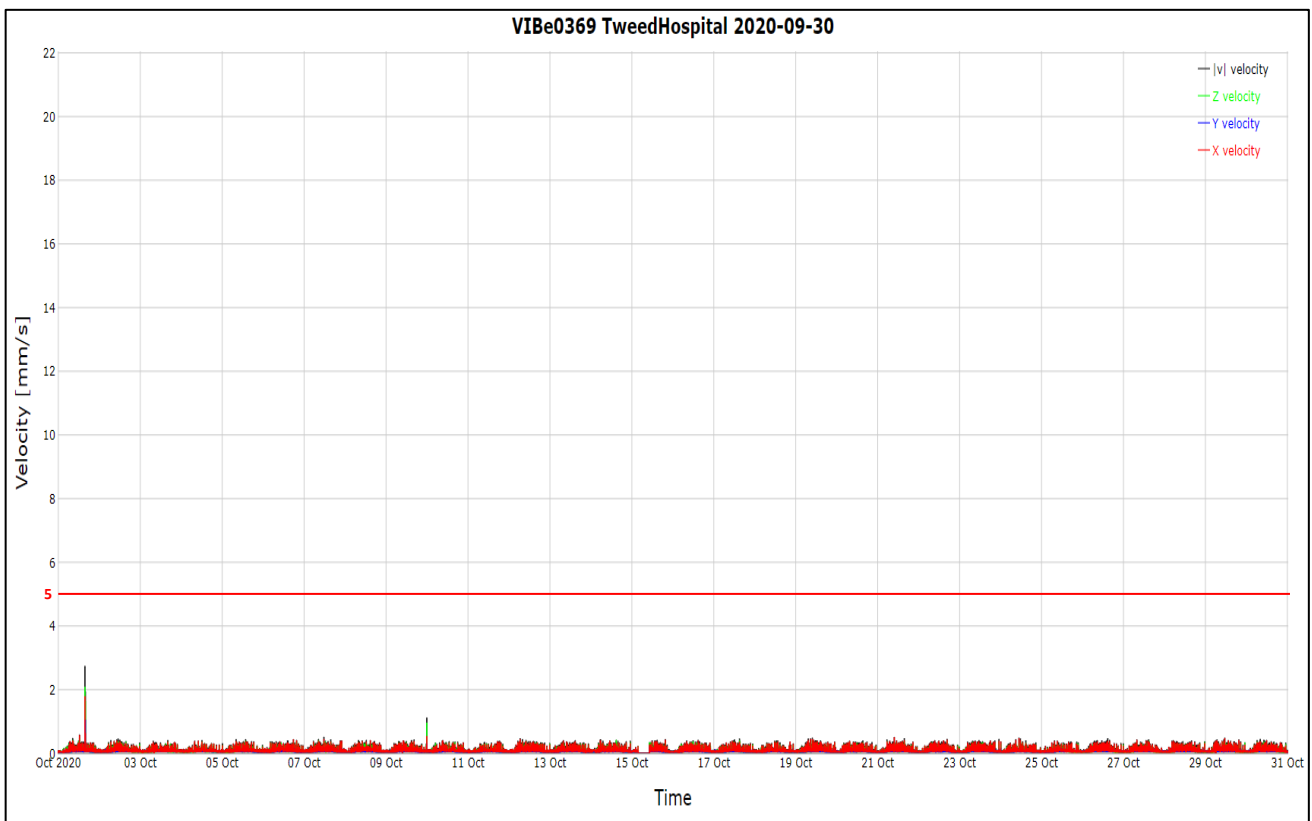
Figure 3. Results of the vibration monitoring from 1 – 31 October 2020 at monitoring location 003 – Eastern section.

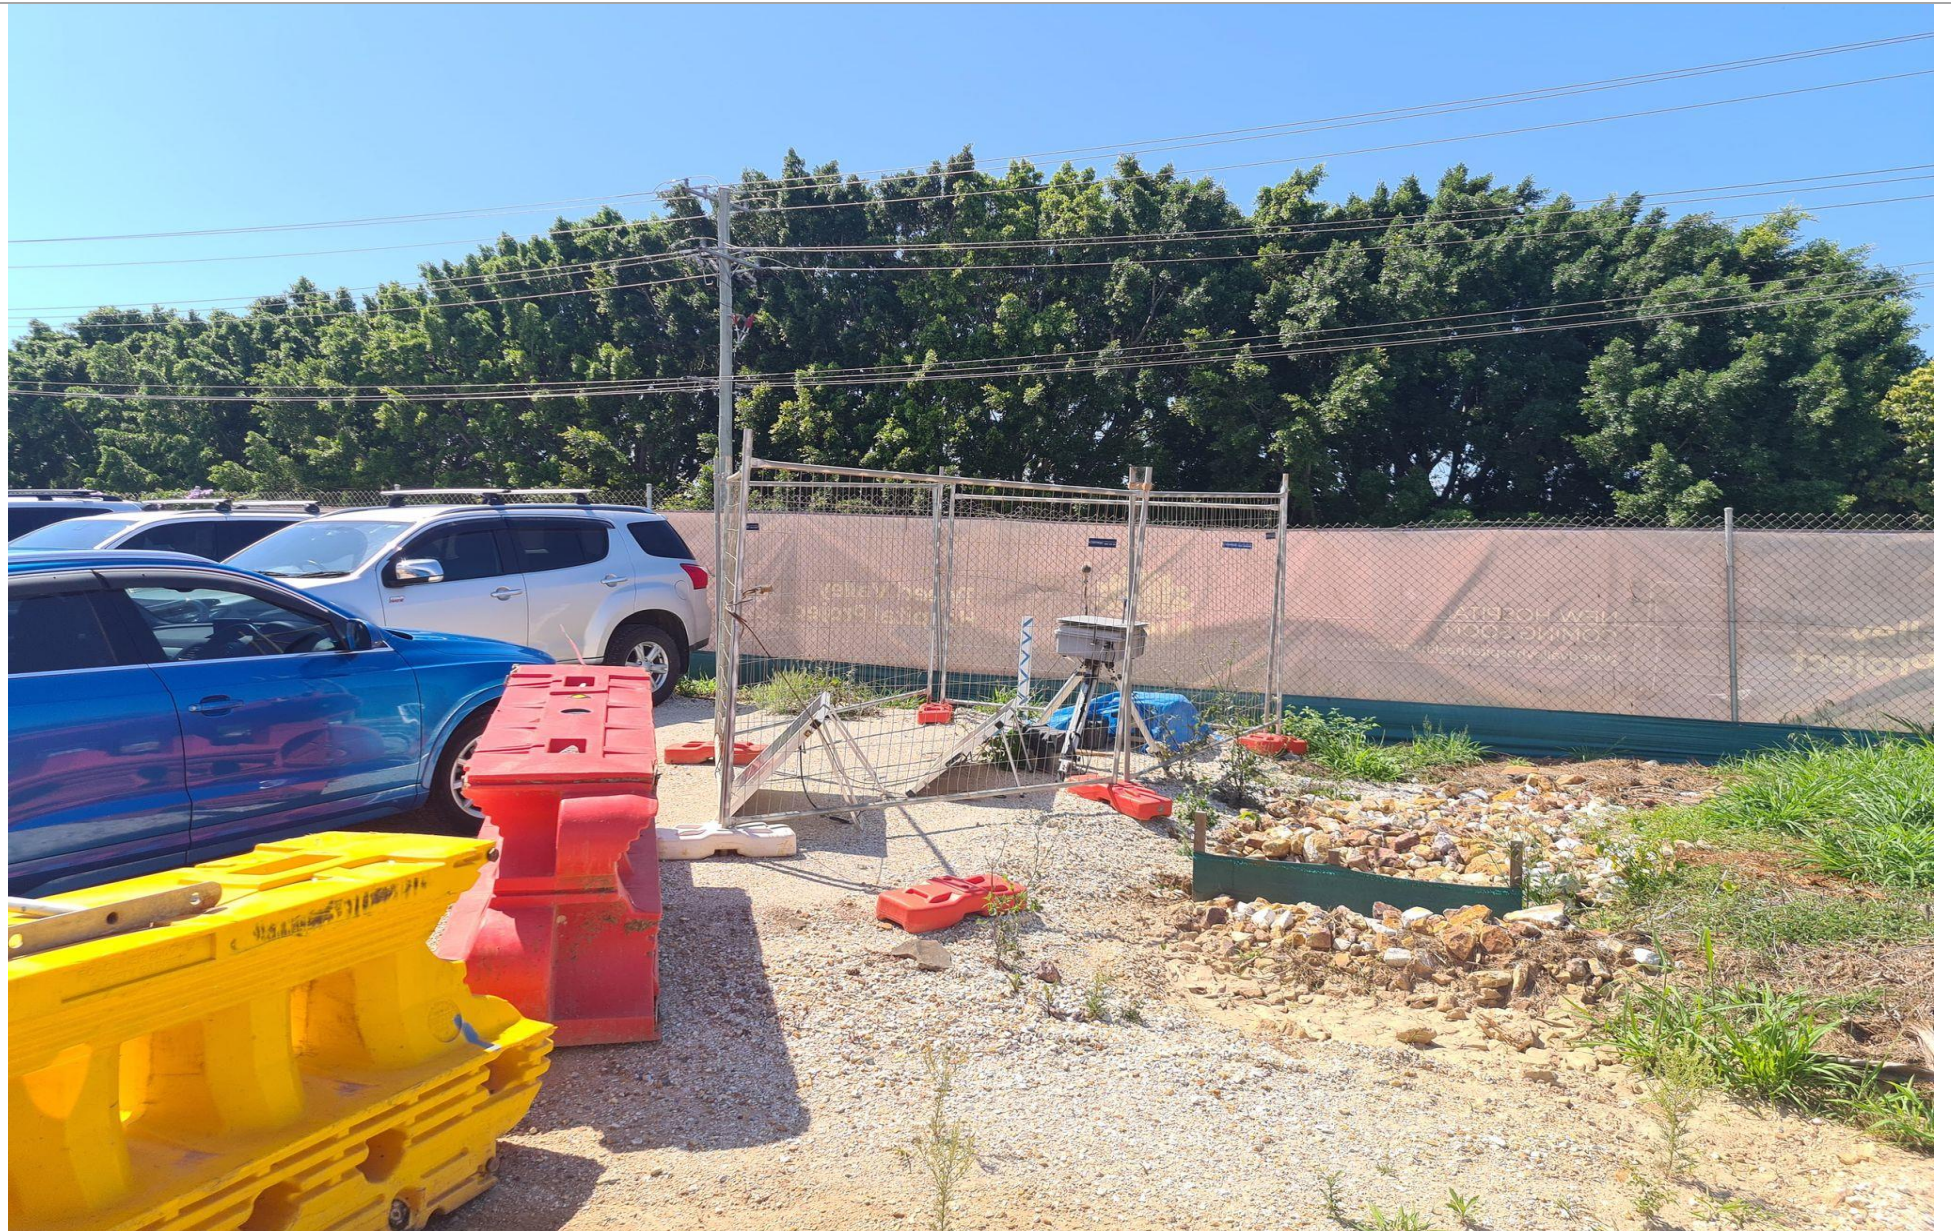
Photograph 1. Representative photograph of monitoring location 001 – Adjacent Carpark location, as observed 15 October 2020

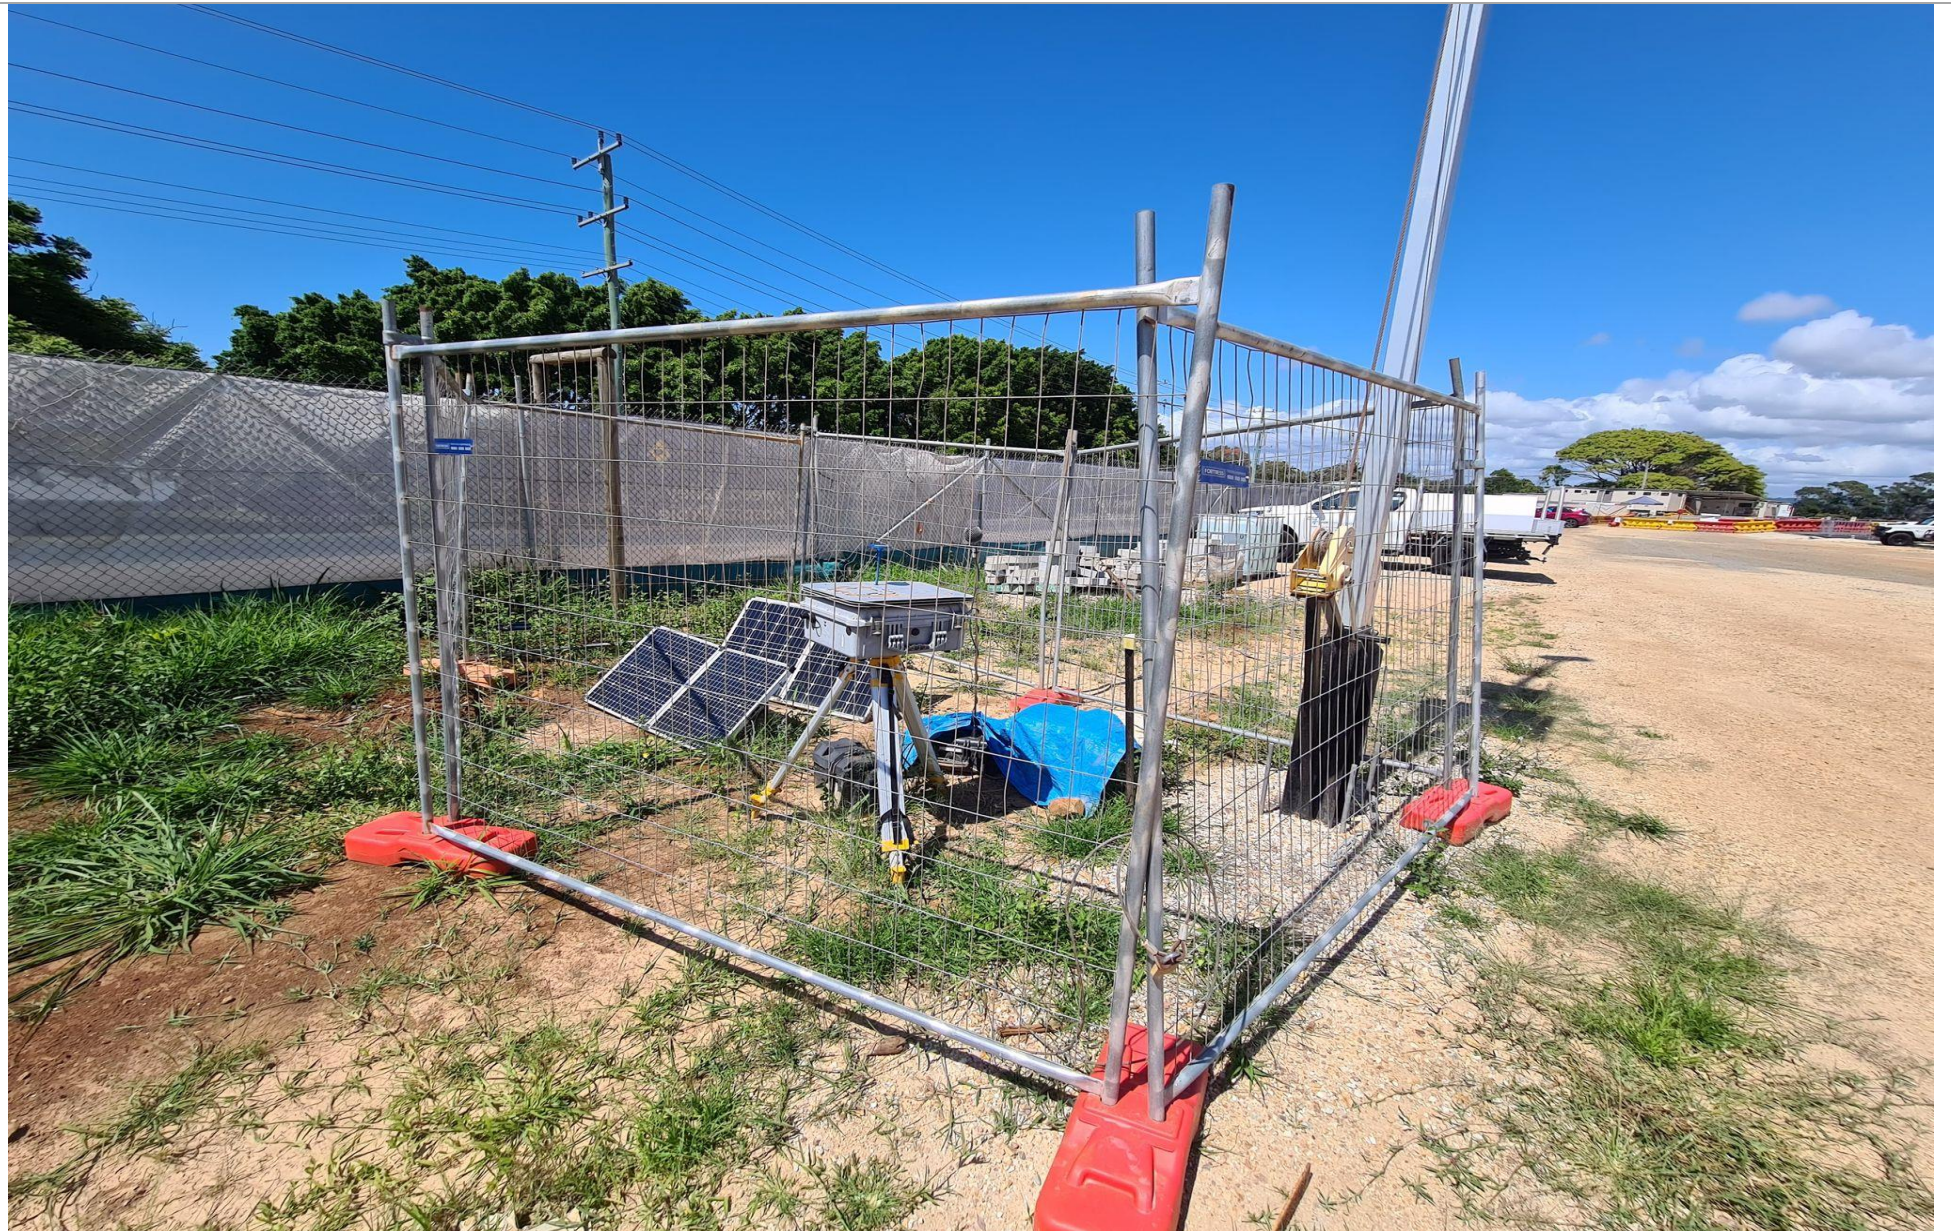
Photograph 2. Representative photograph of monitoring location 002 – Central location, as observed 15 October 2020

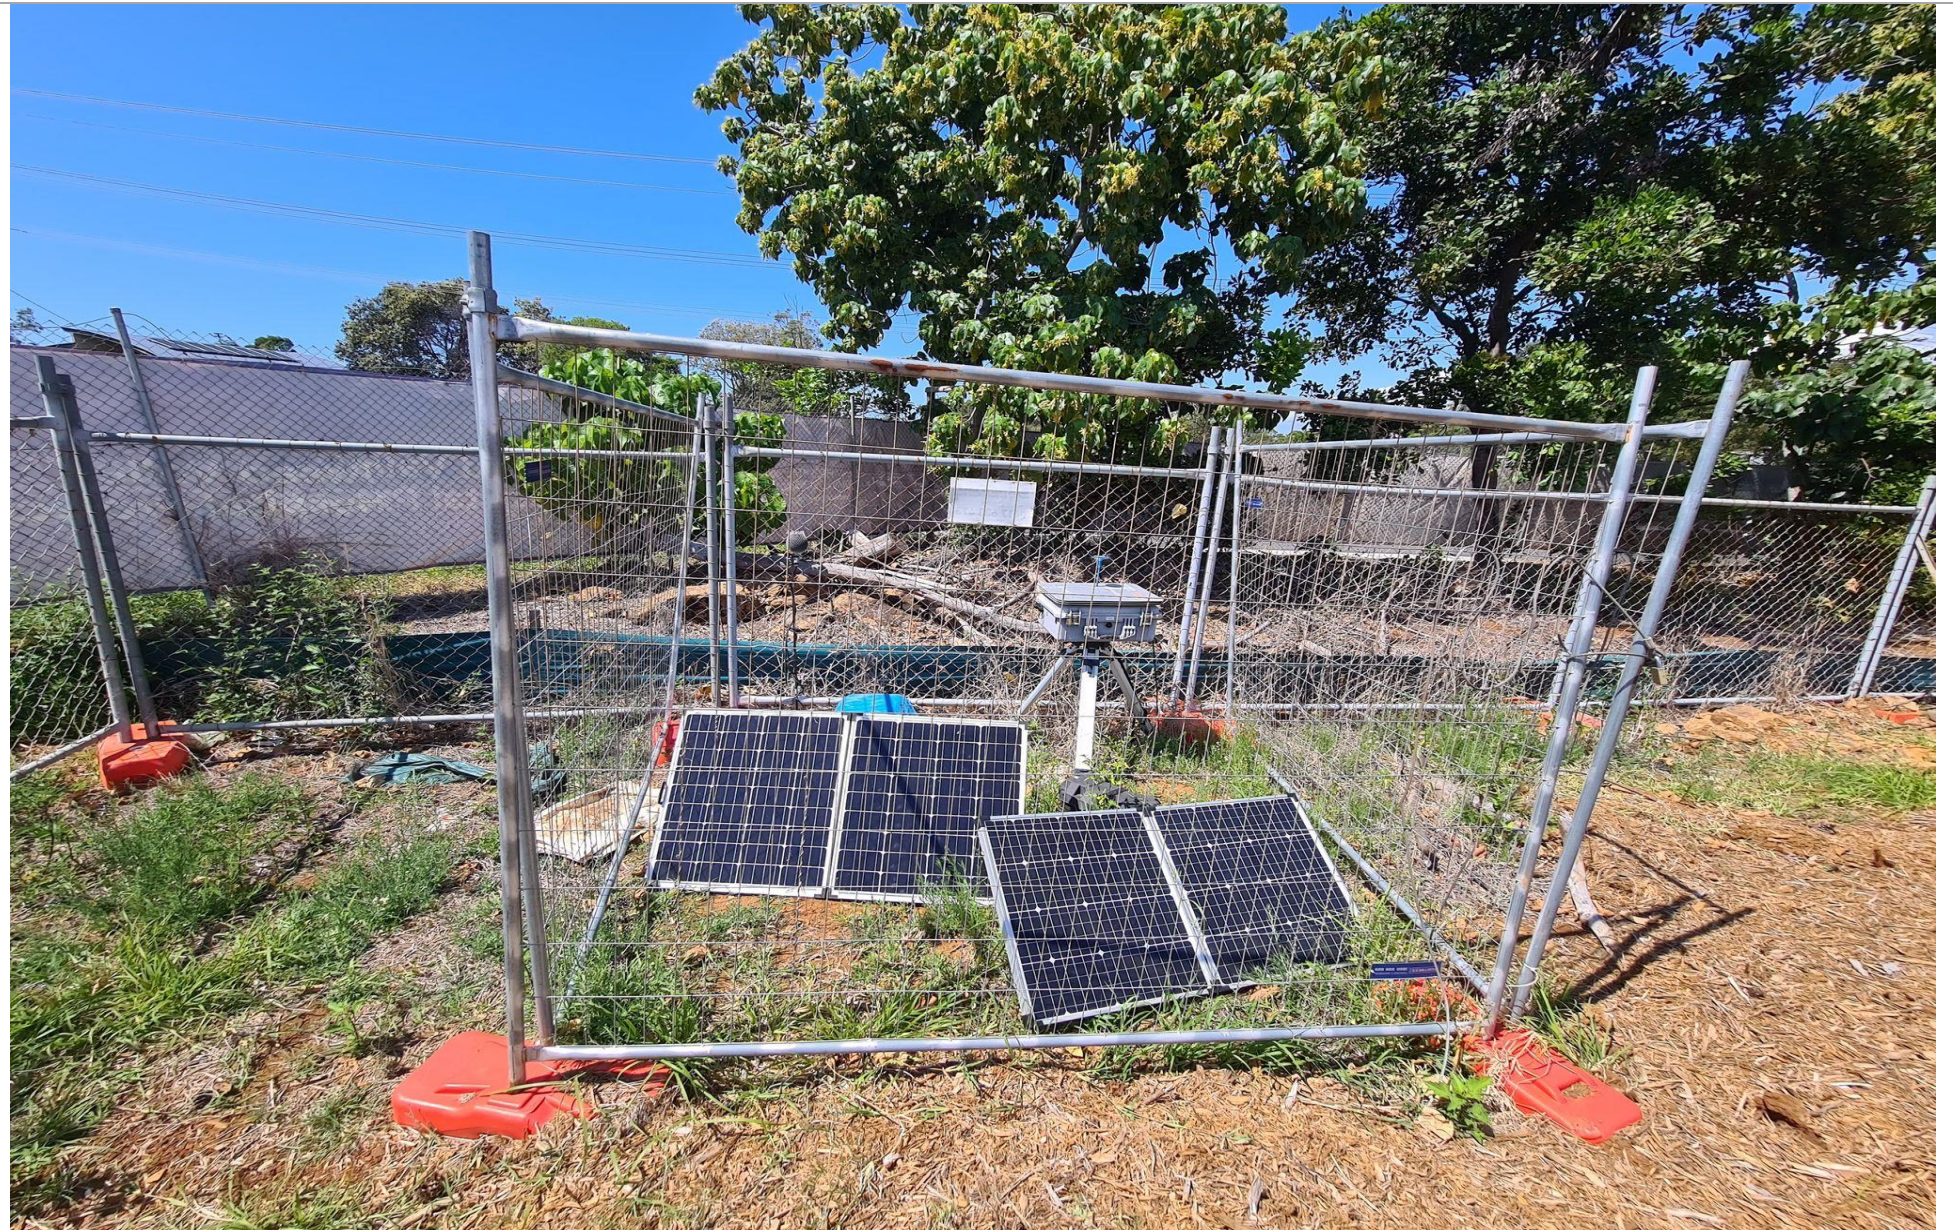
Photograph 3. Representative photograph of monitoring location 003 – Eastern Section of Site, as observed 15 October 2020
