Vibration Monitoring Assessment Report (November 2020)

Tweed Valley Hospital Project, Kingscliff NSW

Prepared for: Lendlease Group

DLT-01-Q1013 | VIB16.V1F | Date: 11/12/2020

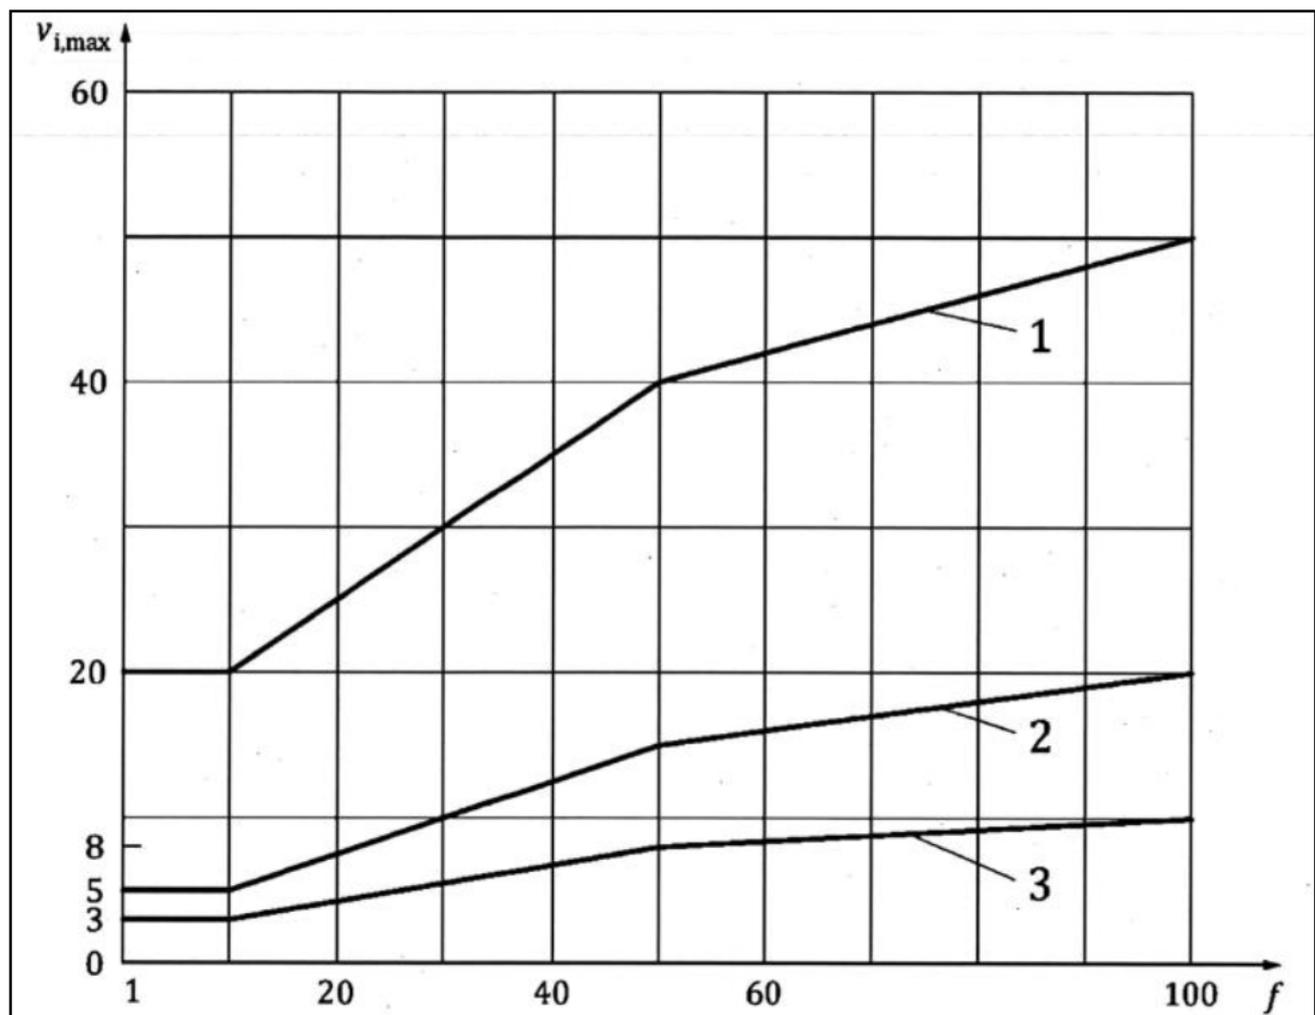
Graph 1. Graph of the lines 1, 2 and 3 according to Table 2.

The Peak Vibration Velocity (PVV) limits for the duration of work have been adopted from *Vibrations in buildings Part 3: Effects on structures DIN4150-3 February 2016*. Lines 1 and 2 in Table 2 on the following page apply to the surrounding structures of the Tweed Valley Hospital project, including the Kingscliff TAFE and nearby residences. A visual representation of Table 2 is also shown below in Graph 1 on the following page.

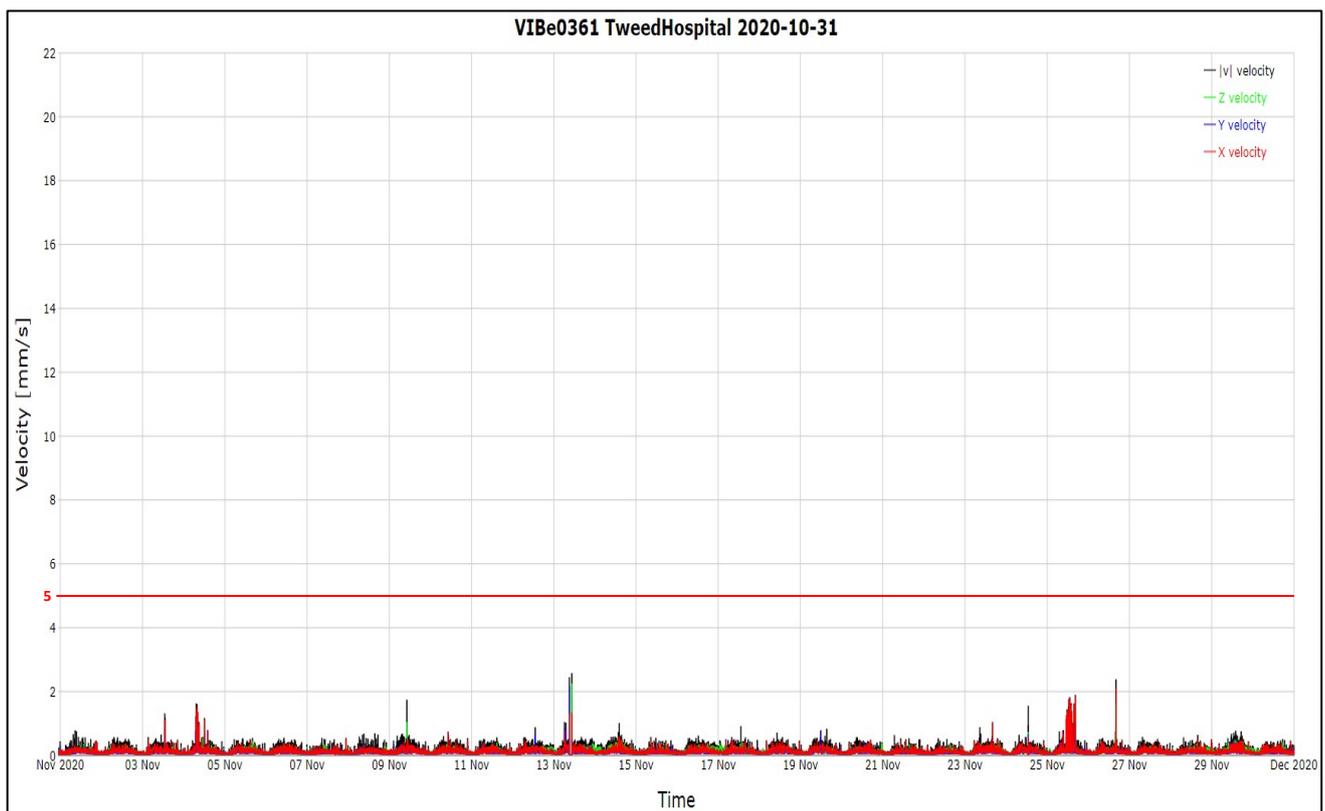
Figure 1. Results of the vibration monitoring from 1 – 30 November 2020 at monitoring location 001 – Adjacent carpark.

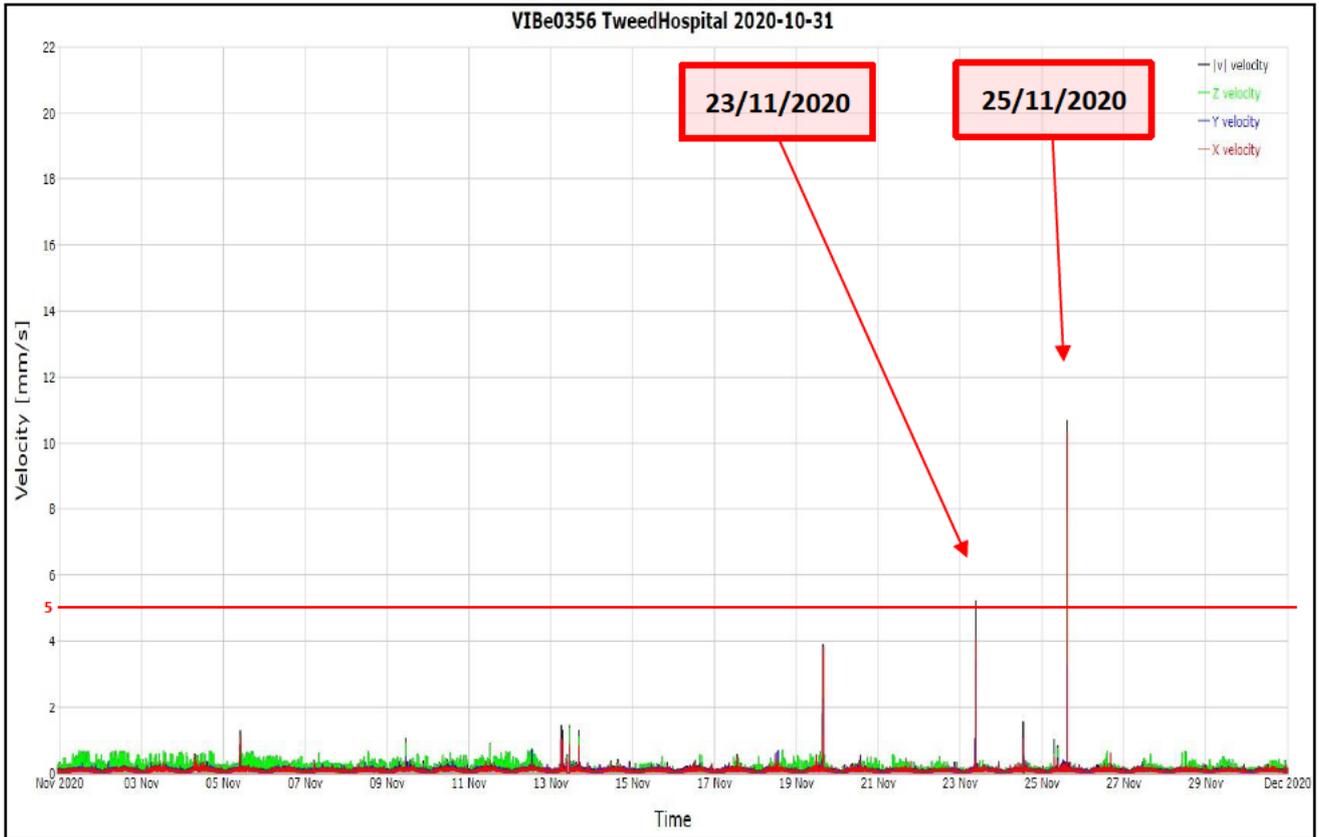
- Location 002:
 - 23 November; and
 - 25 November.

Figure 2. Results of the vibration monitoring from 1 – 30 November 2020 at monitoring location 002 – Central monitor.

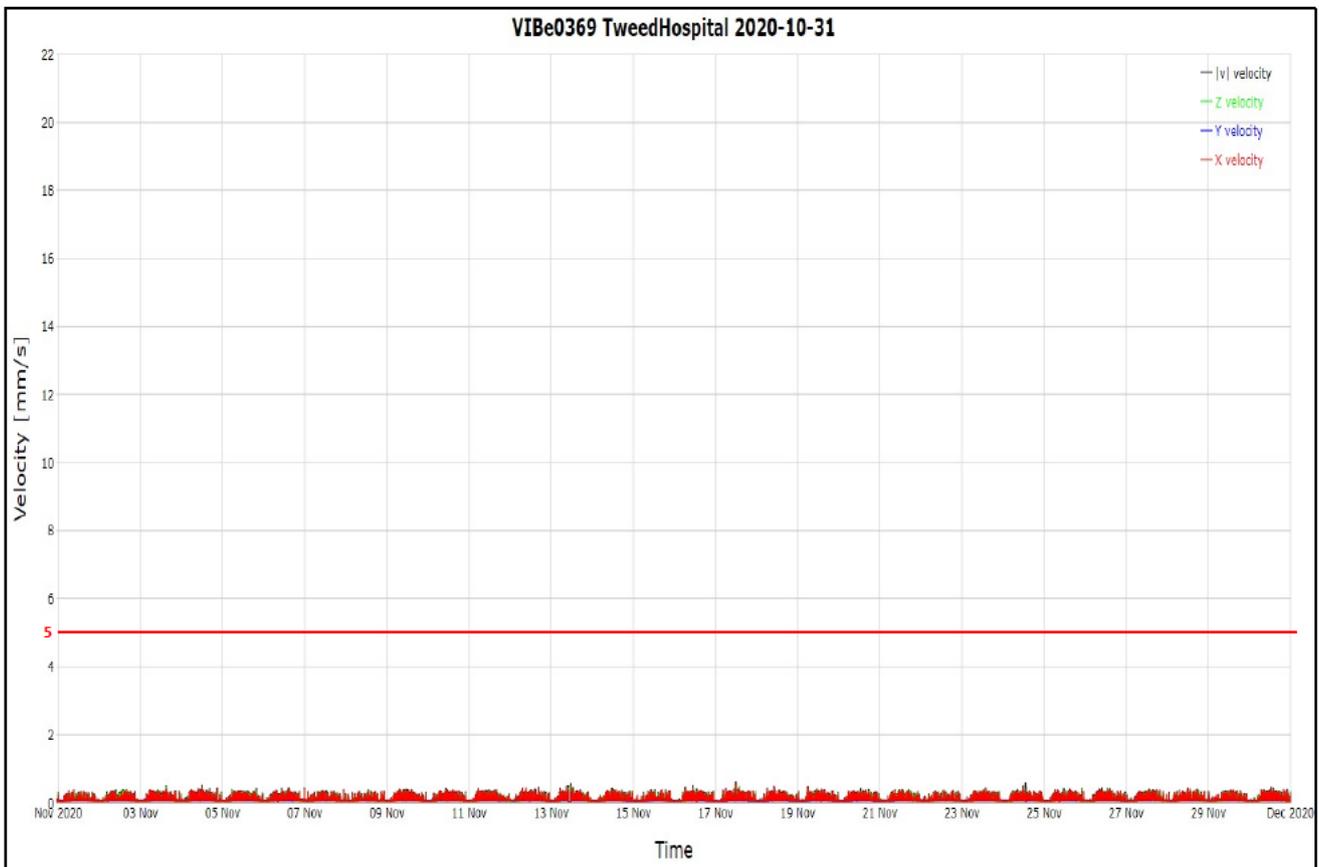
Figure 3. Results of the vibration monitoring from 1 – 30 November 2020 at monitoring location 003 – Eastern section.

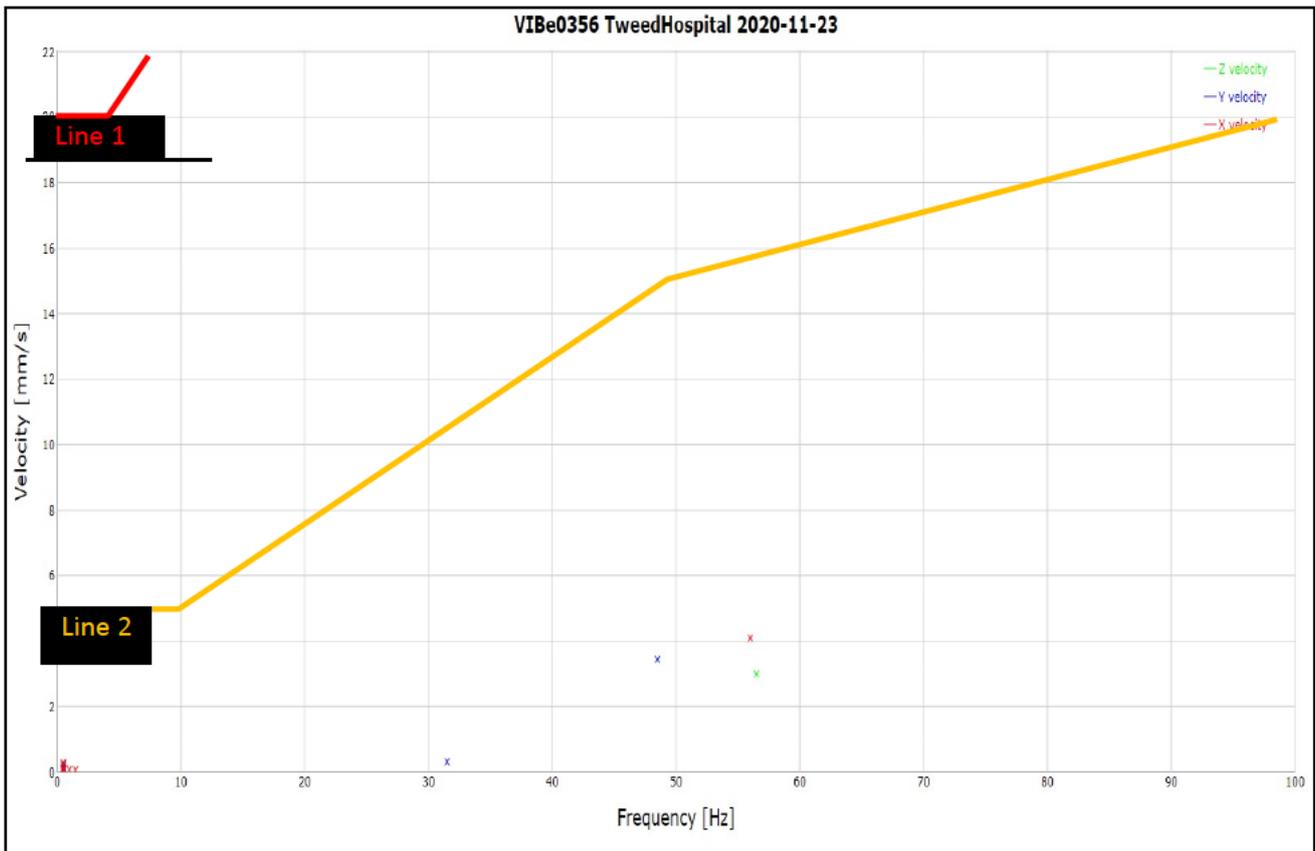
Figure 4. Velocity-Frequency results of the exceedance detected on Monday 23 November 2020 at monitoring location 002 – Central monitor. No Velocity-Frequency exceedance of Line 1 or Line 2.

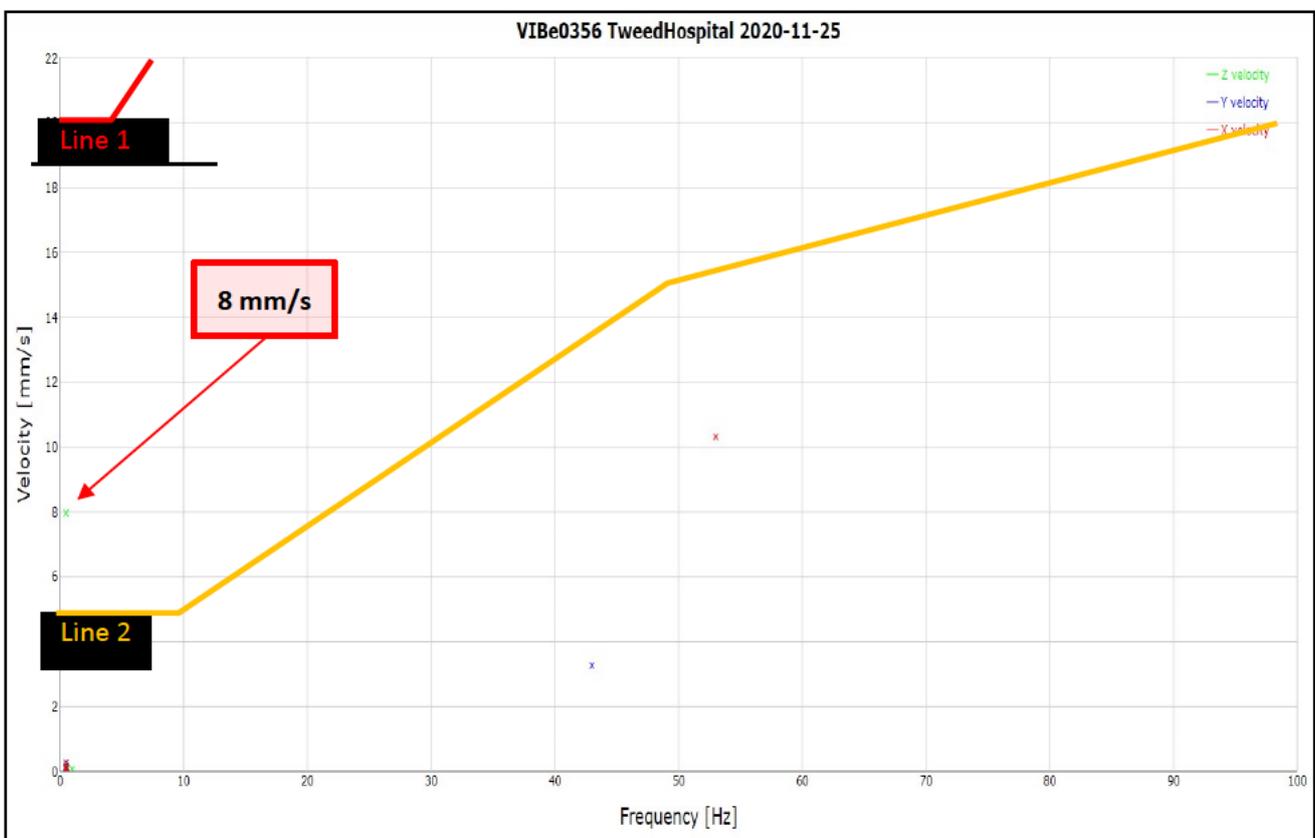
Figure 5. Velocity-Frequency results of the exceedance detected on wednesday 25 November 2020 at monitoring location 002 – Central monitor. Velocity-Frequency exceedance of Line 2.

One (1) exceedance of DIN 4150 Line 2 occurred during this reporting period.

The exceedance occurred at Location 002 on Wednesday 25 November 2020, at approximately 14:48 (AEDT). The vibration had a maximum Z Velocity of approximately 8 mm/s at a frequency of 2 Hz.

On 25 November 2020, ADE was advised by Lendlease that the exceedance was caused by an 8 tonne excavator being unloaded from a flat bed truck approximately 6 m from the monitoring location.

ADE recommends that careful consideration is given when loading and unloading of plant and/or machinery to reduce future vibration exceedances. This includes loading and unloading of plant and/or machinery as far as practicable away from the vibration monitor to minimise the chance of an exceedance.

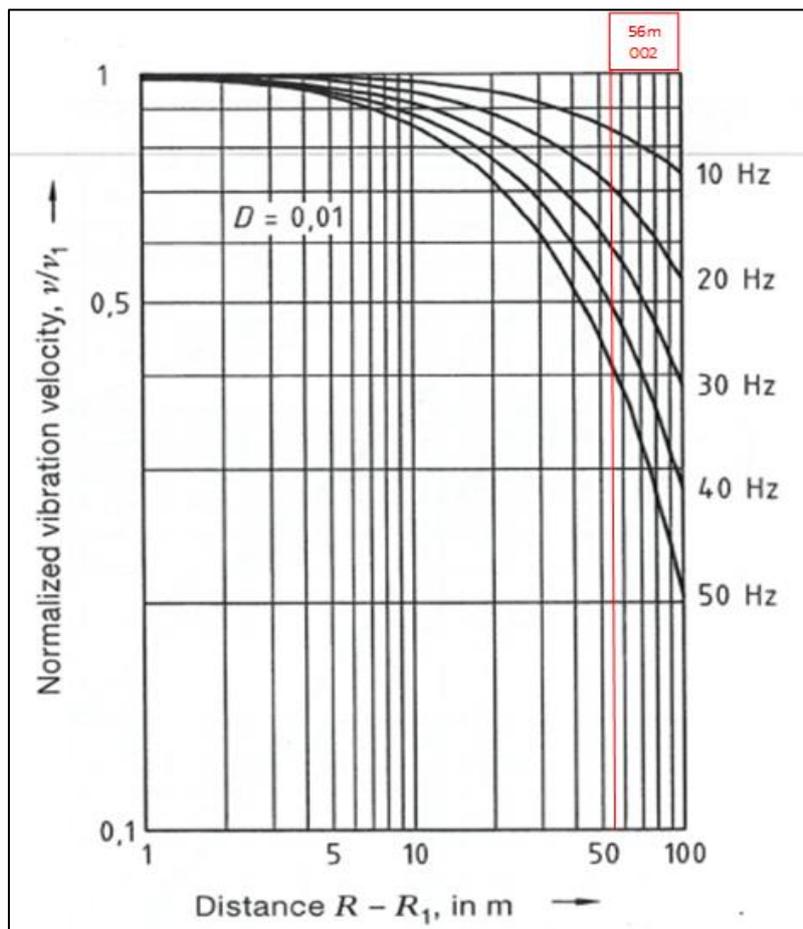
The distance from the monitor at Location 002 to the nearest sensitive receiver is 56 m. As per DIN 4150-1:2001-06, a 2 Hz vibration will reduce to 95% of the initial velocity before reaching the receiver at 56 m (refer to **Graph 2**, below).

Graph 2. Effect of vibration energy absorption by the soil on amplitude attenuation with increasing distance, as a factor of frequency (for $D = 0.01$ and a shear wave propagation velocity of 200 m/s). (Adapted from DIN 4150-1:2001-06, page 6).

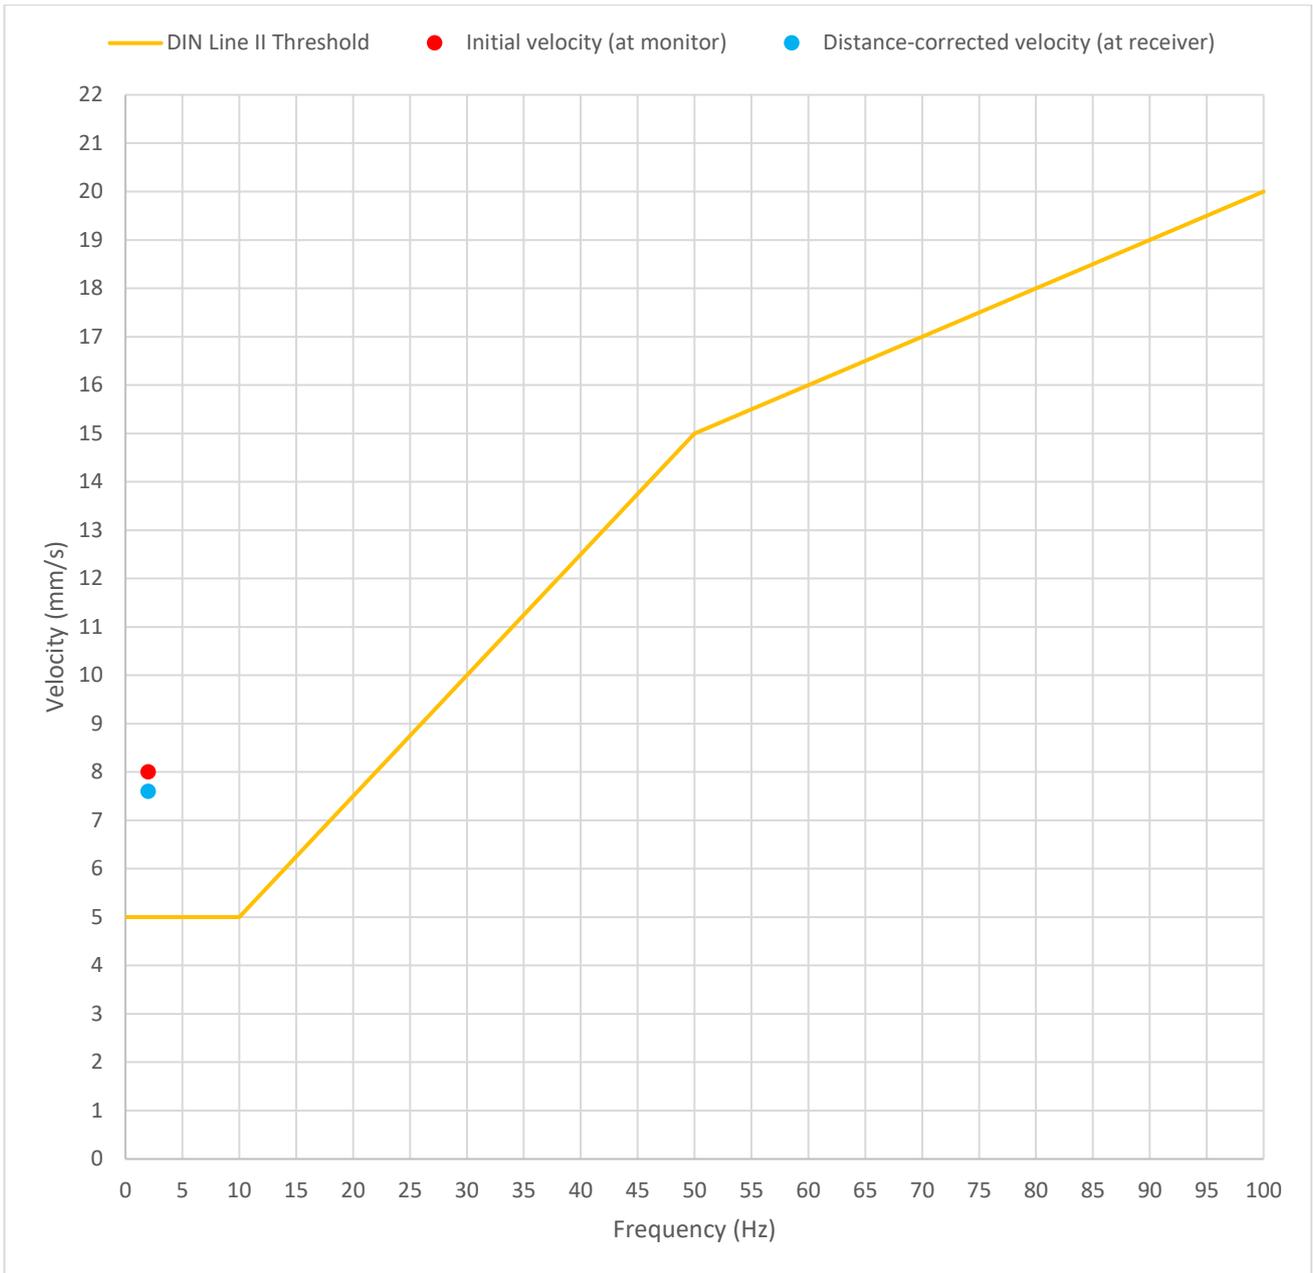
Therefore, the velocity of the vibration observed at the receiver at 14:48 (AEDT) would have been approximately **7.6 mm/s** (refer to **Figure 6** on the following page).

At a frequency of 2 Hz, a velocity of 7.6 mm/s is an exceedance of the DIN Line 2 threshold velocity of 5 mm/s.

Figure 6. Distance based vibration velocity correction.

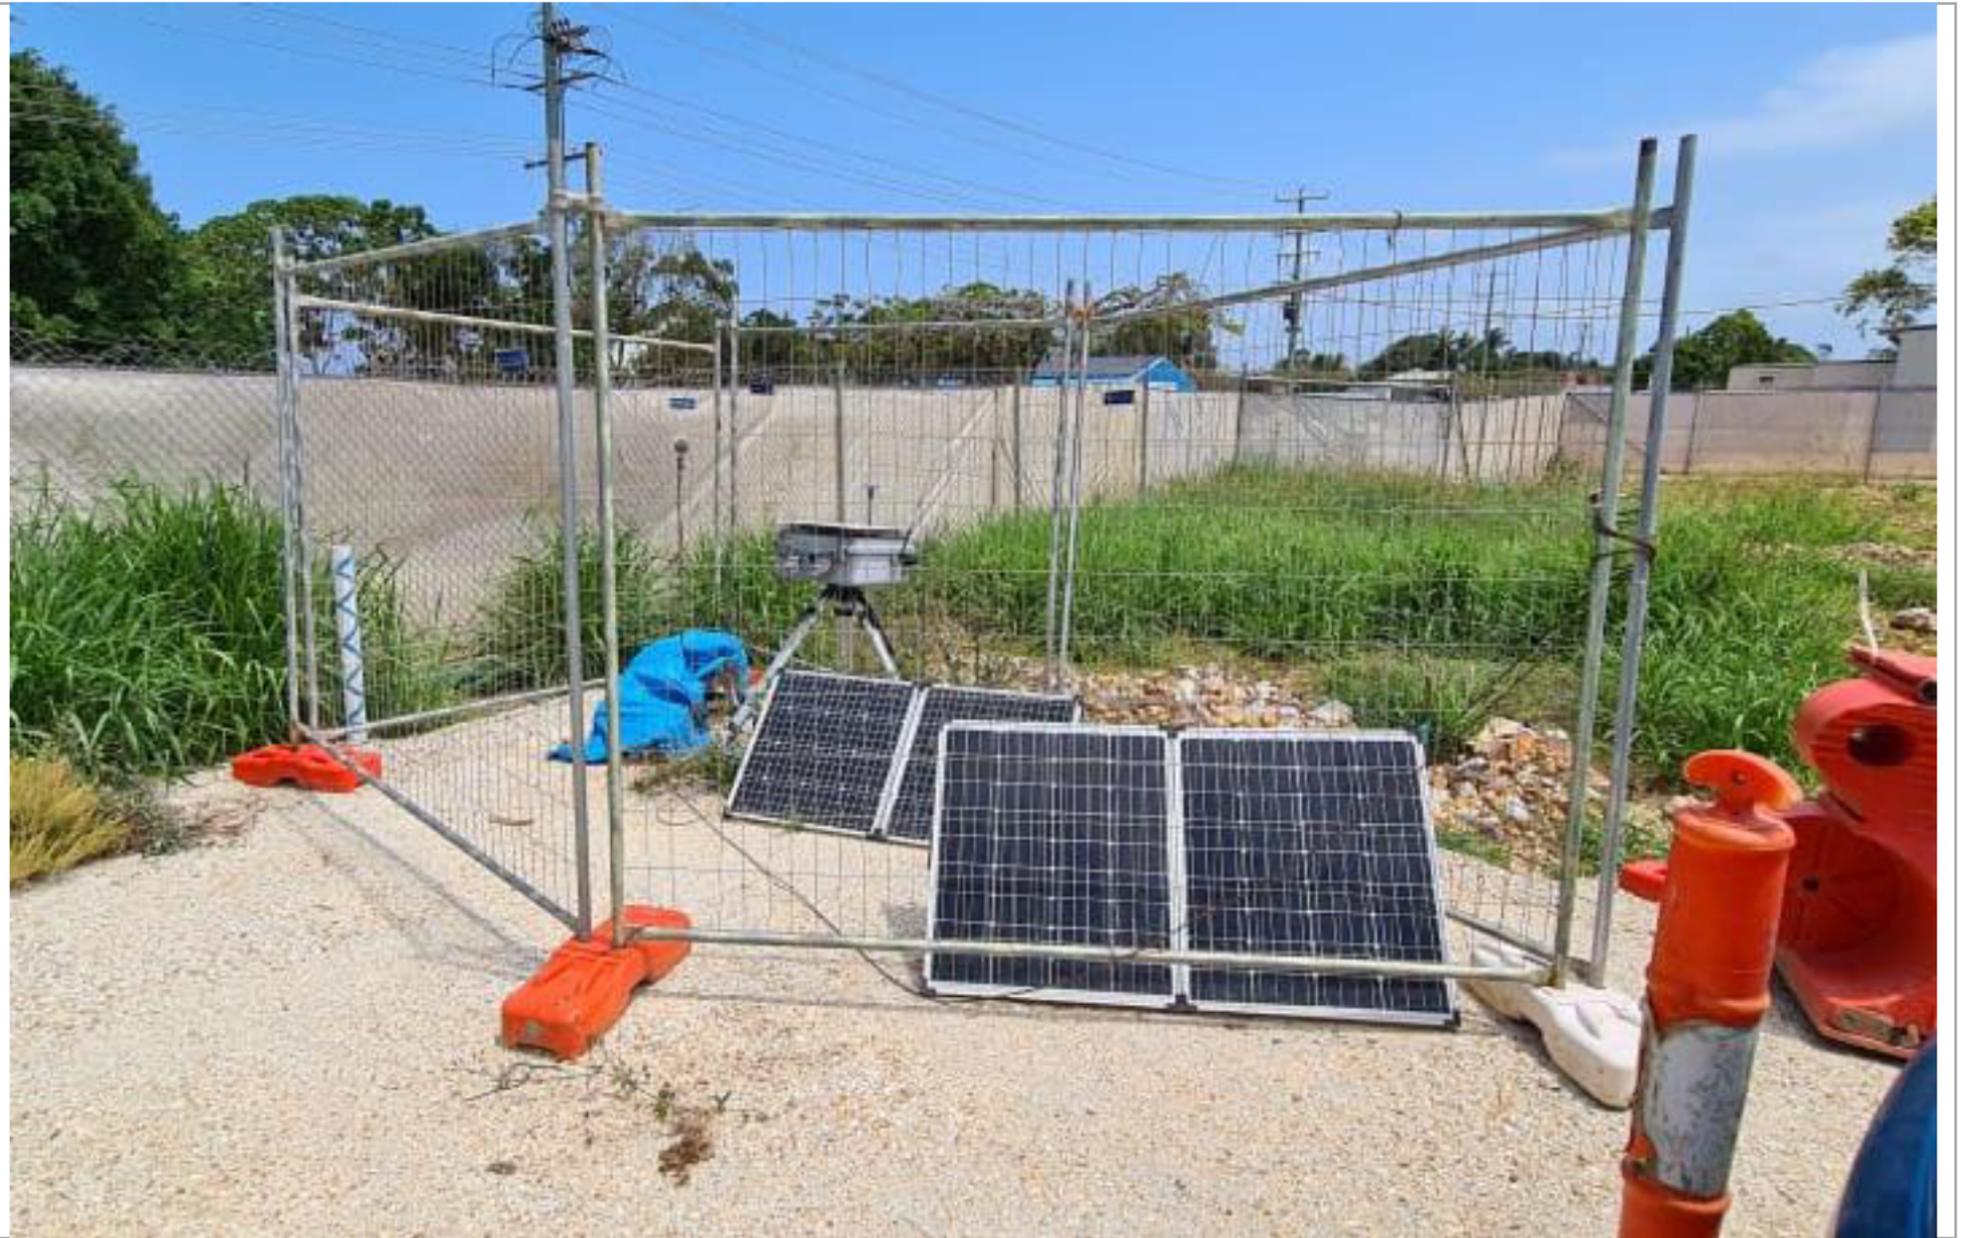
Photograph 1. Representative photograph of monitoring location 001 – Adjacent Carpark location, as observed 24 November 2020

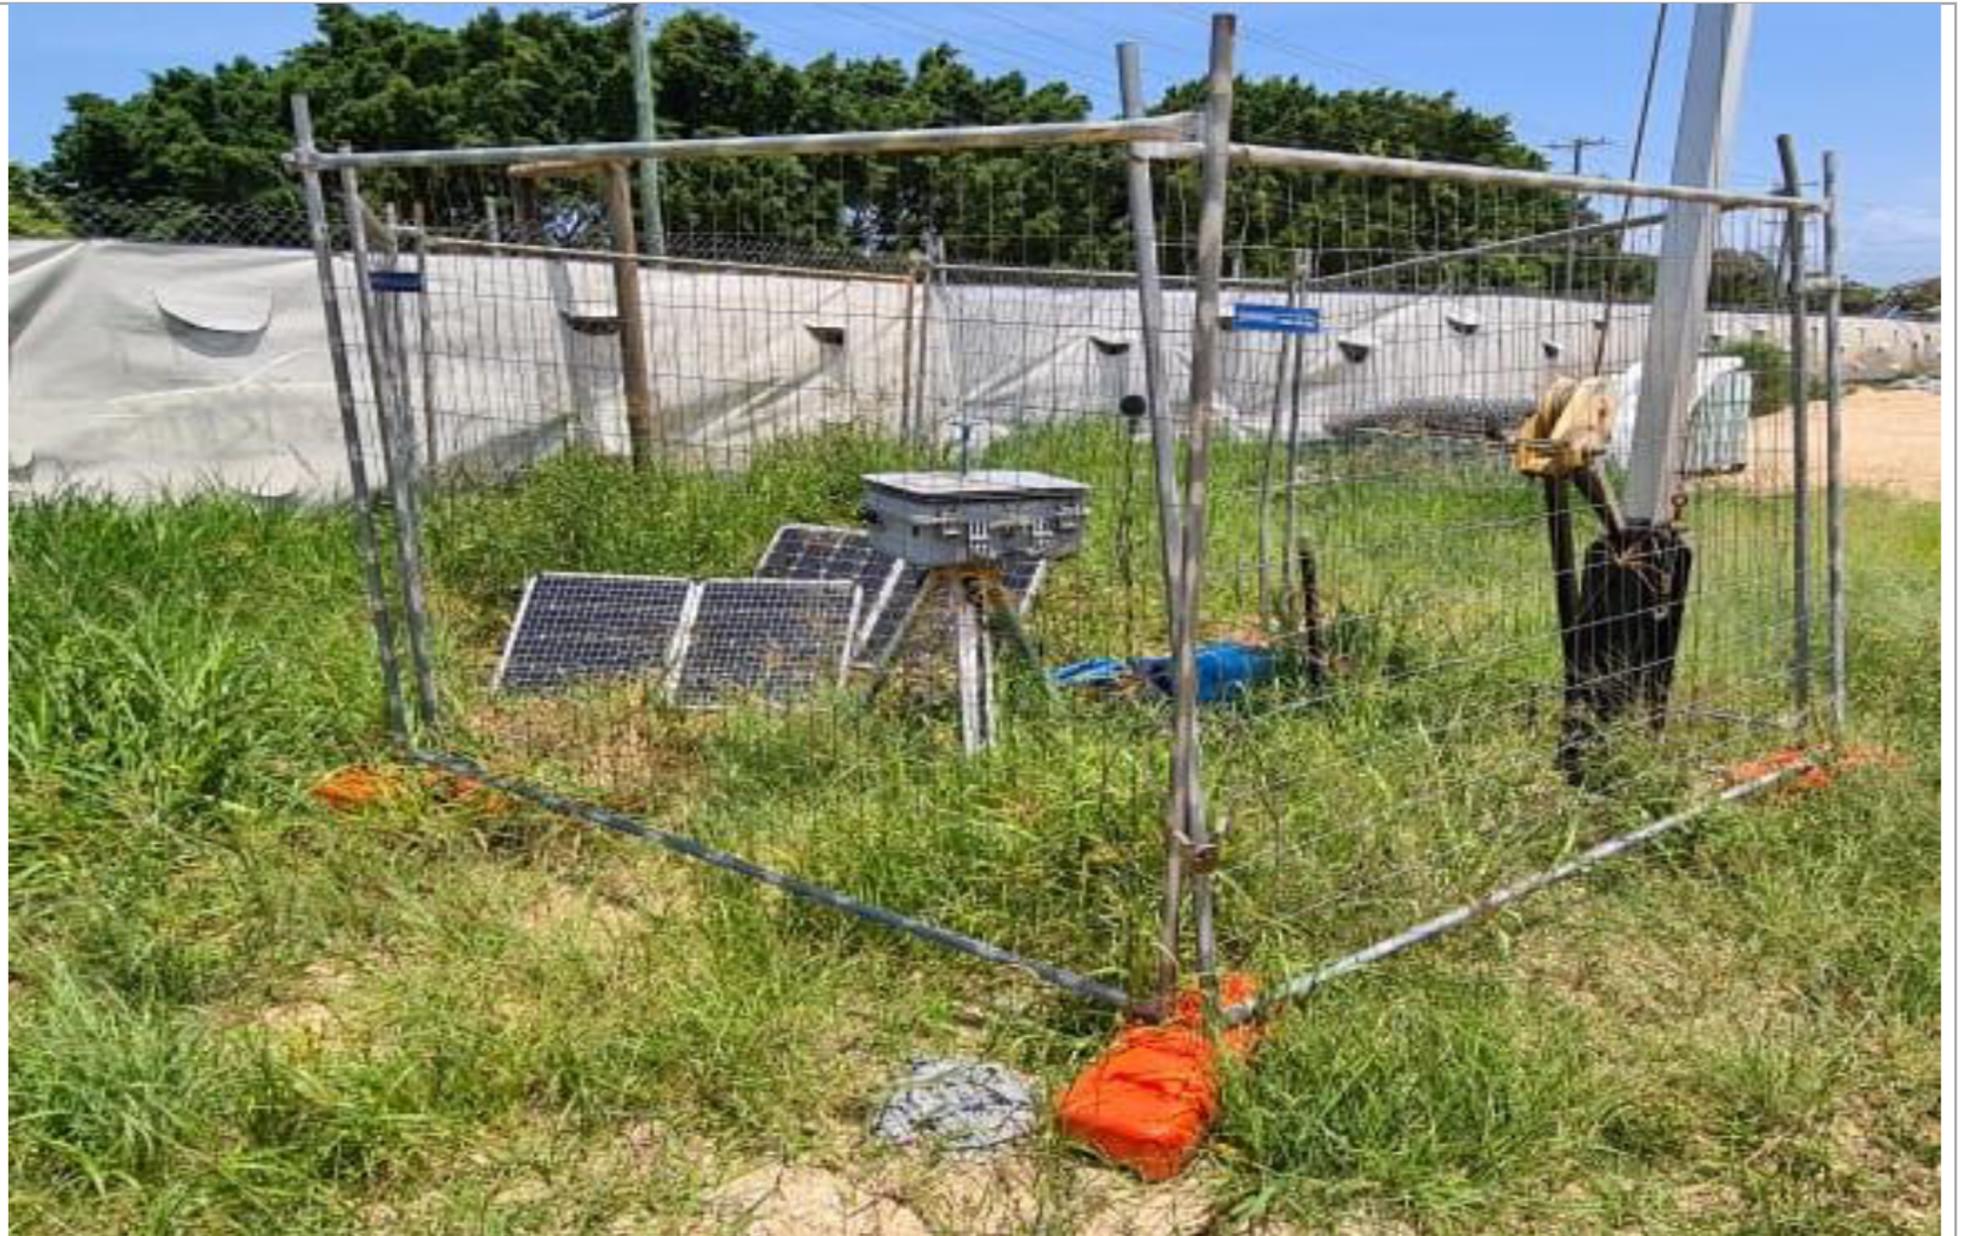
Photograph 2. Representative photograph of monitoring location 002 – Central location, as observed 24 November 2020

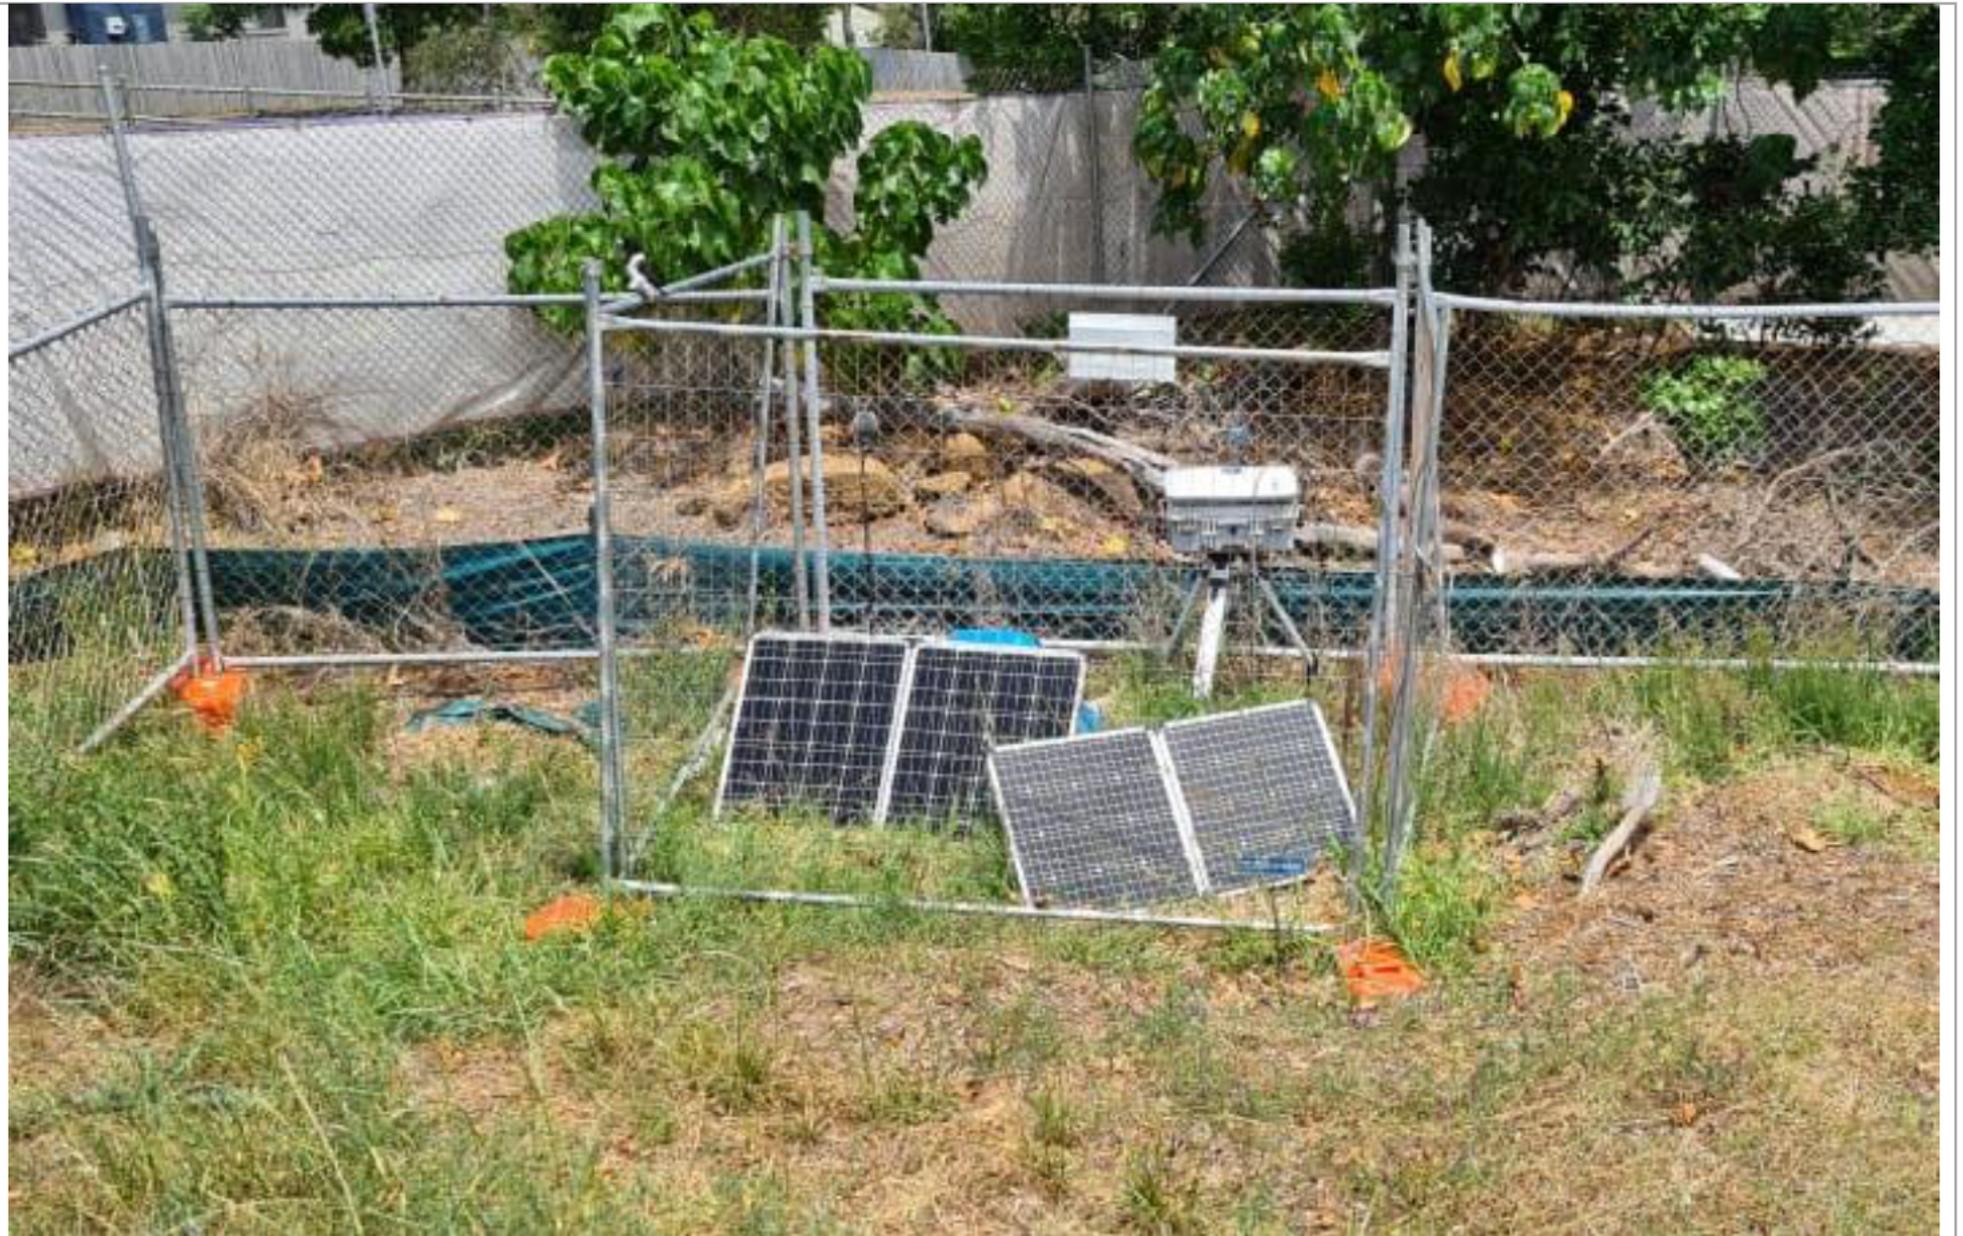
Photograph 3. Representative photograph of monitoring location 003 – Eastern Section of Site, as observed 24 November 2020.

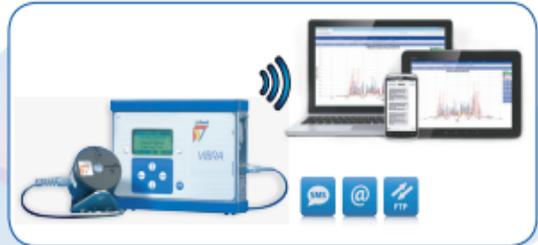
Profound VIBRA-series

The VIBRA's robust aluminium housing is IP65 watertight. The system is easily portable, lightweight and battery-operated which allows for up to 4 weeks of continuous and unmanned operation.

Setting up the system on site is easy: attach the 3-dimensional sensor to the structure to be monitored, switch on the system and start measuring. While measuring the VIBRA displays date, time, time interval and the current peak vibration values including frequency in all 3 directions. In advance an alarm level can be set.
