Vibration Monitoring Assessment Report

771 Cudgen Road, Kingscliff NSW

DLT-01-Q1013 / VIB4 / v1.1f
9th December 2019

Delta Group are undertaking Earthworks for the Tweed Valley Hospital Project located at 771 Cudgen Road, Kingscliff NSW, hereafter referred to as 'the Site'. The Site was previously agricultural land and excavation works were on going during November 2019.

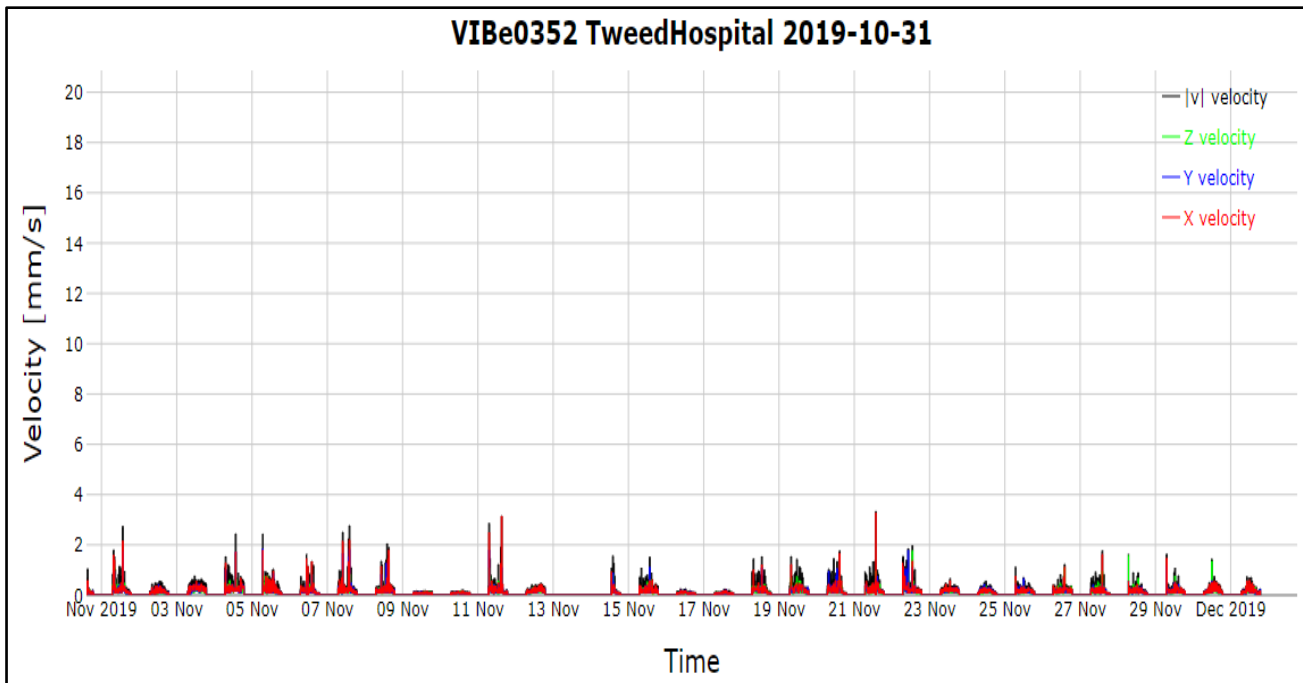
Figure 2. Results of the vibration monitoring from 1st November 2019 to 30th November 2019 at monitoring location 001 – Adjacent carpark.

- Results from vibration monitoring undertaken during the monitoring periods were **below** the threshold PVV value determined by DIN 4150 for the duration of this monitoring period;
- The peak vibration results were below the adopted threshold of 20 mm/s; and
- The effects of vibration at the levels seen through November would have little to no effect on the neighbouring properties.

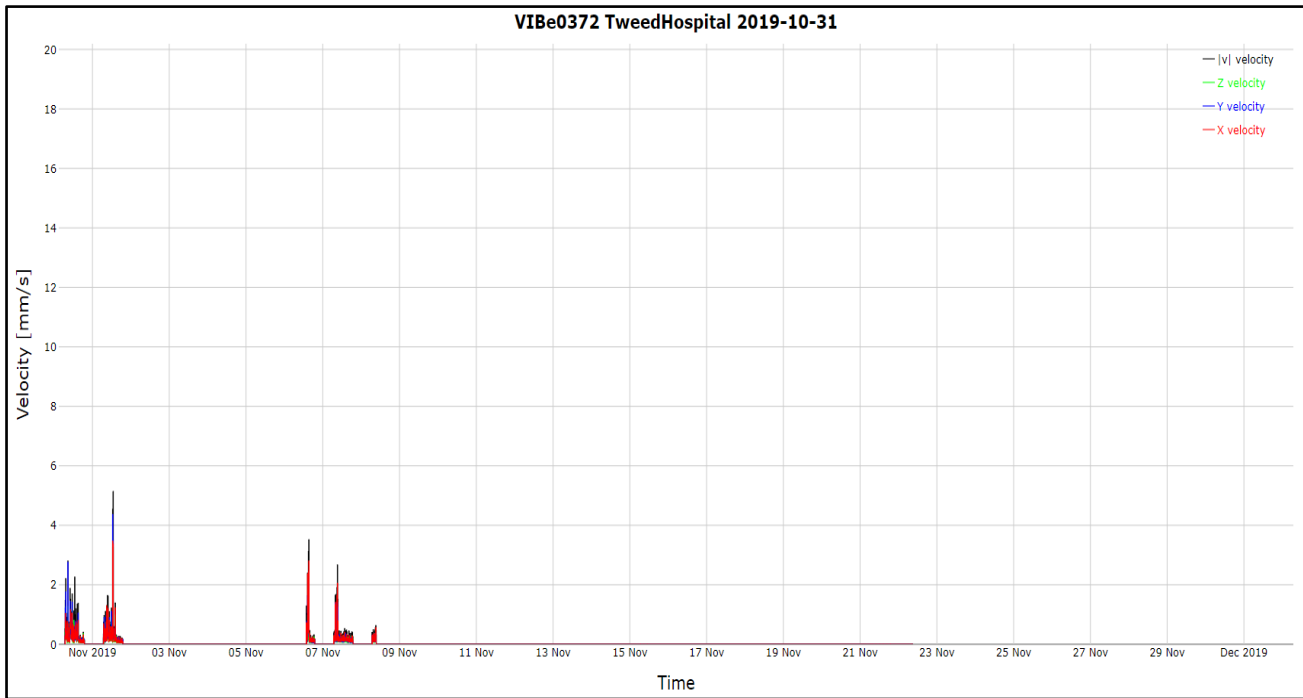
Figure 4. Results of the vibration monitoring from 1st November 2019 to 7th November 2019 at monitoring location 003 – Eastern section of site.

*Note: No Data periods from the 3rd- 7th and 17th – 21st for the Eastern monitoring location are believed to be due to temperatures >60°C.

ADE has installed a new Vibration monitor at the eastern monitoring location on Friday the 8th of November 2019 due to a fault in the previous monitor believed to be caused by high temperatures. Figures 4 and 5 represent the two vibration monitors and the applicable monitoring period.

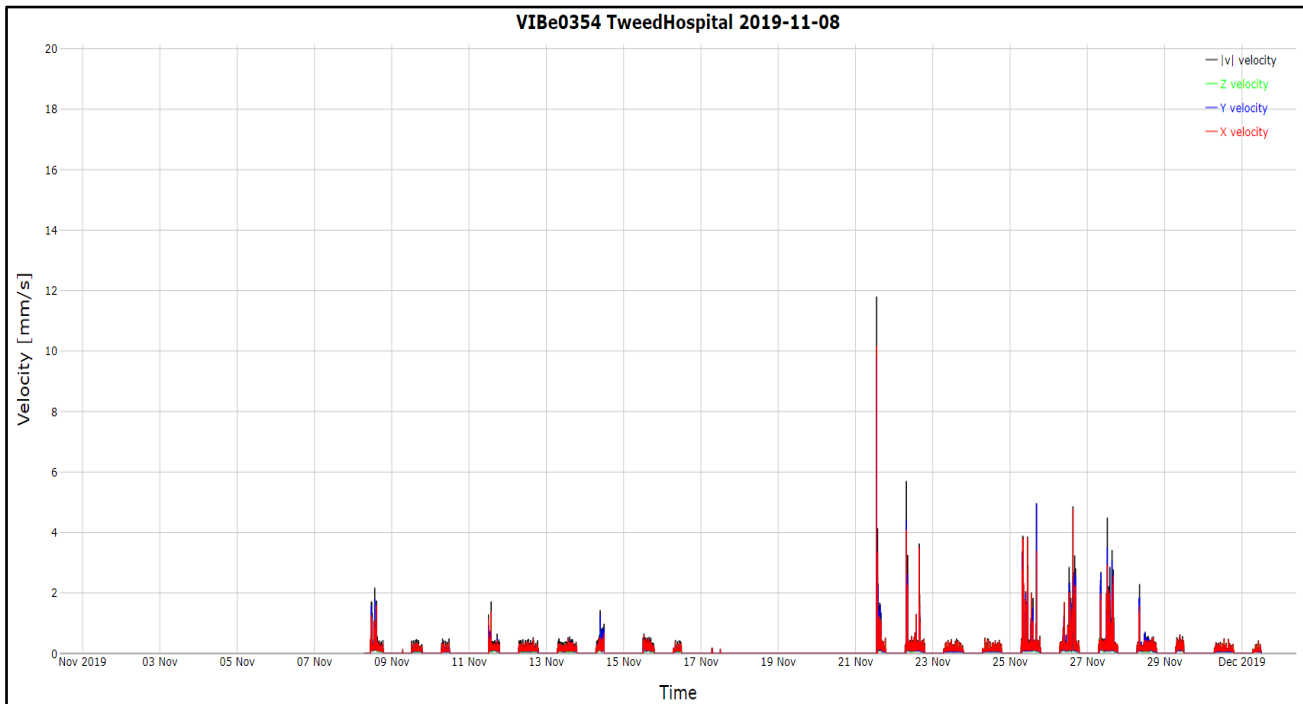
Figure 5. Results of the vibration monitoring from 8th November 2019 to 30th November 2019 at monitoring location 003 – Eastern section of site.

ADE site visits on the 21st of November 2019 had results >5mm/s as can be seen in Figures 3 and 5 of this report. The activities undertaken by ADE included manoeuvring within close proximity to the vibration sensors in the enclosure and replacing the vibration sensor in the eastern monitoring location. These values can be correlated with the peaks on these particular days (refer to *Appendix B – ADE Site Time Summary*).

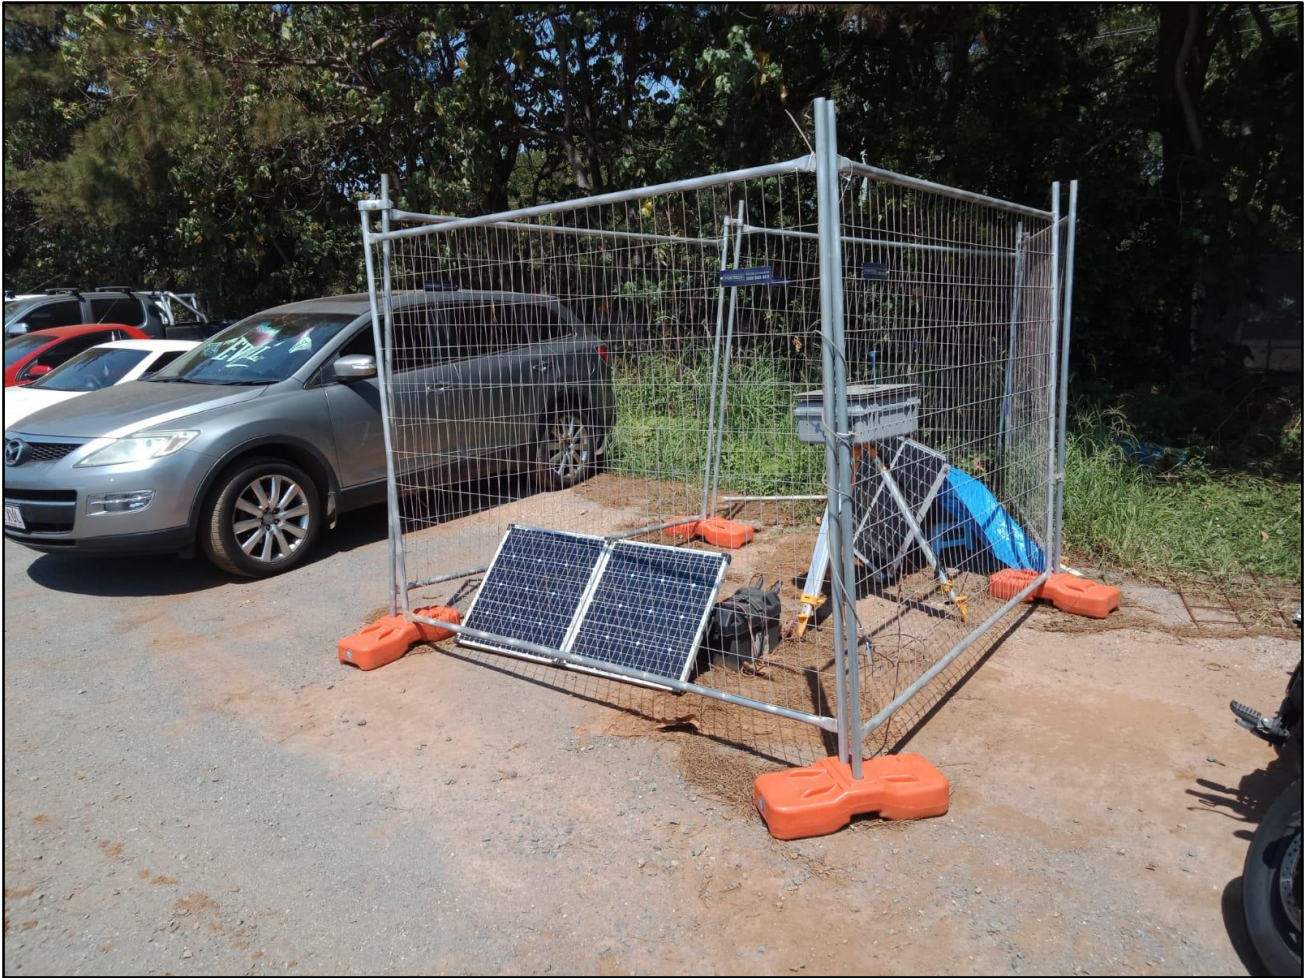
Photograph 1. Representative photo of the monitoring location 001 – adjacent carpark, as observed on the 04.12.2019

During ADEs site visit on the 4th of December, the cases that contain the vibration monitors were raised above the ground and covered with a tarp to aid in keeping temperatures below 60°C and ensure continuous monitoring.

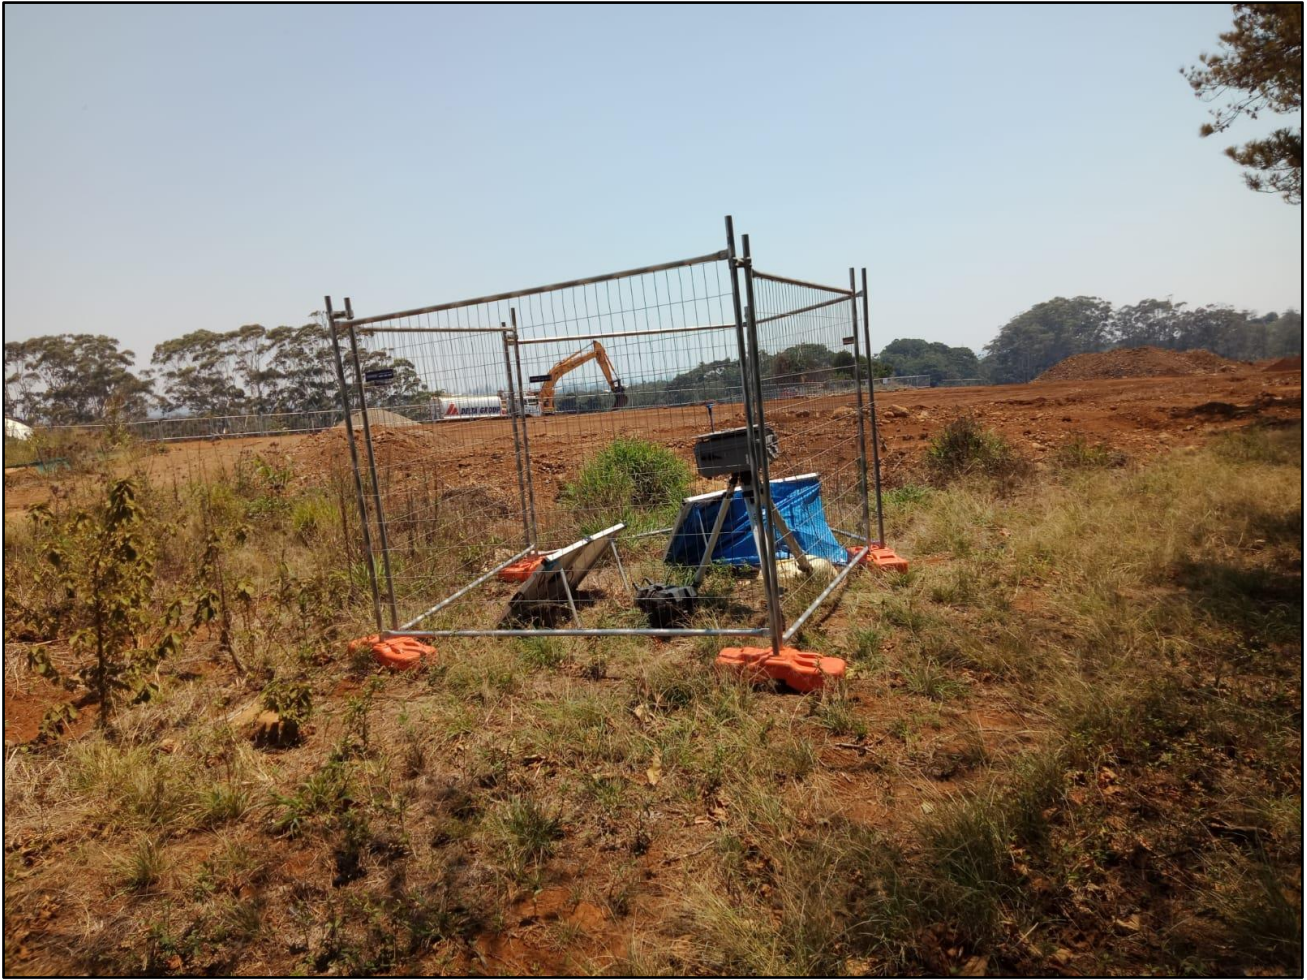
Photograph 2. Representative photo of the monitoring location 002 – central location, as observed on the 04.12.2019

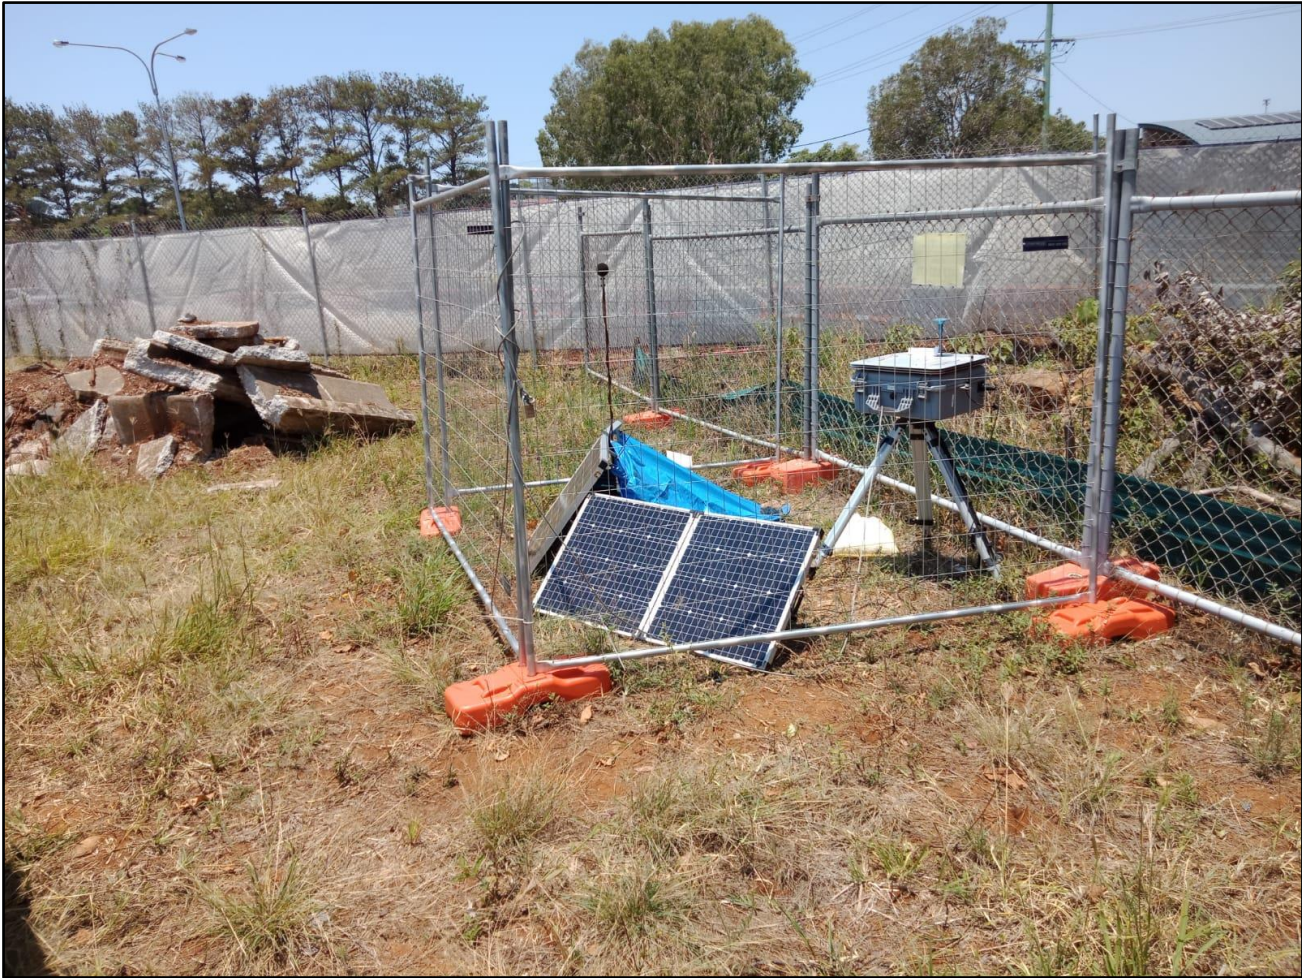
Photograph 3. Representative photo of the monitoring location 003 – eastern section of site, as observed on the 04.12.2019.

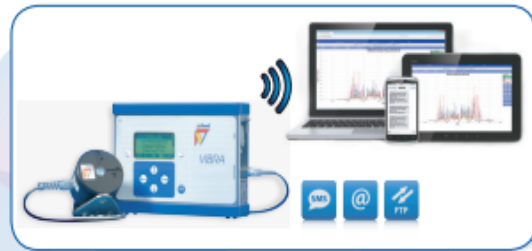
Profound VIBRA-series

The VIBRA's robust aluminium housing is IP65 watertight. The system is easily portable, lightweight and battery-operated which allows for up to 4 weeks of continuous and unmanned operation.

Setting up the system on site is easy: attach the 3-dimensional sensor to the structure to be monitored, switch on the system and start measuring. While measuring the VIBRA displays date, time, time interval and the current peak vibration values including frequency in all 3 directions. In advance an alarm level can be set.
