Environmental Dust Assessment Report (November 2021)

Tweed Valley Hospital Project, Cudgen NSW

Prepared for: Lendlease Building Pty Ltd

A101021.0286.00 | EDM28.Rev1 | Date: 20/12/2021

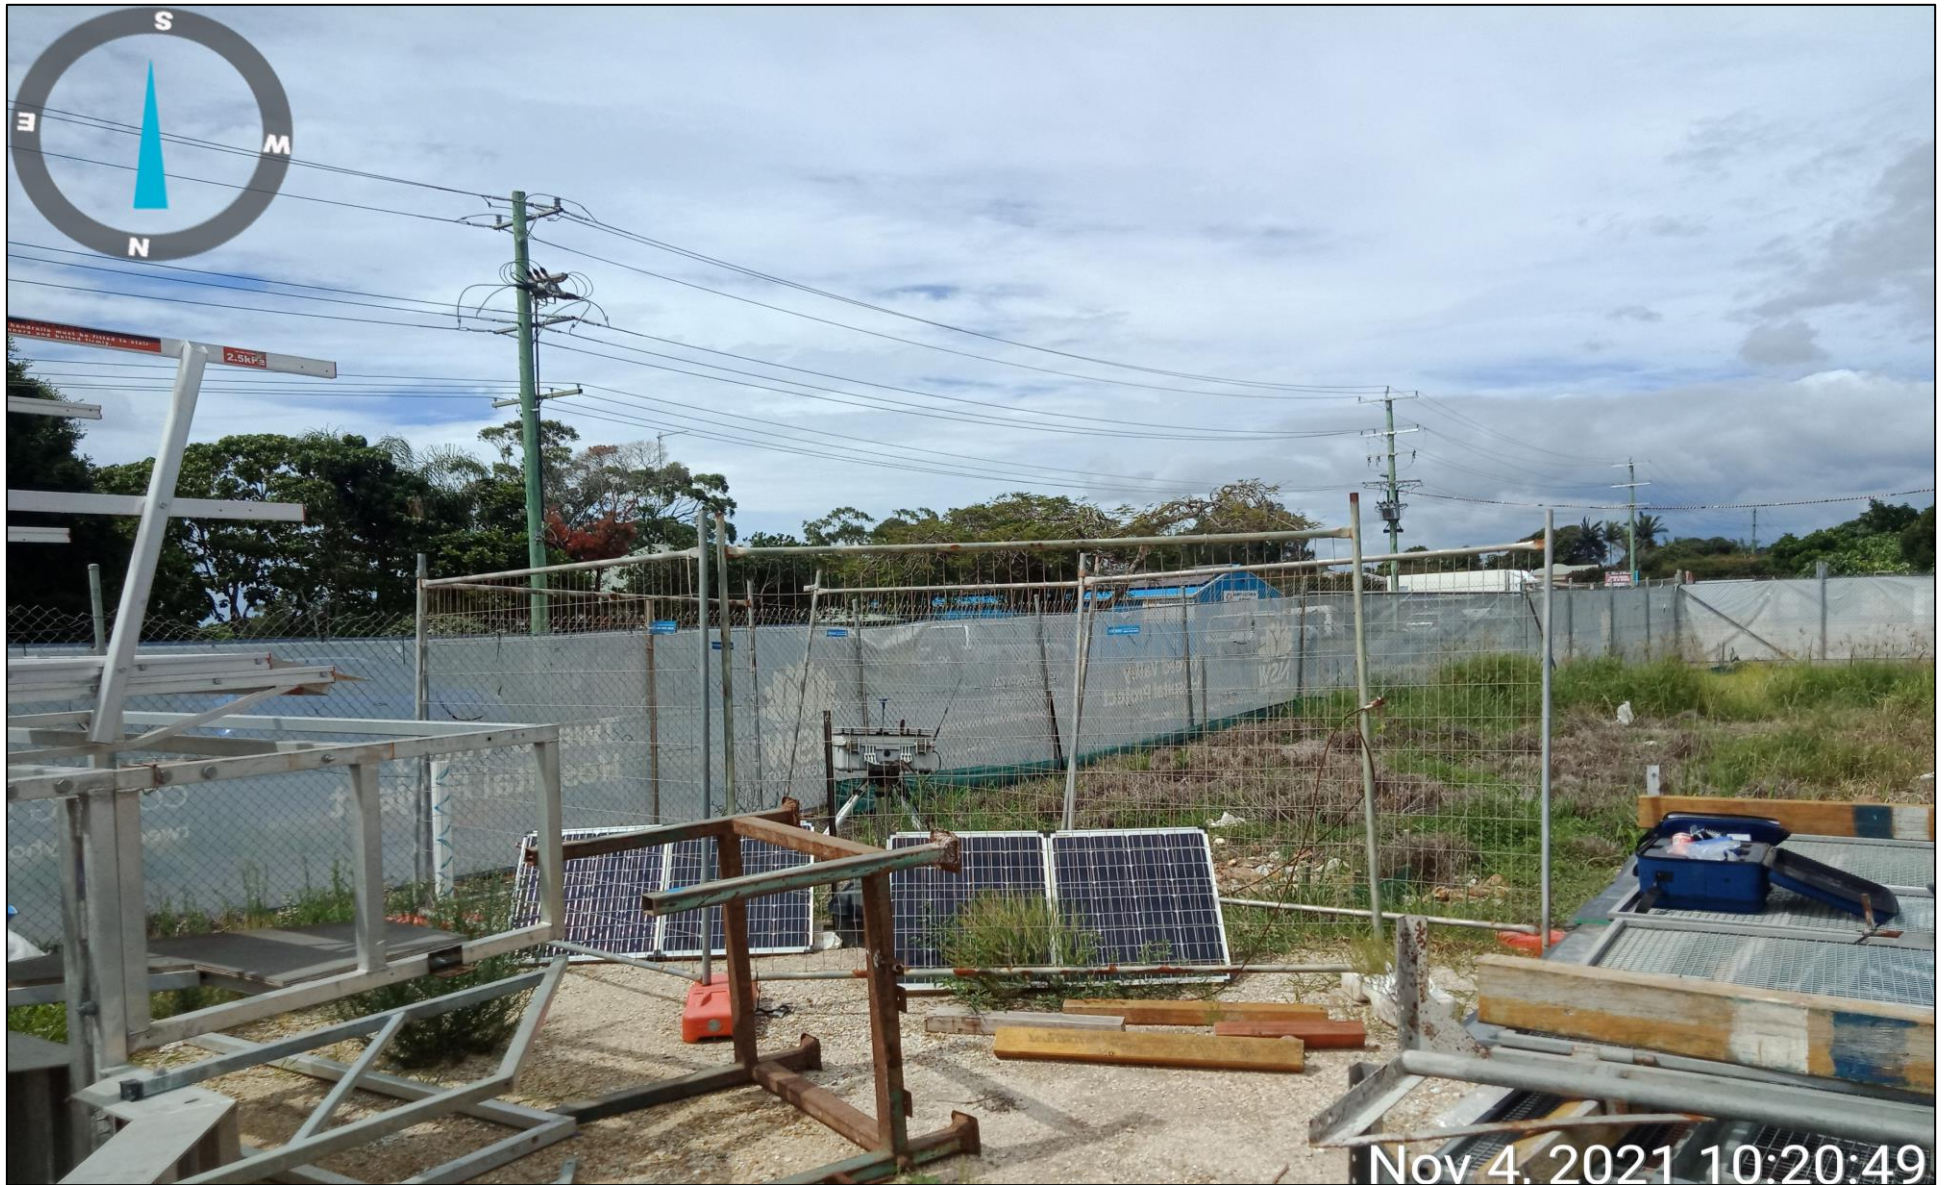
Photograph 1 Representative photograph of monitoring location 001 – Adjacent Carpark location, as observed 04/11/2021

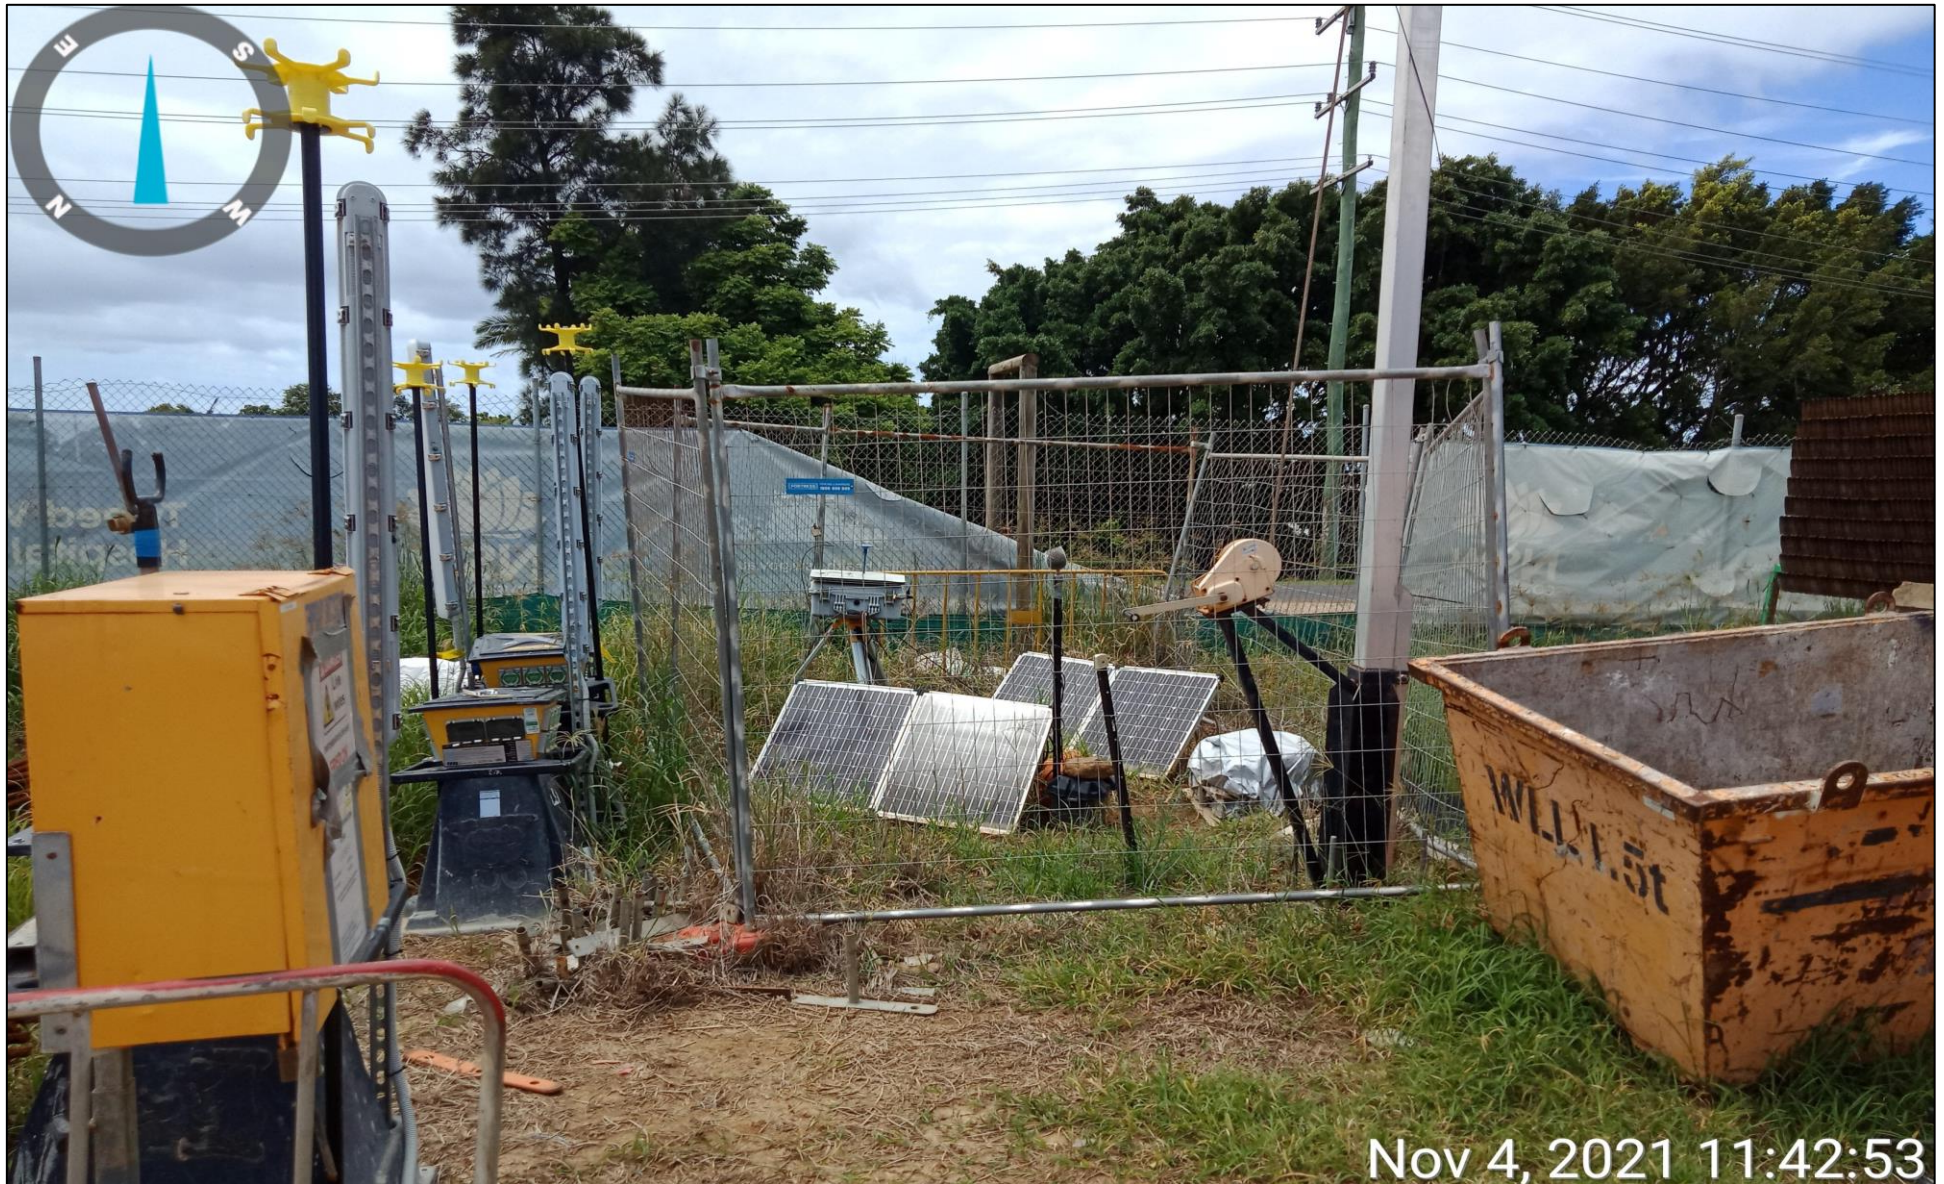
Photograph 2 Representative photograph of monitoring location 002 – Central location, as observed 04/11/2021

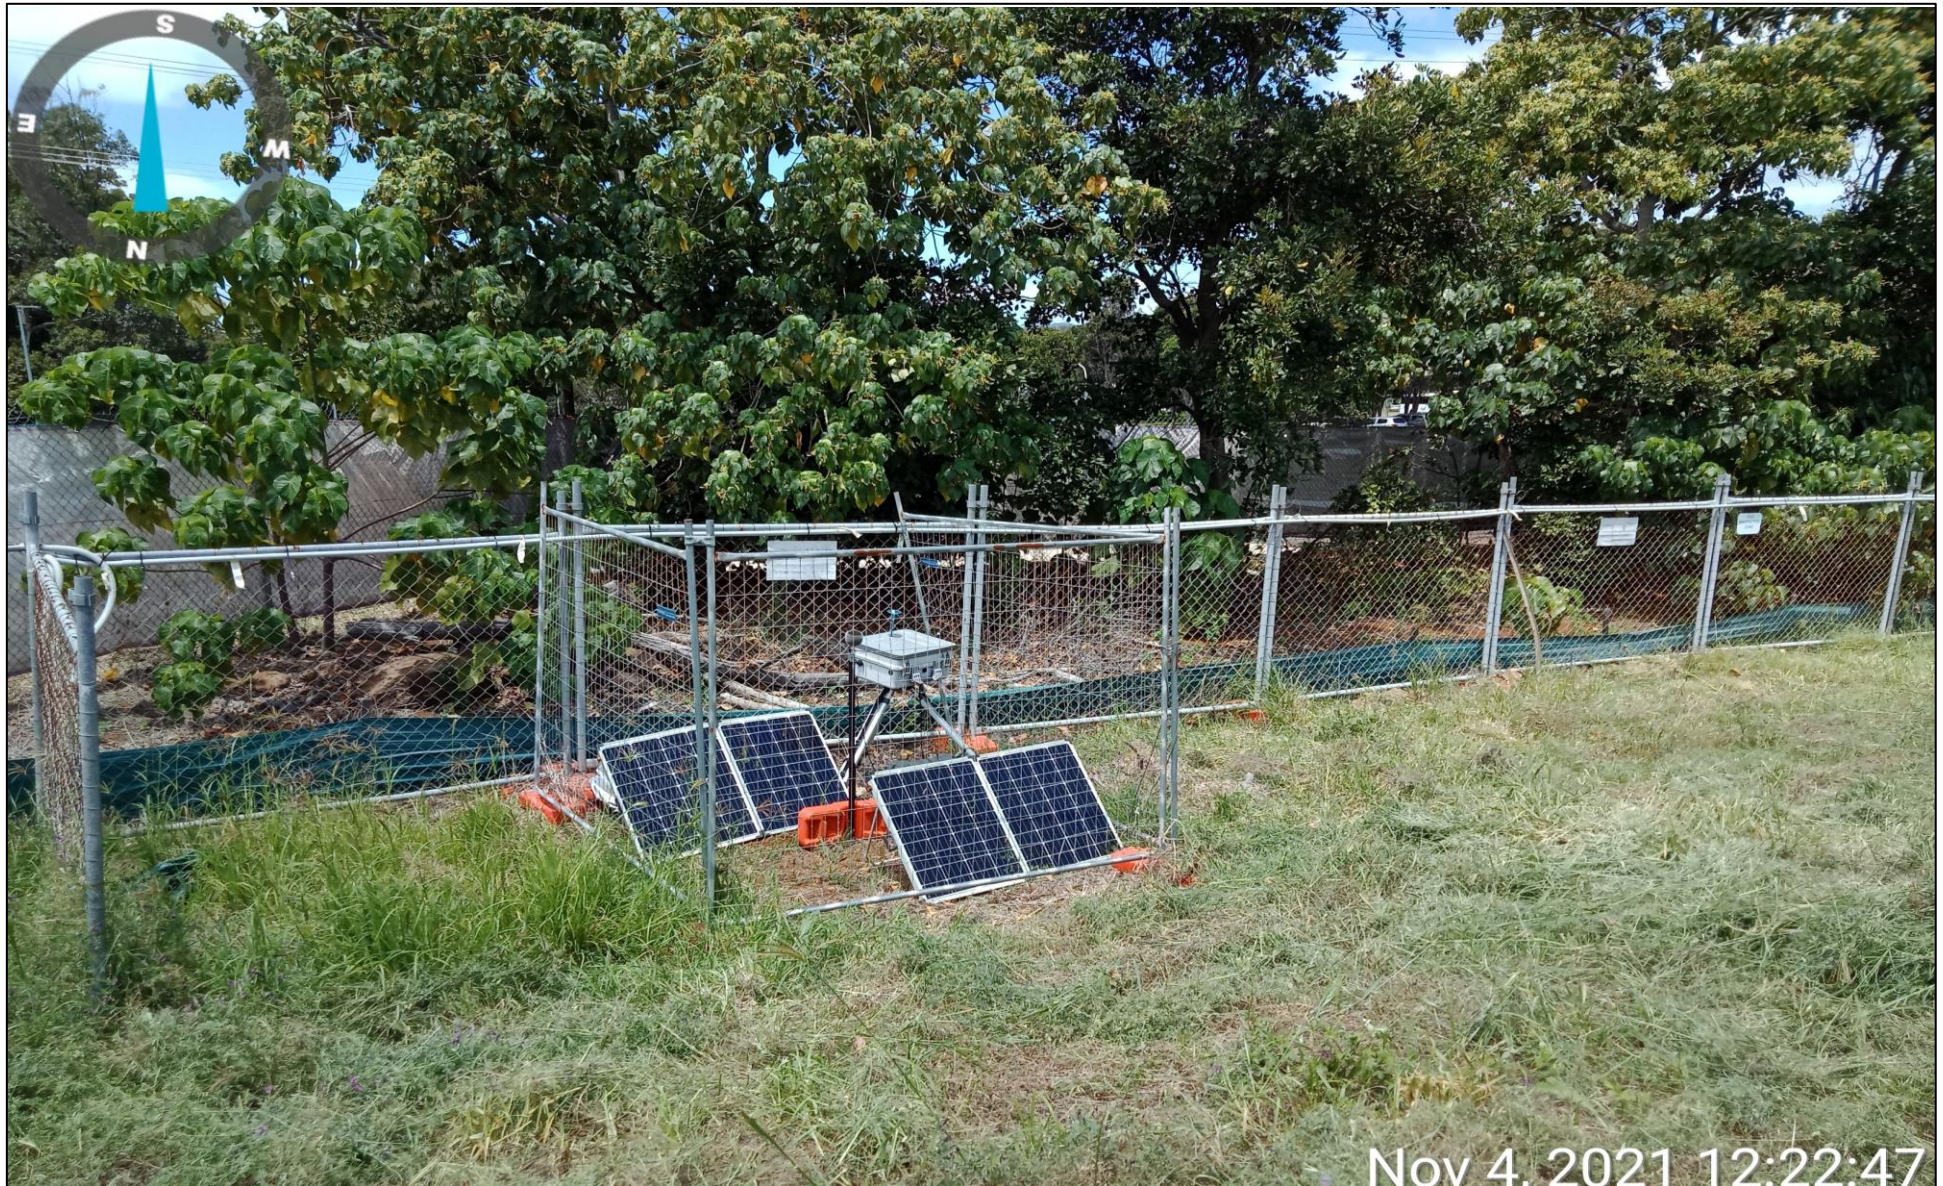
Photograph 3 Representative photograph of monitoring location 003 – Eastern Section of Site, as observed 04/11/2021
