# Environmental Dust Assessment Report (July 2021)

**Tweed Valley Hospital Project, Cudgen NSW**

LND-01-Q1299 | EDM24.V1.1F | Date: 23/08/2021

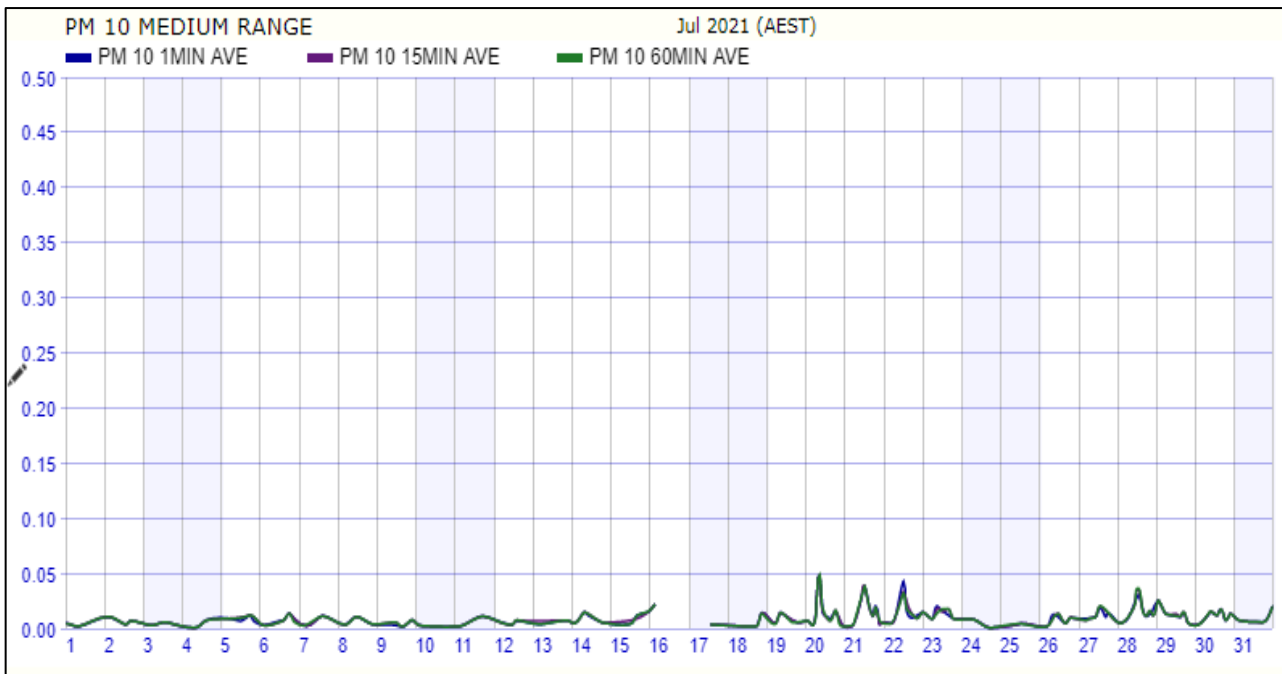
**Figure 2.** Summary of PM10 from the real time monitoring at location 002 – Central location for the month of July 2021.

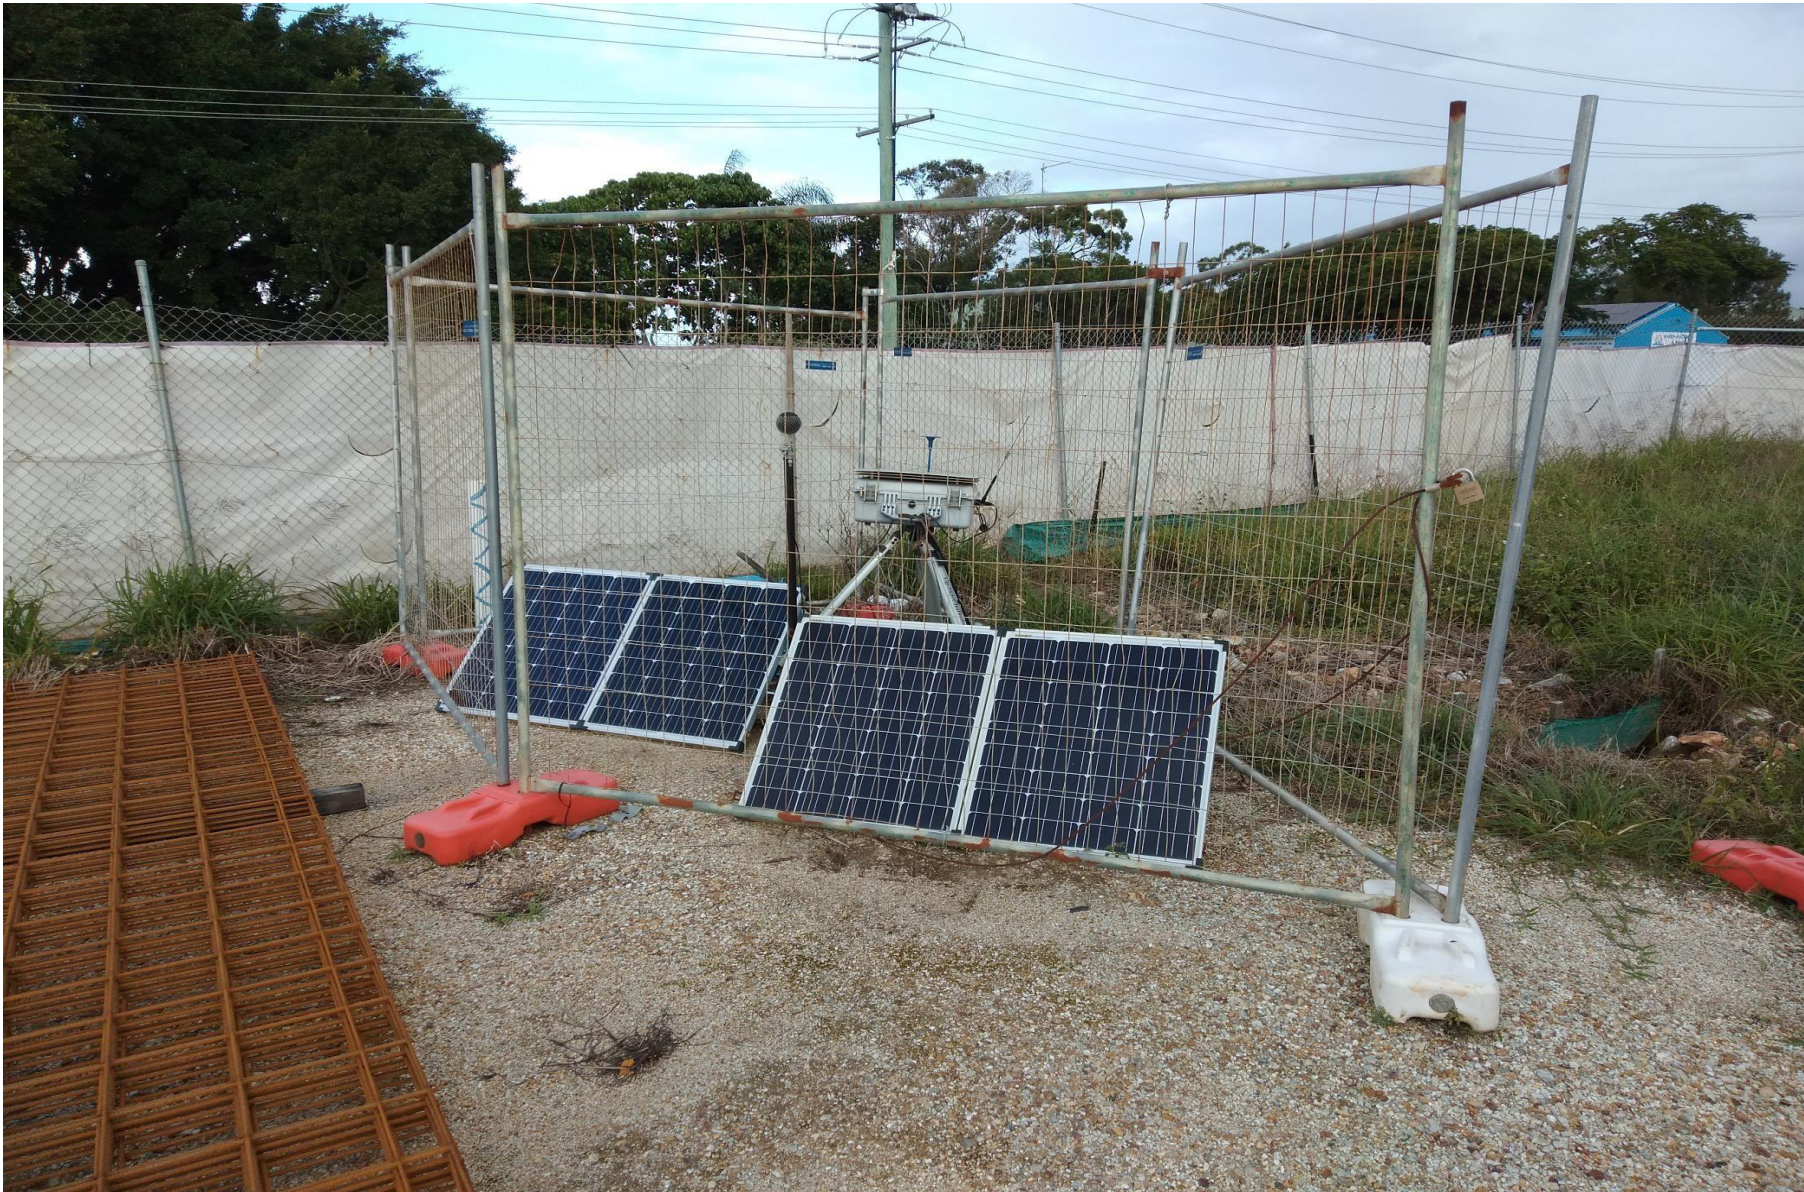
Photograph 1 Representative photograph of monitoring location 001 – Adjacent Carpark location, as observed 02/07/2021

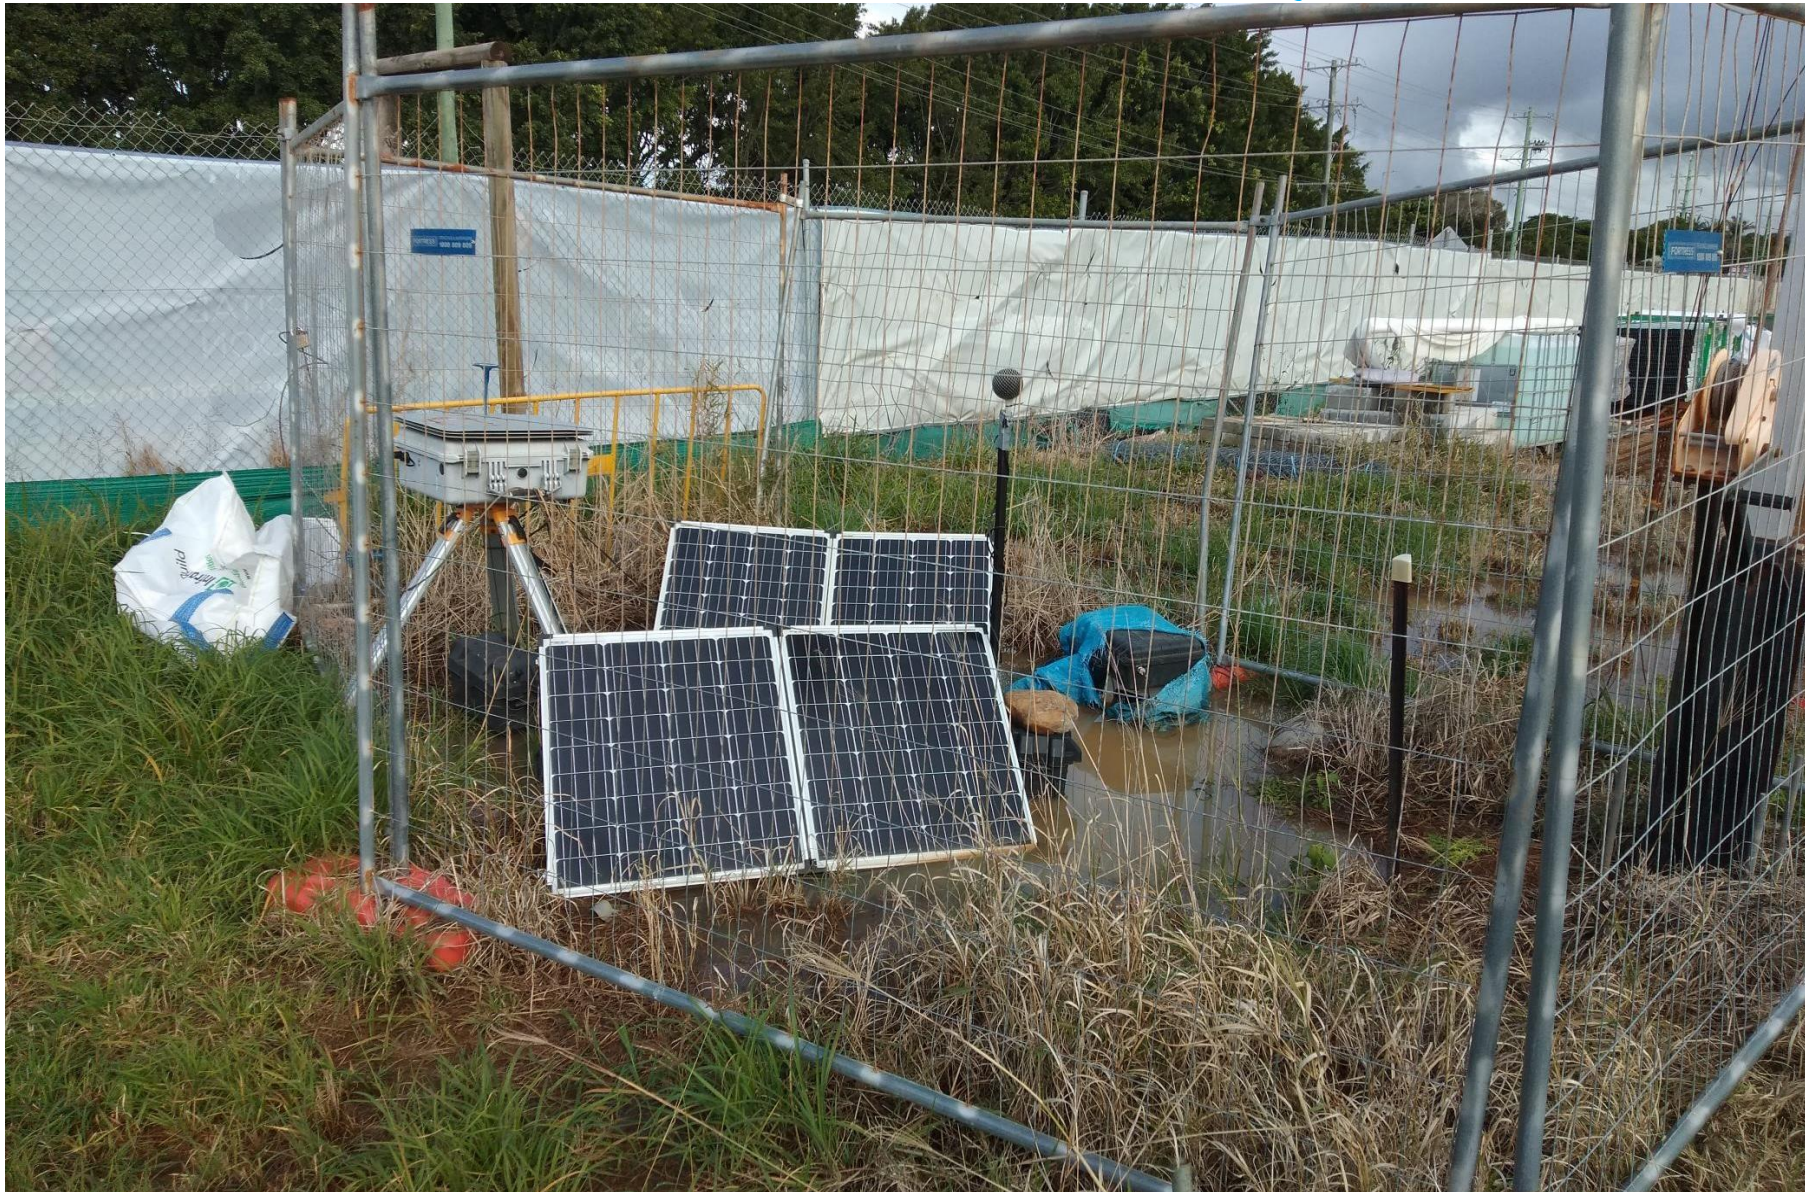
Photograph 2 Representative photograph of monitoring location 002 – Central location, as observed 02/07/2021

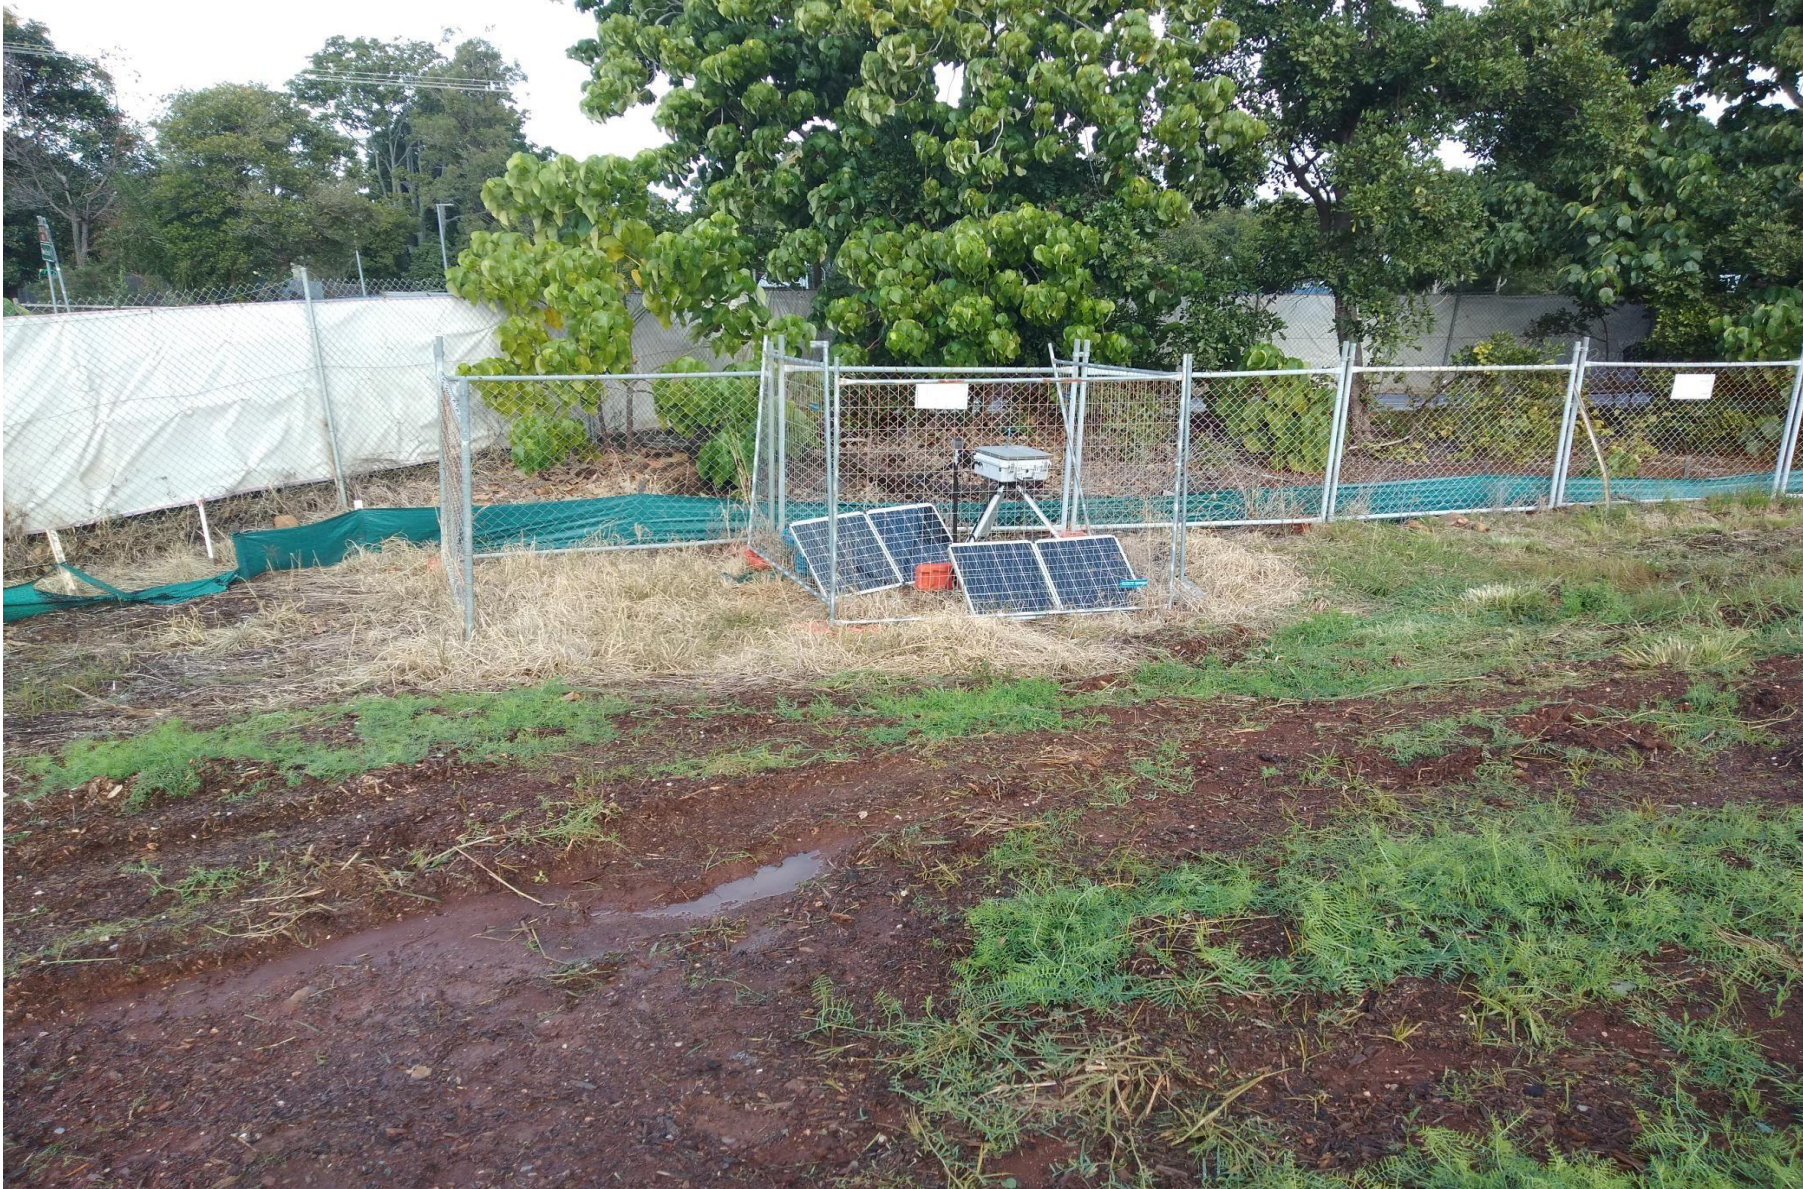
Photograph 3 Representative photograph of monitoring location 003 – Eastern Section of Site, as observed 02/07/2021
