# Vibration Monitoring Assessment Report (August 2021)

**Tweed Valley Hospital Project, Cudgen NSW**

Prepared for: Lendlease Building Pty Ltd

LND-01-Q1299 | VIB25.V1F | Date: 10/09/2021

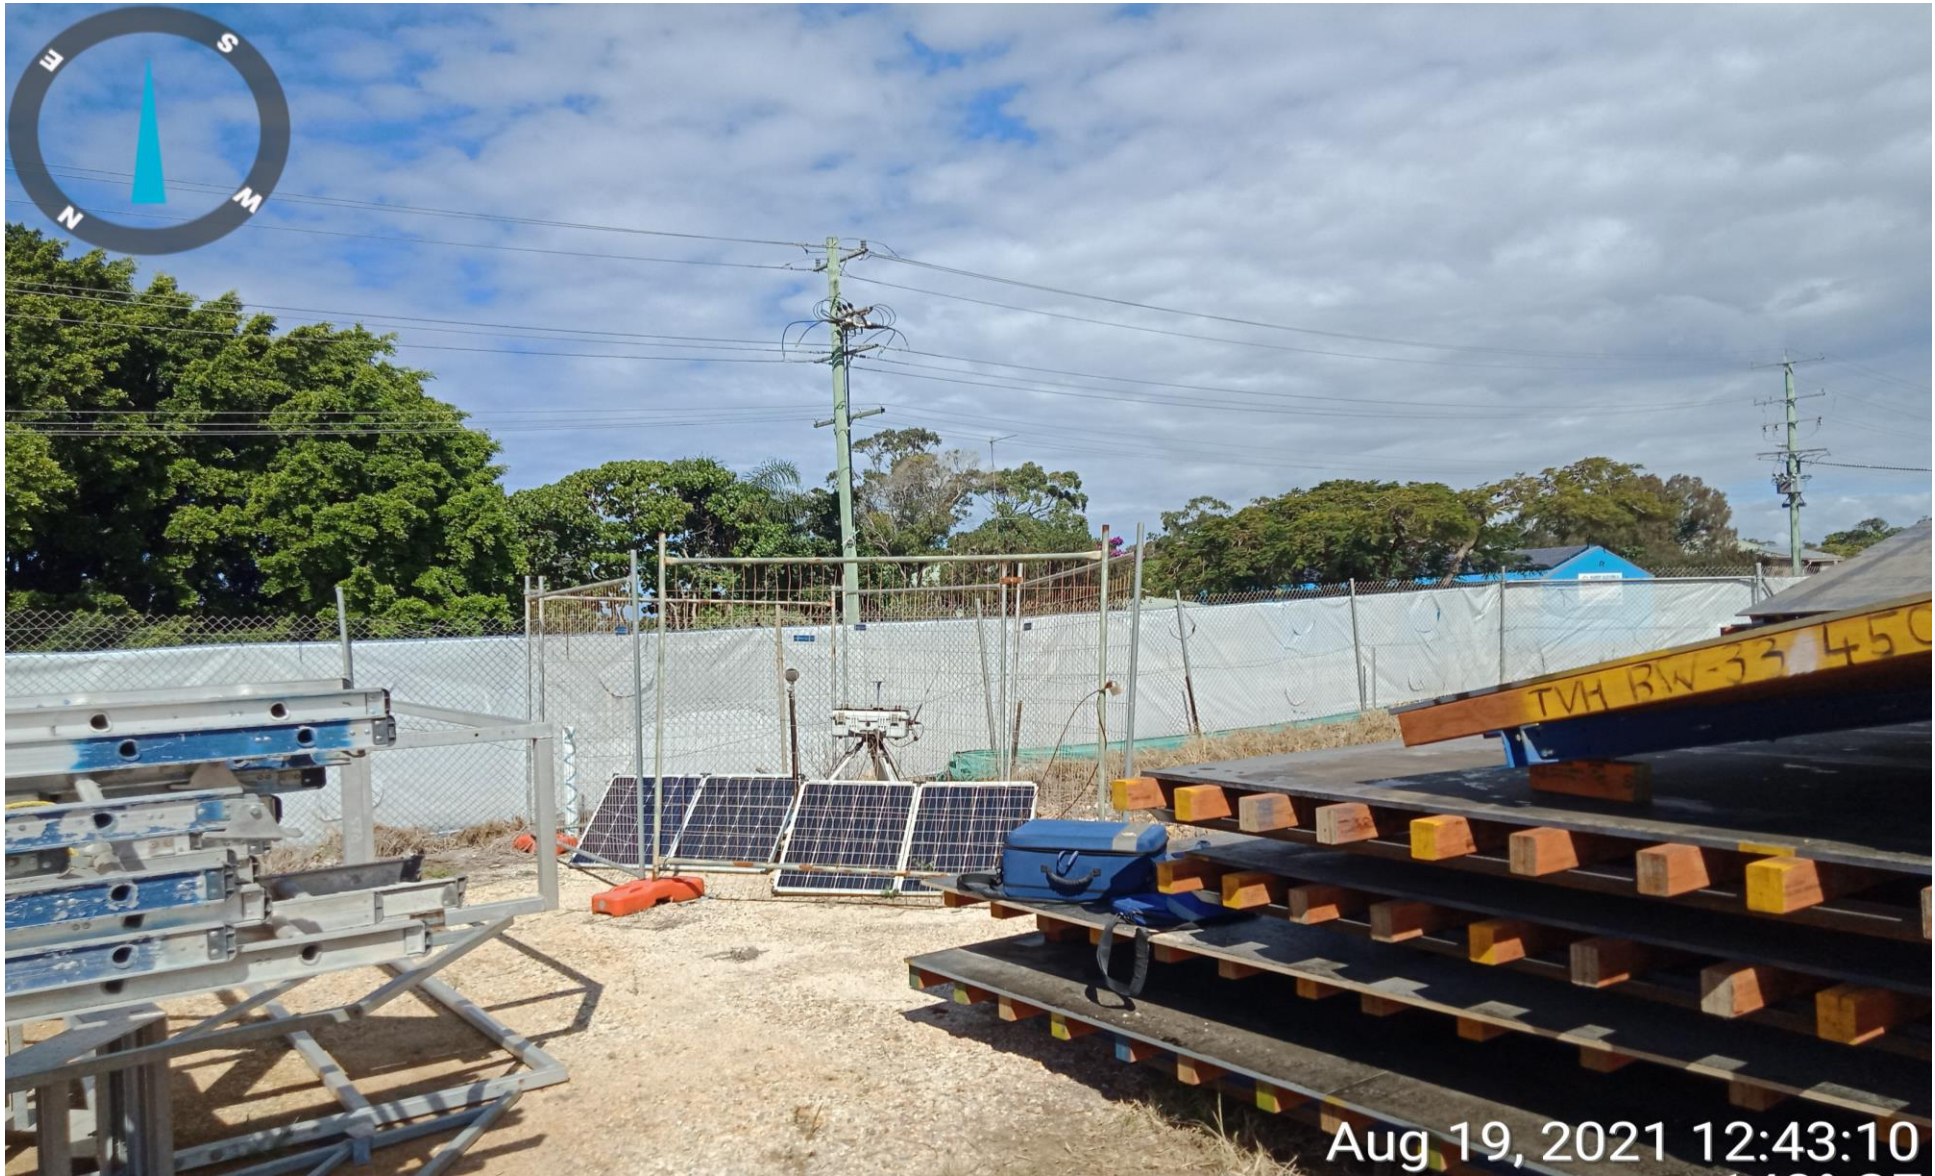
Photograph 1 Representative photograph of monitoring location 001 – Adjacent Carpark location, as observed 19/08/2021

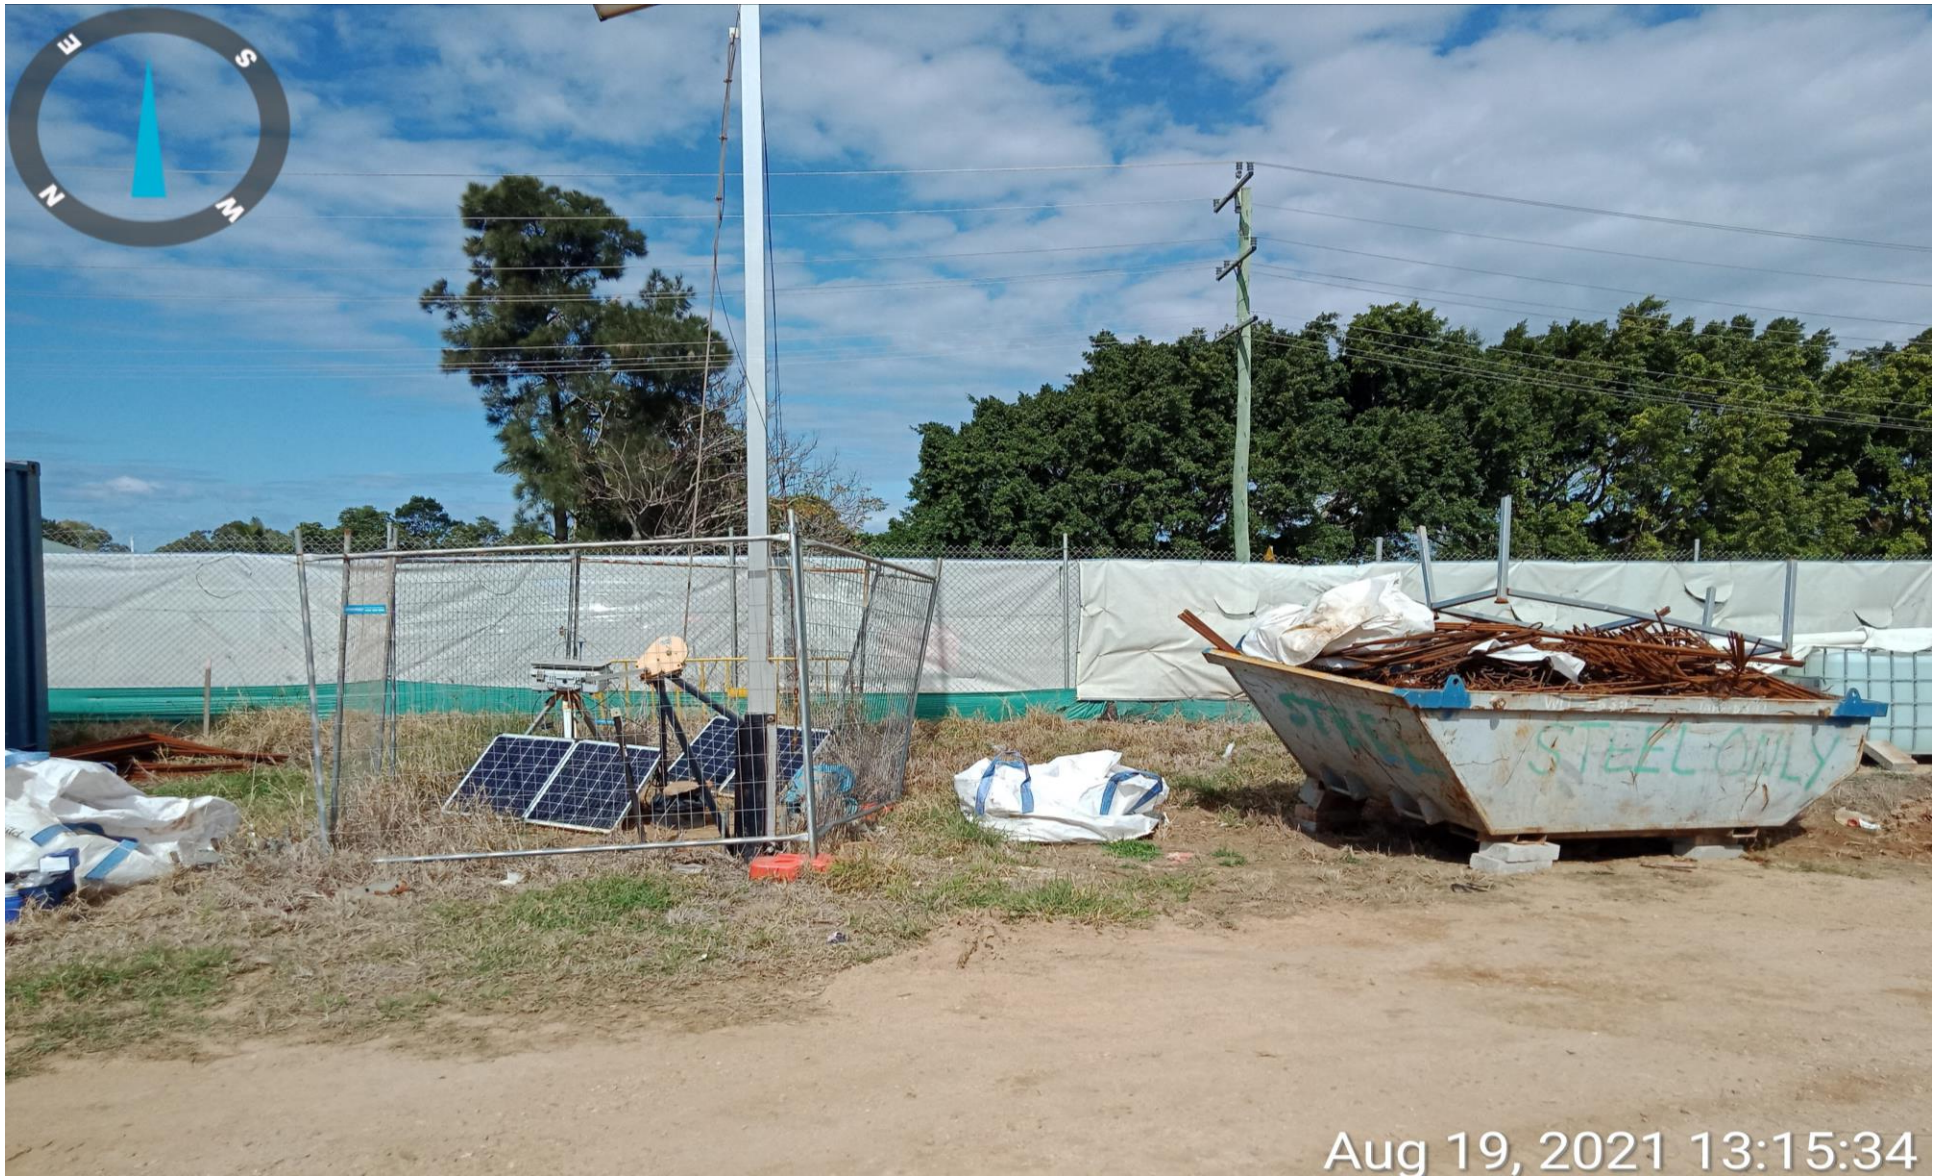
Photograph 2 Representative photograph of monitoring location 002 – Central location, as observed 19/08/2021

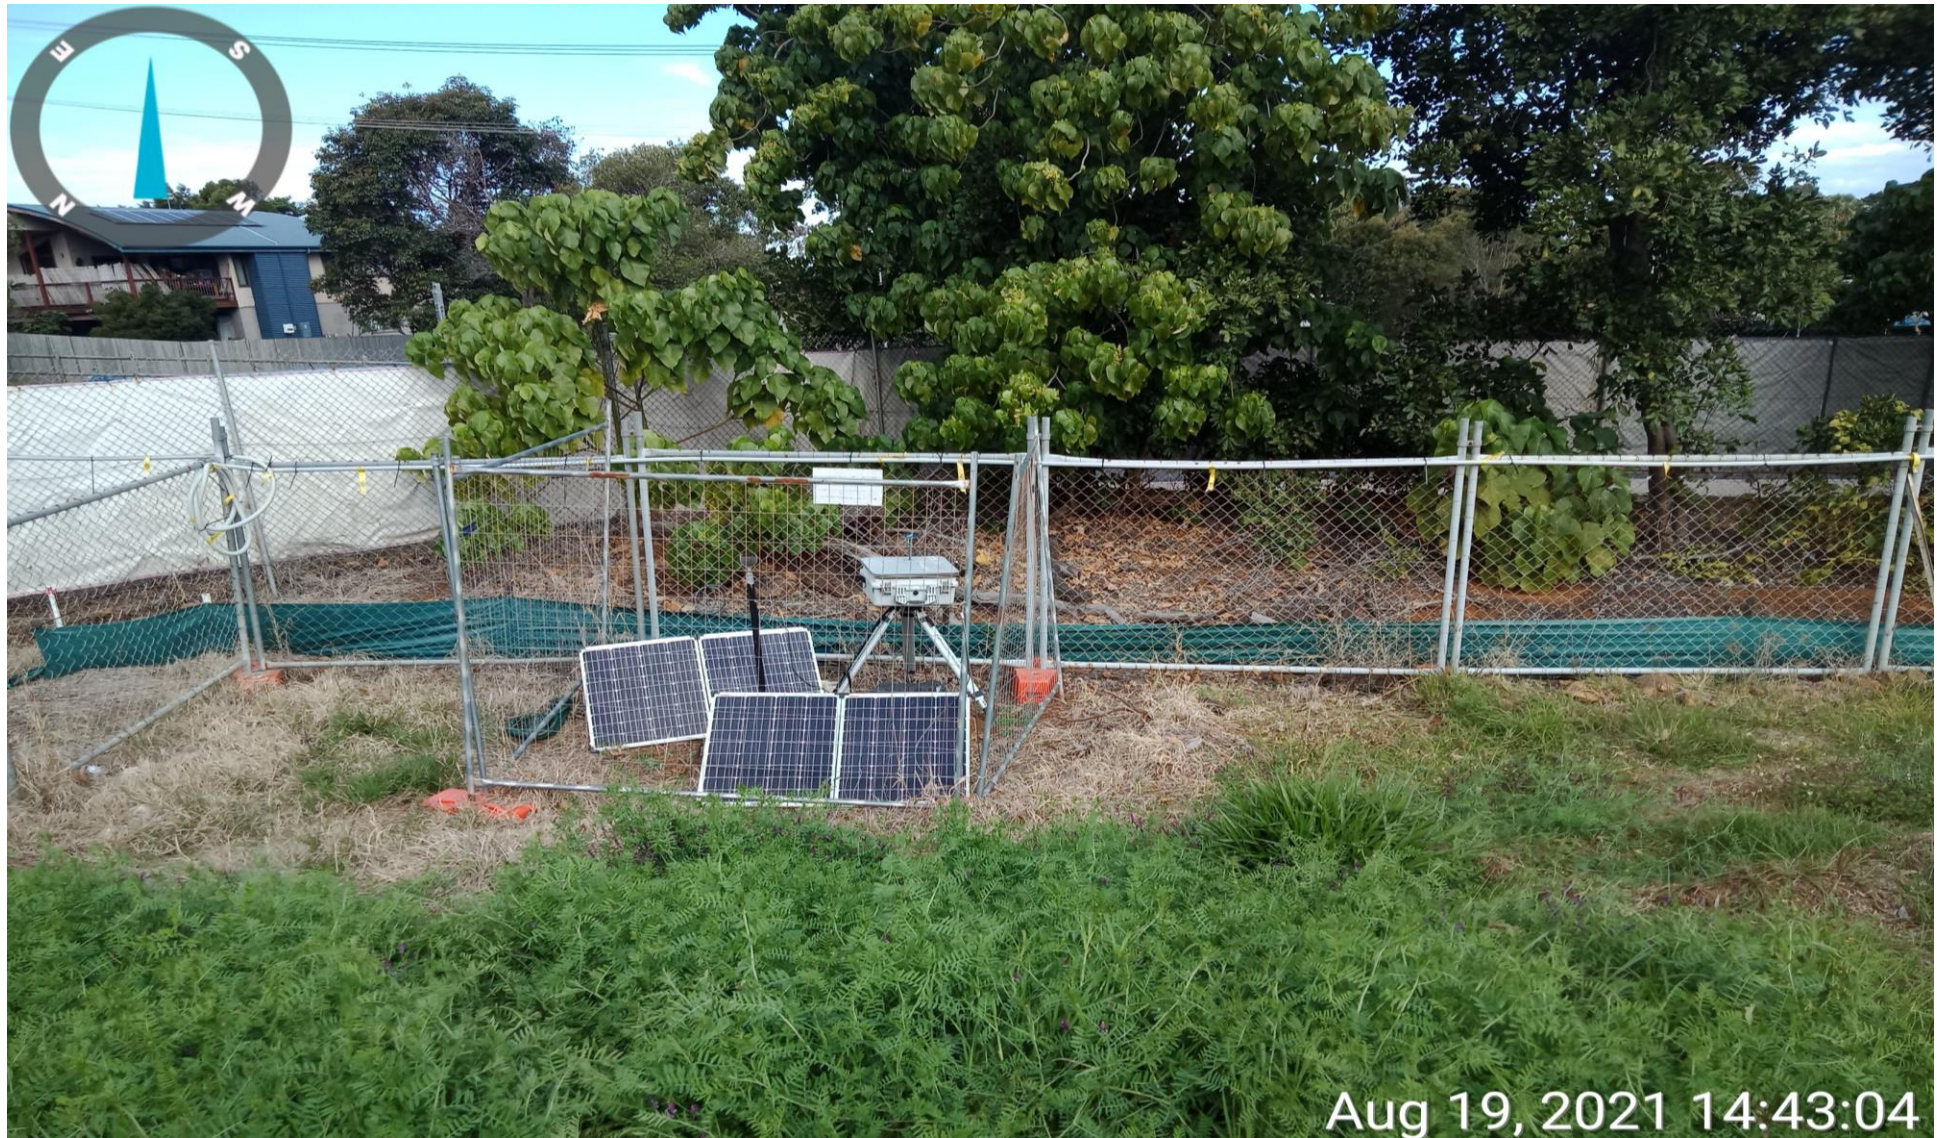
Photograph 3 Representative photograph of monitoring location 003 – Eastern Section of Site, as observed 19/08/2021
