# **Environmental Dust Assessment Report (January 2021)**

**Tweed Valley Hospital Project, Kingscliff NSW**

LND-01-Q1299 | EDM18.V1F | Date: 10/02/2021

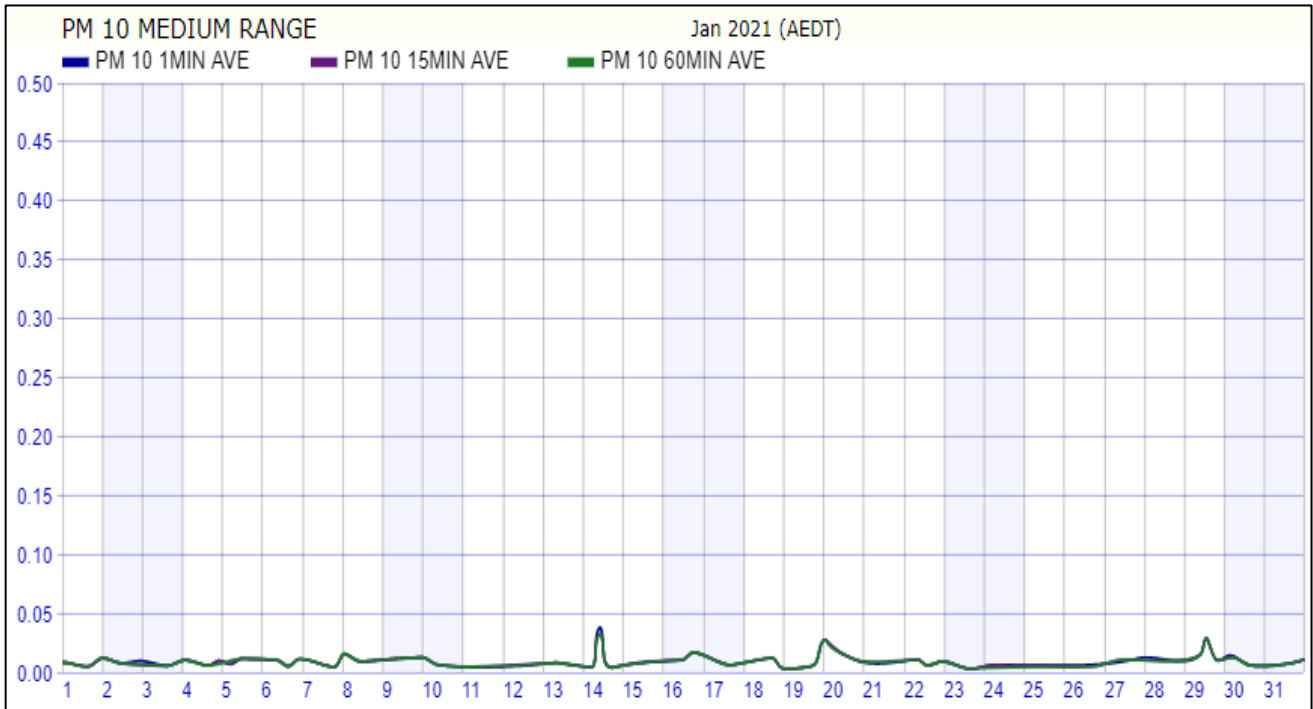
**Figure 1.** Summary of PM10 from the real time monitoring at location 001 – Adjacent the carpark for the month of January 2021.

Ensure adequate dust control measures continue to be implemented as per the Tweed Valley Hospital Management Plan – Air Quality and continue monitoring of PM<sub>10</sub> for the duration of the project. If the action limit of 2.5 mg/m<sup>3</sup> (8-hour time weighted average) is exceeded, cease works and review and implement additional dust prevention techniques.

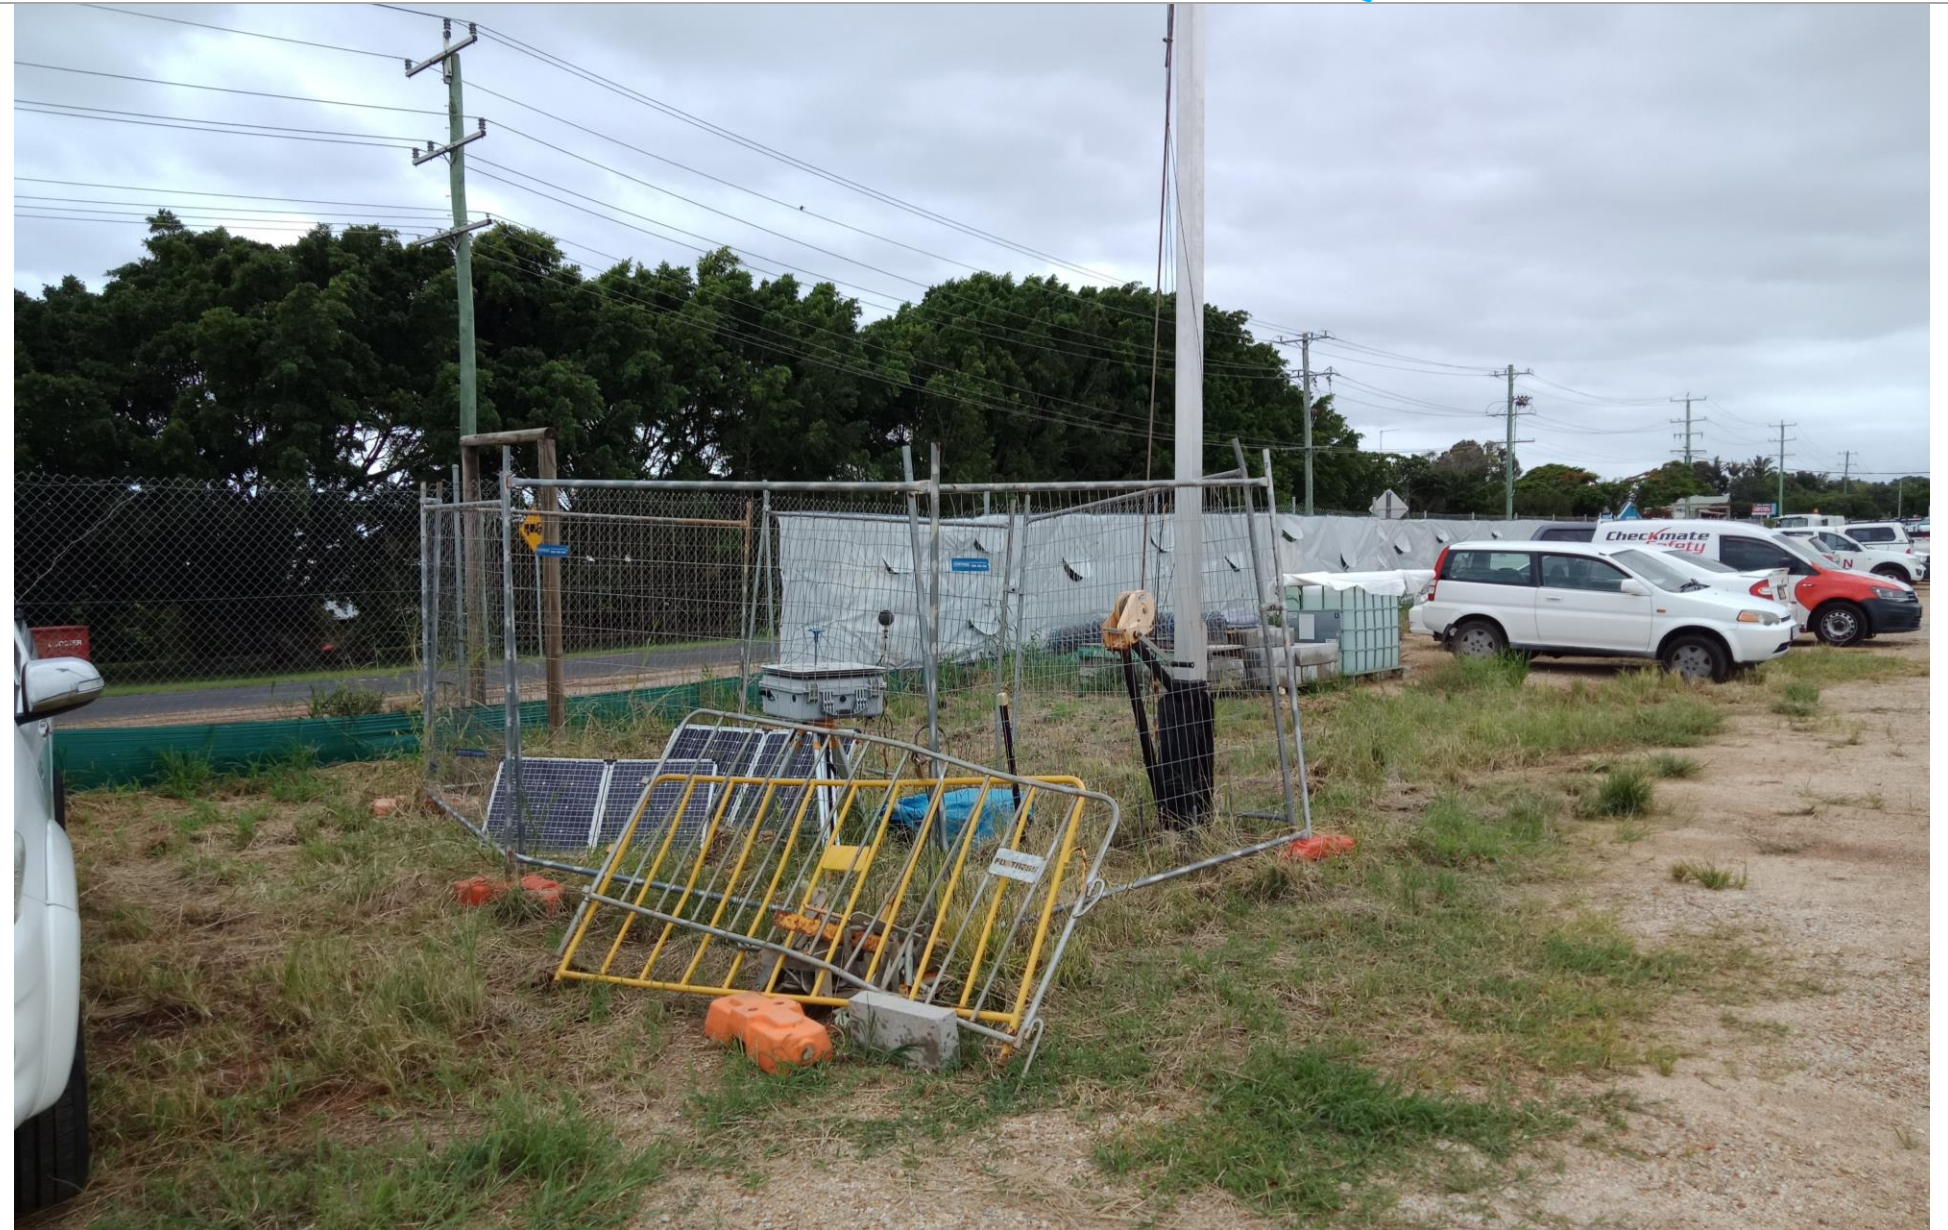
Photograph 2. Representative photograph of monitoring location 002 – Central location, as observed 21 January 2021.

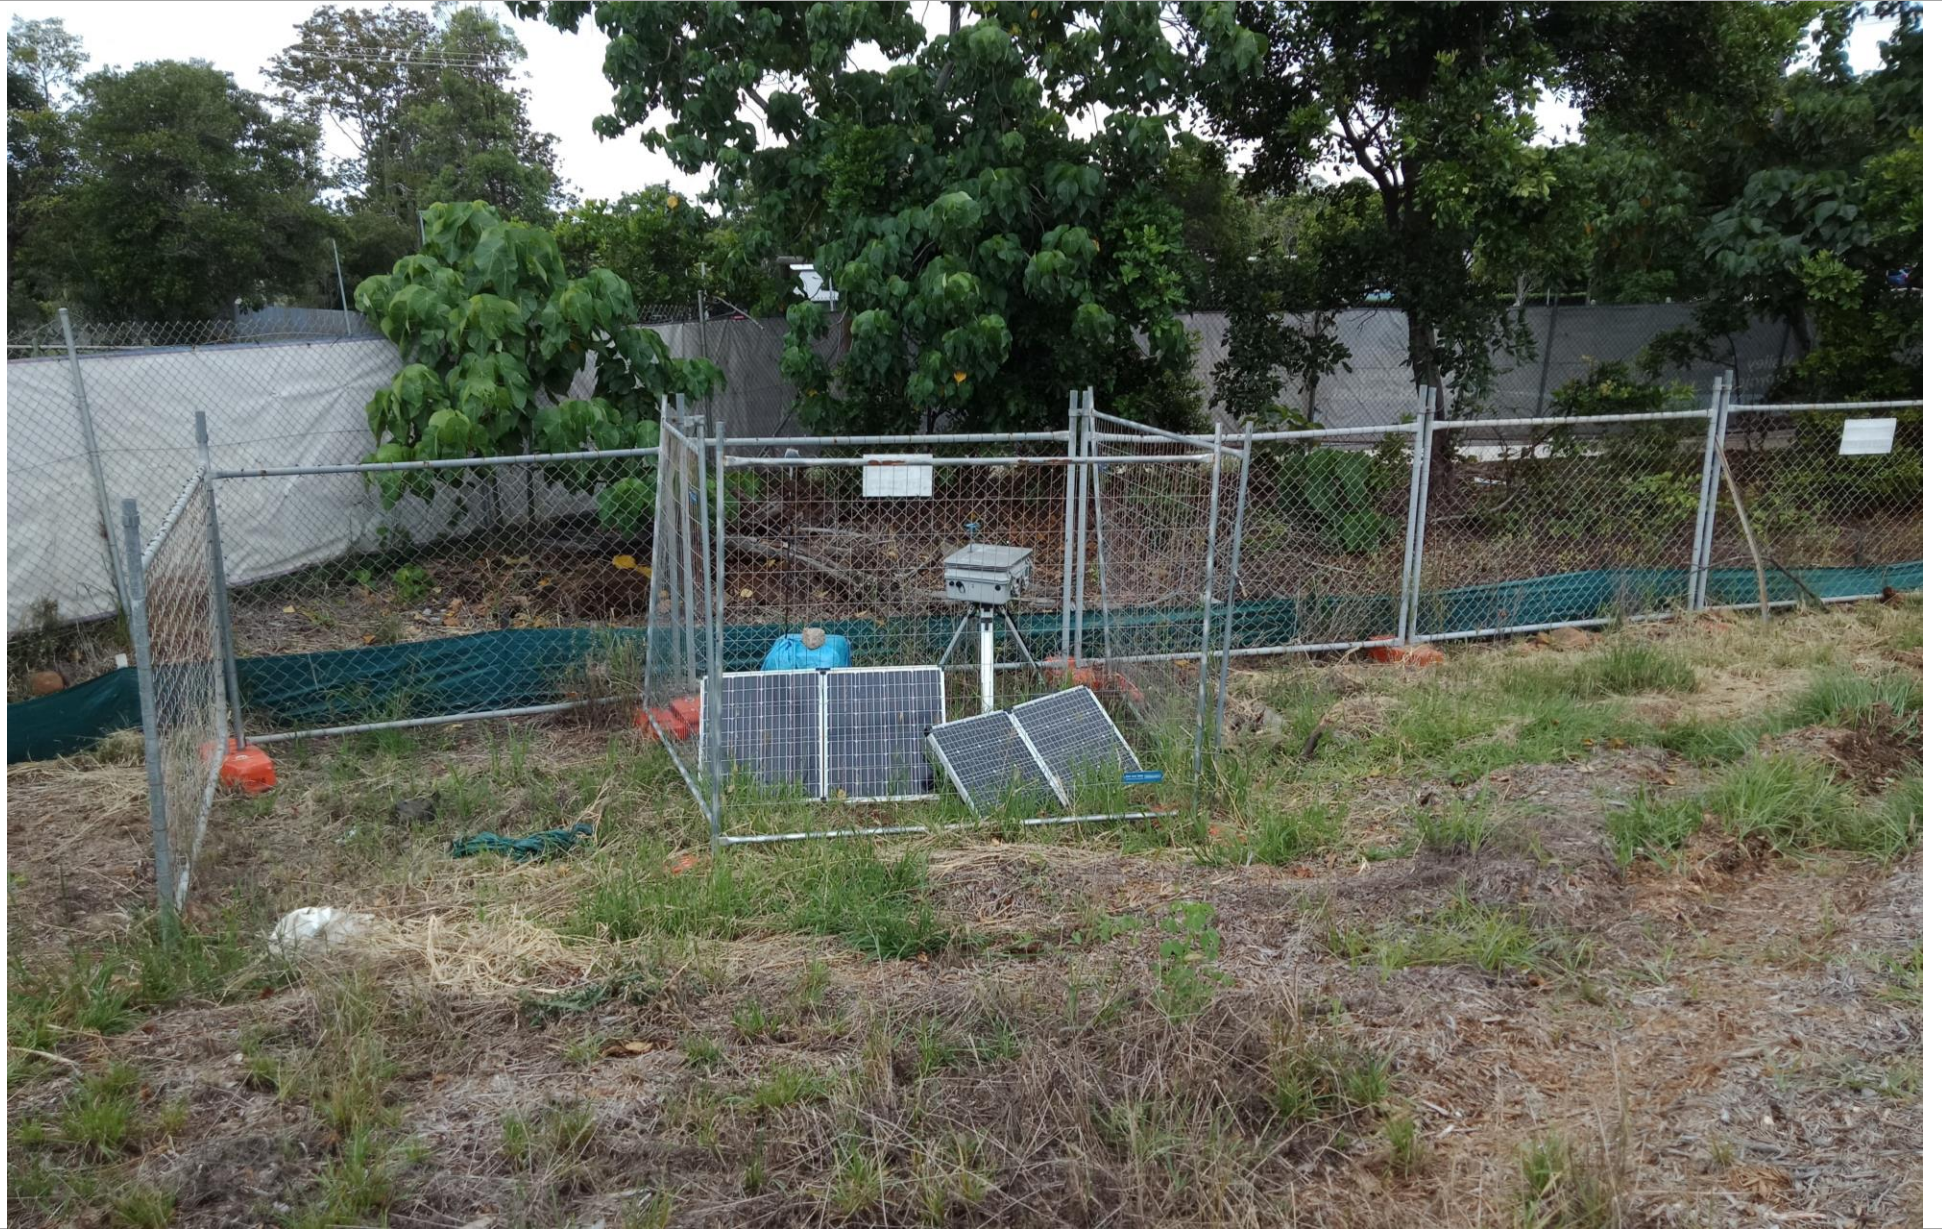
Photograph 3. Representative photograph of monitoring location 003 – Eastern Section of Site, as observed 21 January 2021.
