# Environmental Dust Assessment Report (February 2021)

**Tweed Valley Hospital Project, Kingscliff NSW**

Prepared for: Lendlease Group

LND-01-Q1299 | EDM19.V1F | Date: 17/03/2021

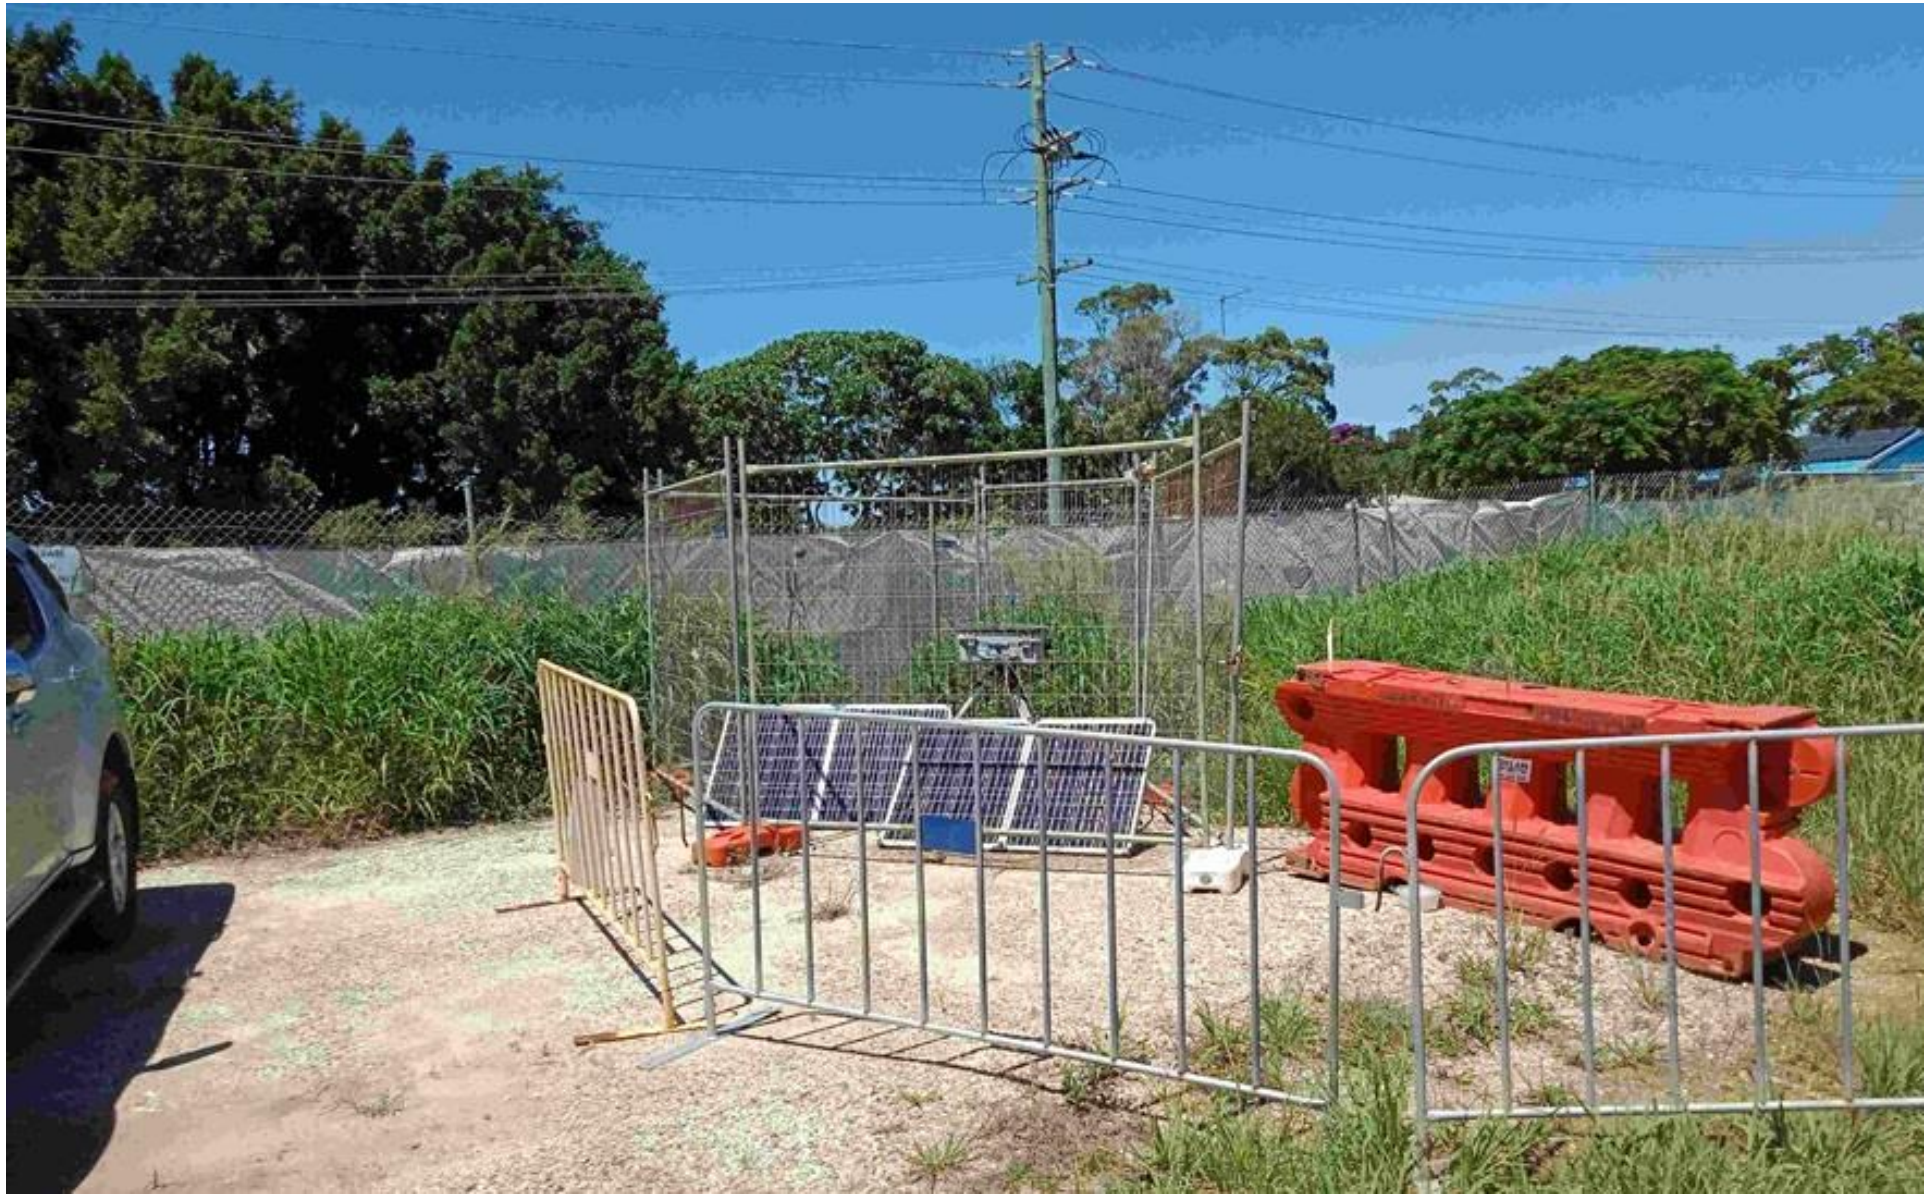
Photograph 1. Representative photograph of monitoring location 001 – Adjacent Carpark location, as observed 22/02/21.

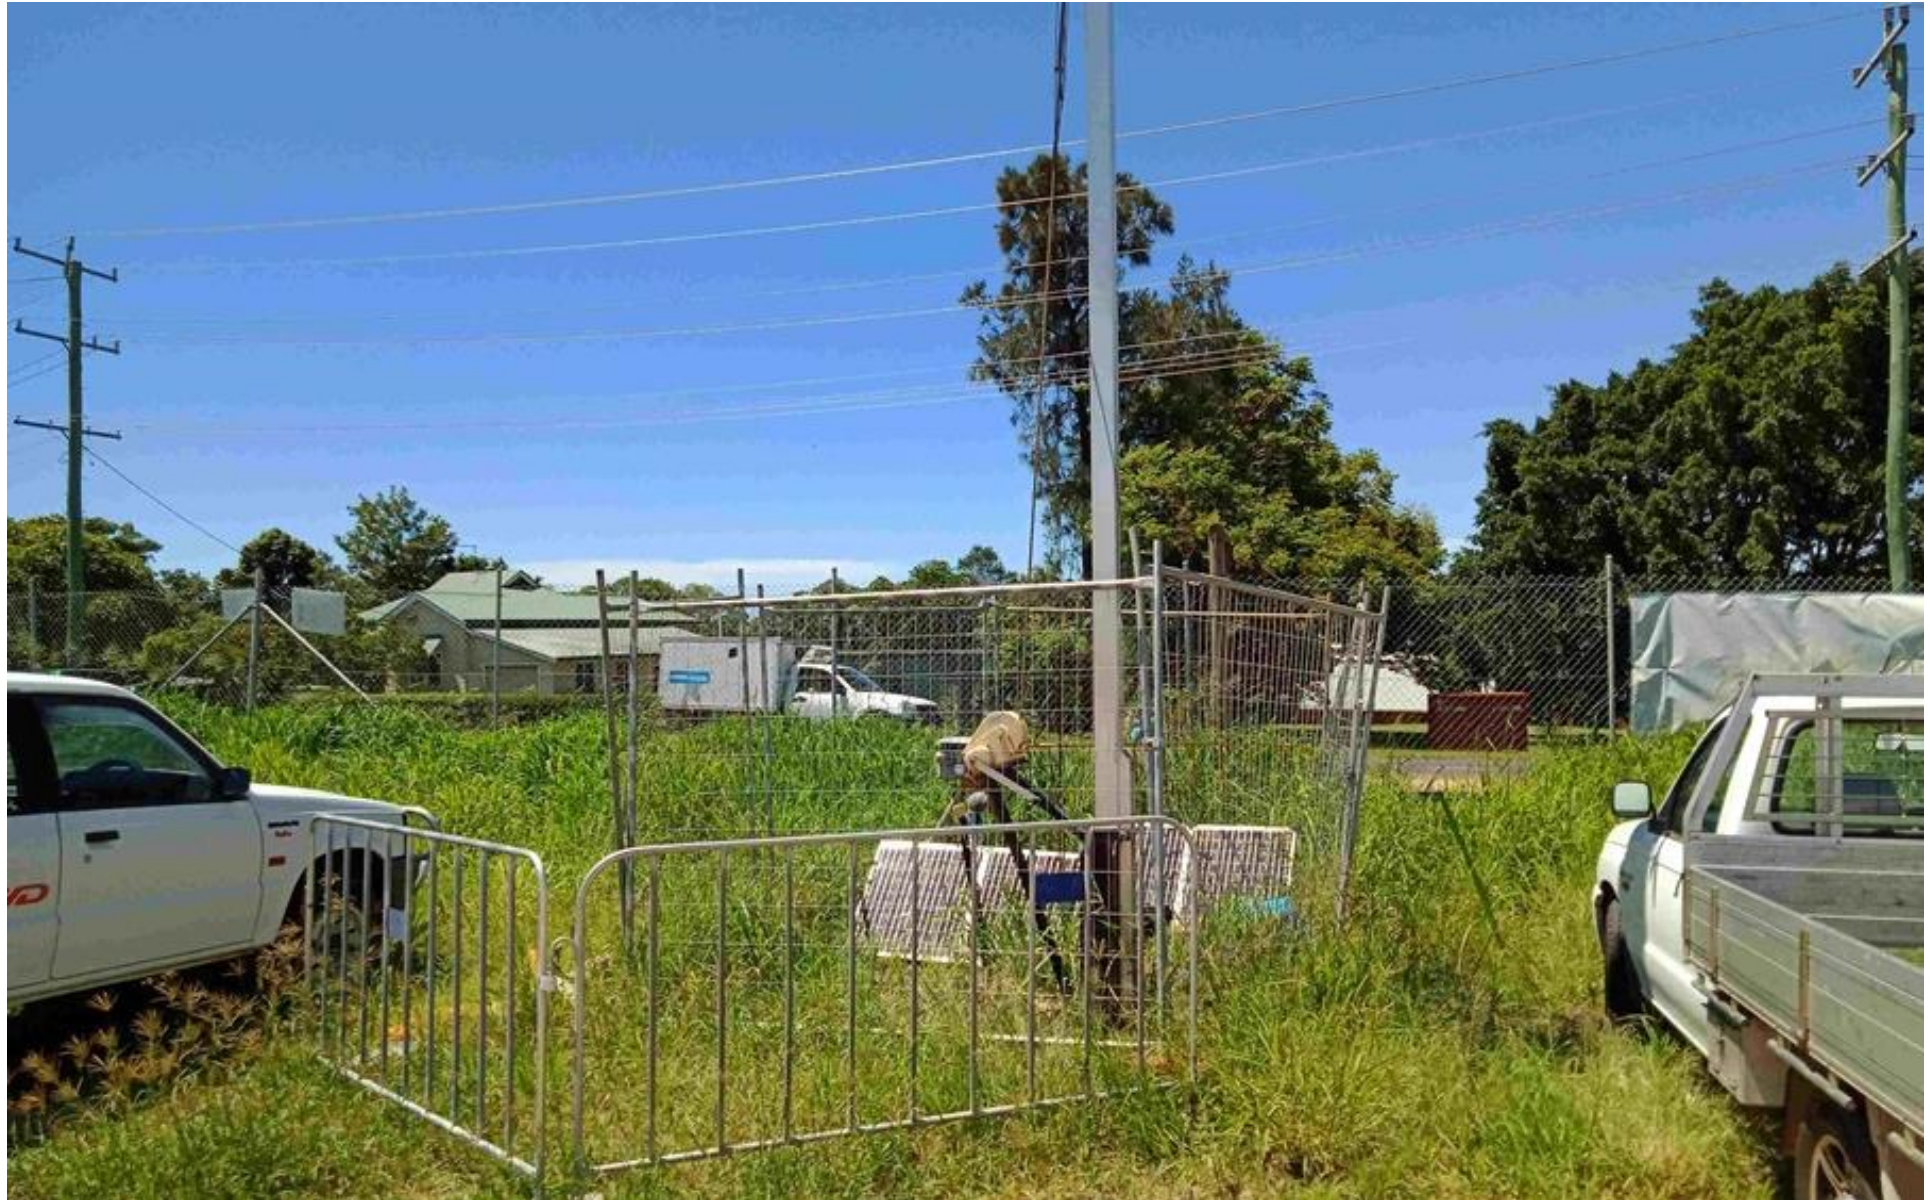
Photograph 2. Representative photograph of monitoring location 002 – Central location, as observed 22/02/21.

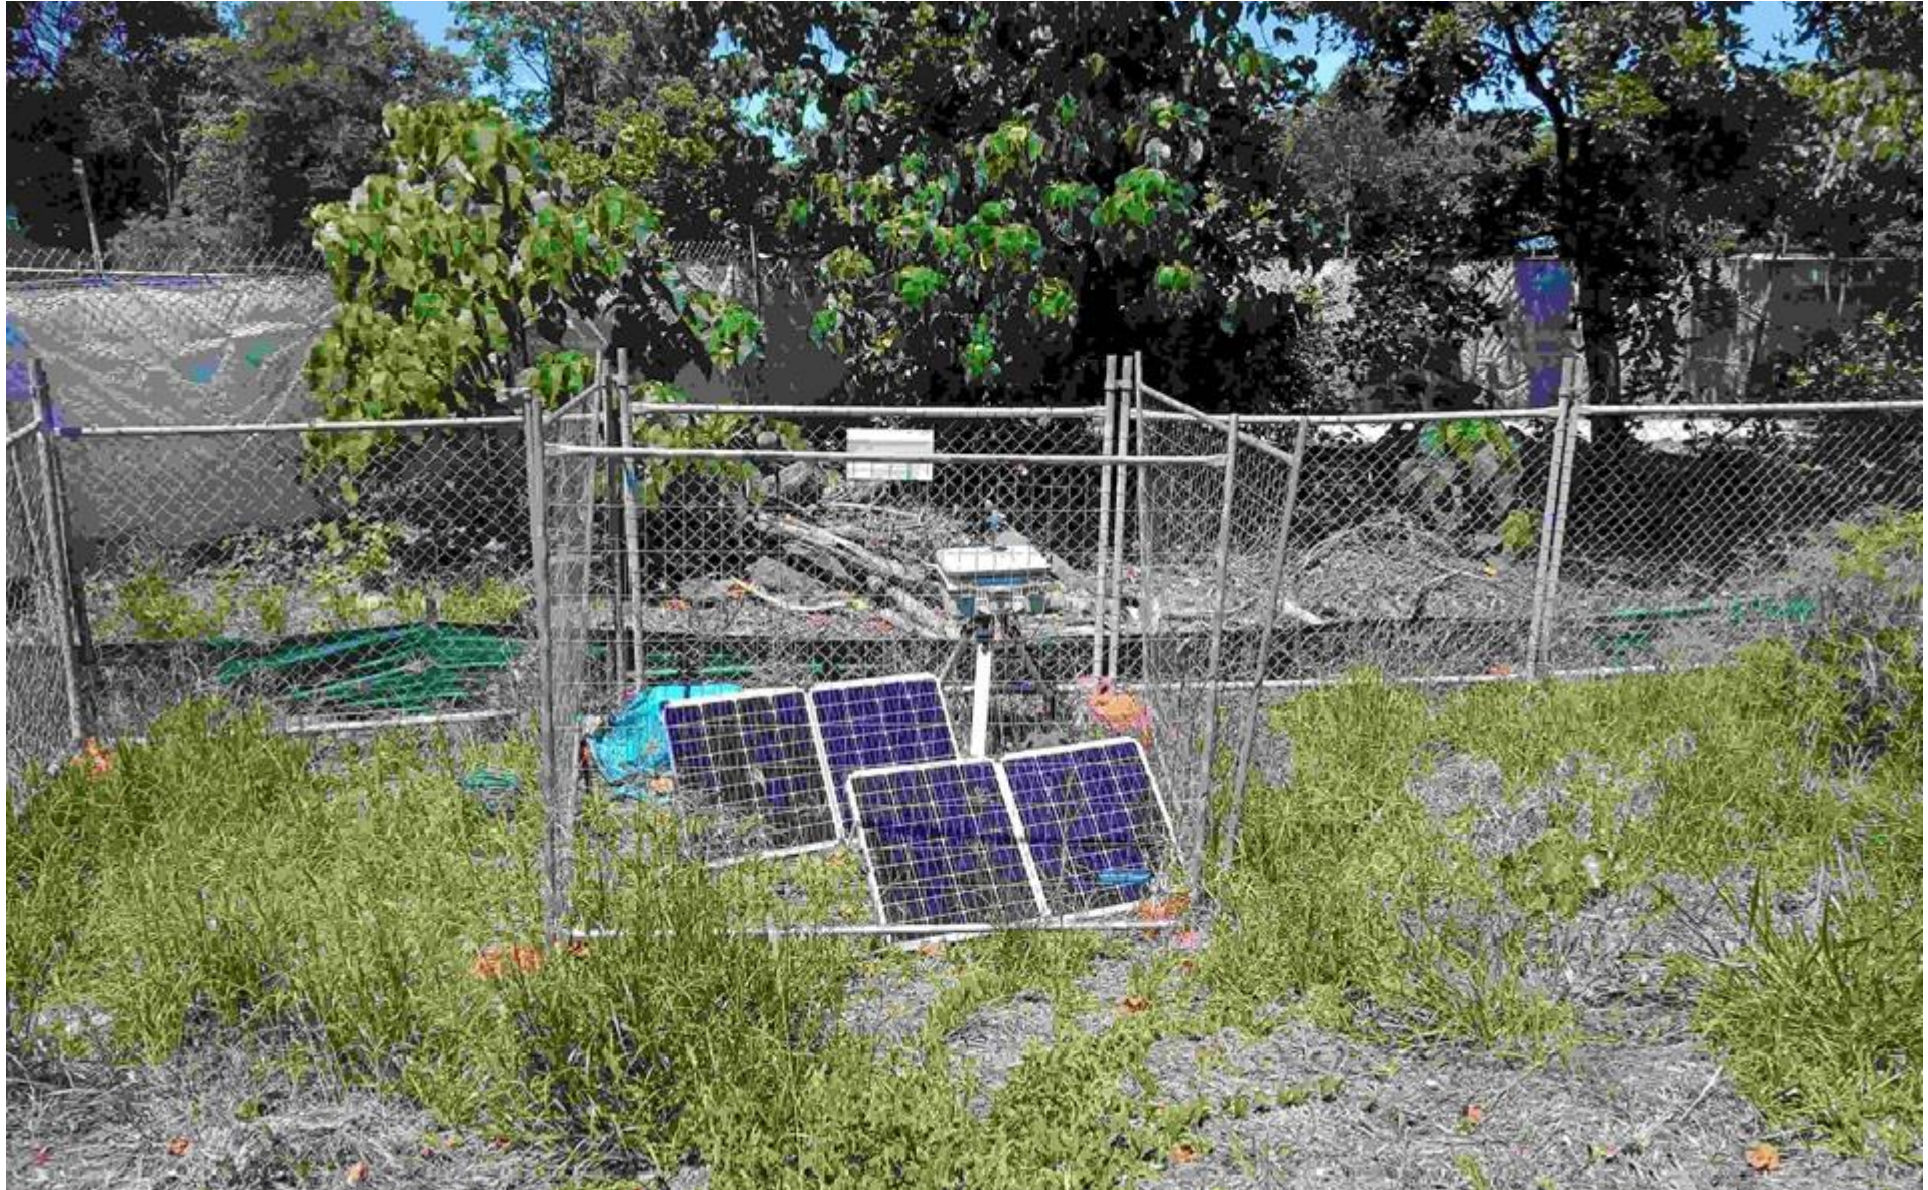
Photograph 3. Representative photograph of monitoring location 003 – Eastern Section of Site, as observed 22/02/21.
