Vibration Monitoring Assessment Report (January 2021)

Tweed Valley Hospital Project, Kingscliff NSW

Prepared for: Lendlease Group

LND-01-Q1299 | VIB18.V1F | Date: 10/02/2021

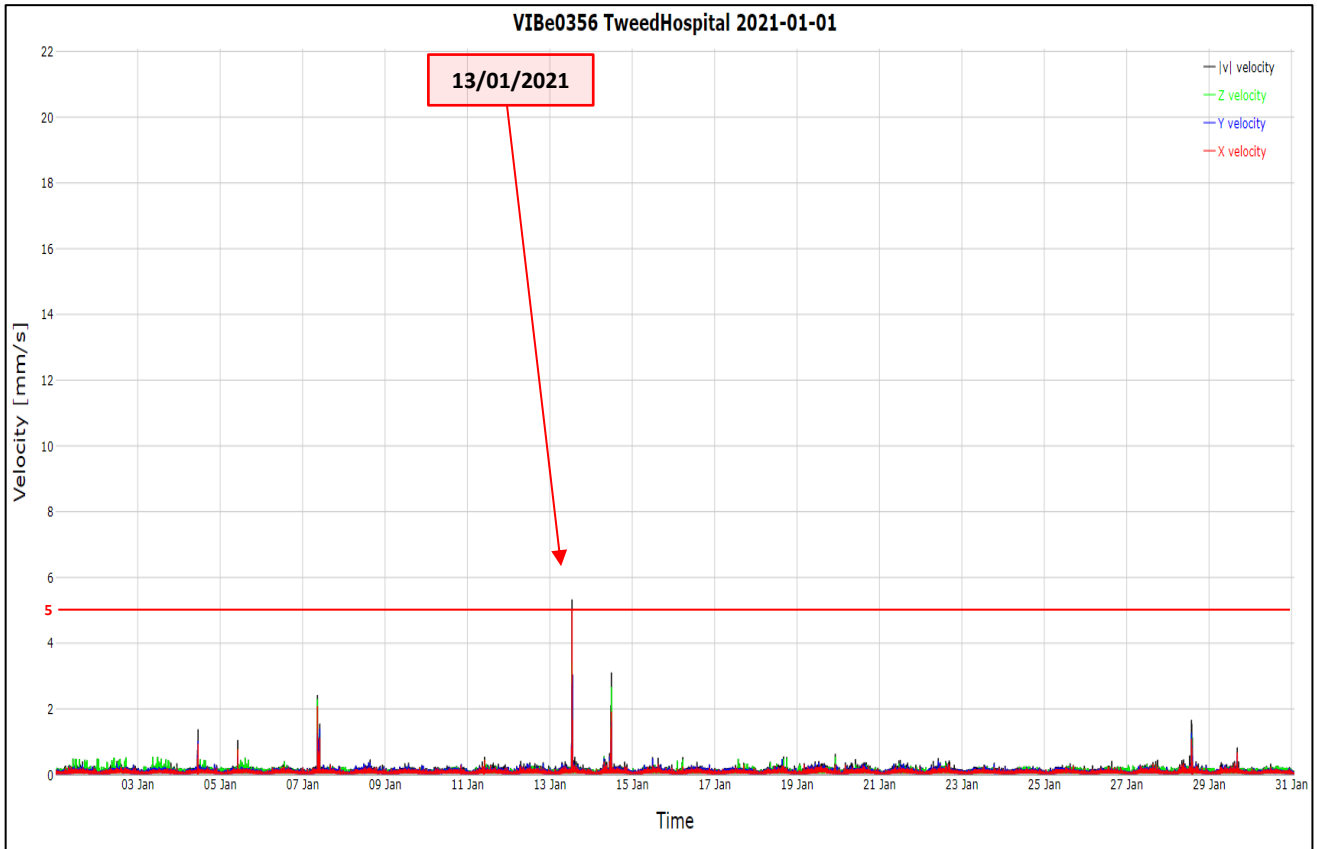
- Location 002 on 13/01/2021.

Figure 2. Results of the vibration monitoring from 1 – 31 January 2021 at monitoring location 002 – Central monitor.

The results of the **total velocity** in mm/s from the monitoring performed for **January 2021** are summarised in Figures 1 – 3 below.

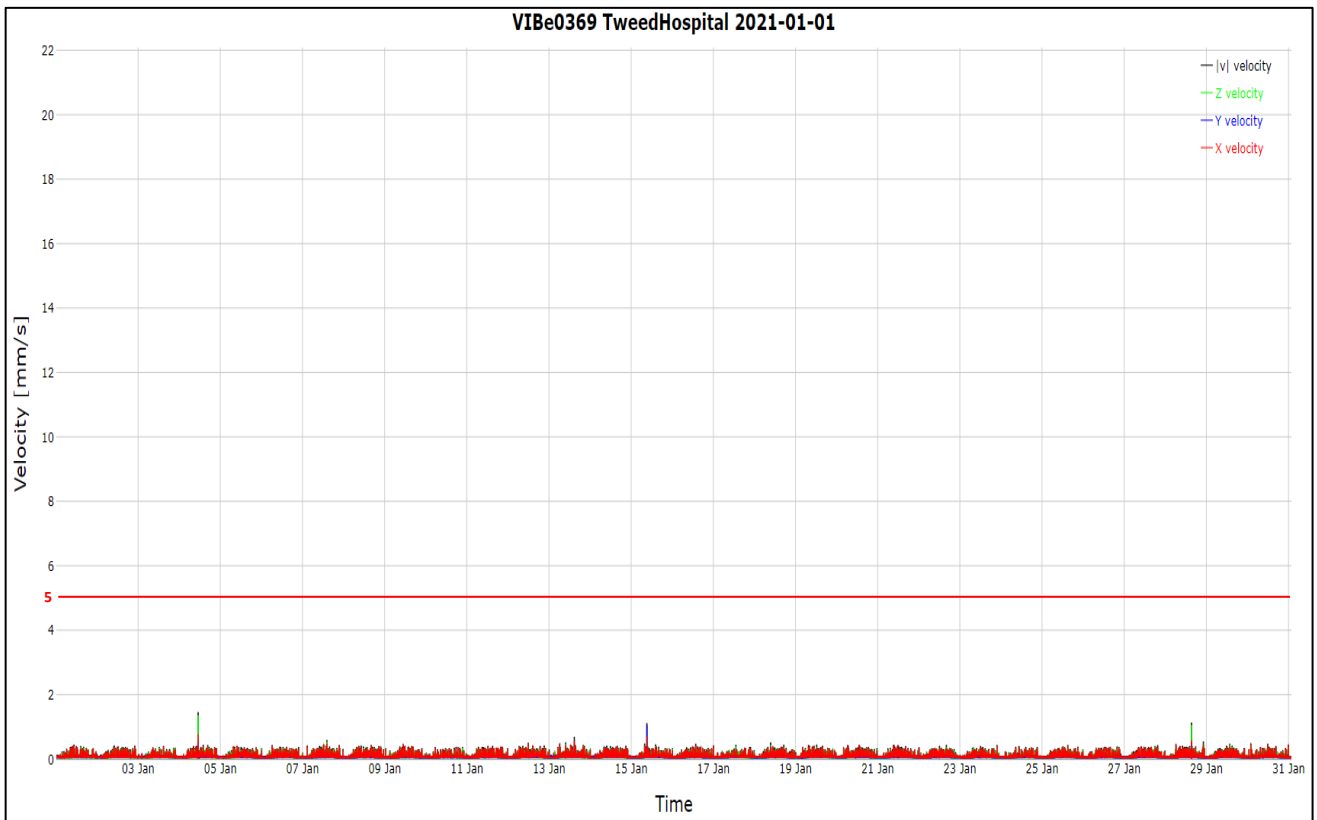
Figure 3. Results of the vibration monitoring from 1 – 31 January 2021 at monitoring location 003 – Eastern section.

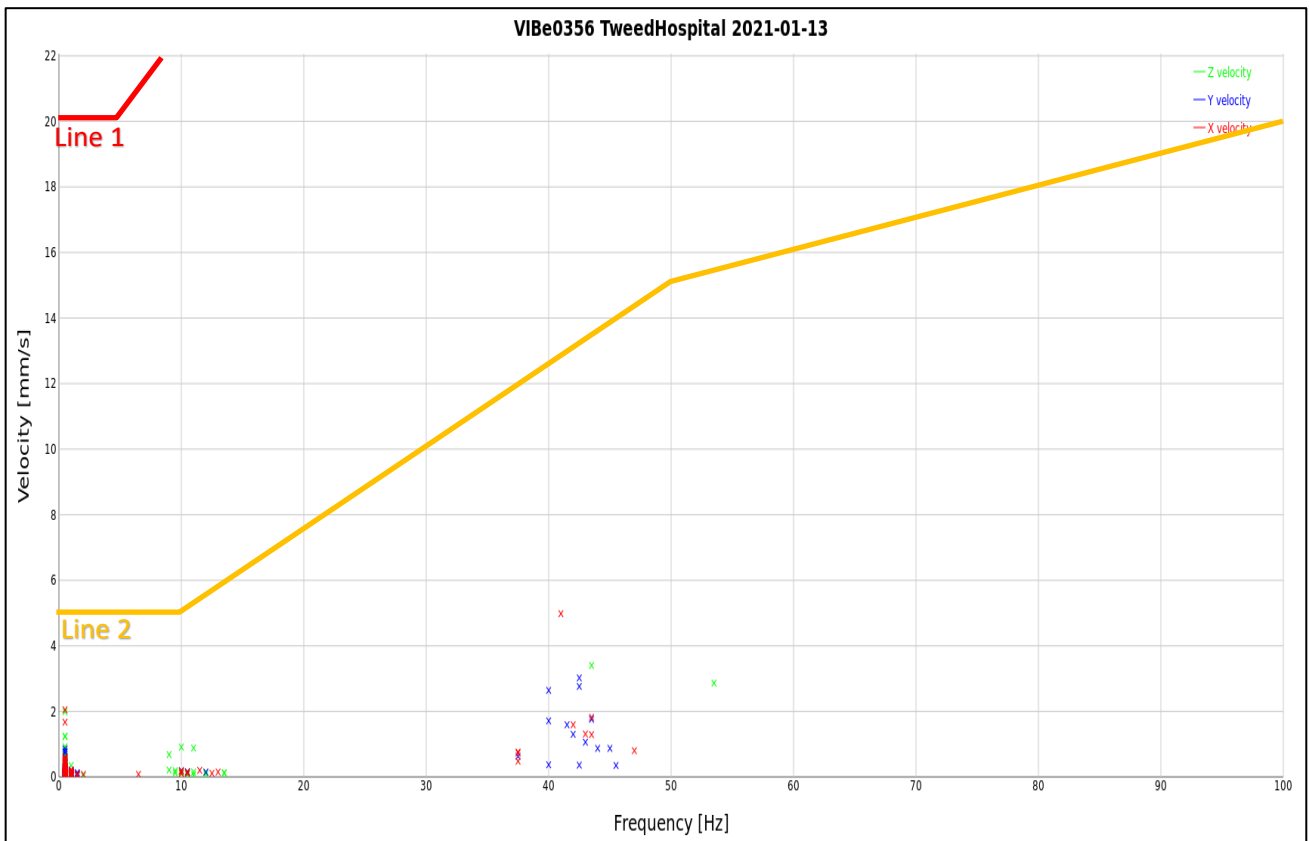
Figure 4. Velocity-Frequency results of the exceedance detected on Wednesday 13 January 2021 at monitoring location 002 – Central monitor. No Velocity-Frequency exceedance of Line 1 or Line 2.

No exceedance of DIN 4150 Line 1 or Line 2 occurred during this reporting period.

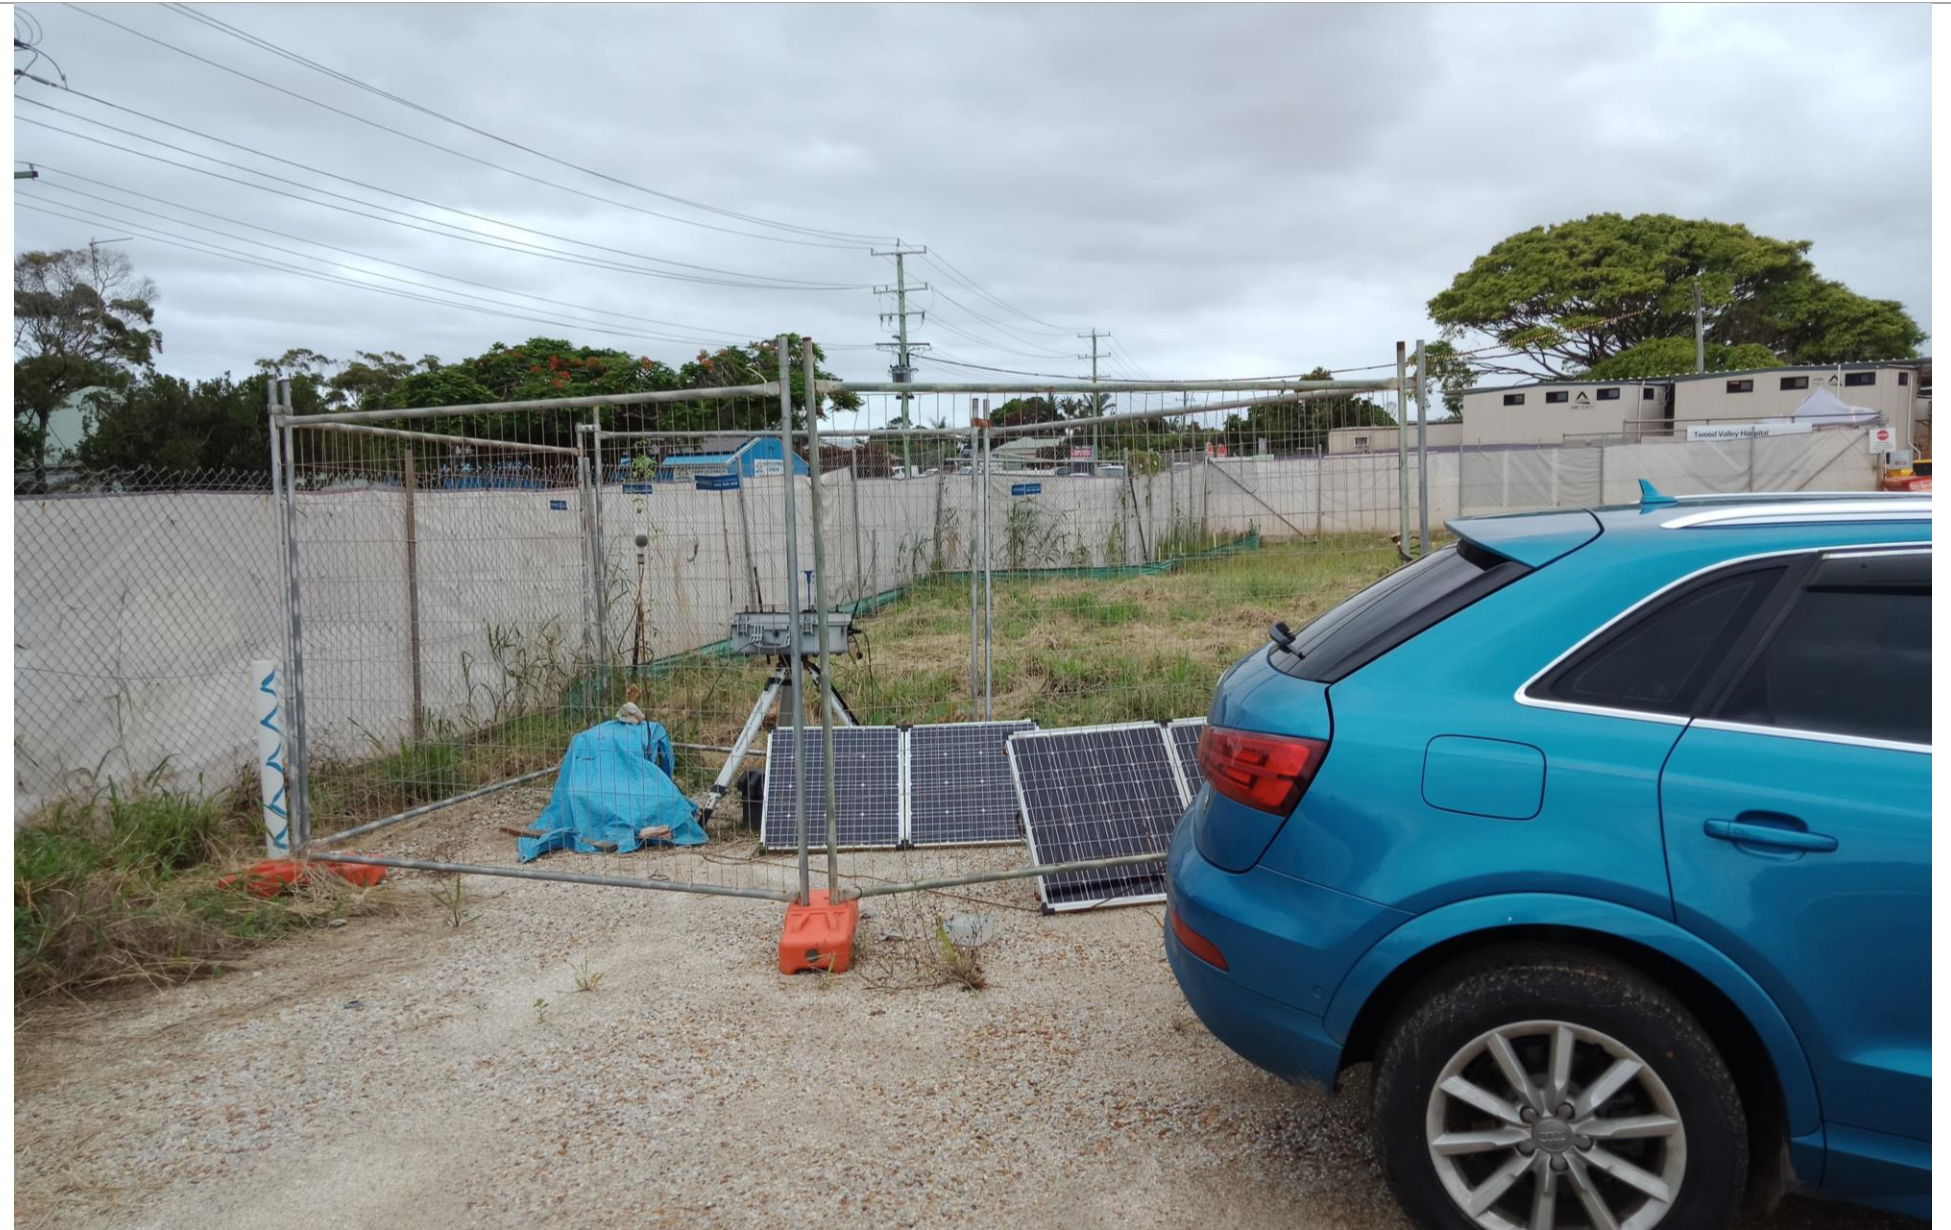
Photograph 1. Representative photograph of monitoring location 001 – Adjacent Carpark location, as observed 21 January 2021.

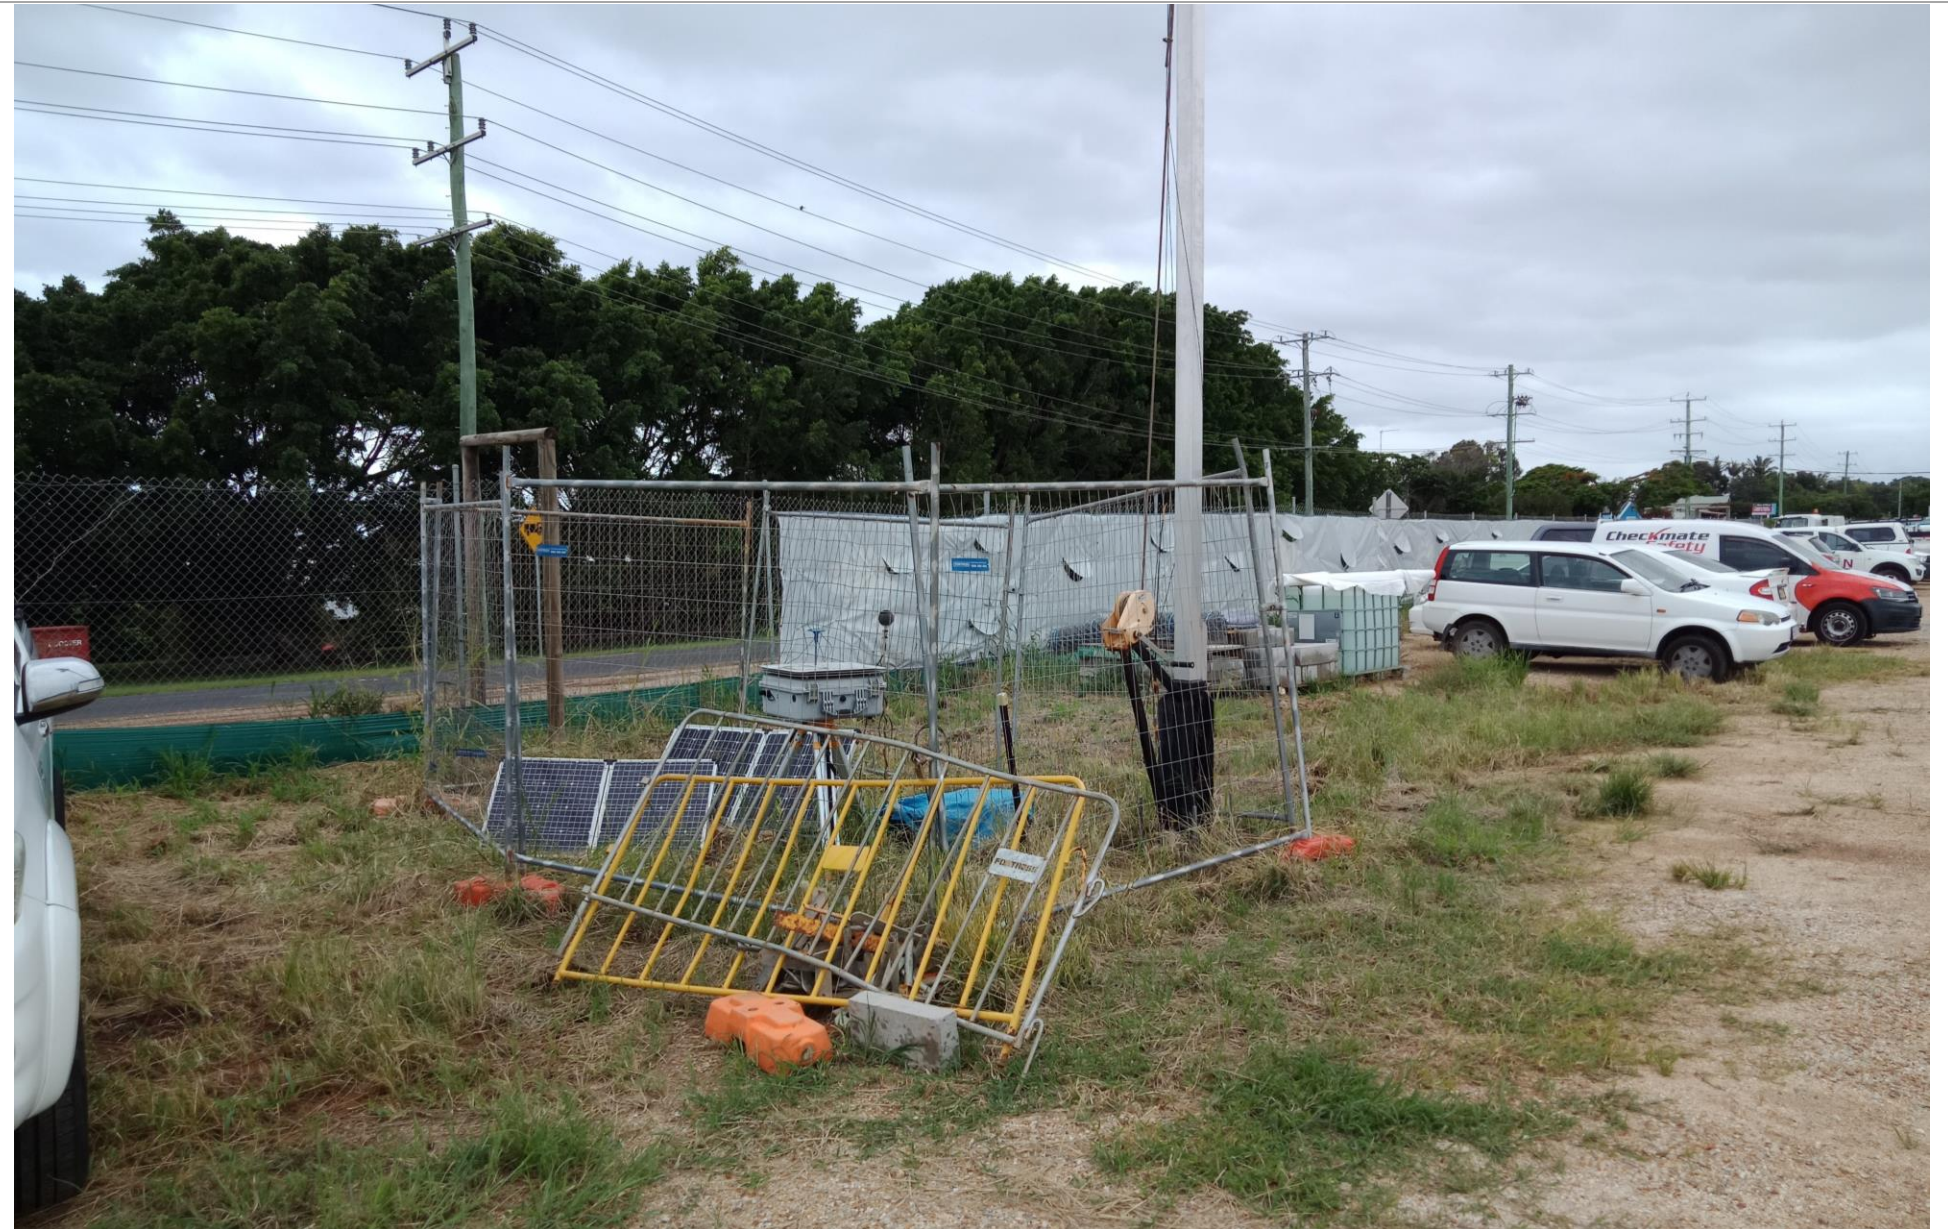
Photograph 2. Representative photograph of monitoring location 002 – Central location, as observed 21 January 2021.

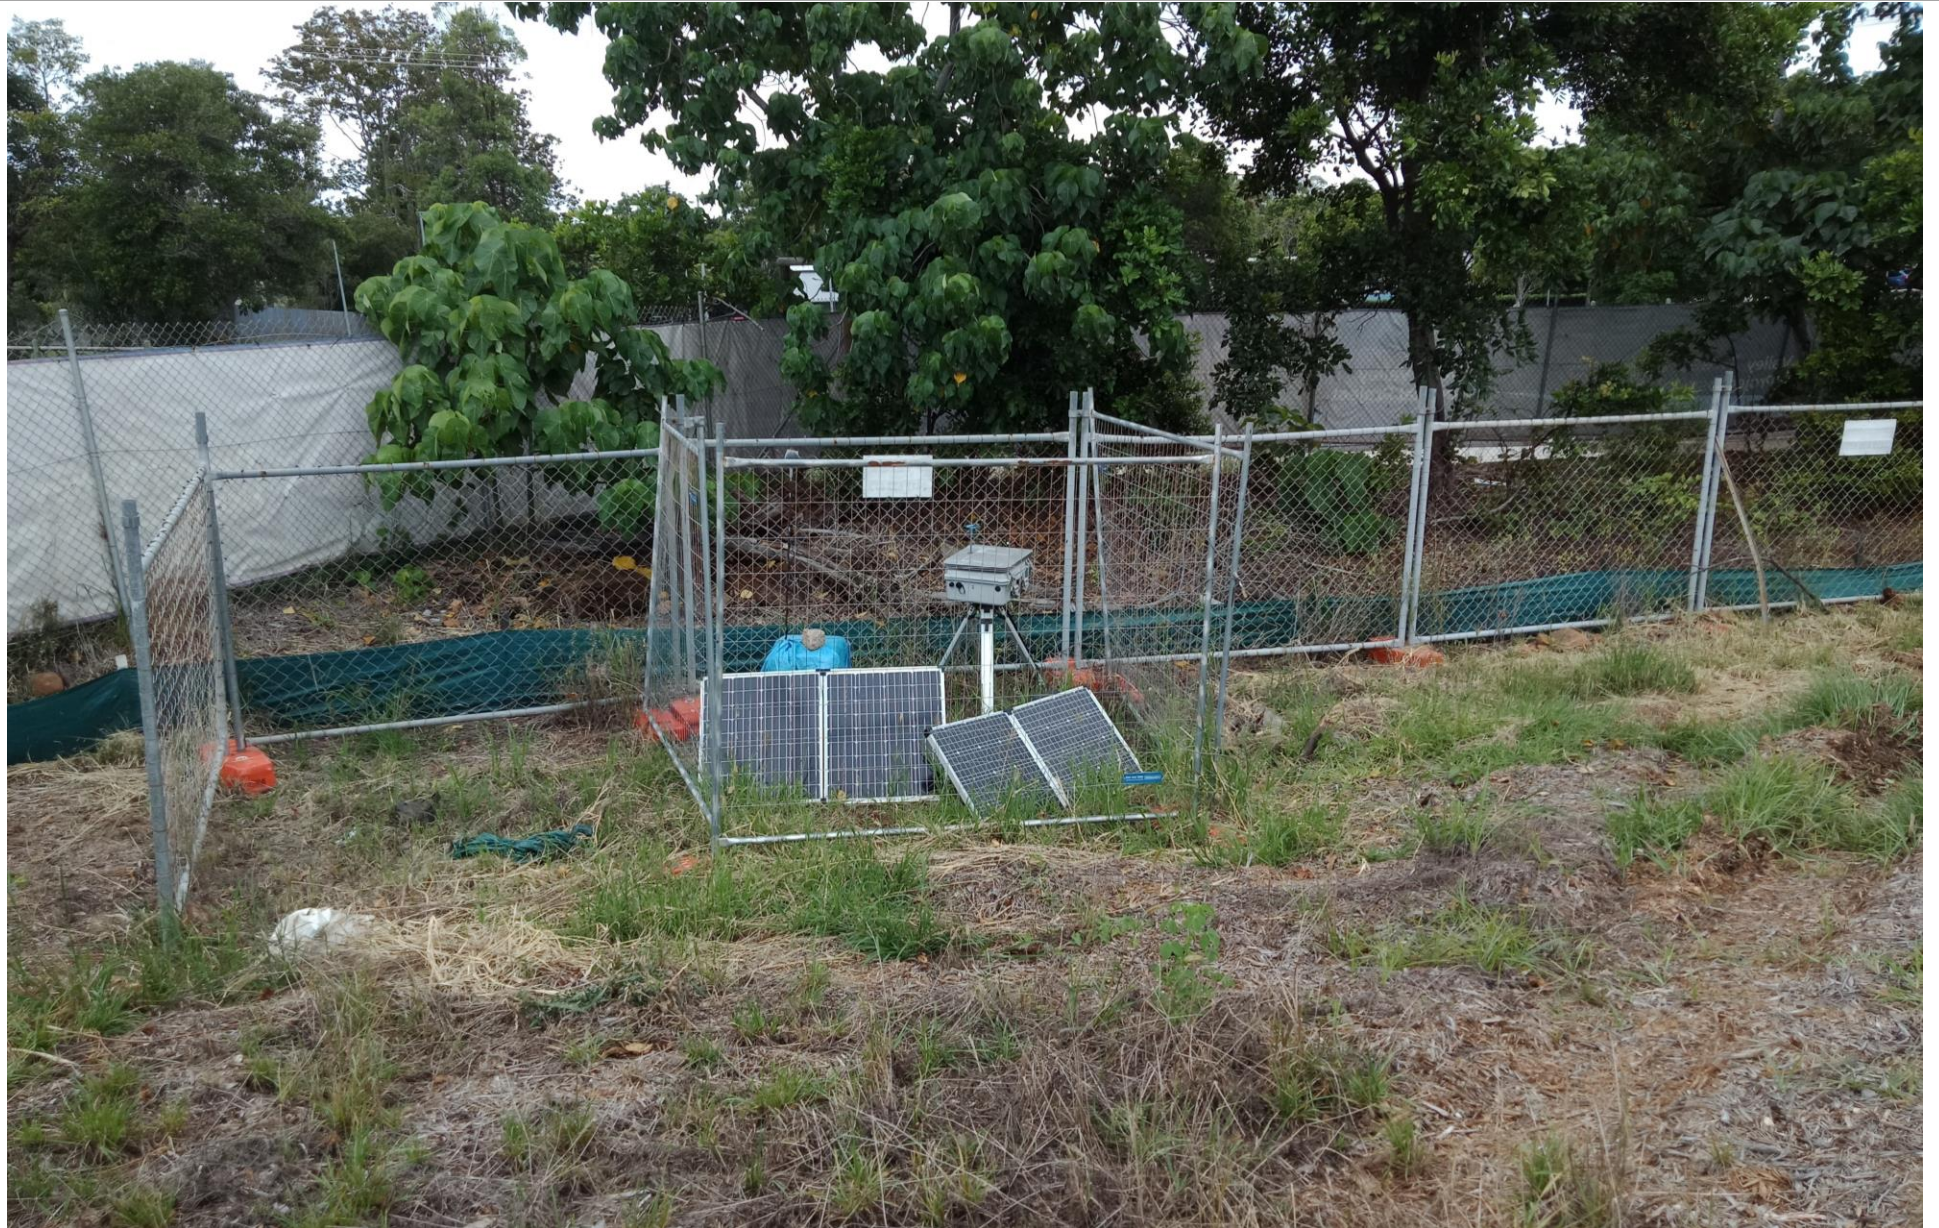
Photograph 3. Representative photograph of monitoring location 003 – Eastern Section of Site, as observed 21 January 2021.
