# Vibration Monitoring Assessment Report (September 2021)

**Tweed Valley Hospital Project, Cudgen NSW**

LND-01-Q1299 | VIB26.V1F | Date: 15/10/2021

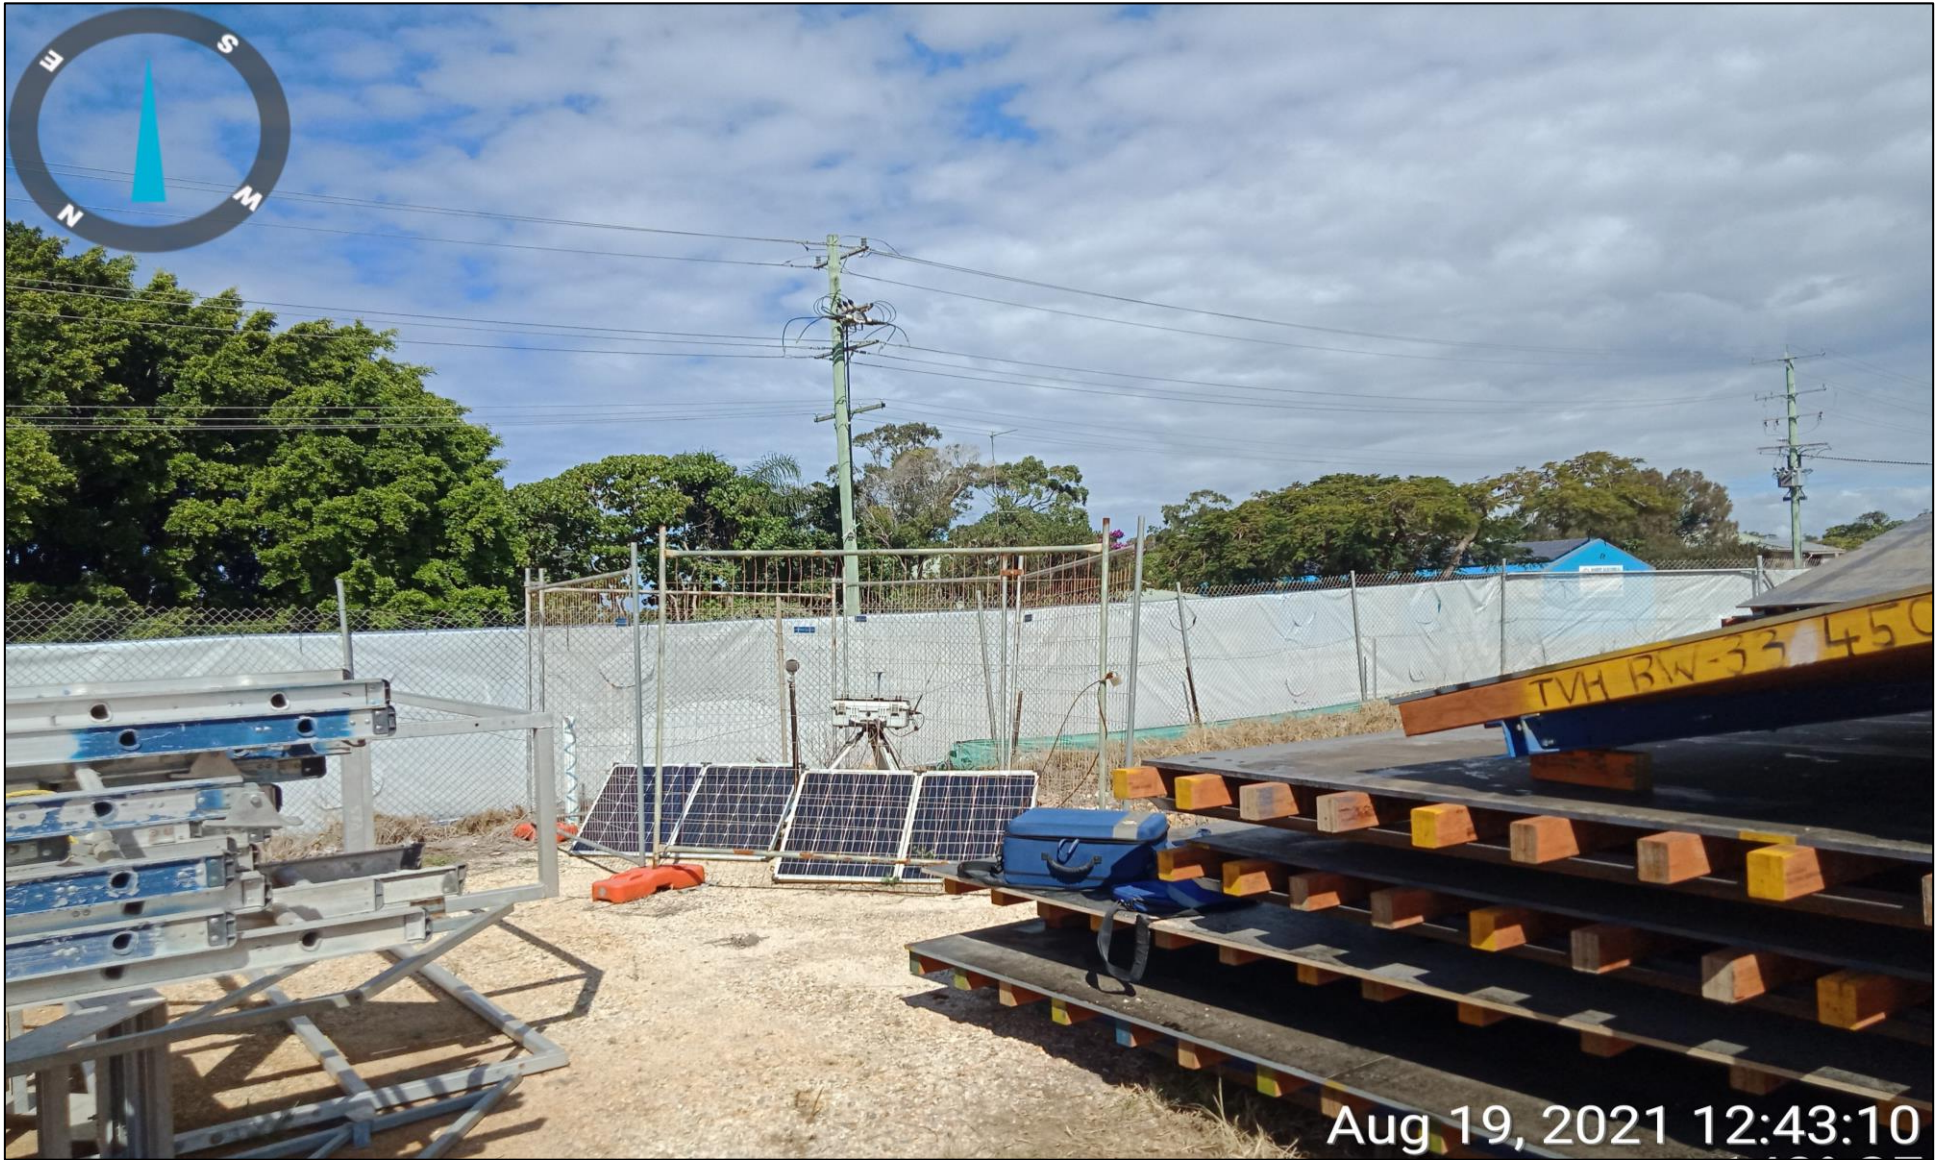
Photograph 1 Representative photograph of monitoring location 001 – Adjacent Carpark location, as observed 19/08/2021

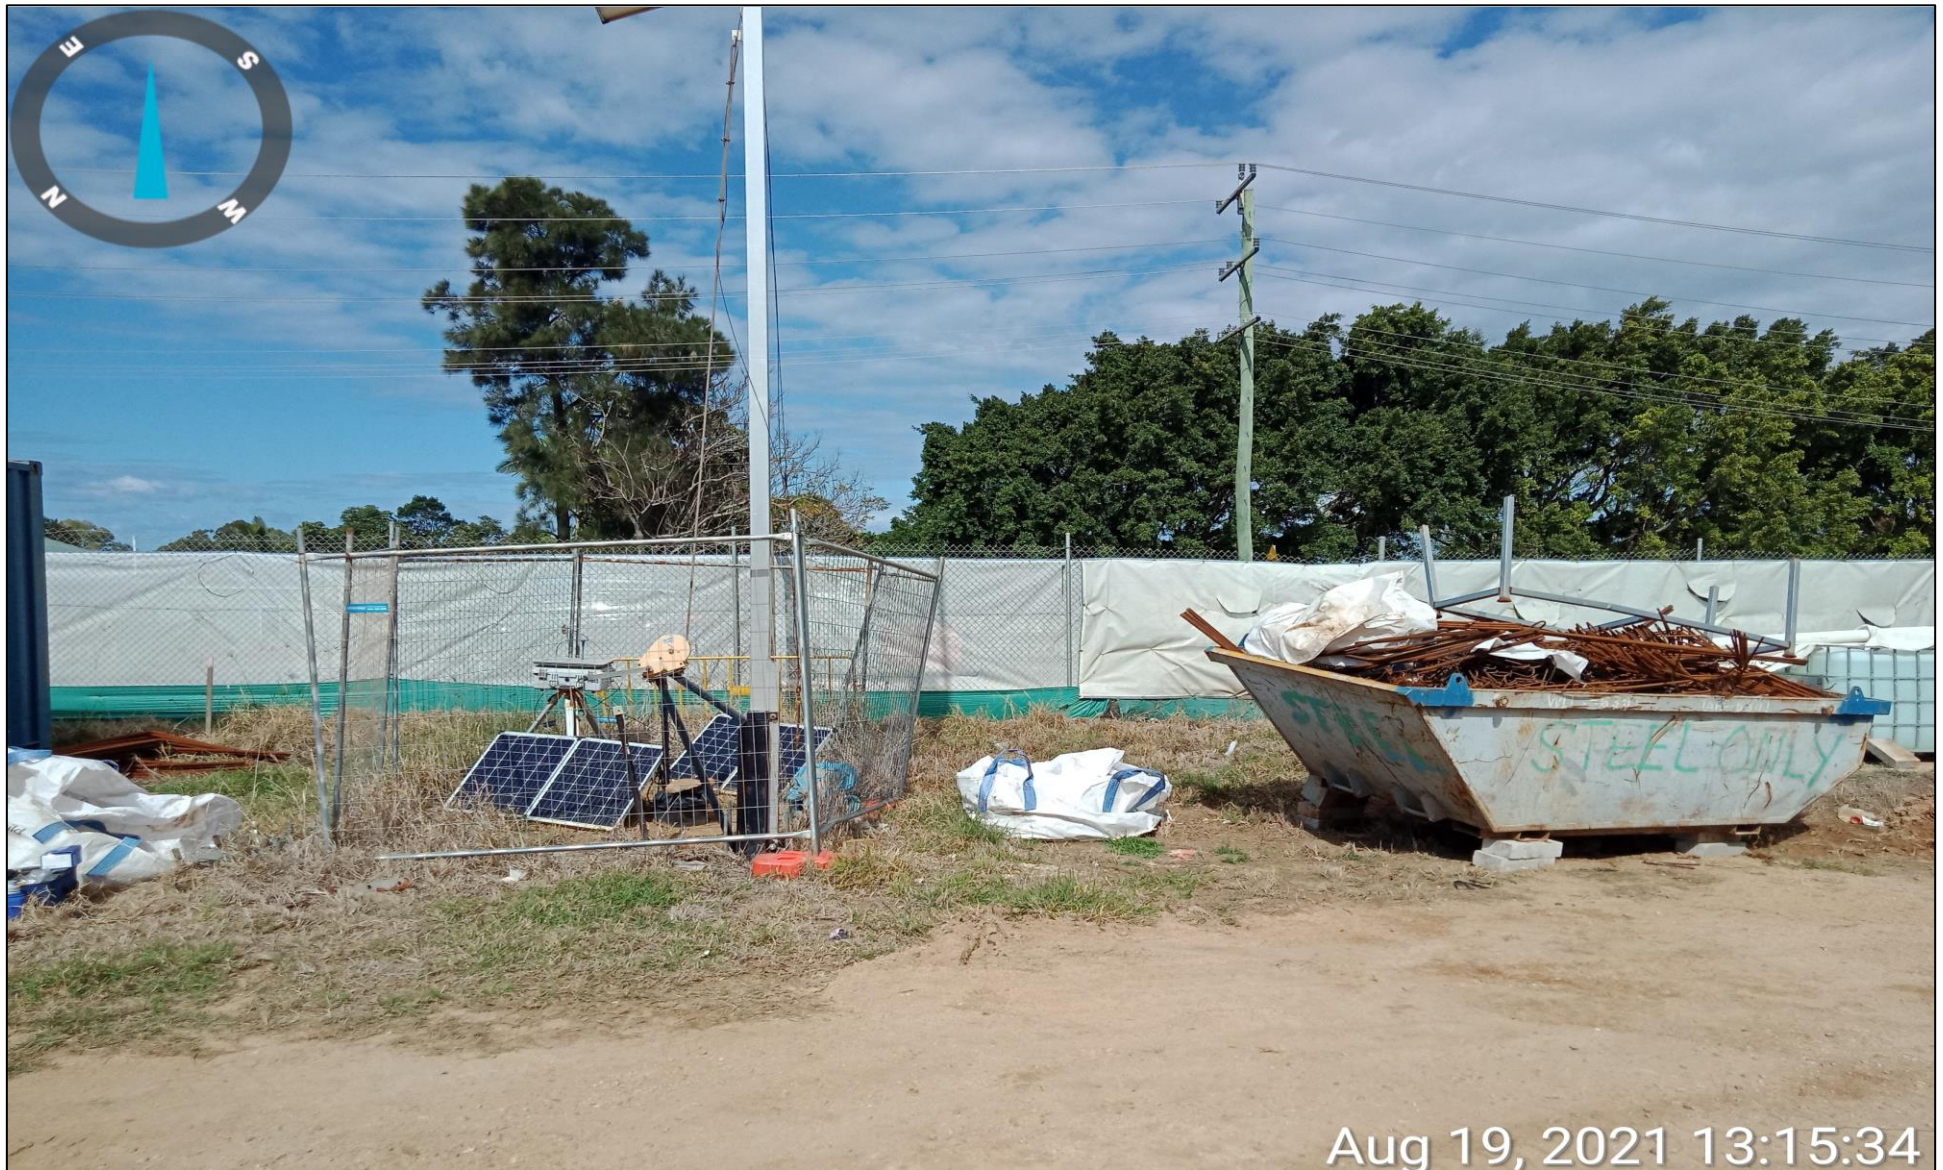
Photograph 2 Representative photograph of monitoring location 002 – Central location, as observed 19/08/2021

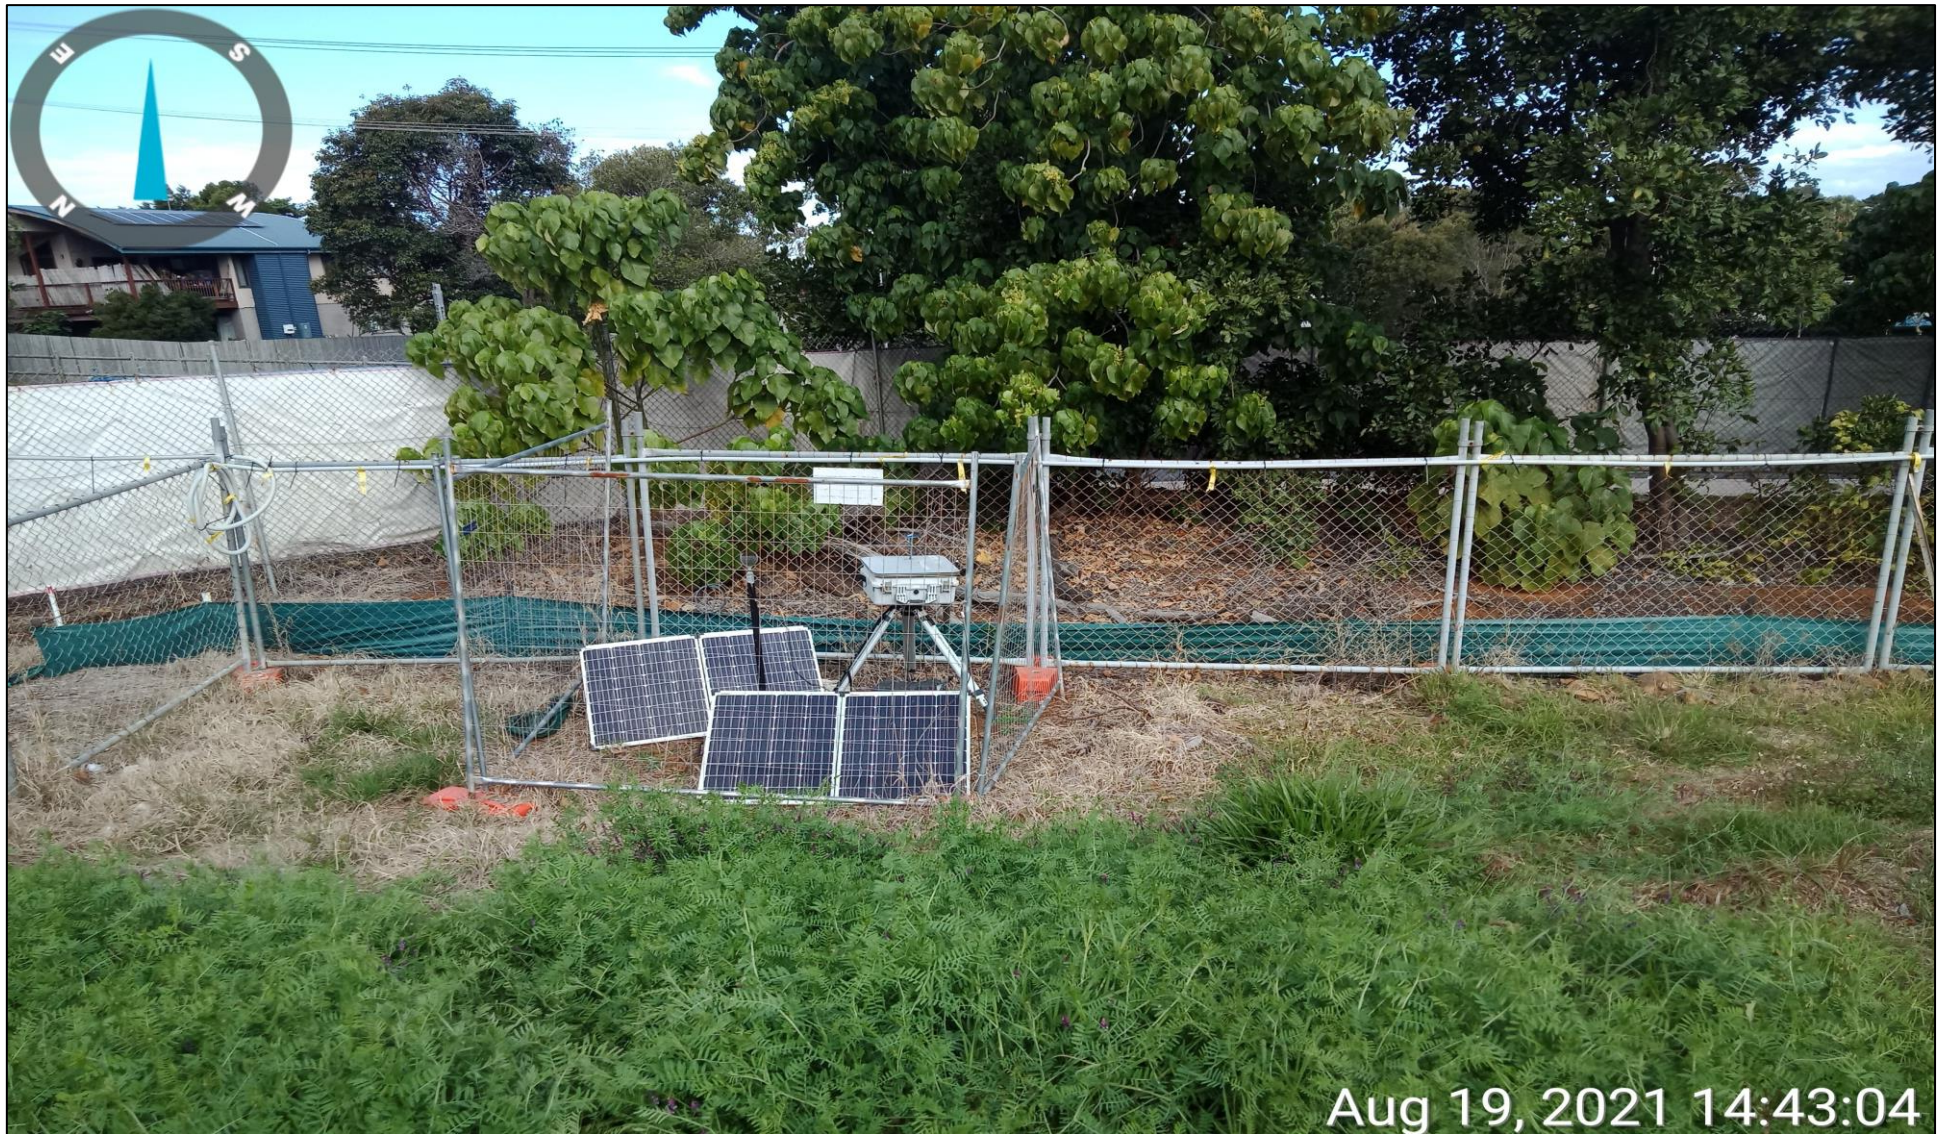
Photograph 3 Representative photograph of monitoring location 003 – Eastern Section of Site, as observed 19/08/2021
