# Vibration Monitoring Assessment Report (October 2021)

**Tweed Valley Hospital Project, Cudgen NSW**

Prepared for: Lendlease Building Pty Ltd

LND-01-Q1299 | VIB27.V1F | Date: 9/11/2021

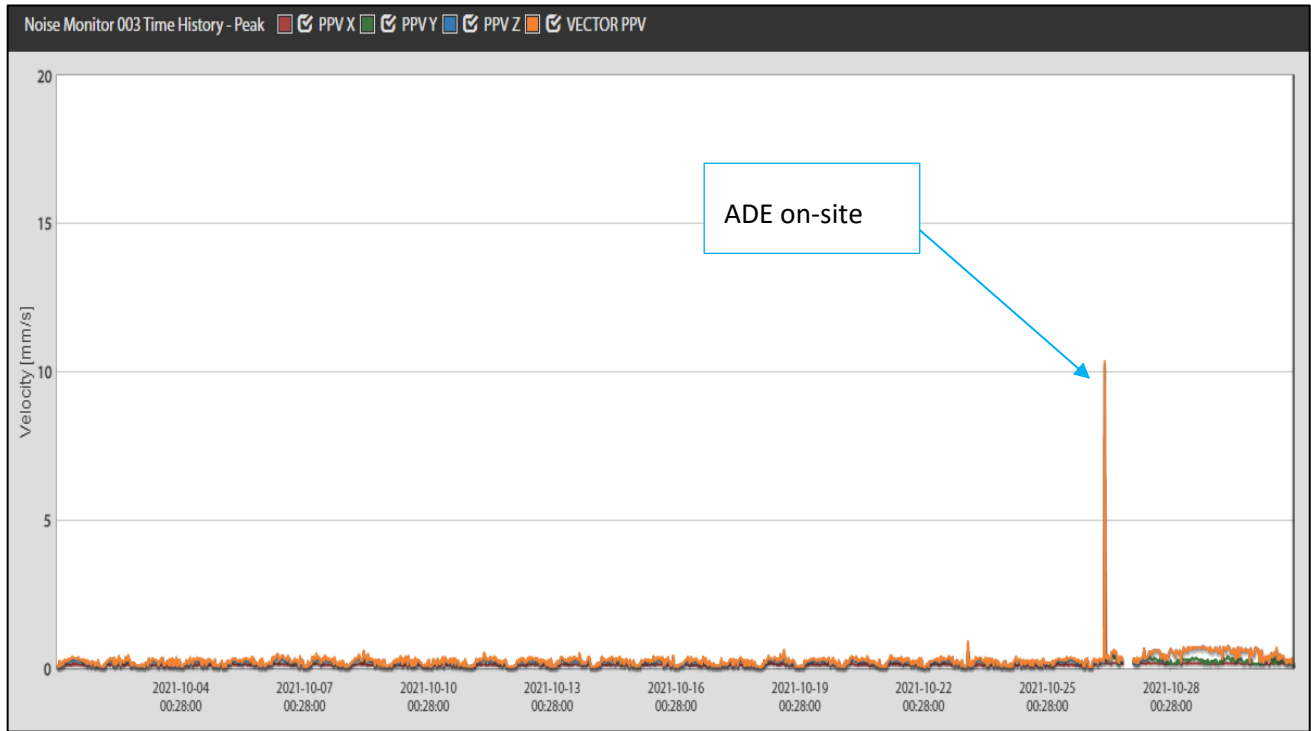
**Figure 3.** Vibration data at location 003 | Eastern section | October 2021

Data measured at location 003 is presented below **Figure 3**.

During the monitoring period (October 2021) no exceedance of DIN 4150 Line 1 or Line 2 PPV guideline values was observed. The results presented in Figure 1 – 3 do not include a distance correction.

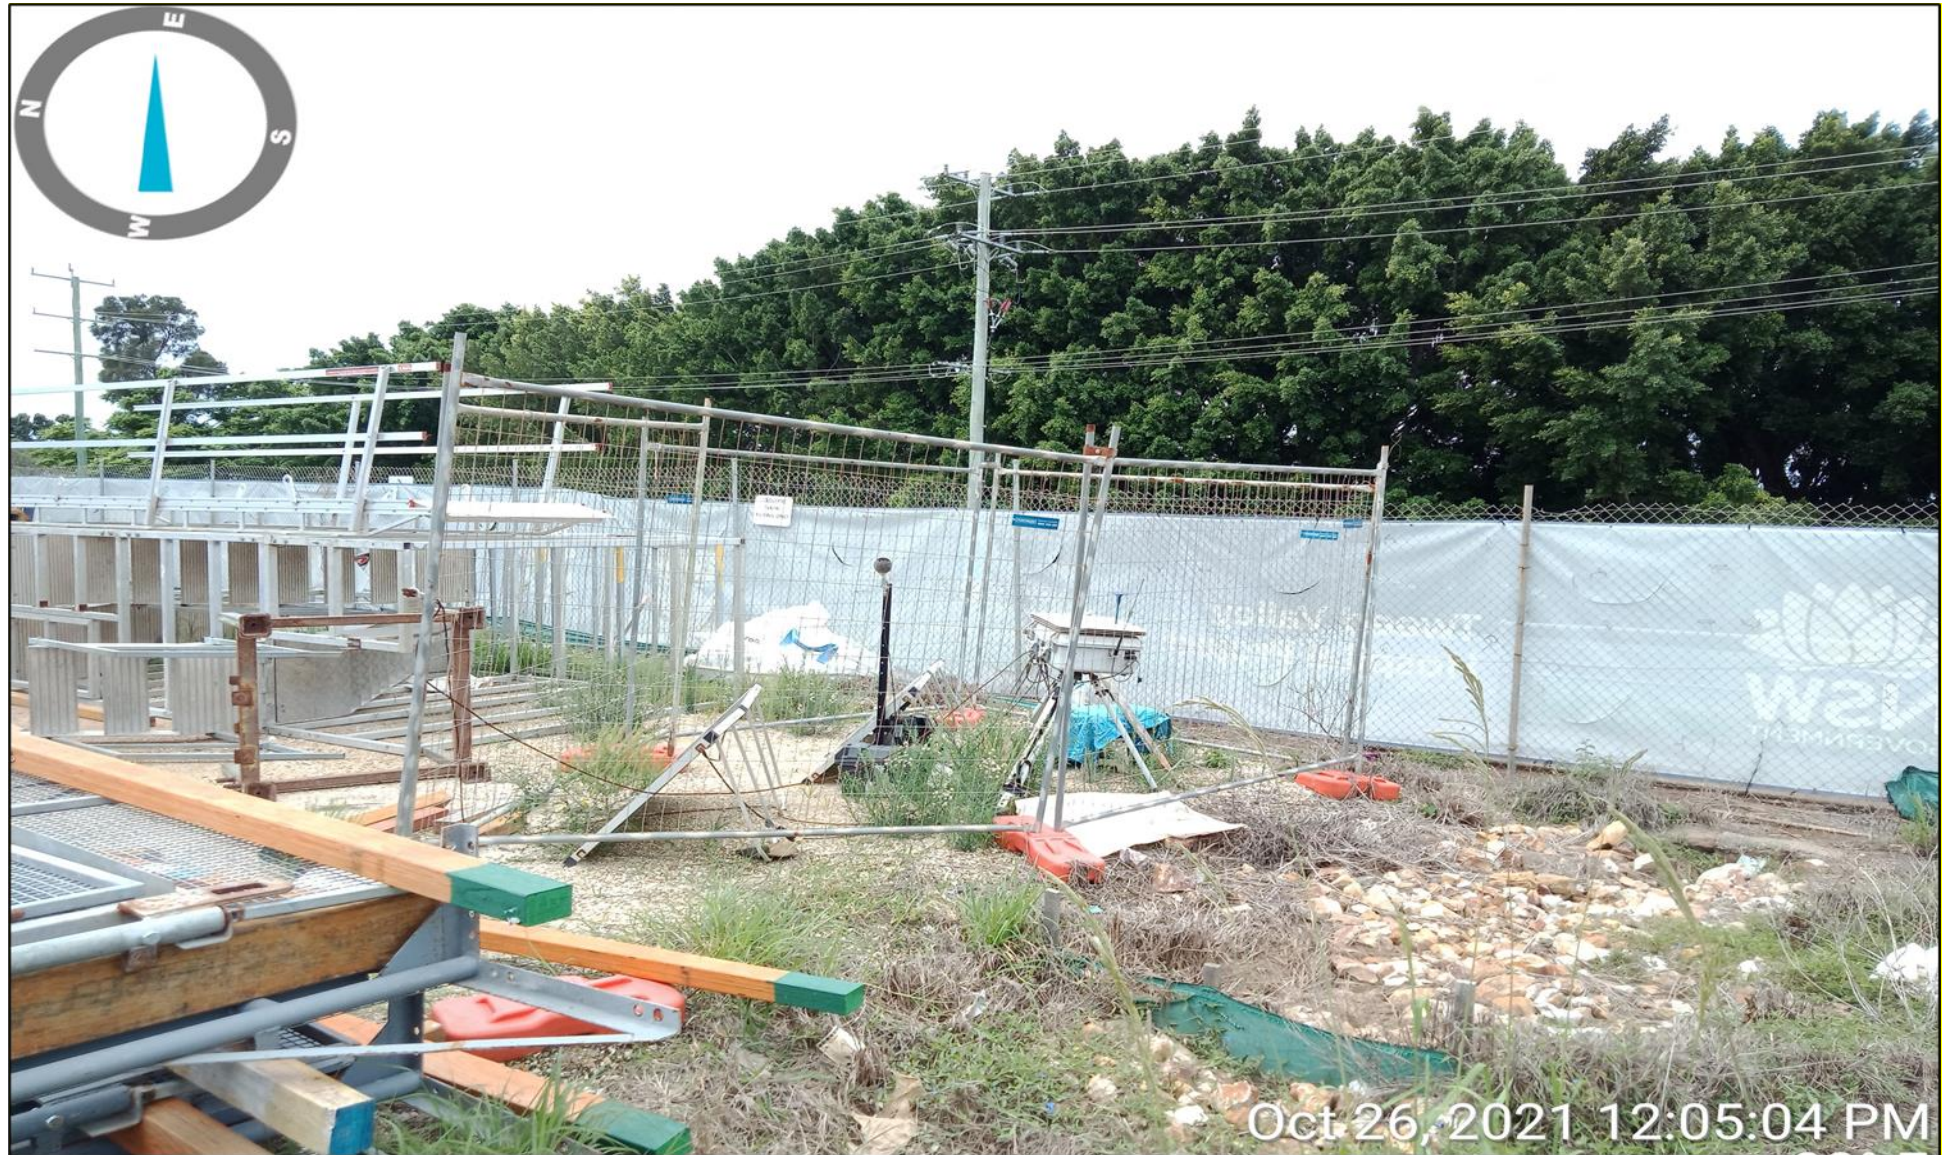
Photograph 1 Representative photograph of monitoring location 001 – Adjacent Carpark location, as observed 26/10/2021

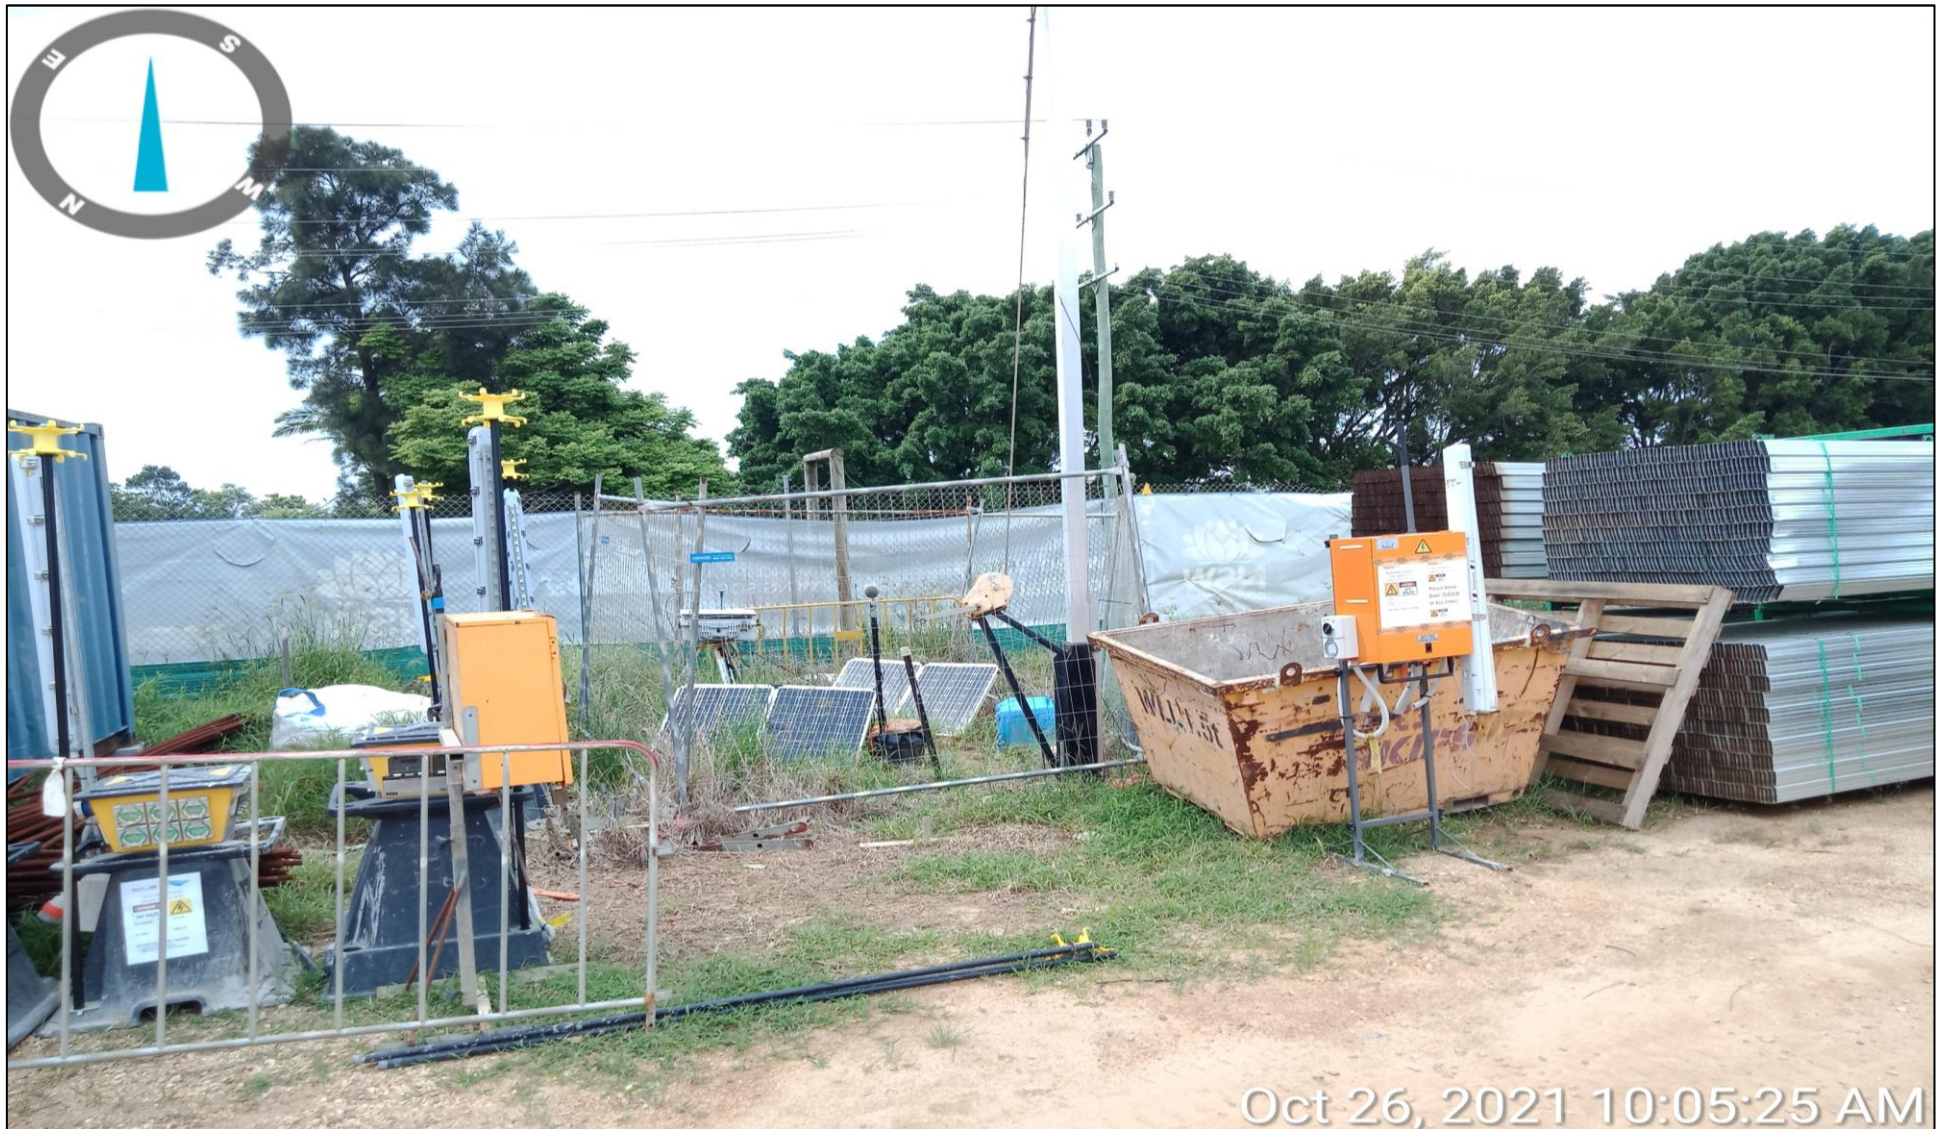
Photograph 2 Representative photograph of monitoring location 002 – Central location, as observed 26/10/2021

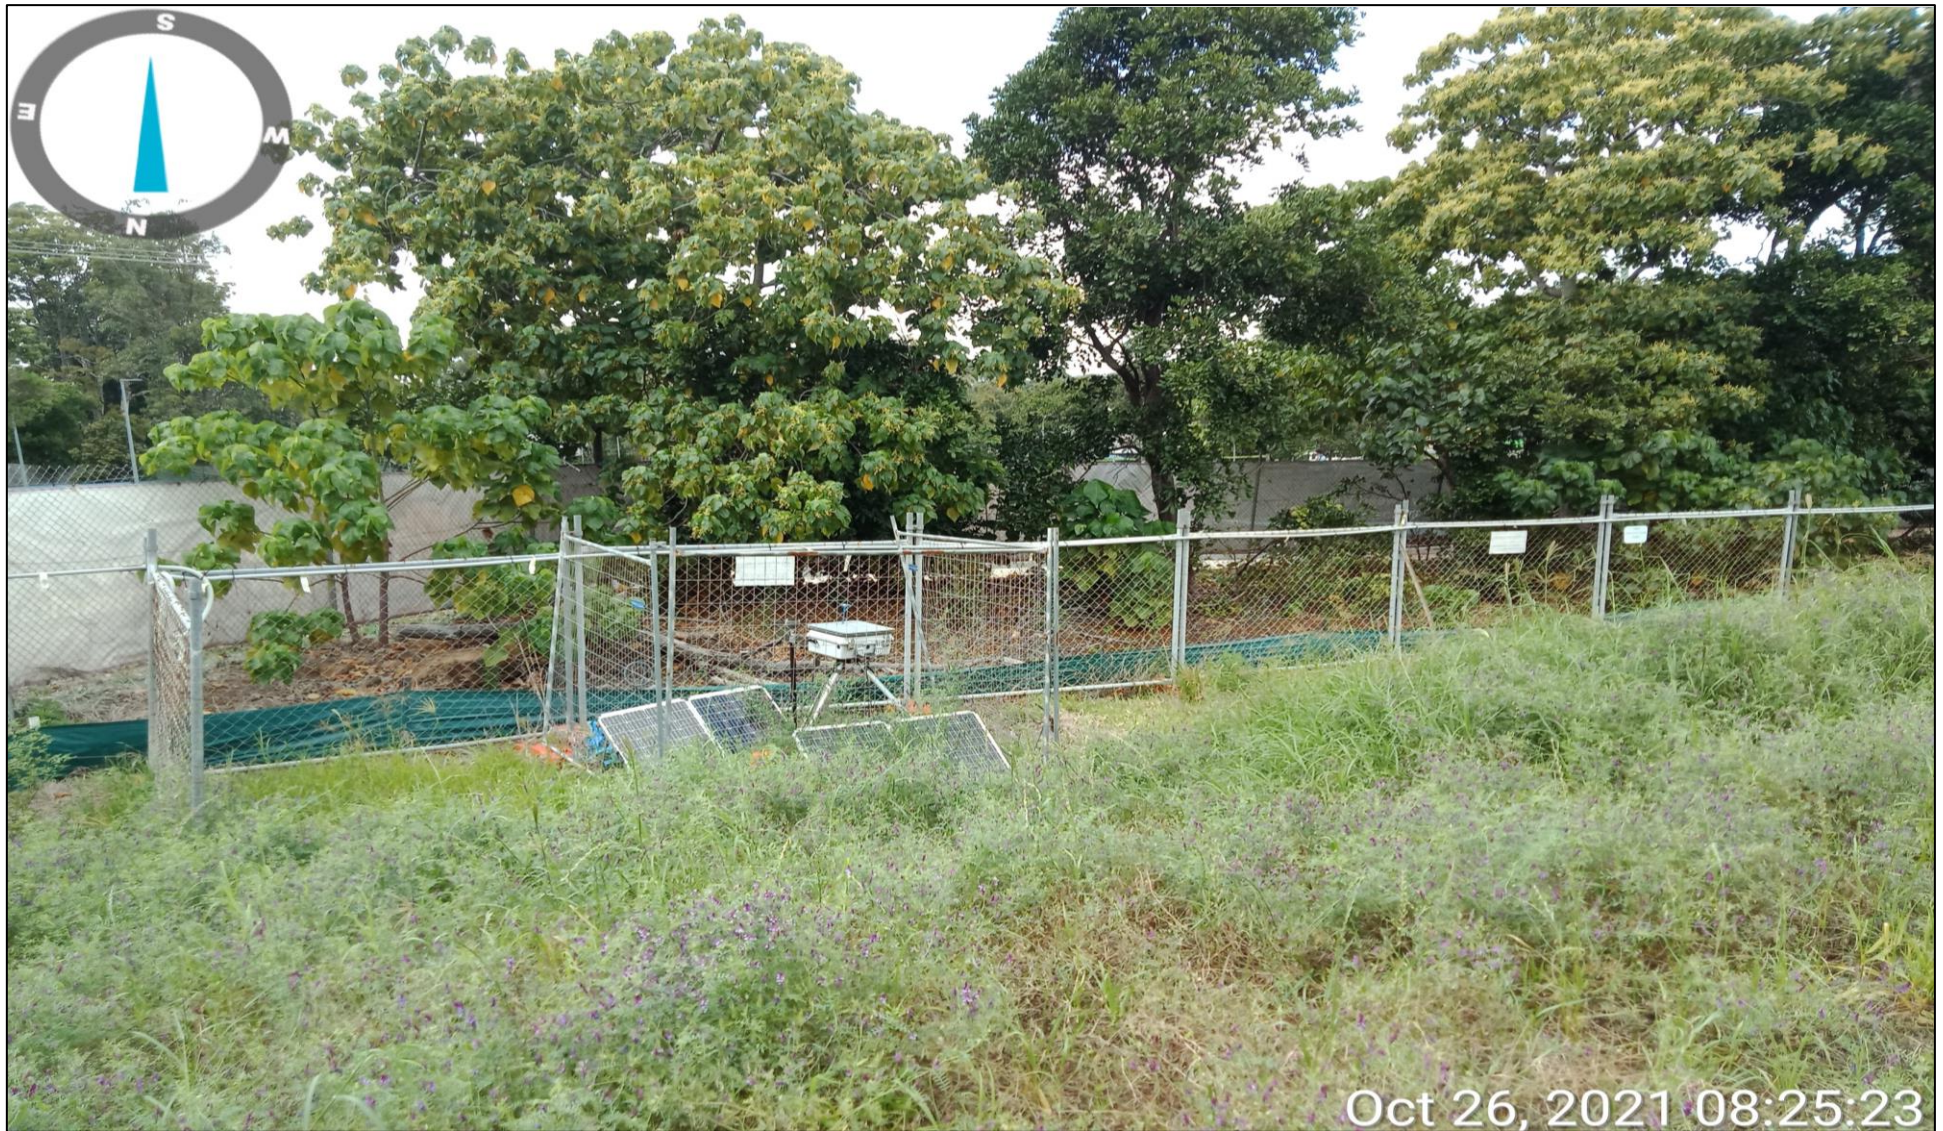
Photograph 3 Representative photograph of monitoring location 003 – Eastern Section of Site, as observed 26/10/2021
