# Environmental Dust Assessment Report (May 2021)

**Tweed Valley Hospital Project, Cudgen NSW**

Prepared for: Lendlease Building Pty Ltd

LND-01-Q1299 | EDM22.V1.1F | Date: 25/06/2021

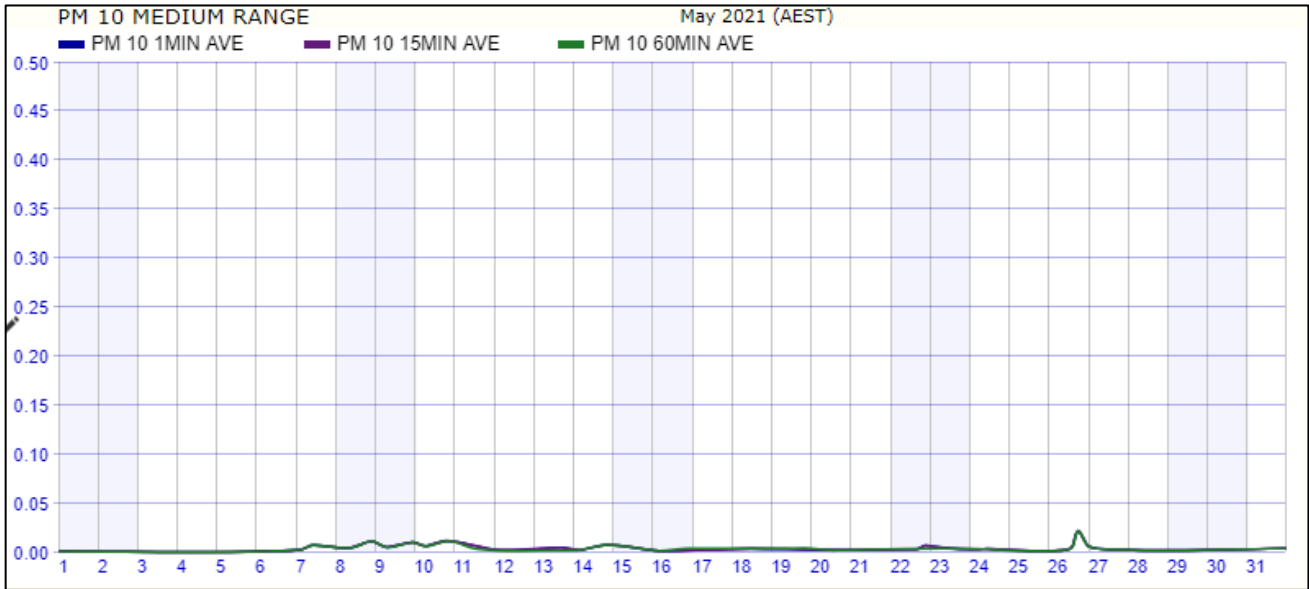
All graphs below express dust levels as an hourly average and values <0.01 will not be graphed. Figures below show monthly dust results for each of the three (3) monitoring locations.

**Figure 1.** Summary of PM10 from the real time monitoring at location 001 – Adjacent the carpark for the month of May 2021.

All dust levels remained below  $0.5\text{mg}/\text{m}^3$  during the month of May 2021 (*refer to Section 3*).

Ensure adequate dust control measures continue to be implemented as per the Tweed Valley Hospital Management Plan – Air Quality and continue monitoring of PM10 for the duration of the project. If the action limit of  $2.5\text{ mg}/\text{m}^3$  (8-hour time weighted average) is exceeded, cease works and review and implement additional dust prevention techniques.

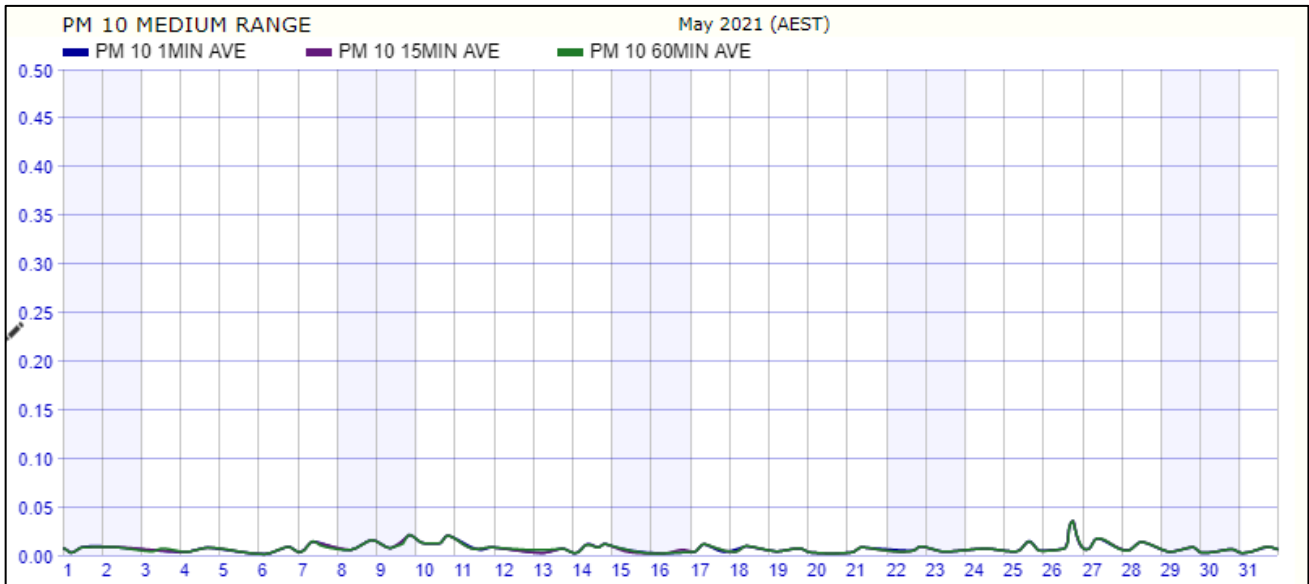
**Figure 2.** Summary of PM10 from the real time monitoring at location 002 – Central location for the month of May 2021.

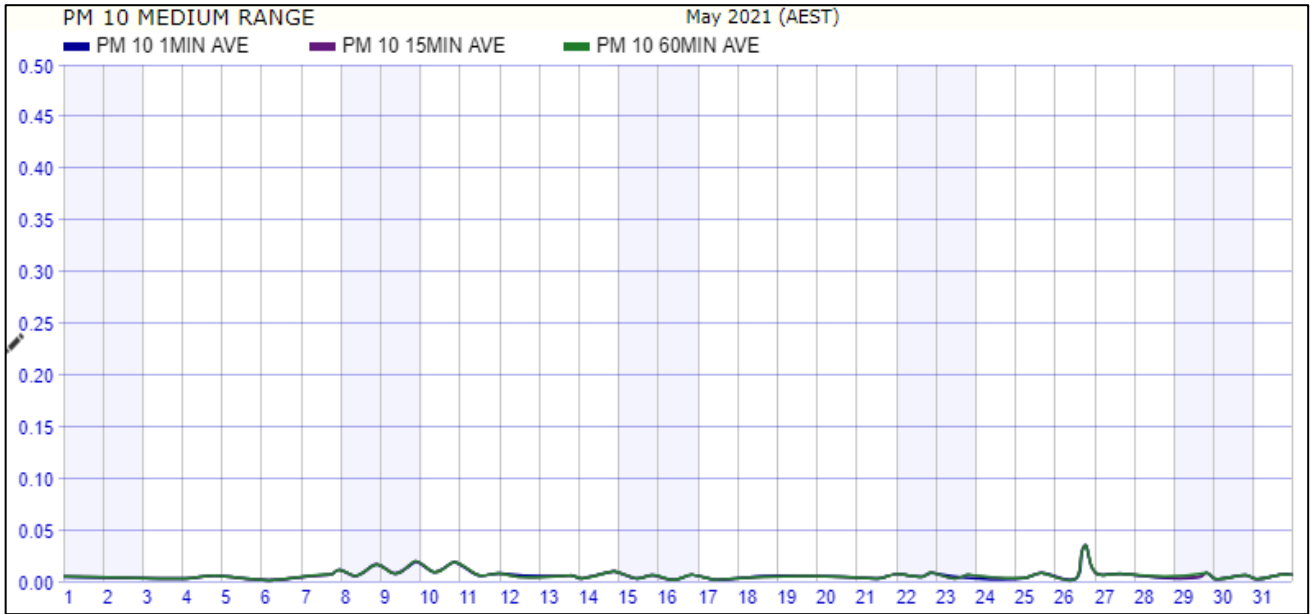
**Figure 3.** Summary of PM10 from the real time monitoring at location 003 – Eastern Section of site for the month of May 2021.

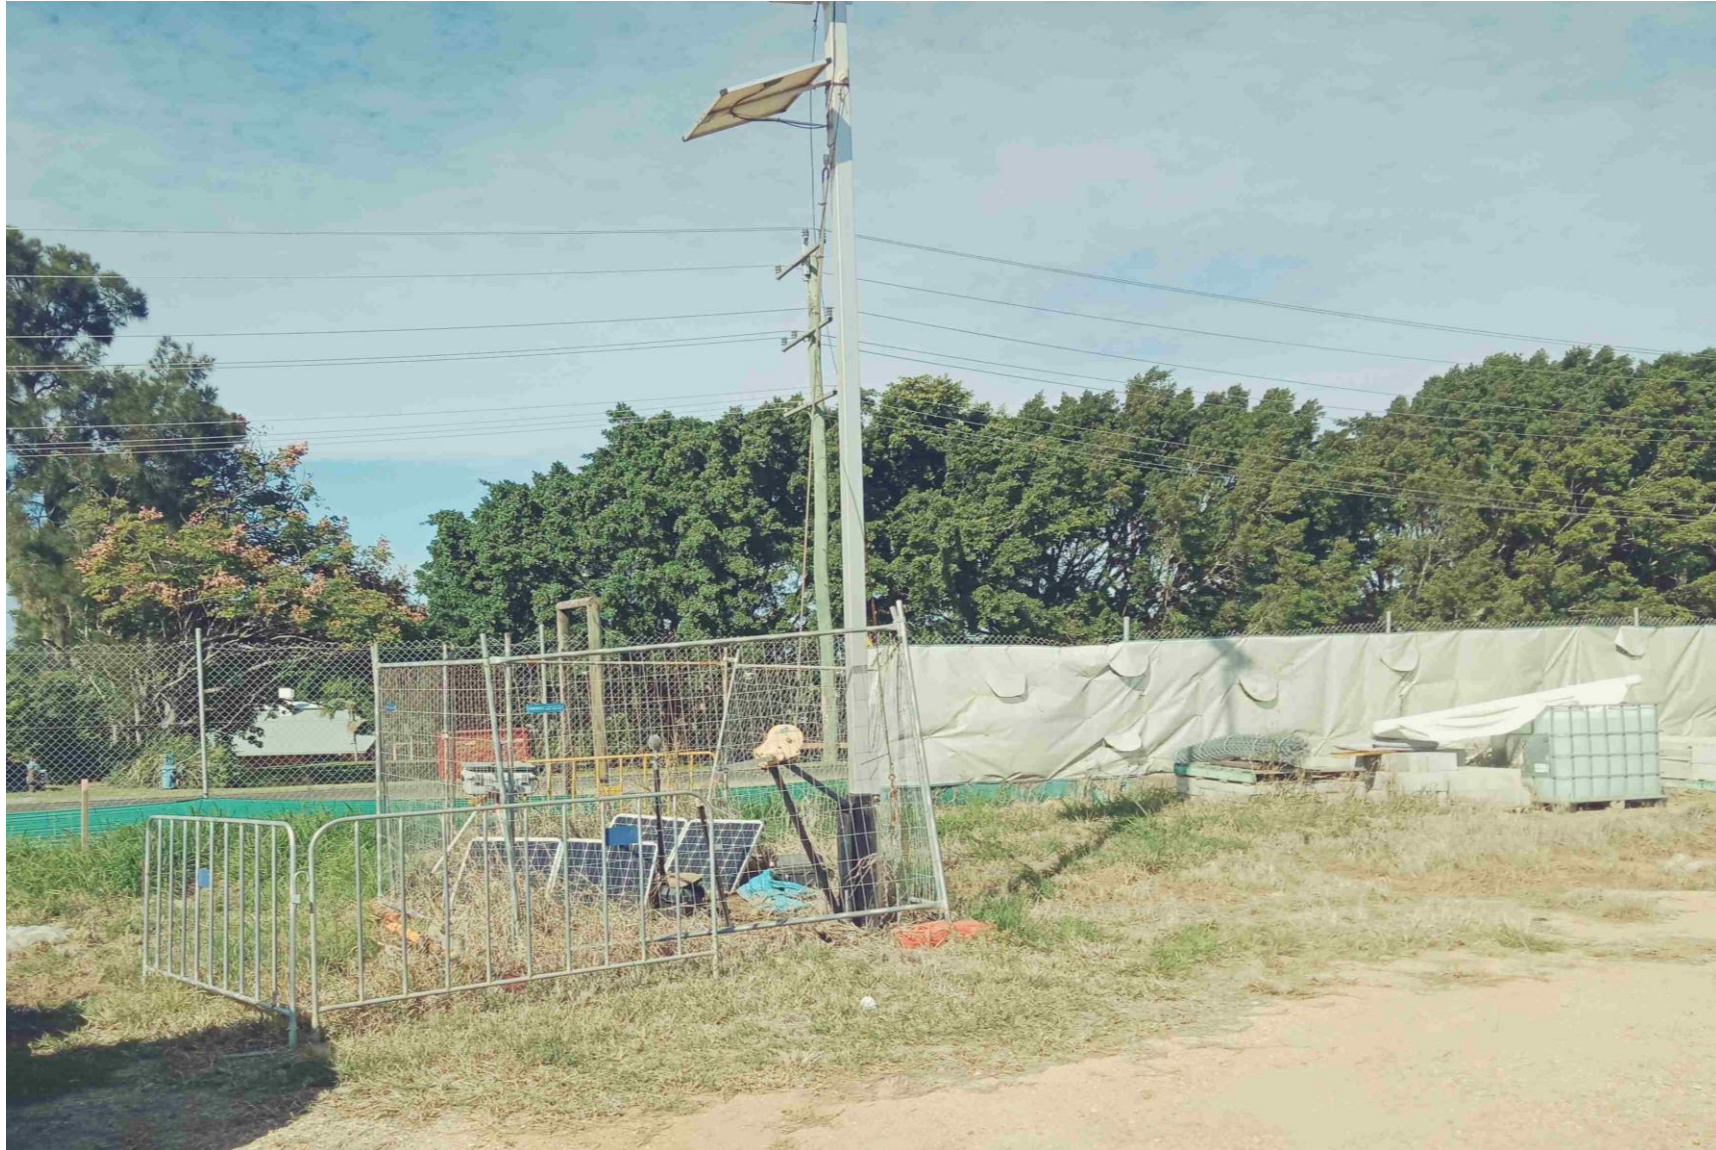
Photograph 2 Representative photograph of monitoring location 002 – Central location, as observed 01/06/2021
