Vibration Monitoring Assessment Report (June 2021)

Tweed Valley Hospital Project, Cudgen NSW

LND-01-Q1299 | VIB23.V1.1F | Date: 21/07/2021

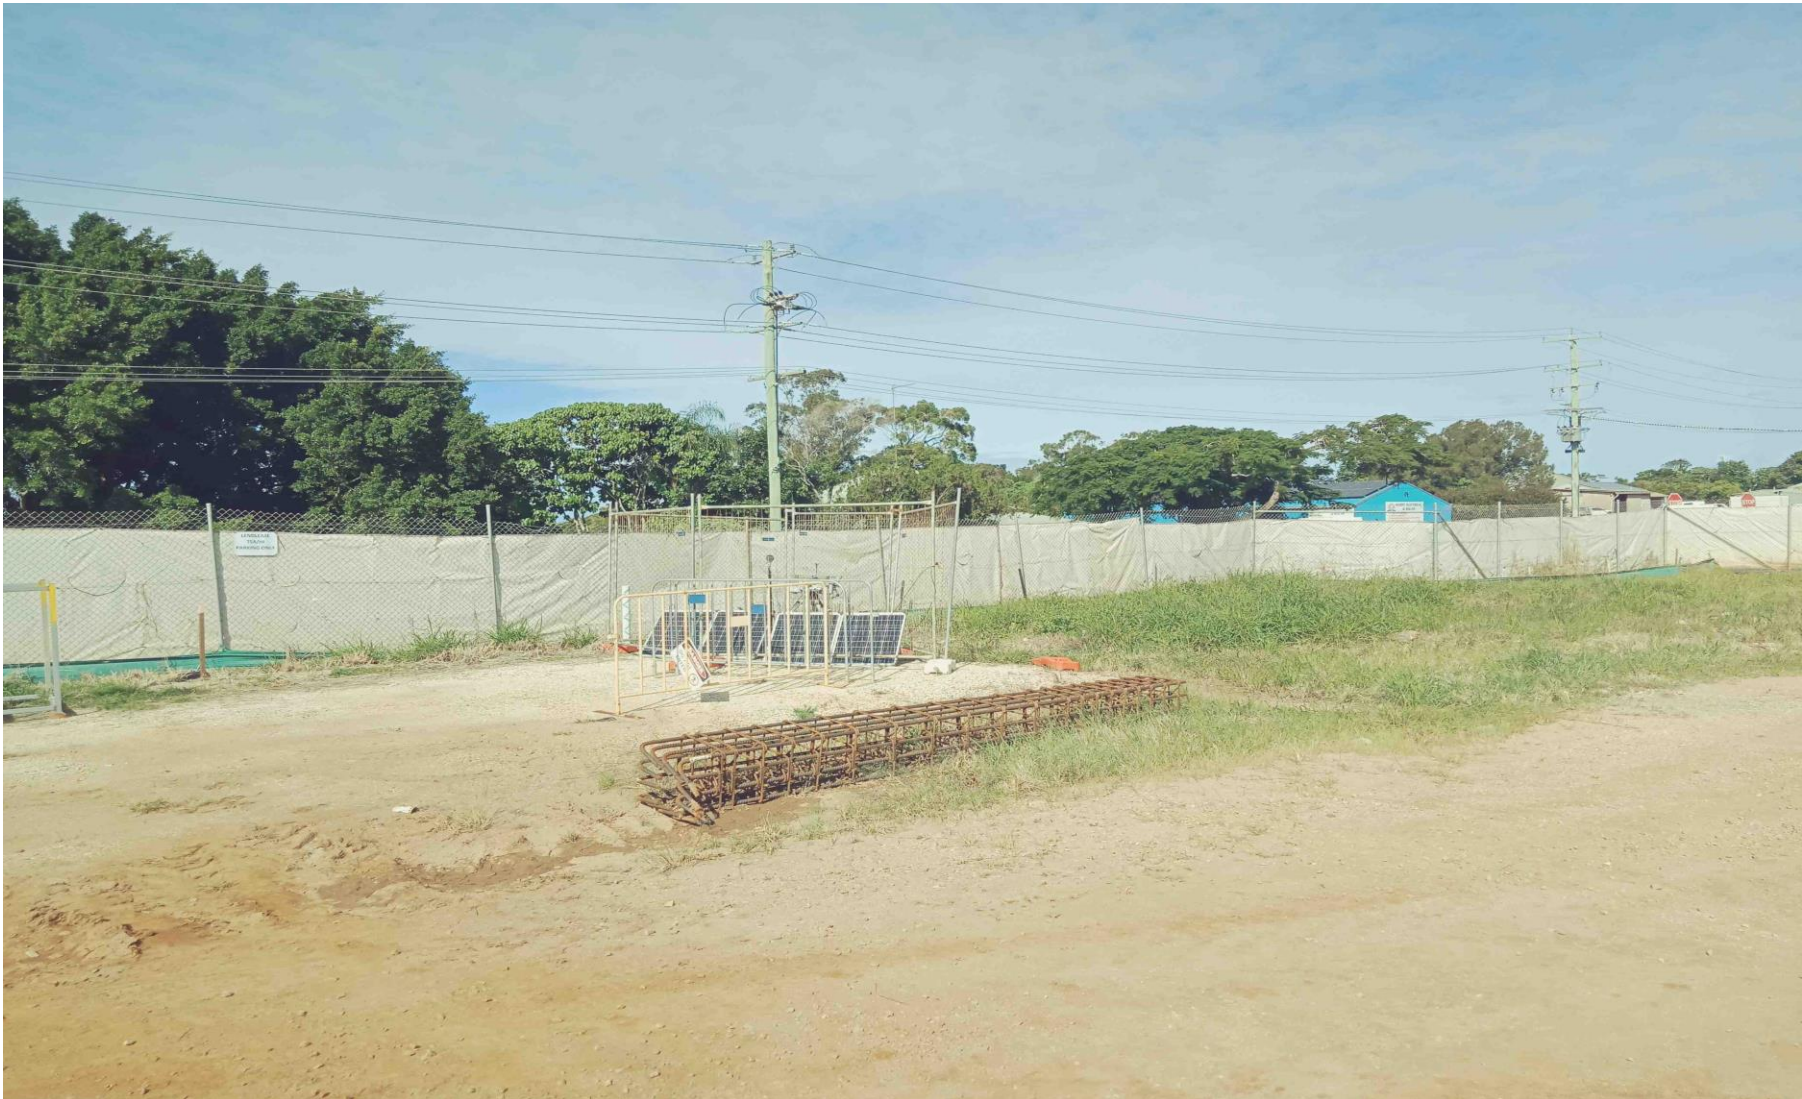
Photograph 1 Representative photograph of monitoring location 001 – Adjacent Carpark location, as observed 01/06/2021

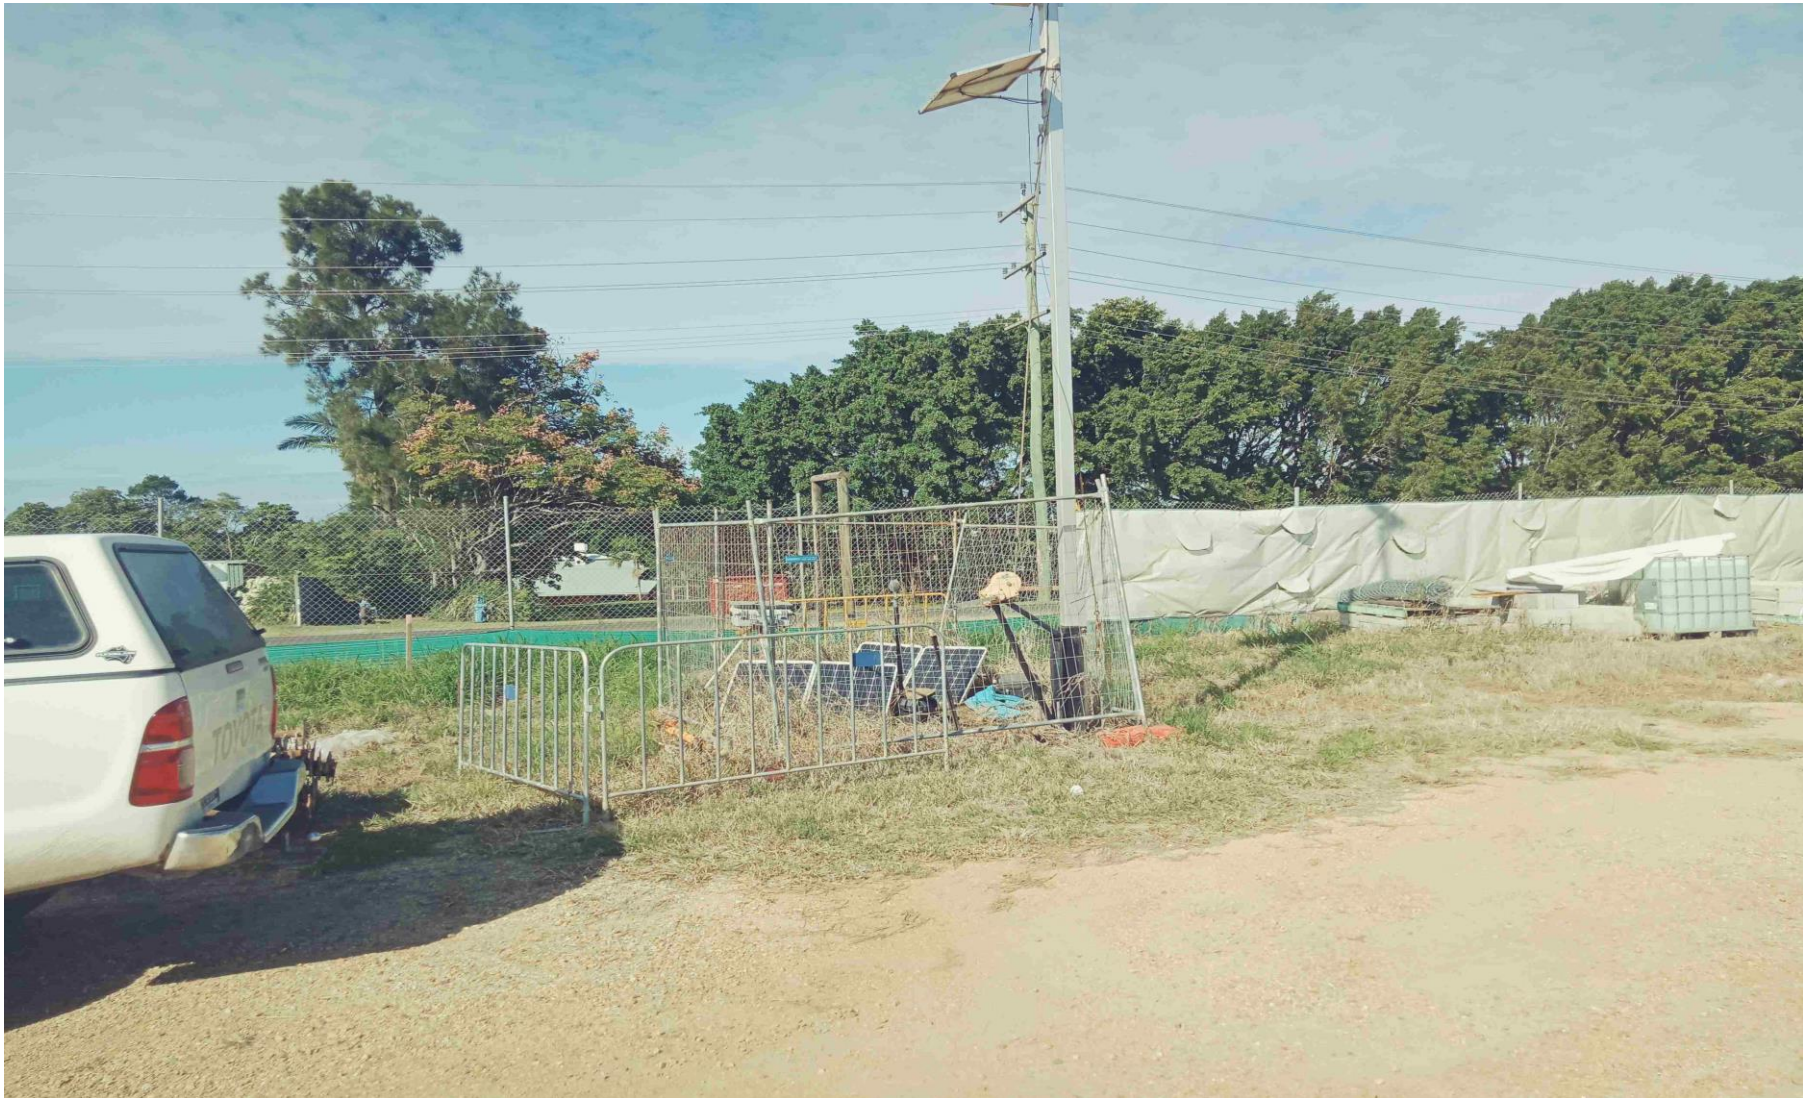
Photograph 2 Representative photograph of monitoring location 002 – Central location, as observed 01/06/2021

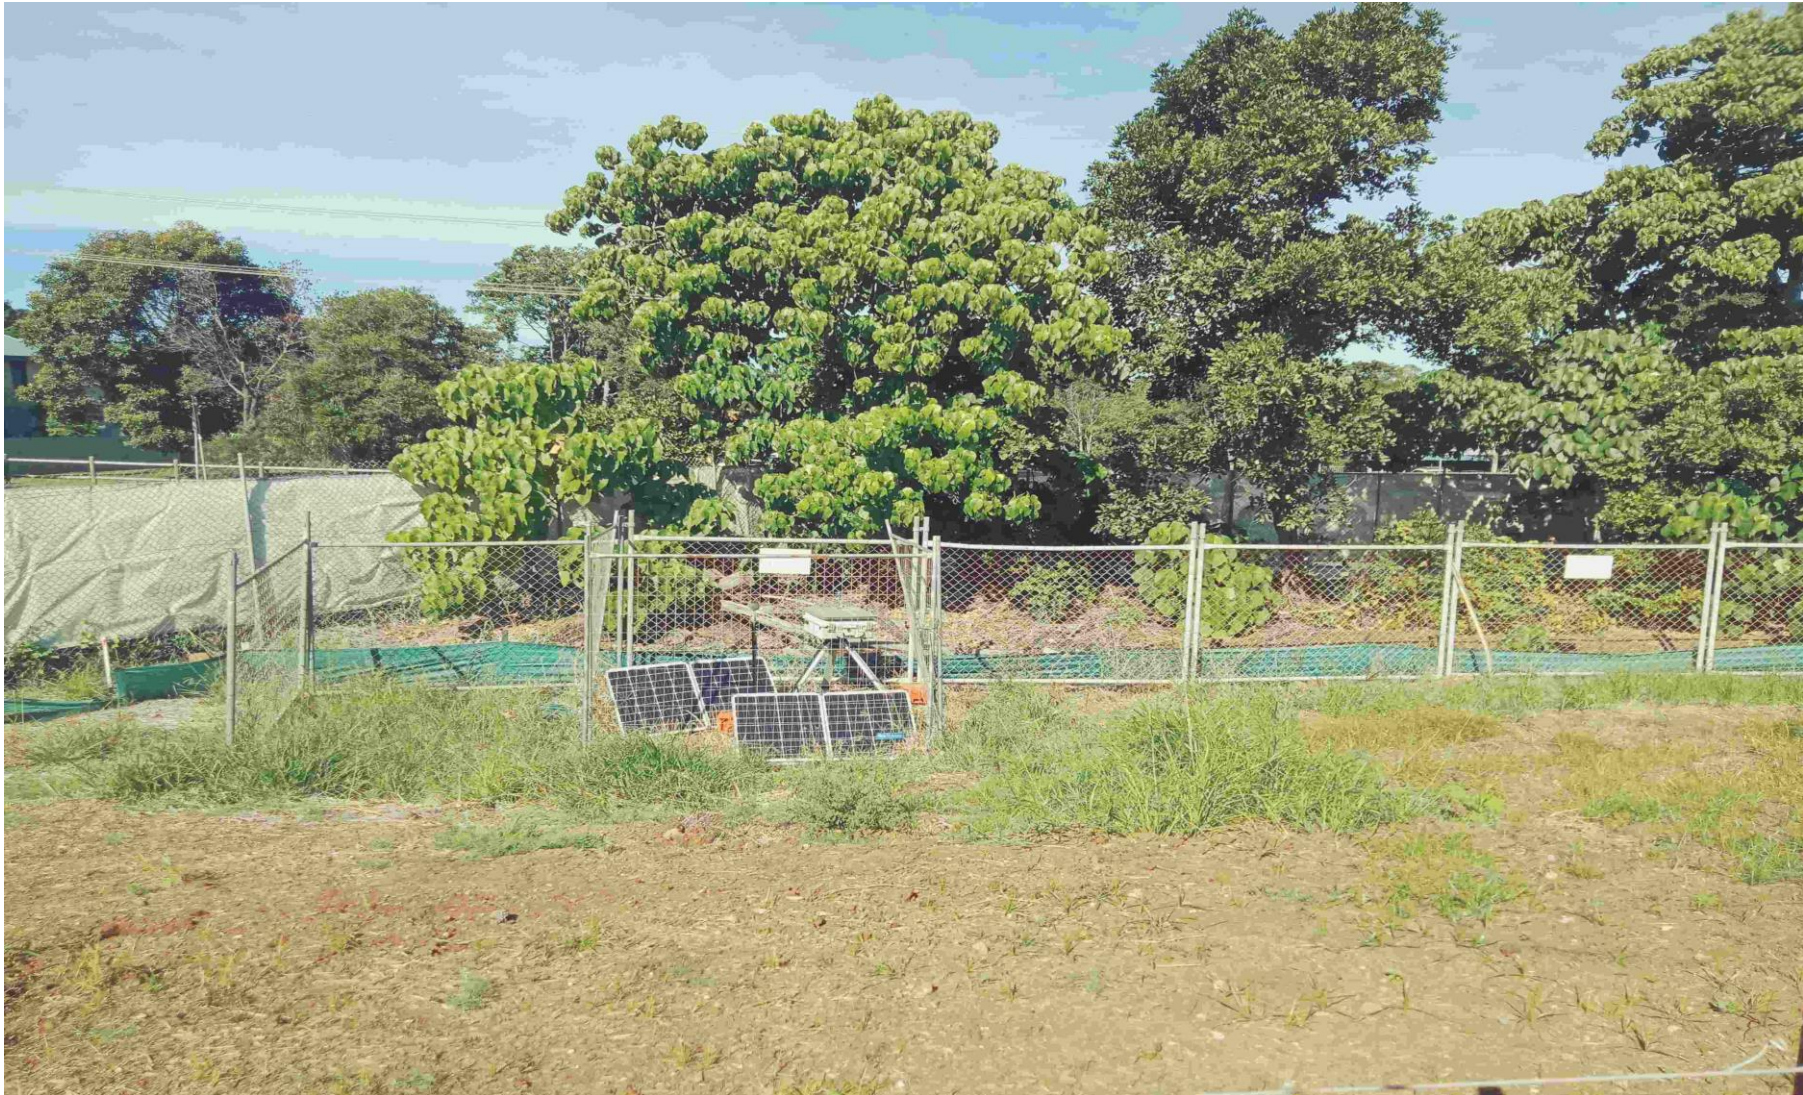
Photograph 3 Representative photograph of monitoring location 003 – Eastern Section of Site, as observed 01/06/2021
