# Vibration Monitoring Assessment Report (November 2021)

**Tweed Valley Hospital Project, Cudgen NSW**

A101021.0286.00 | VIB28.Rev0 | Date: 20/12/2021

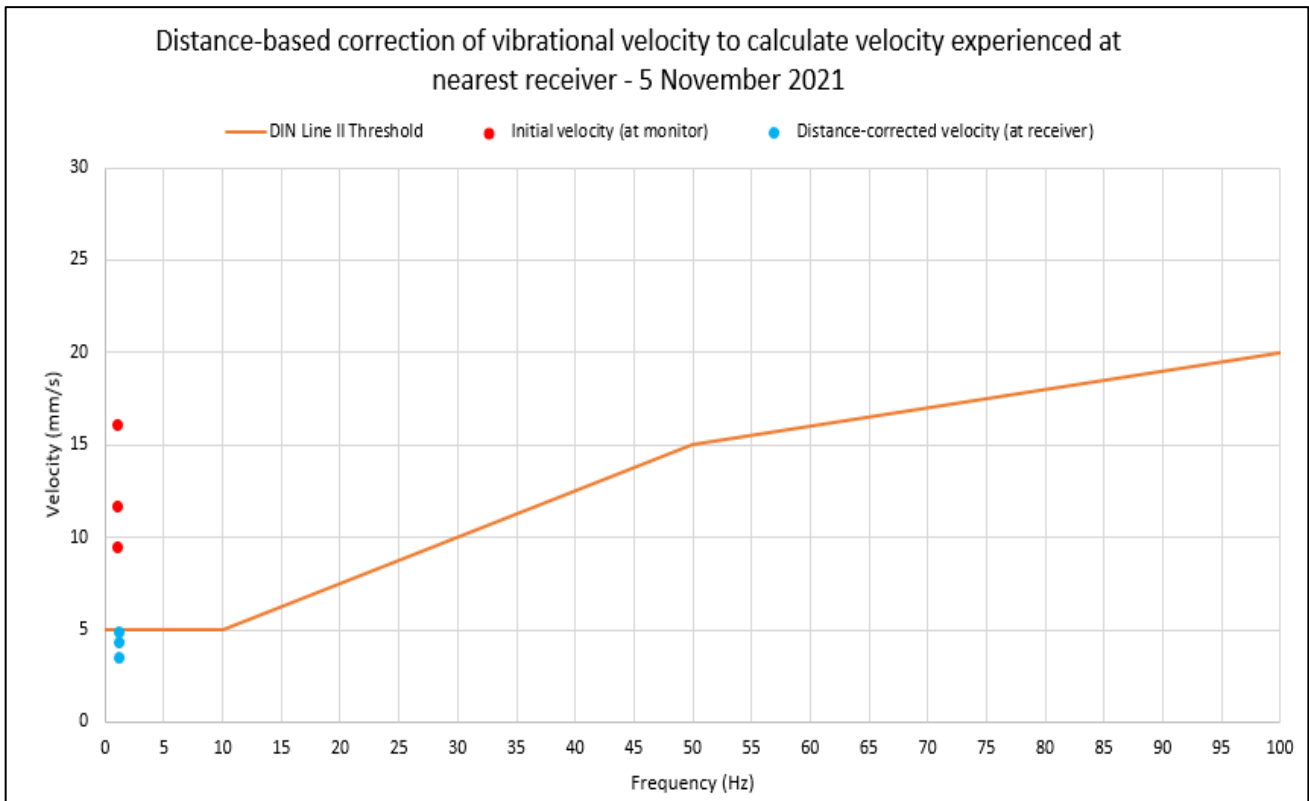
Table 3 below summarises the three (3) exceedances detected at monitoring location 001 on the 5<sup>th</sup> of November 2021 and show the values before and after a distance correction is applied. The “Value (after distance correction)” represents the value experienced at the receiver and in all three (3) cases this value is below the DIN4150 criteria specified in section 1.6.

Figure 4 below shows the three (3) values measured at the logger above DIN4150 Line 2 and the distance corrected velocity (at receiver) values. The distance corrected value were below line 2.

Figure 4 Distance corrected PPV values (monitoring location 001)

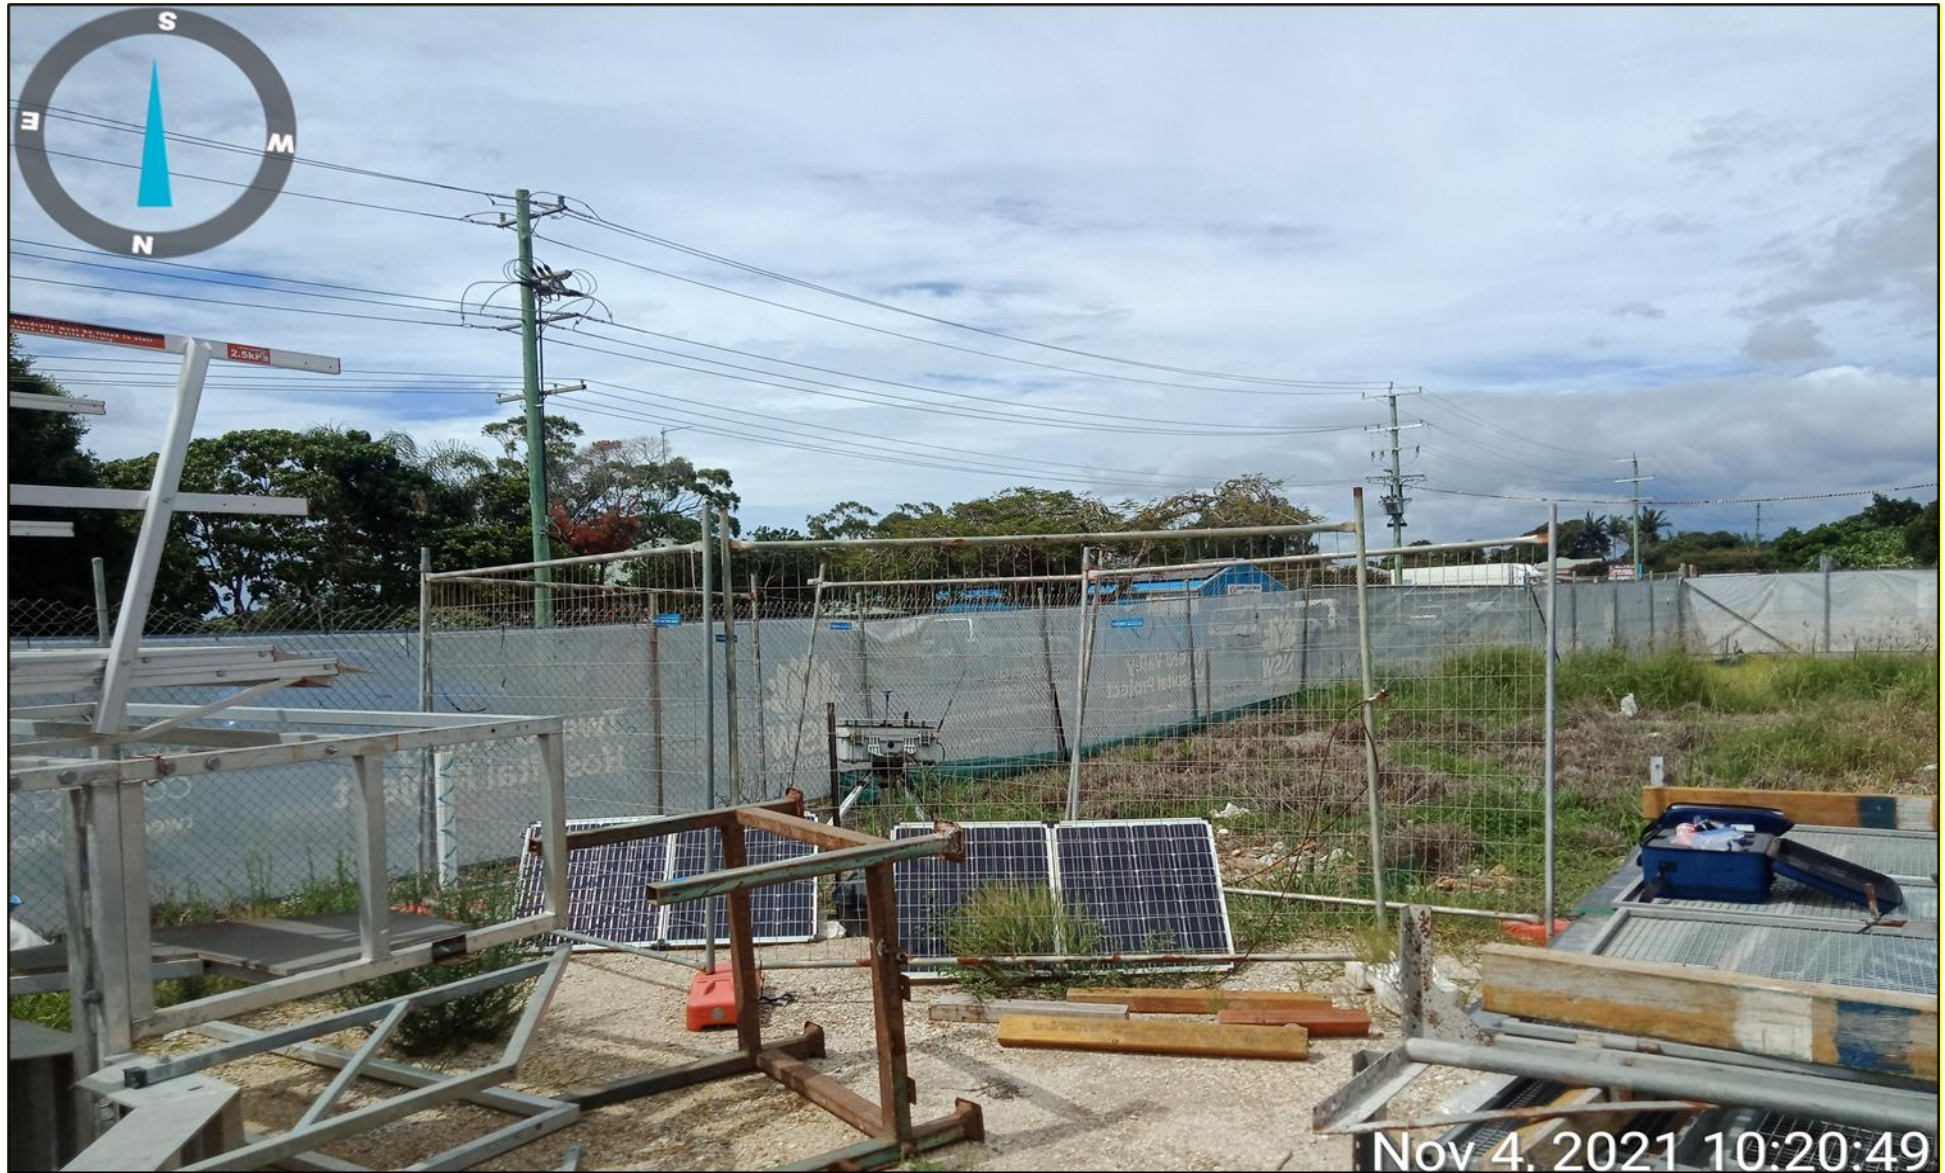
Photograph 1 Representative photograph of monitoring location 001 – Adjacent Carpark location, as observed 04/11/2021

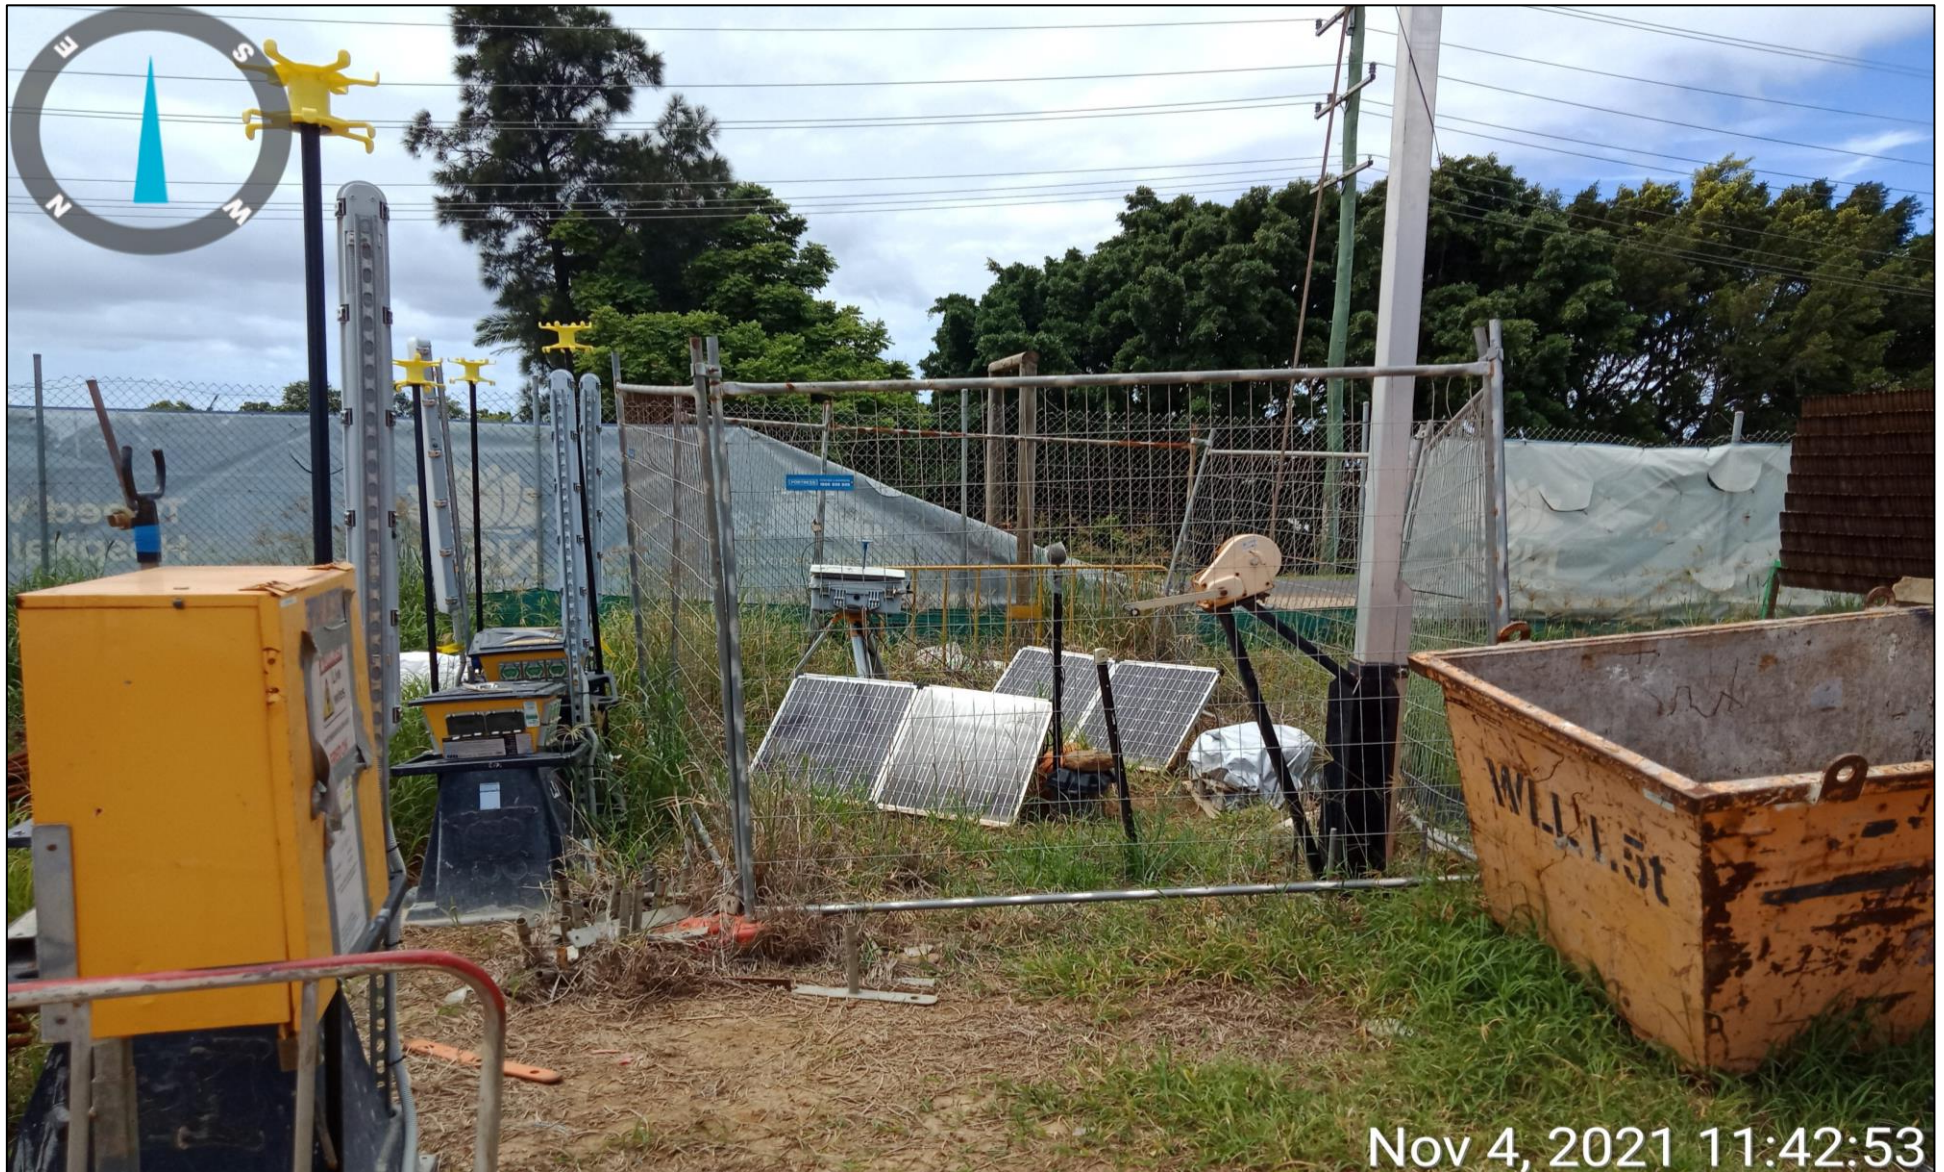
Photograph 2 Representative photograph of monitoring location 002 – Central location, as observed 04/11/2021

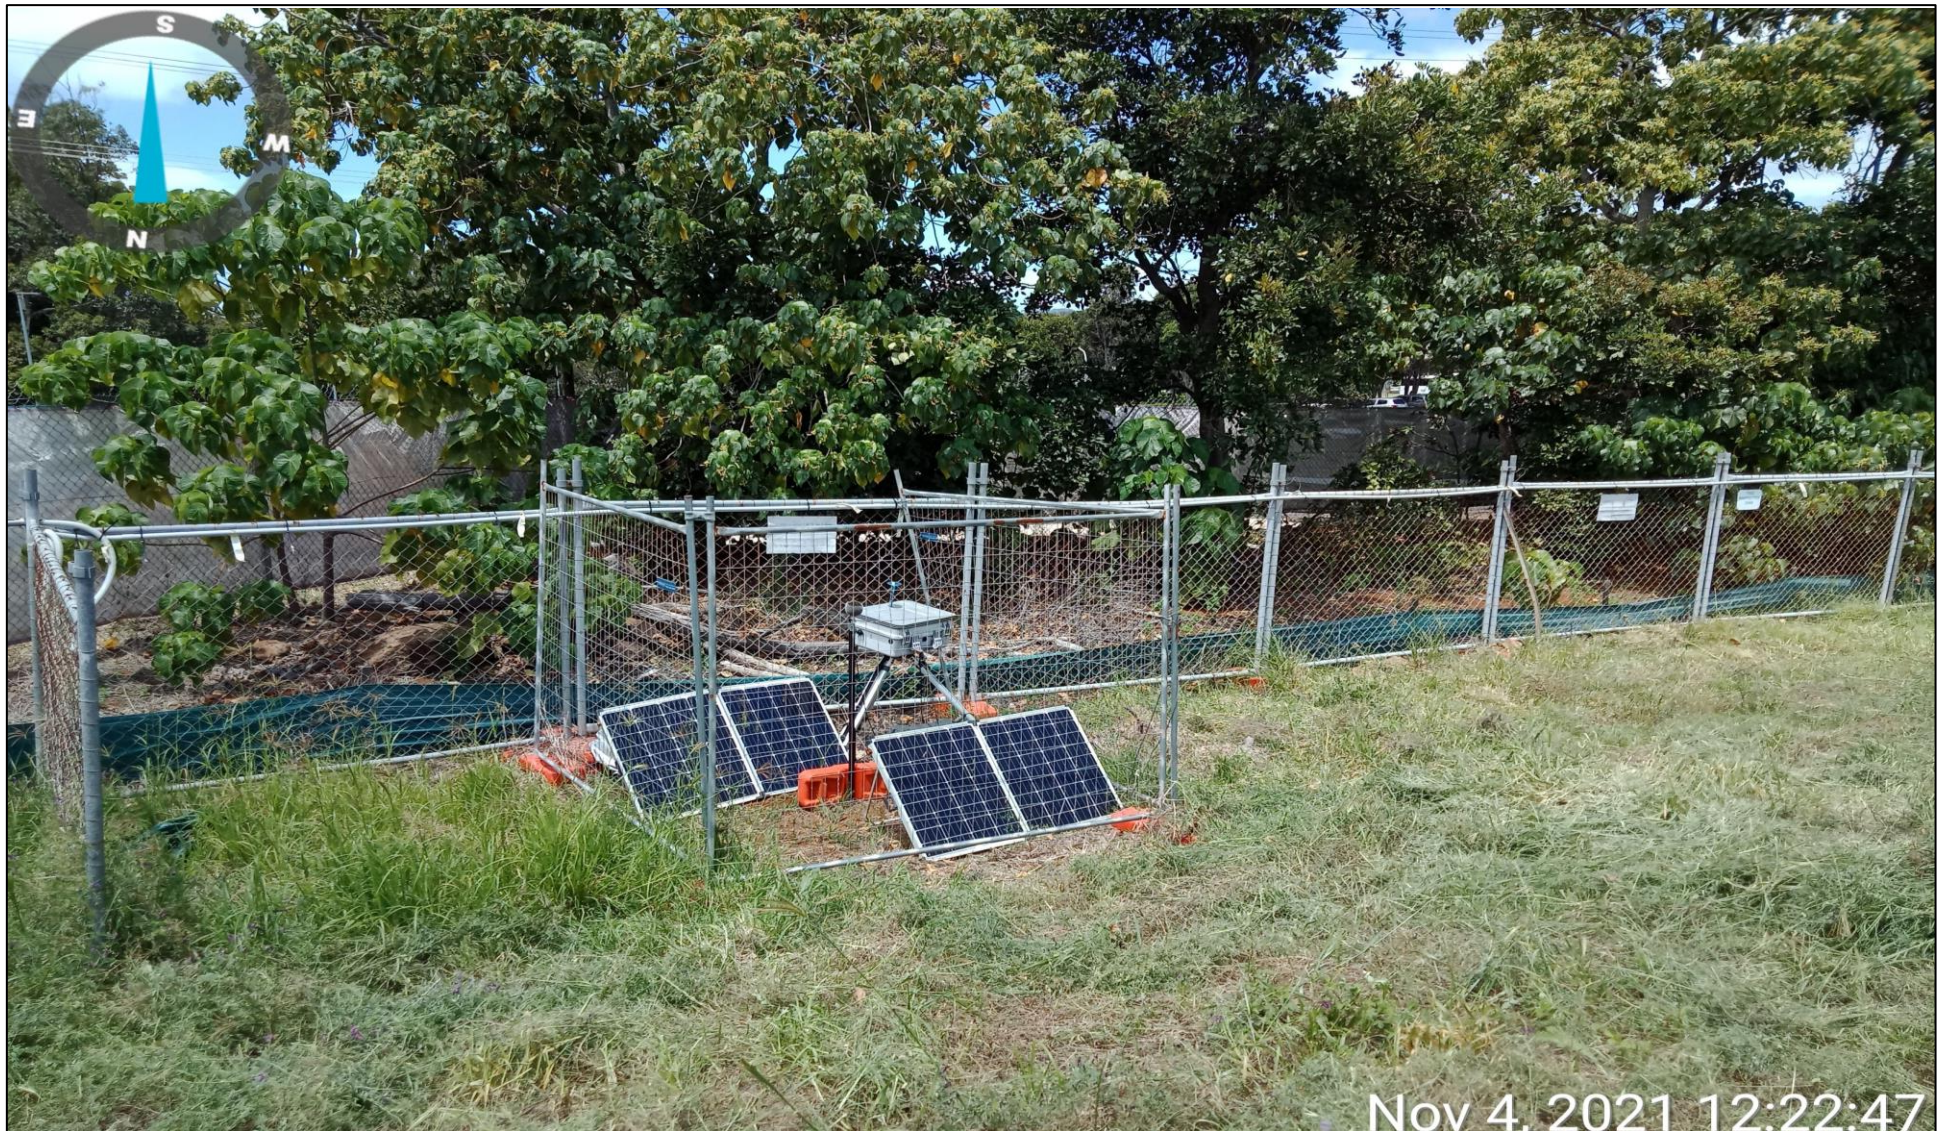
Photograph 3 Representative photograph of monitoring location 003 – Eastern Section of Site, as observed 04/11/2021
