Vibration Monitoring Assessment Report (April 2021)

Tweed Valley Hospital Project, Cudgen NSW

Prepared for: Lendlease Building Pty Ltd

LND-01-Q1299 | VIB21.V15F | Date: 1/07/2021

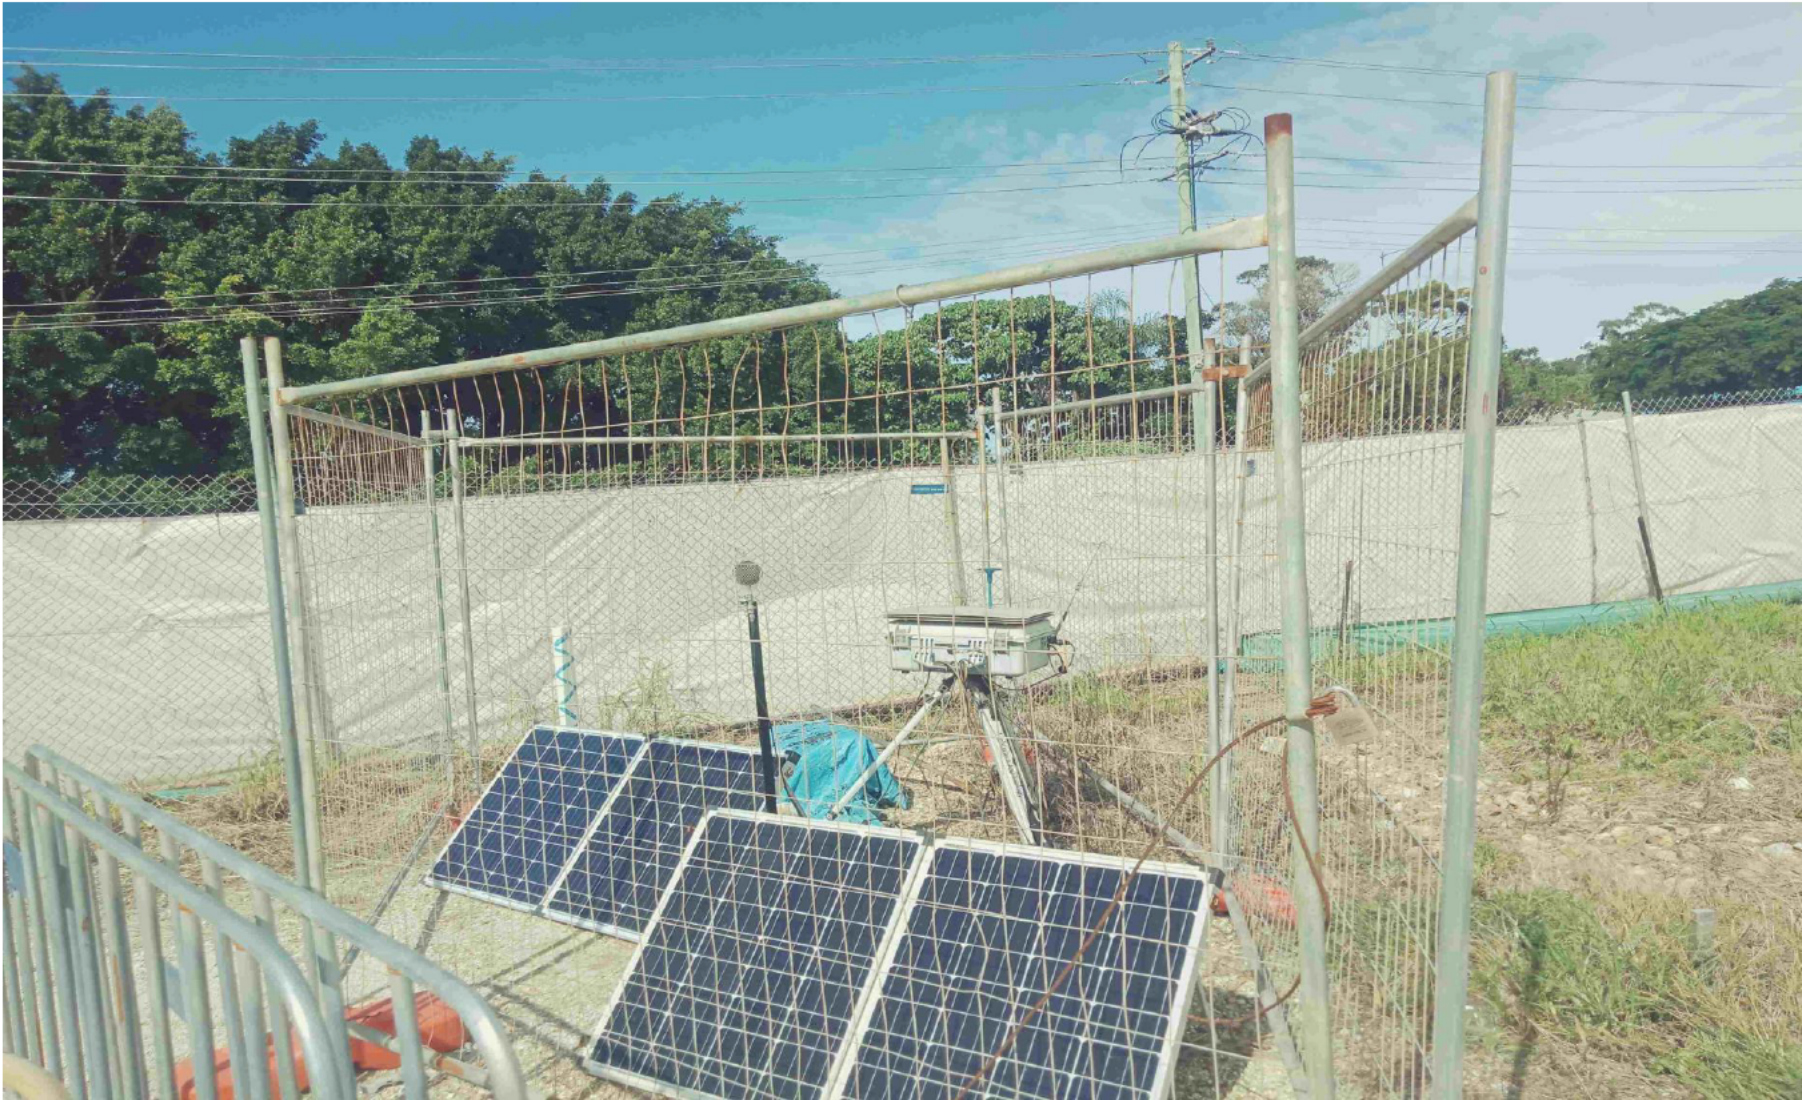
The vibration measurements were recorded using Profound Vibra+ vibration monitors. These vibration monitors are enclosed in a tough case which is placed on the ground and covered with a tarp to aid in keeping temperatures below 60°C, to ensure continuous monitoring. The accelerometer is placed firmly against the soil surface and covered with a sandbag to minimize external interference. The monitors are positioned within the Site along the boundary adjacent Cudgen Road.

Photograph 1 Representative photograph of monitoring location 001 – Adjacent Carpark location, as observed 28/04/2021

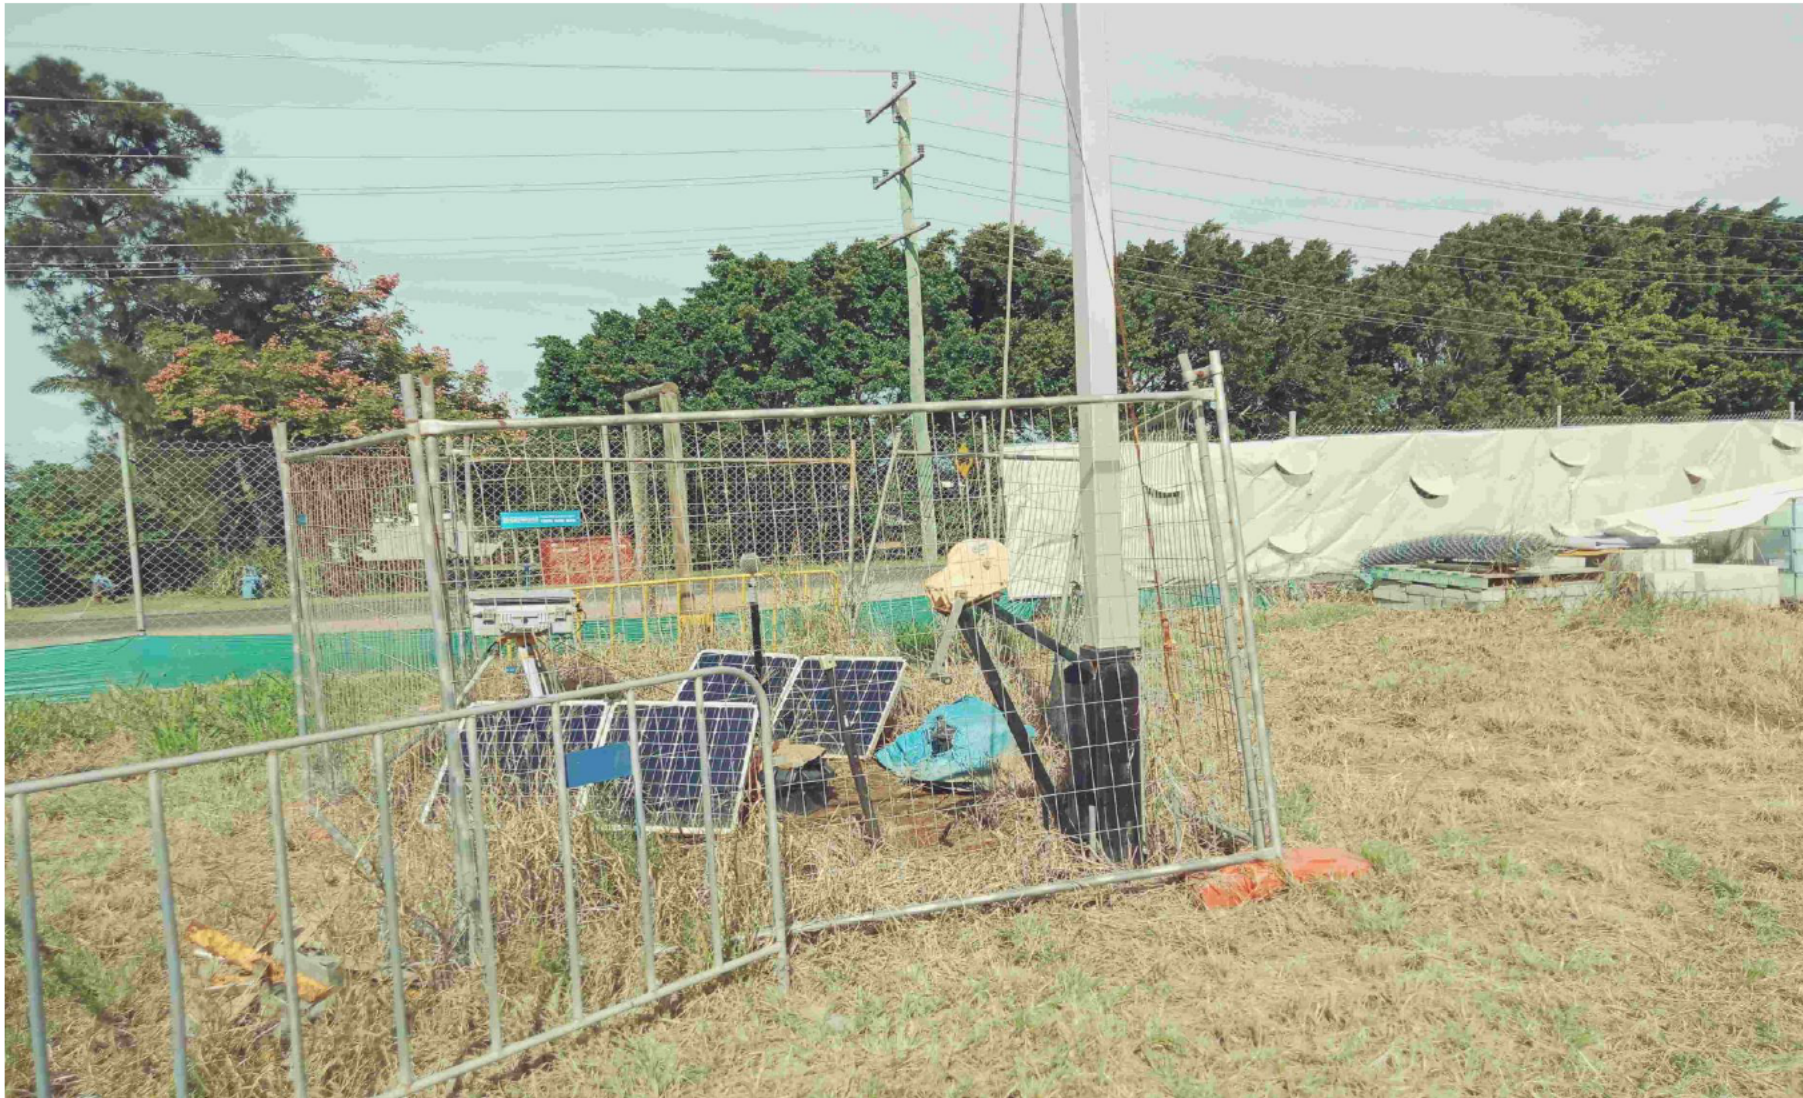
Photograph 2 Representative photograph of monitoring location 002 – Central location, as observed 28/04/2021

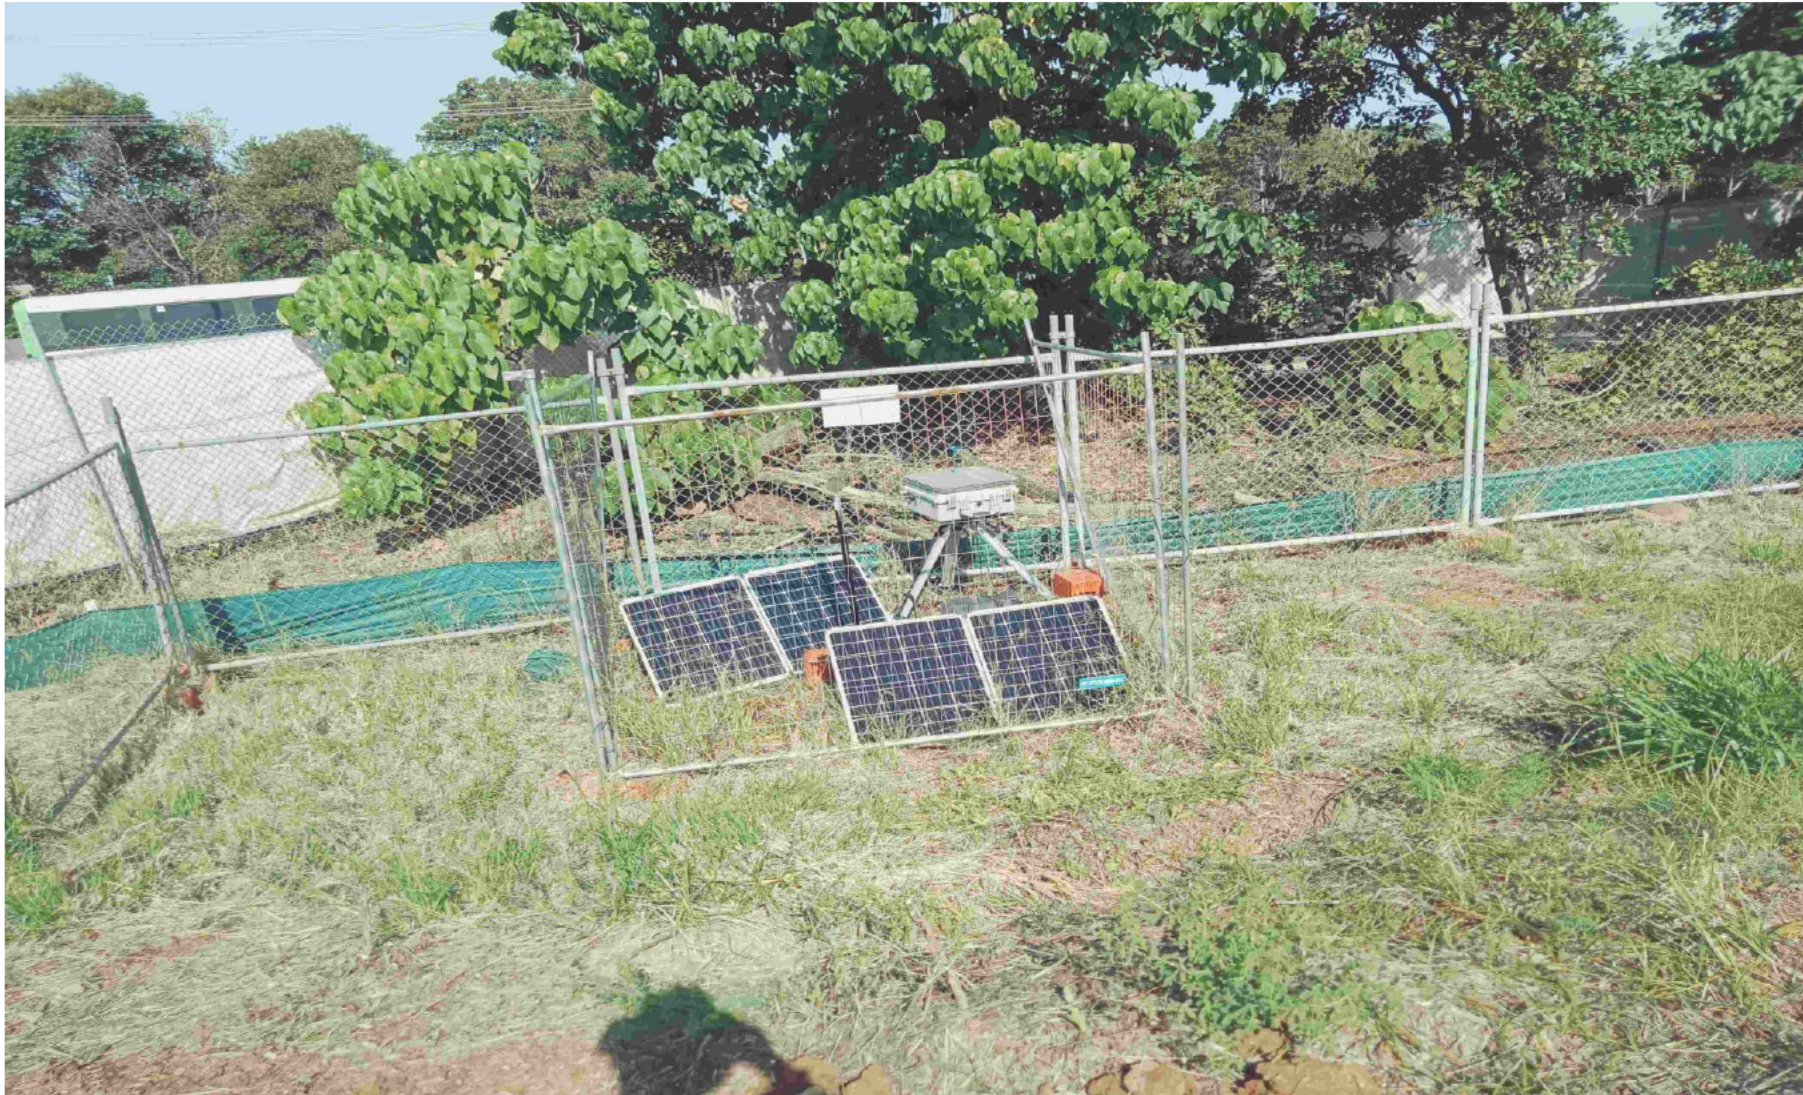
Photograph 3 Representative photograph of monitoring location 003 – Eastern Section of Site, as observed 28/04/2021
