# Vibration Monitoring Assessment Report (February 2021)

**Tweed Valley Hospital Project, Cudgen NSW**

Prepared for: Lendlease Building Pty Ltd

LND-01-Q1299 | VIB19.V1.7F | Date: 1/07/2021

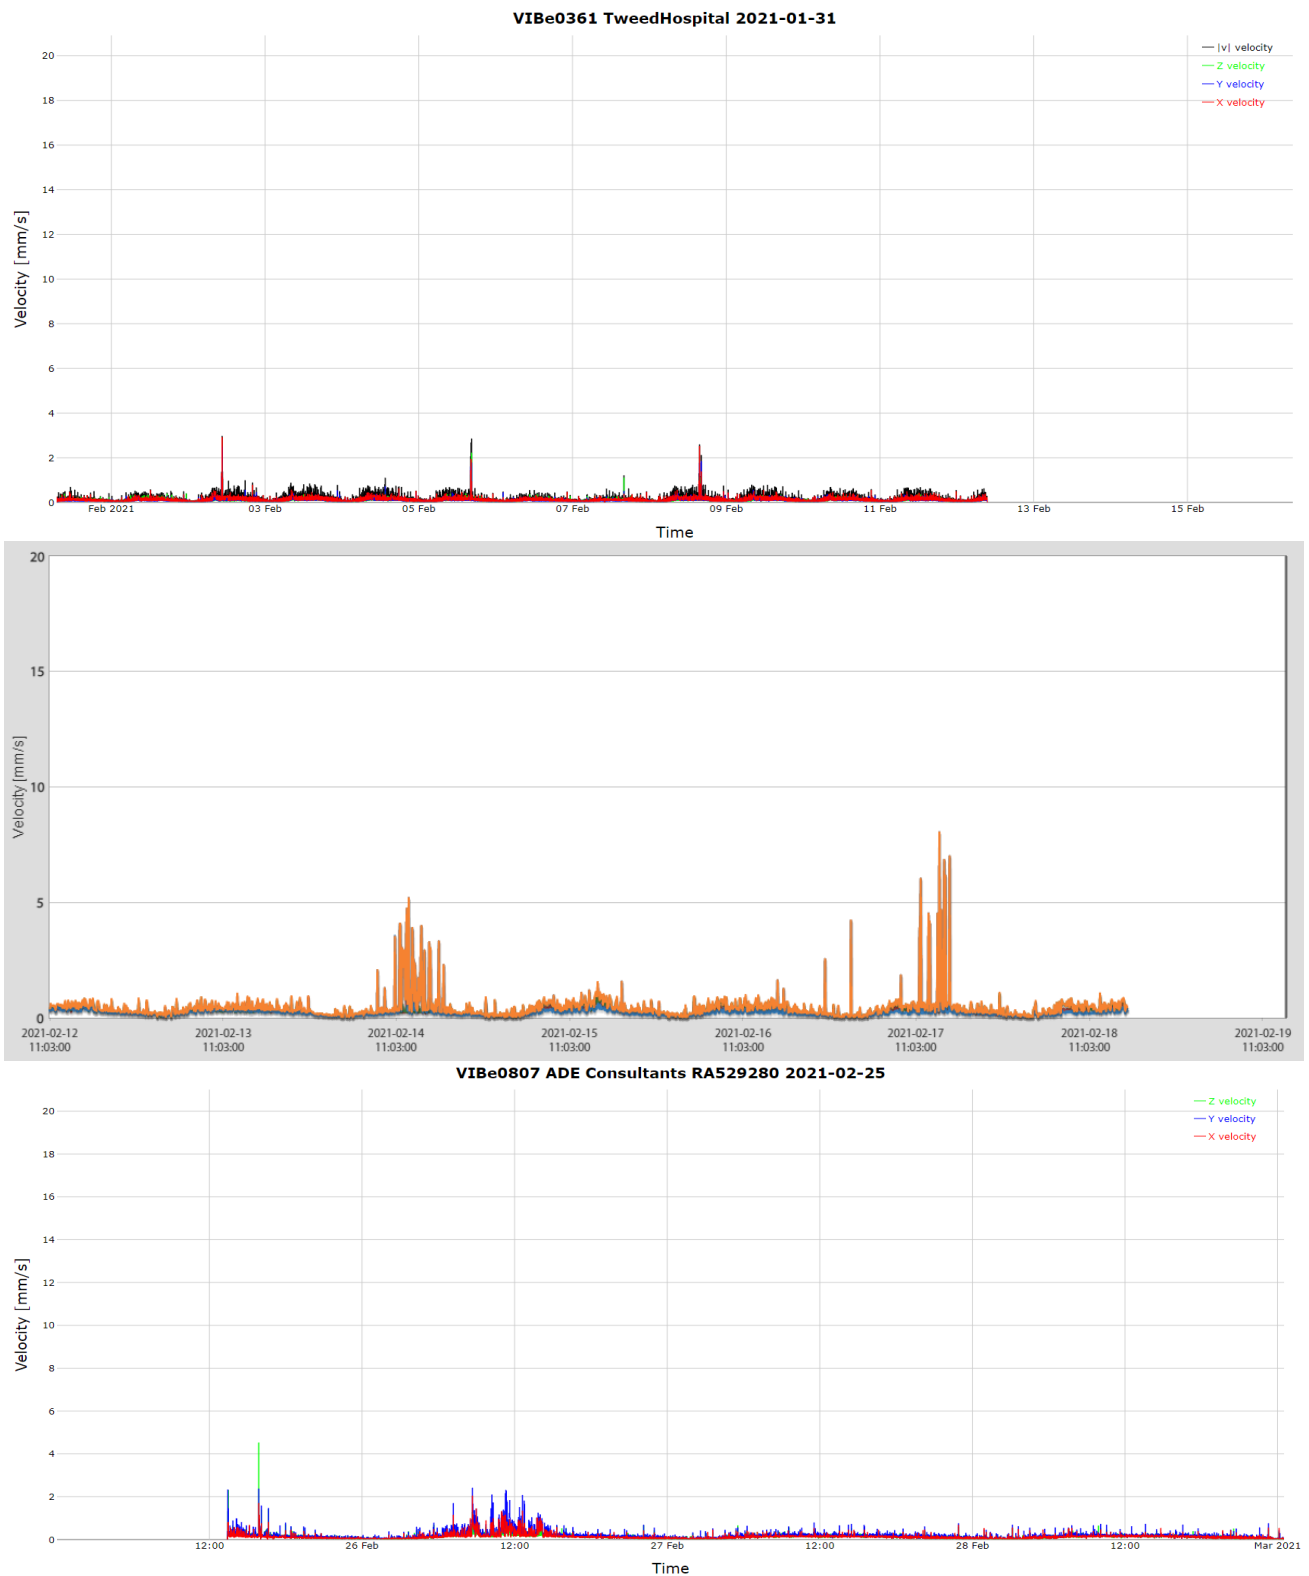
**Figure 1** Vibration data at location 001 | Adjacent carpark | 1 February - 28 February 2021

On 18 February 2021, the monitor at location 001 went down due to manufacturer fault, ADE attended the site and removed the faulty monitor for replacement. A rental Vibra+ monitor was sourced and installed on 25 February. Due to this, there is a gap in the data recorded at location 001 between 18 February and 25 February.

Data measured at location 001 is presented below in **Figure 1**.

During the monitoring period (1 February to 28 February 2021) no exceedance of DIN 4150 Line 1 or Line 2 PPV guideline values was observed.

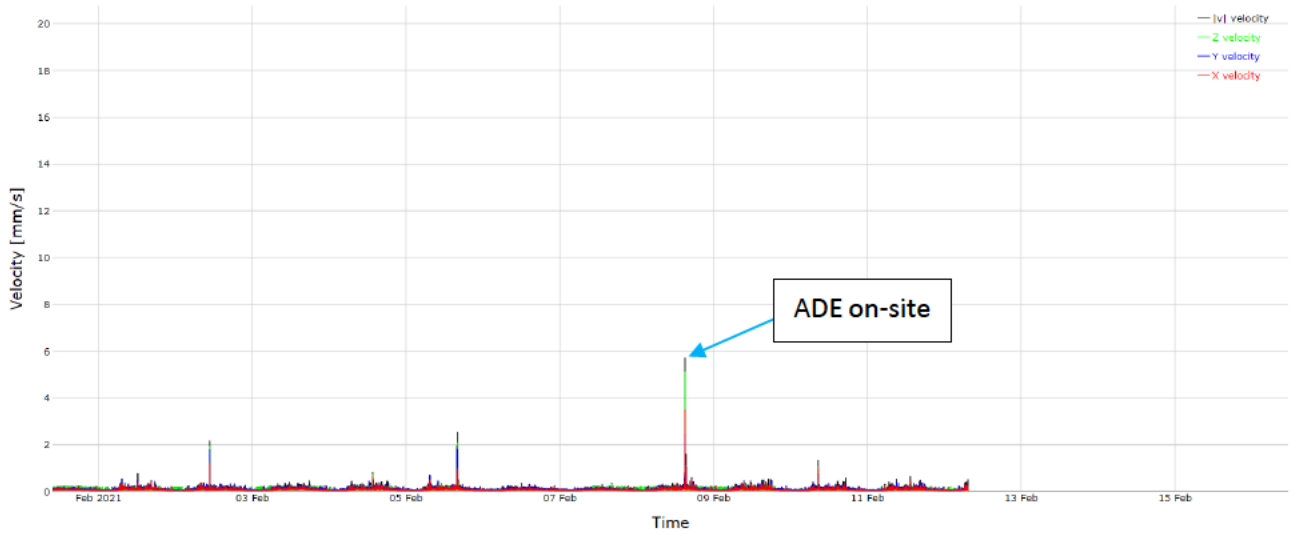
**Figure 2** Vibration data at location 002 | Central monitor | 1 February - 28 February 2021

Data measured at location 002 is presented below in Figure 2.

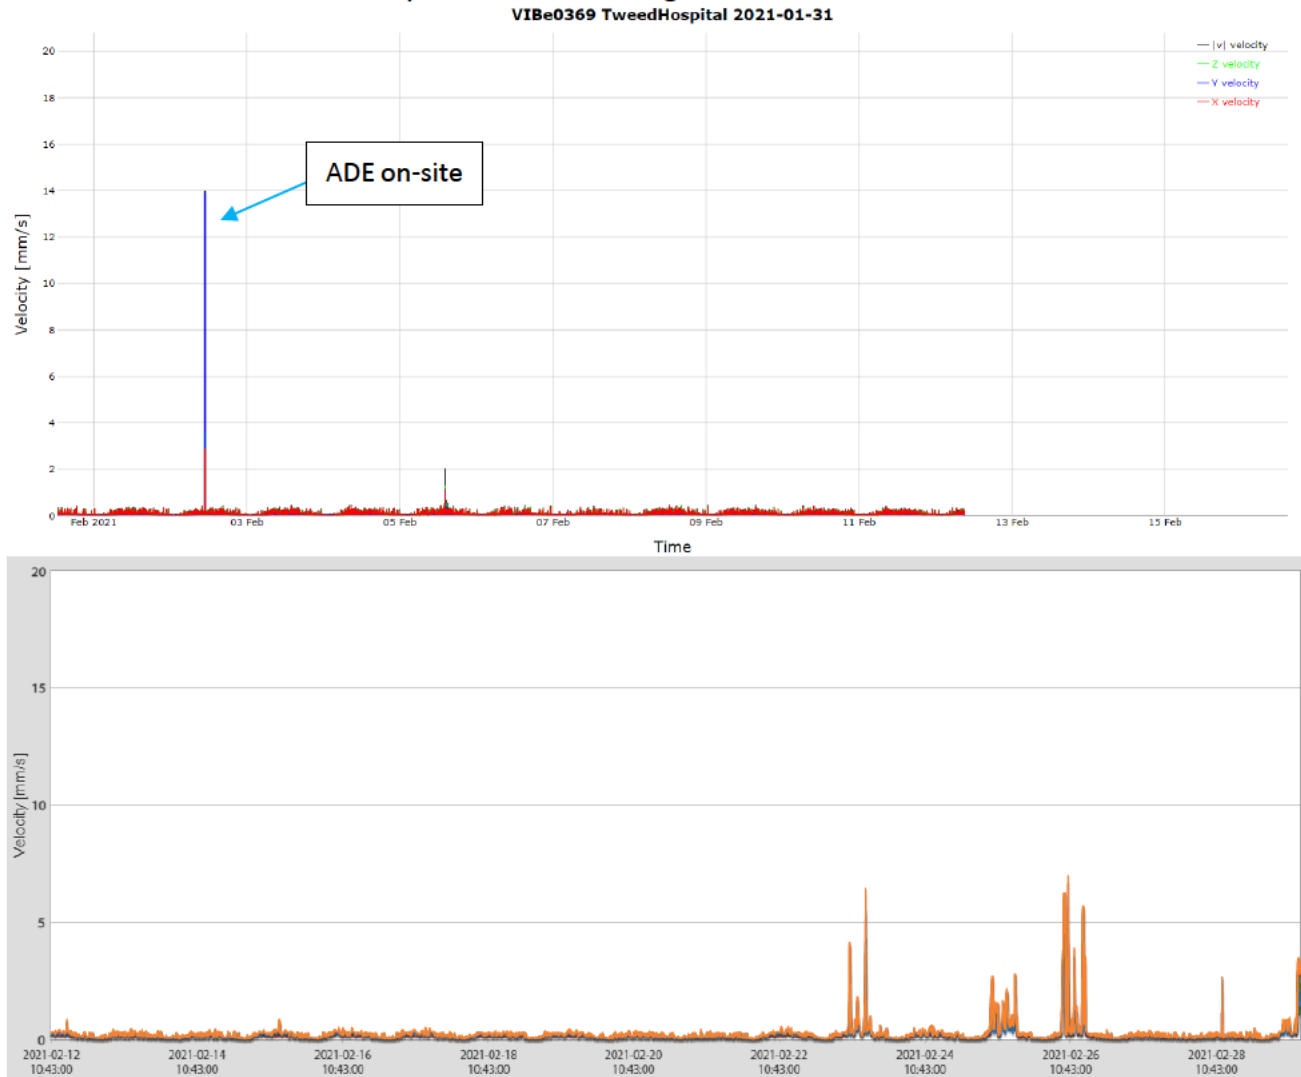
**Figure 3** Vibration data at location 003 | Eastern section | 1 February - 28 February 2021

Data measured at location 003 is presented below in Figure 3.

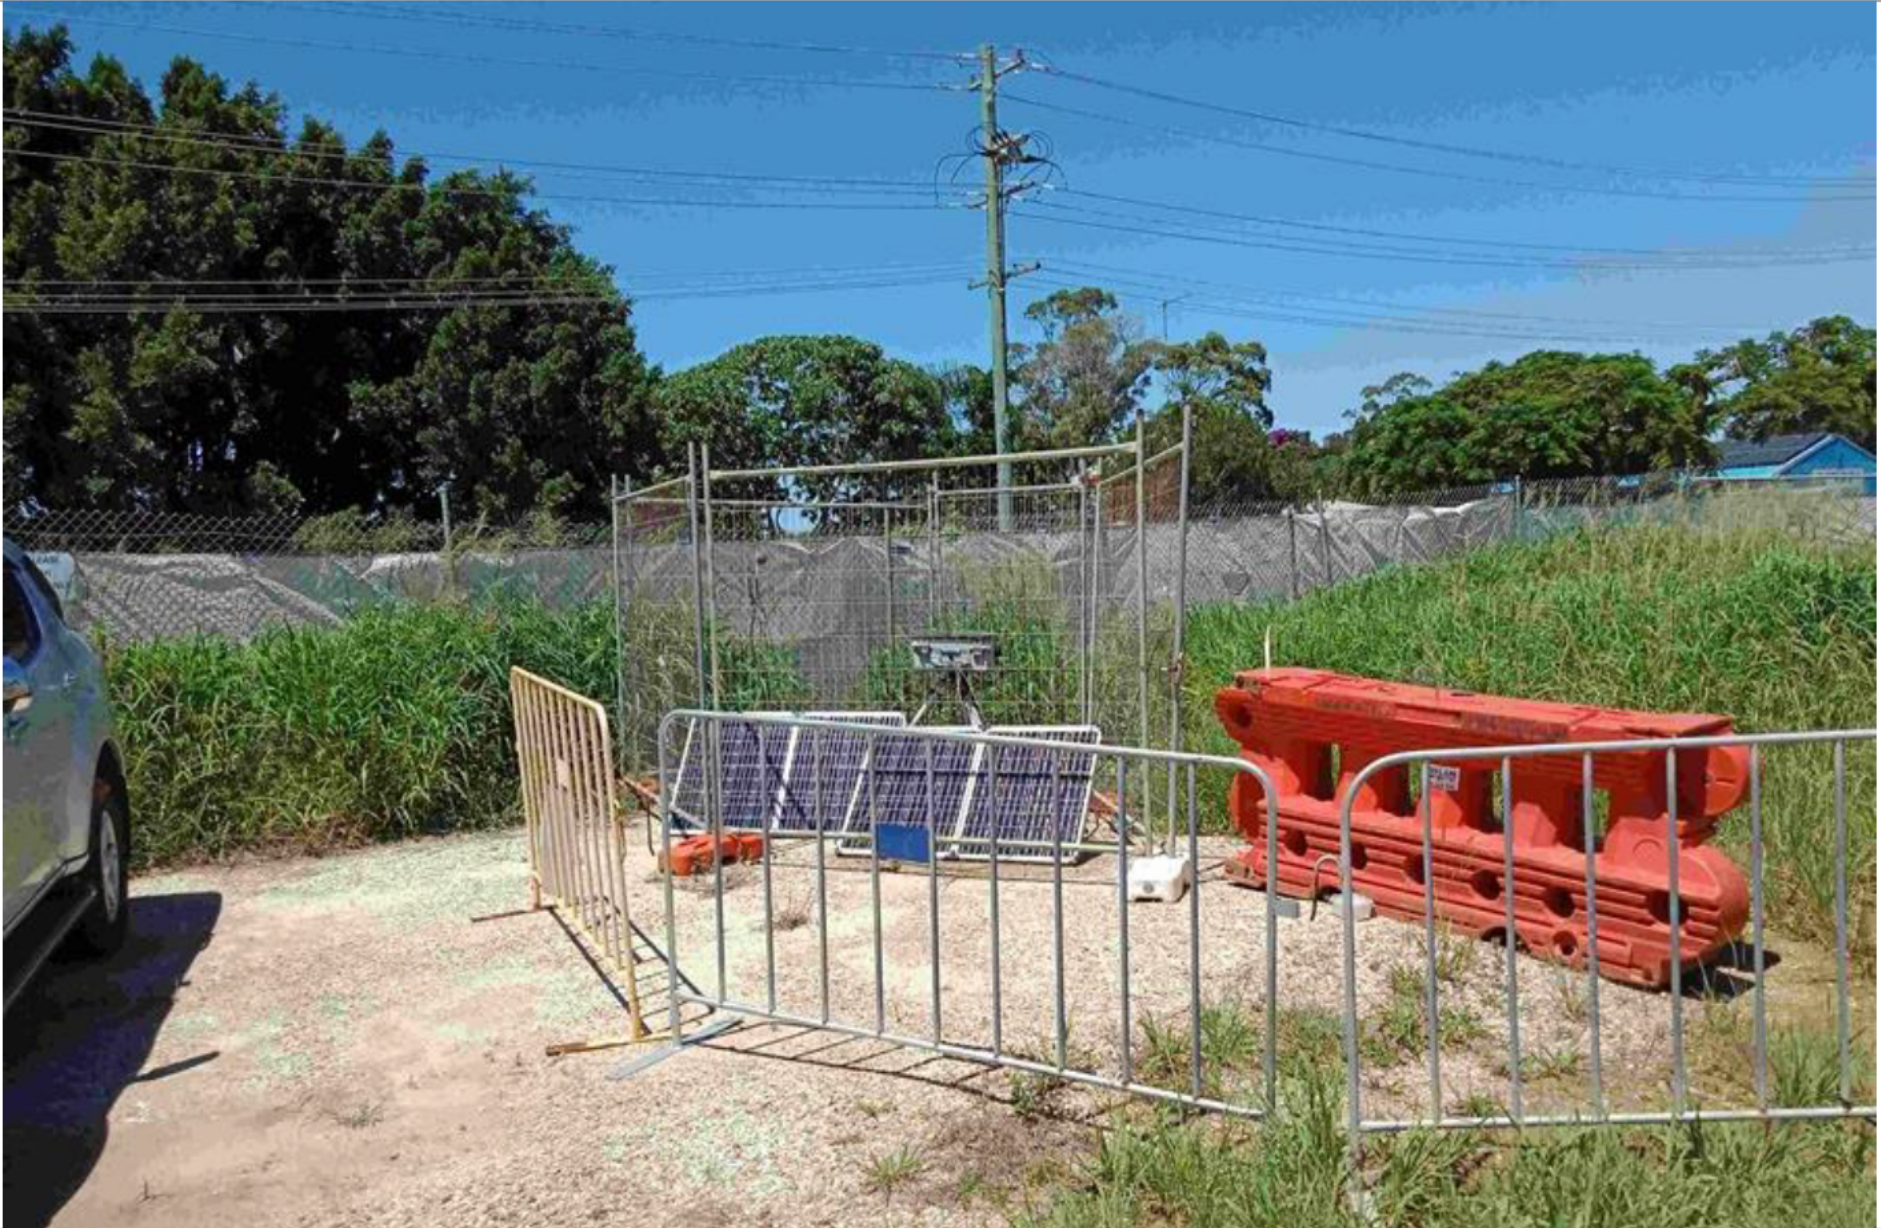
Photograph 1 Representative photograph of monitoring location 001 – Adjacent Carpark location, as observed 22/02/2021

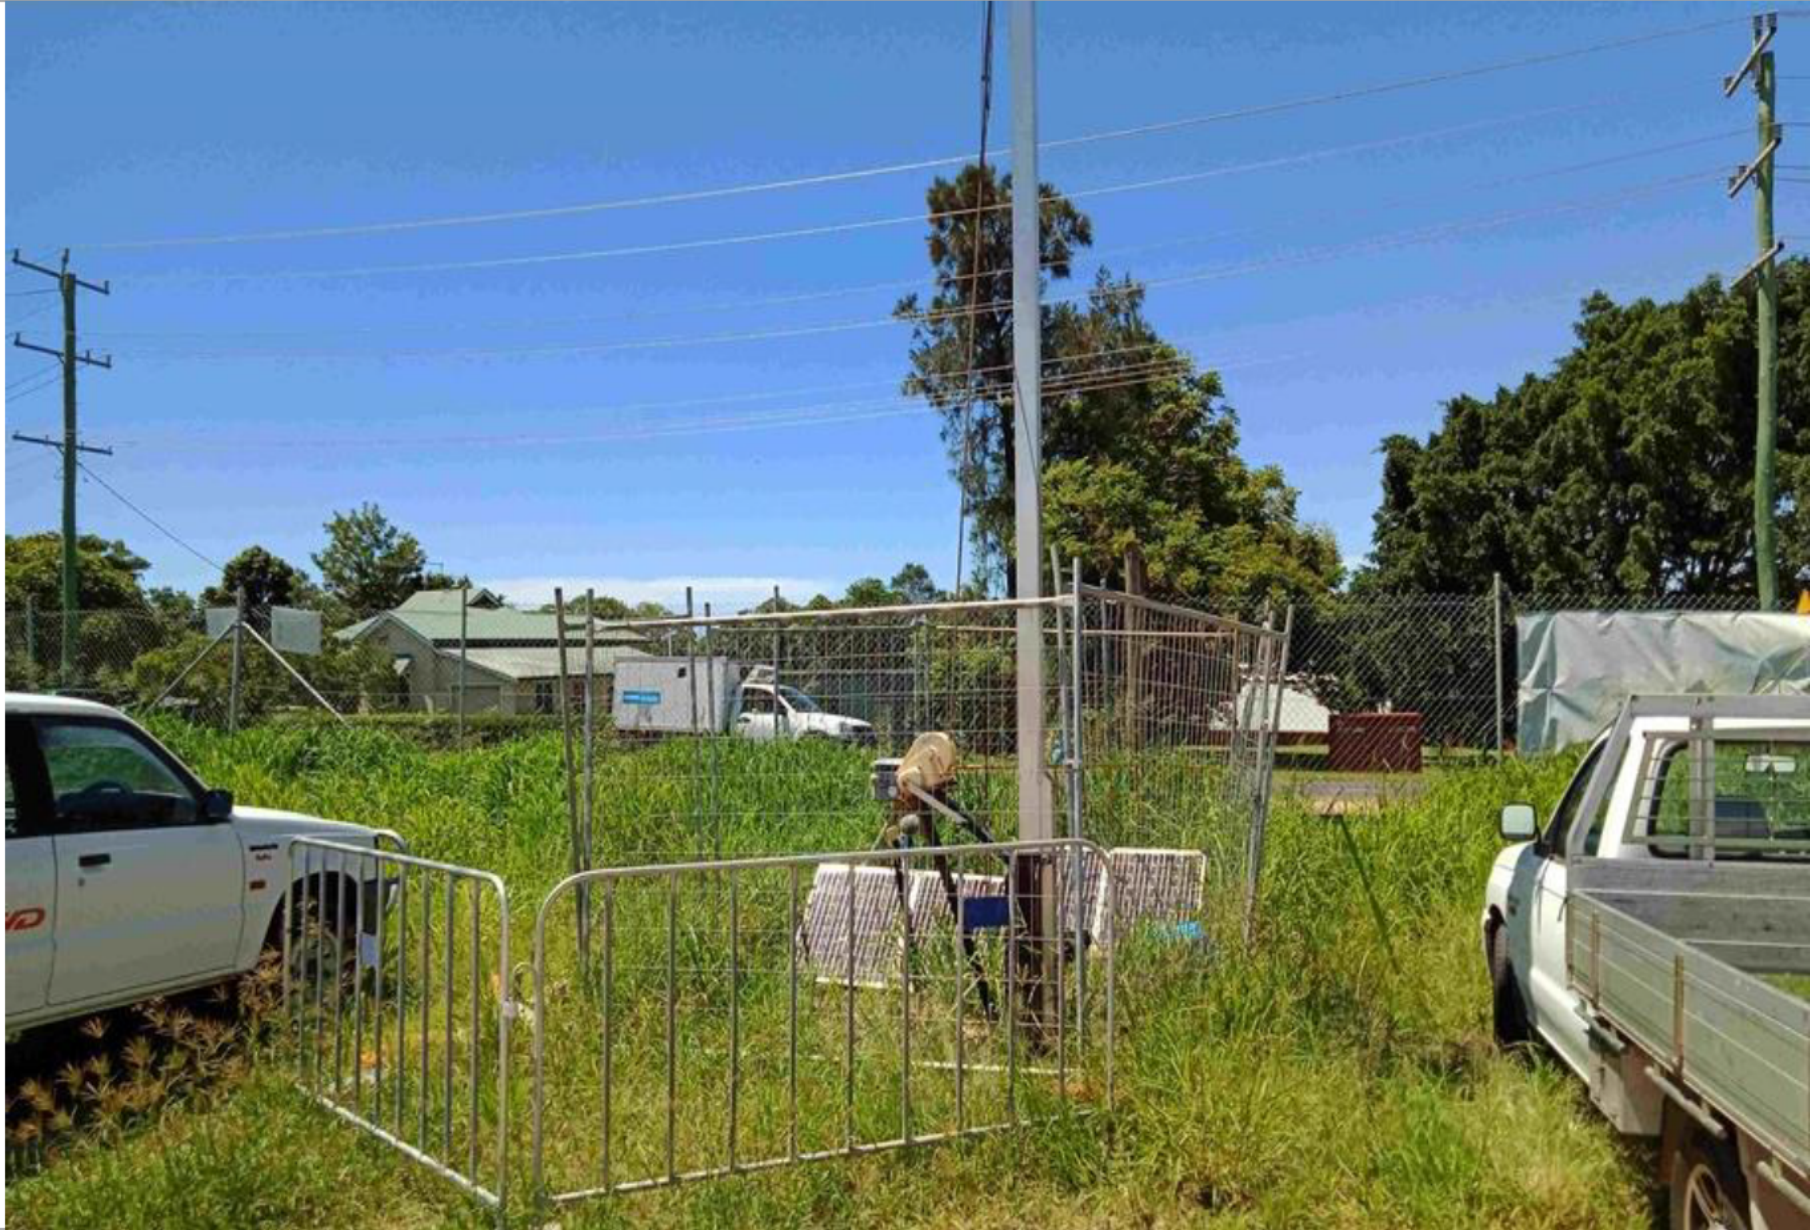
Photograph 2 Representative photograph of monitoring location 002 – Central location, as observed 22/02/2021

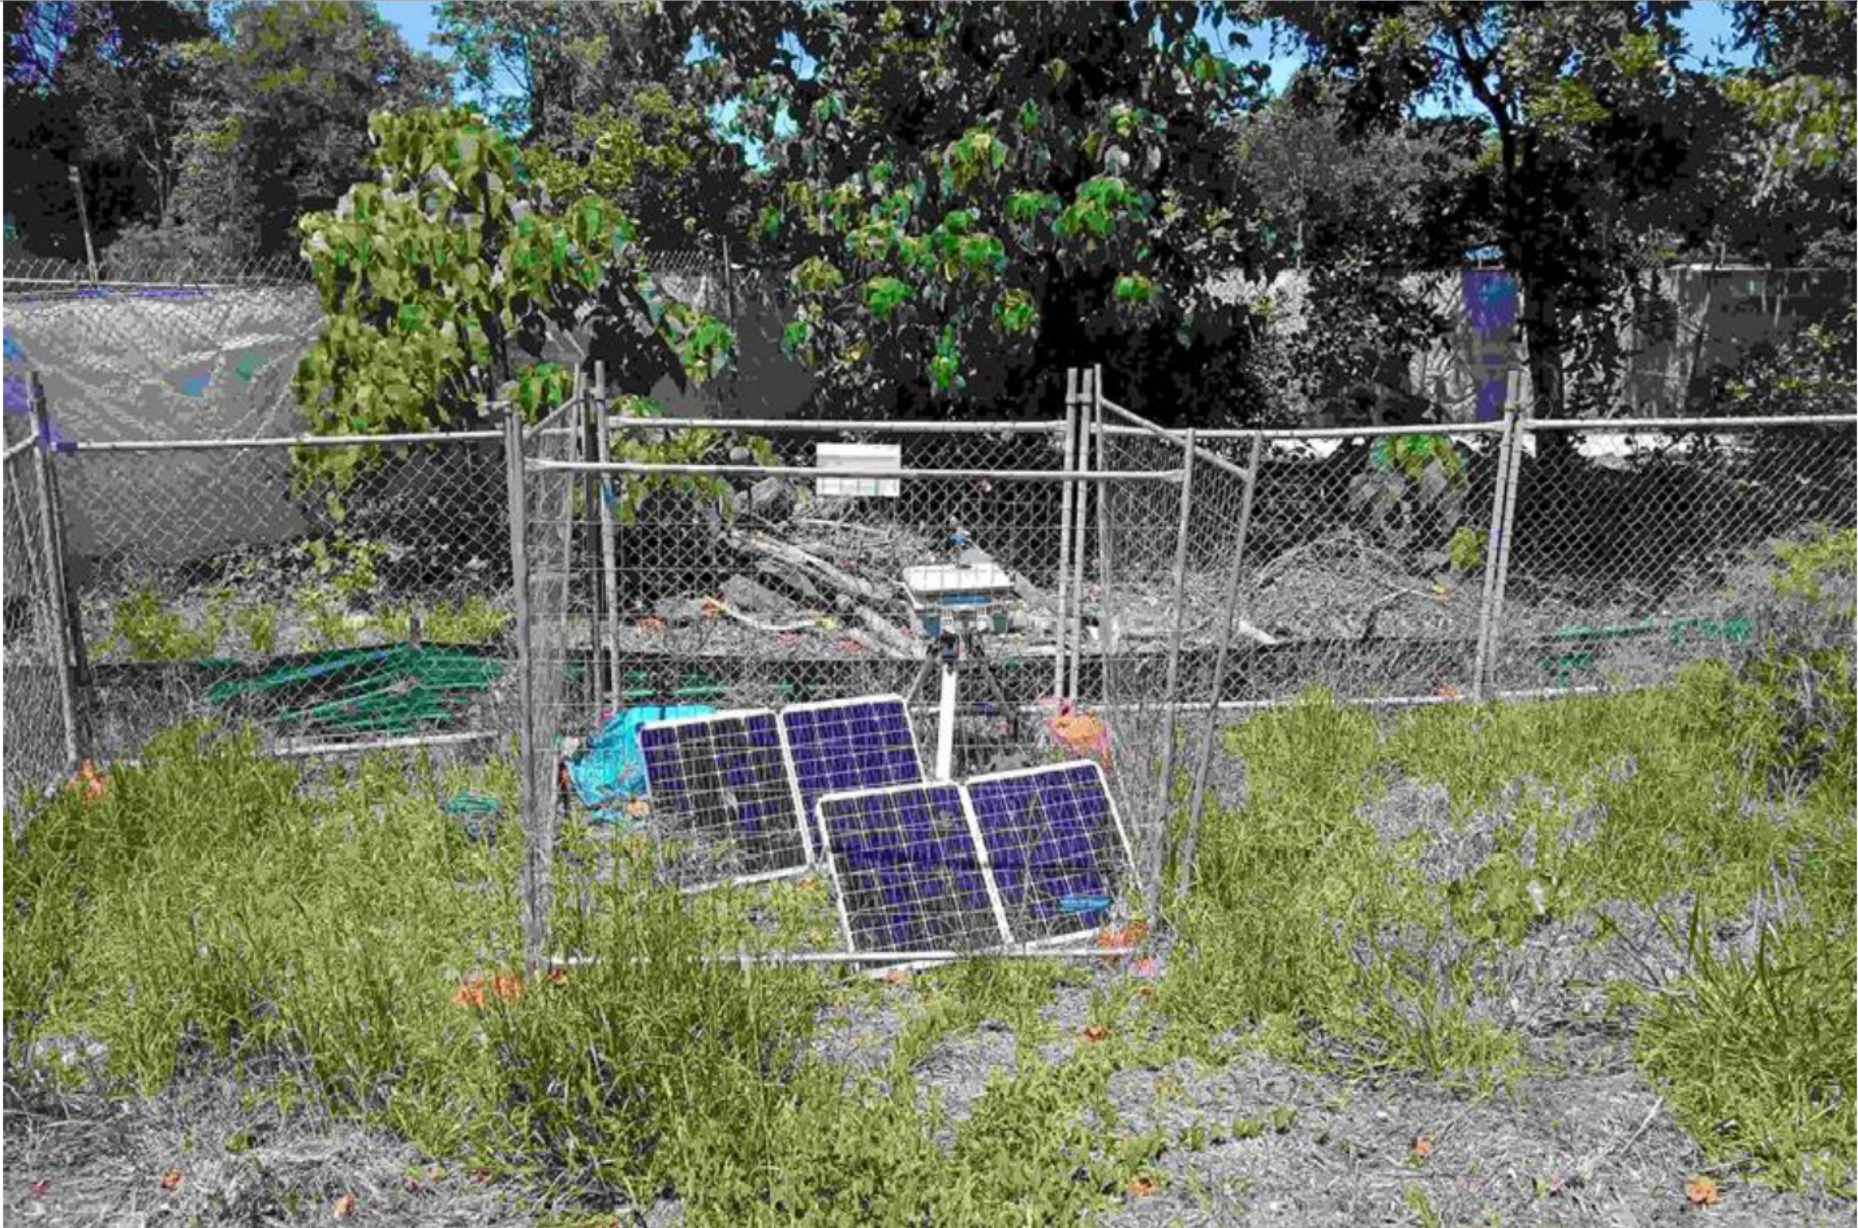
Photograph 3 Representative photograph of monitoring location 003 – Eastern Section of Site, as observed 22/02/2021

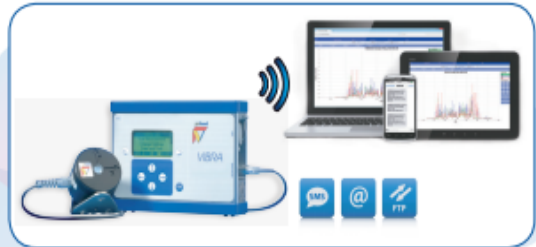
### Profound VIBRA-series

The VIBRA's robust aluminium housing is IP65 watertight. The system is easily portable, lightweight and battery-operated which allows for up to 4 weeks of continuous and unmanned operation.

Setting up the system on site is easy: attach the 3-dimensional sensor to the structure to be monitored, switch on the system and start measuring. While measuring the VIBRA displays date, time, time interval and the current peak vibration values including frequency in all 3 directions. In advance an alarm level can be set.
