Vibration Monitoring Assessment Report

771 Cudgen Road, Cudgen NSW

Prepared for: Lendlease Building Pty Ltd

Job Number: A101021.0286.00 VIB43.Rev0 | Date: 23/03/2023

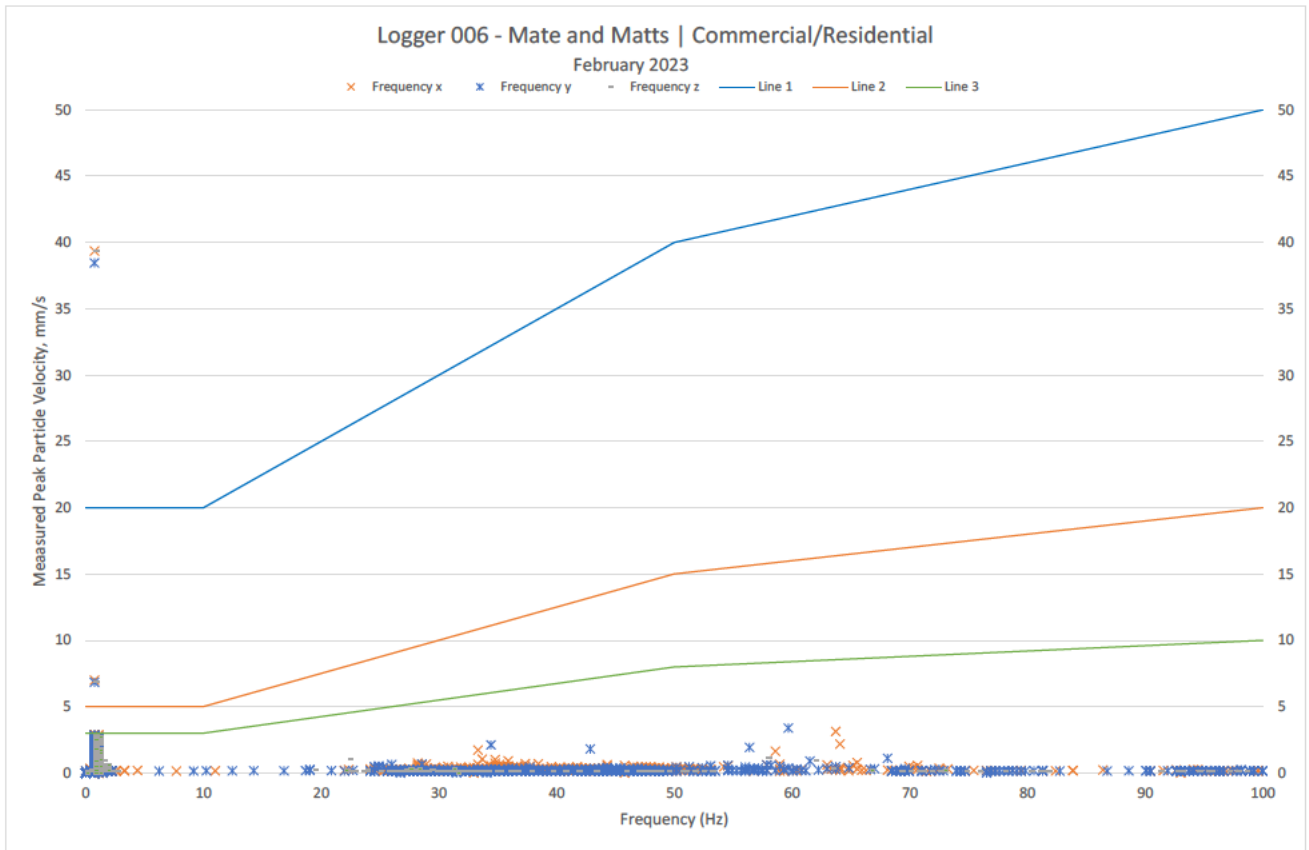
Figure 4 below illustrates the frequency for each axis over the velocity of each axis for Logger L.006. The data shows that high frequency over low velocity is indicative of extraneous data captured at the site, and likely not of site origin.

In regards to cosmetic damage or structural concerns, no impact to any of the structures near to this location is anticipated as frequency thresholds are lower than the limitations outlined in both the British and German Standards.

Figure 4 Frequency over Velocity (Logger 006 – Residential/Commercial)

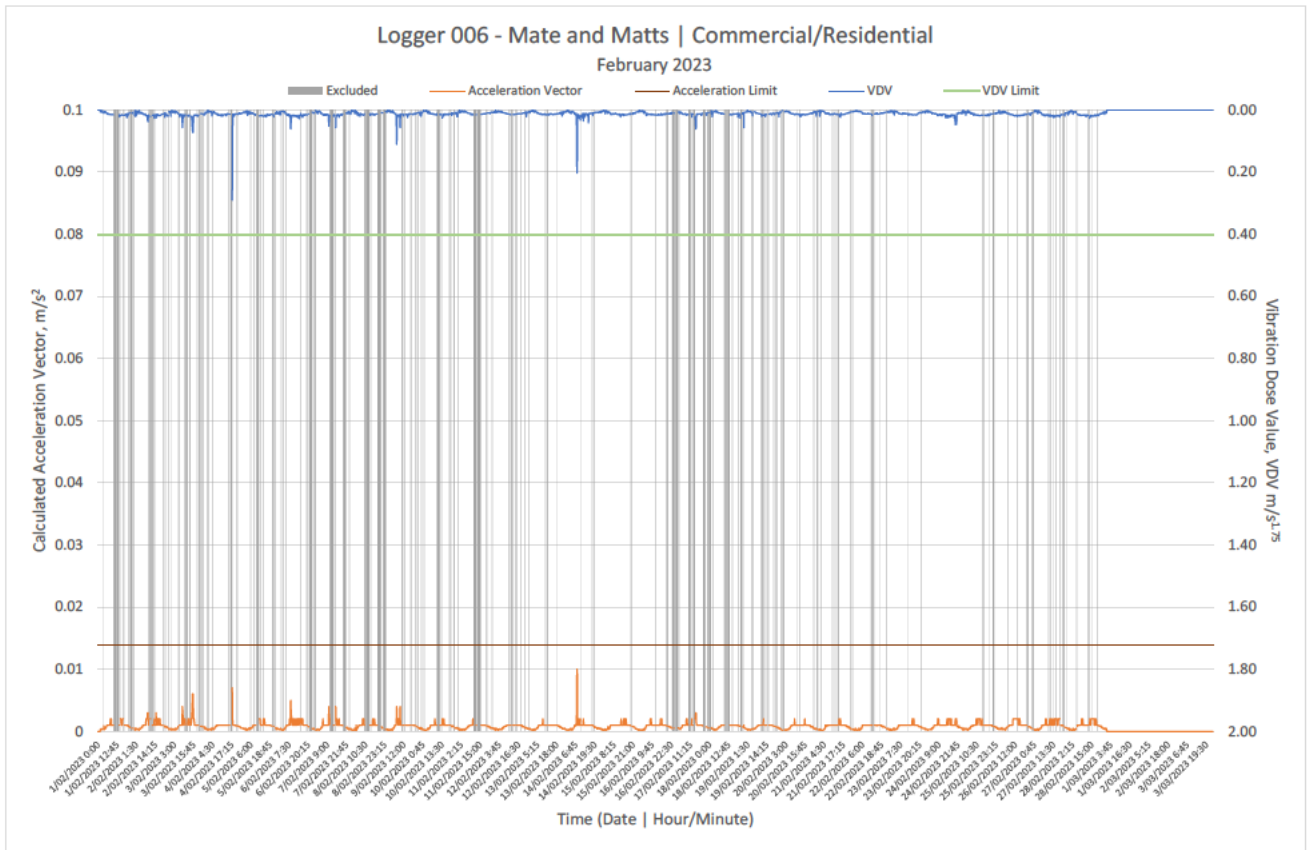
During the monitoring period at Location L.006, two (2) days measured dosages exceeding the recommended levels of $\leq 0.4 \text{ m/s}^{1.75}$ and seven (7) night-time periods where the night-time recommended levels of $\leq 0.26 \text{ m/s}^{1.75}$ were exceeded. The maximum measured VDV for the daytime period was $0.8 \text{ m/s}^{1.75}$ and the maximum measured VDV for the night-time period was $0.6 \text{ m/s}^{1.75}$.

The vibration impact at the commercial and residential premises is presented below in Figure 8. Generally, the measured data which is considered extraneous in nature (including ADE influence) has been removed from the data analysis and the graph. The occupants at this location are less likely to have experienced any increase of perceptible vibration during the days where heavy plant equipment were in use, and the likelihood of adverse comment is not considered probable during these activities at this location during February.

Figure 8 Acceleration and Vibration Dose Value over time (Logger 006 – Residential/Commercial)

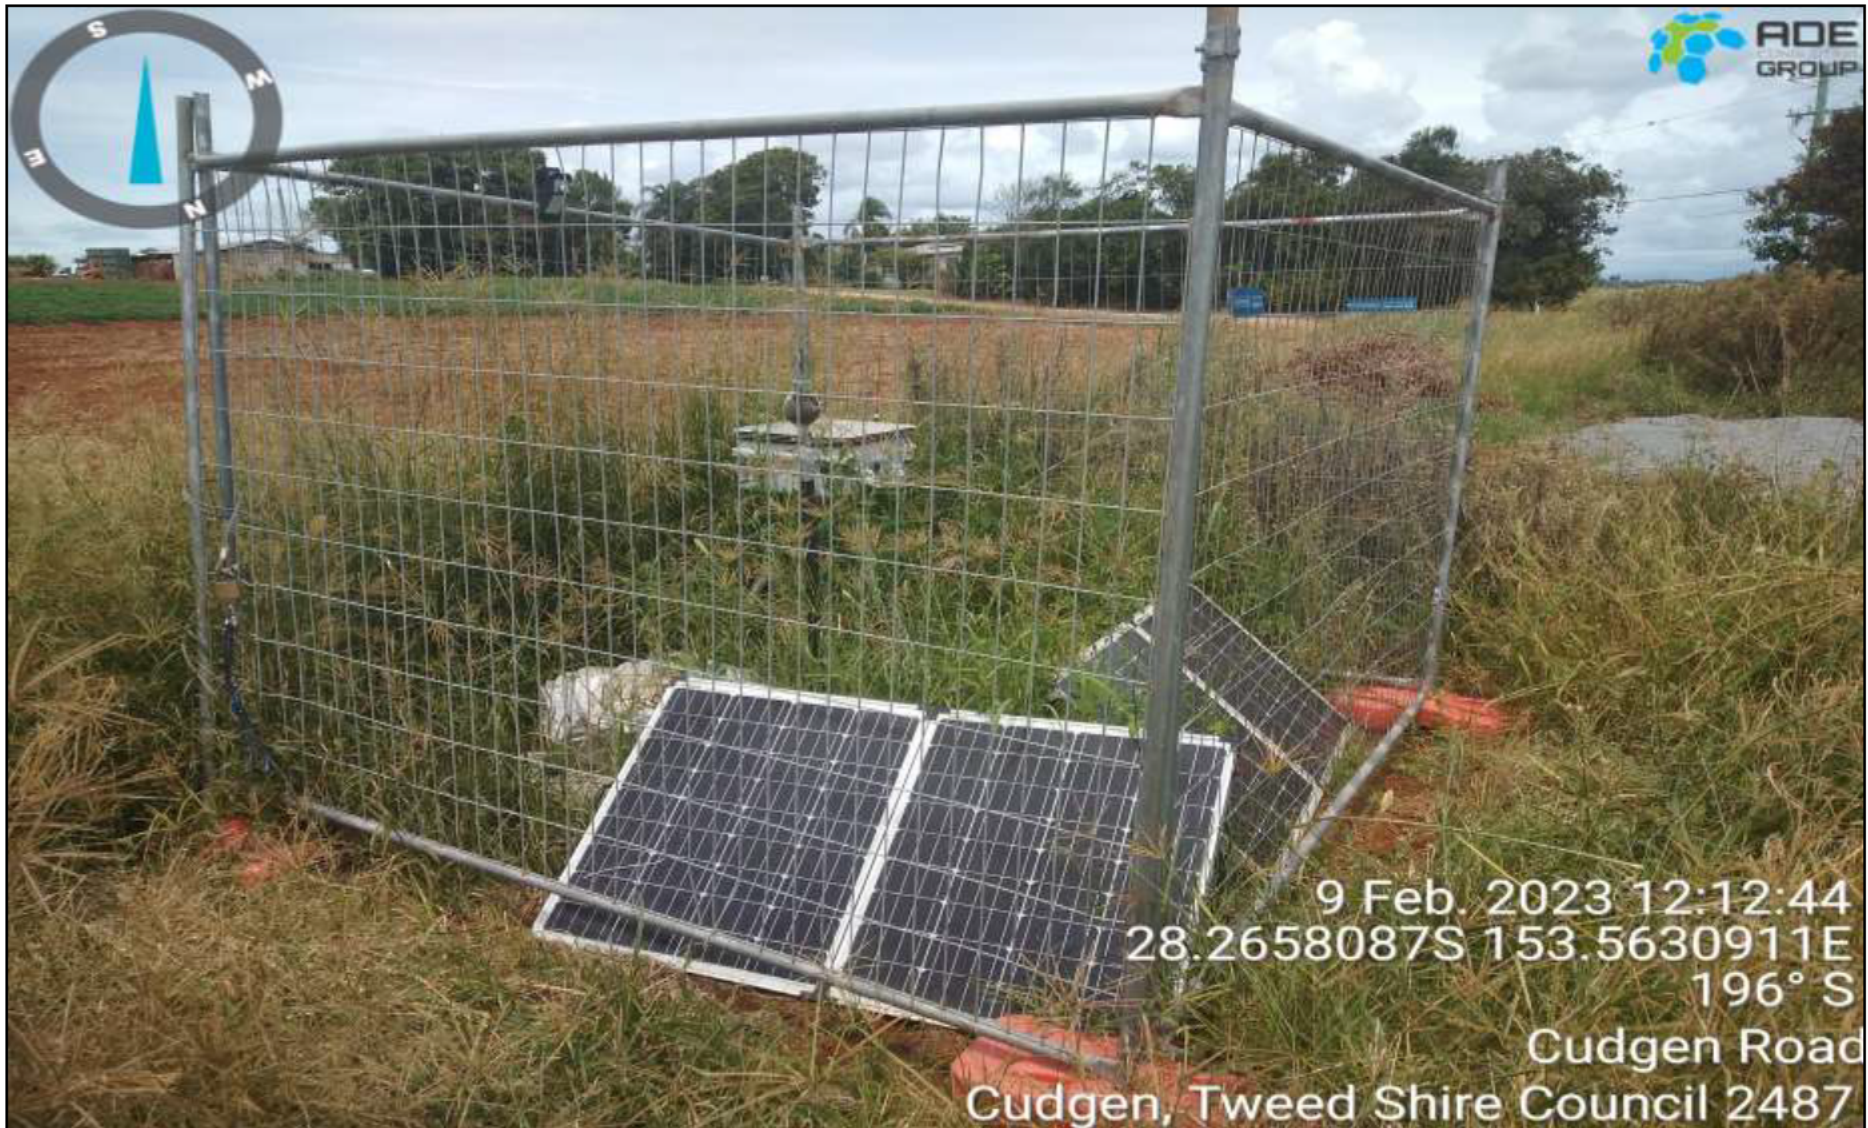
Photograph 1 Representative photograph of monitoring location 007 – Residential, as observed 09/02/2023

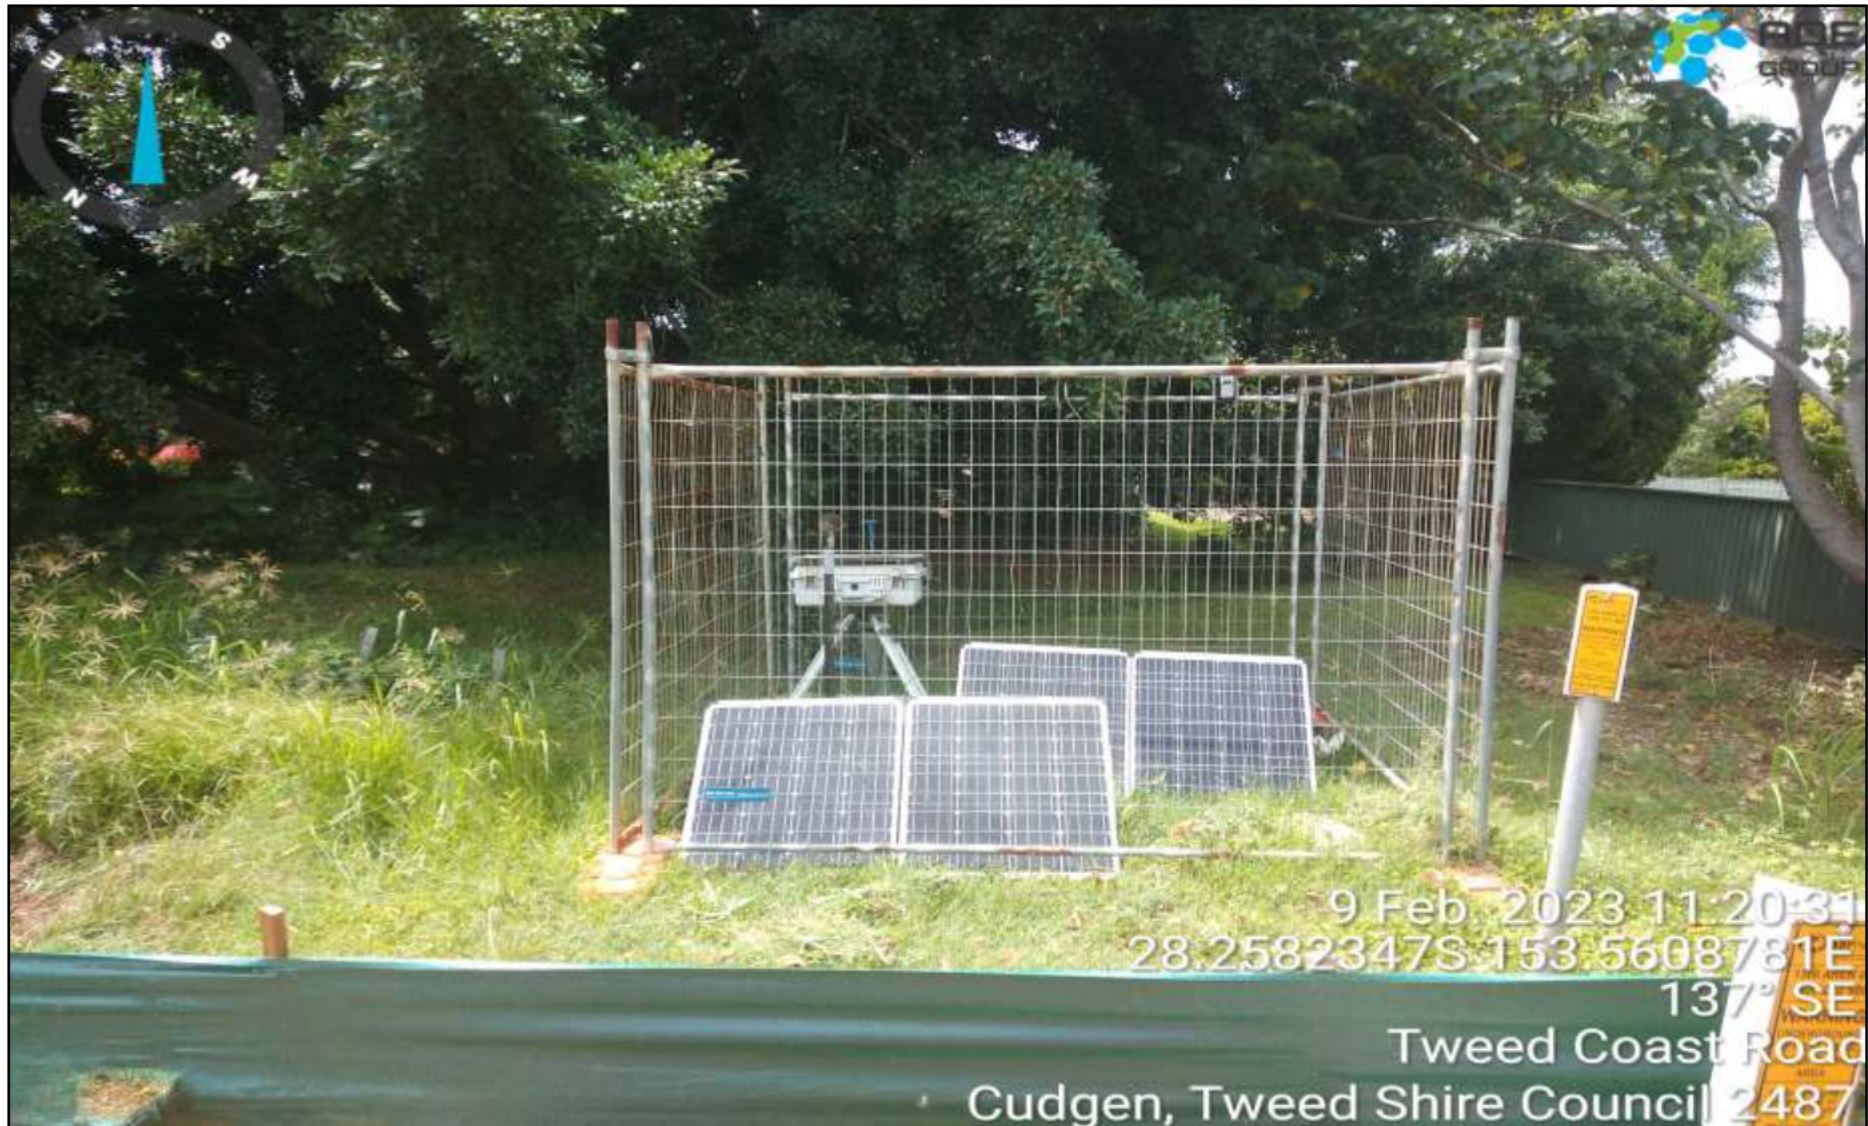
Photograph 2 Representative photograph of monitoring location 005 – Solar Industry, as observed 09/02/2023

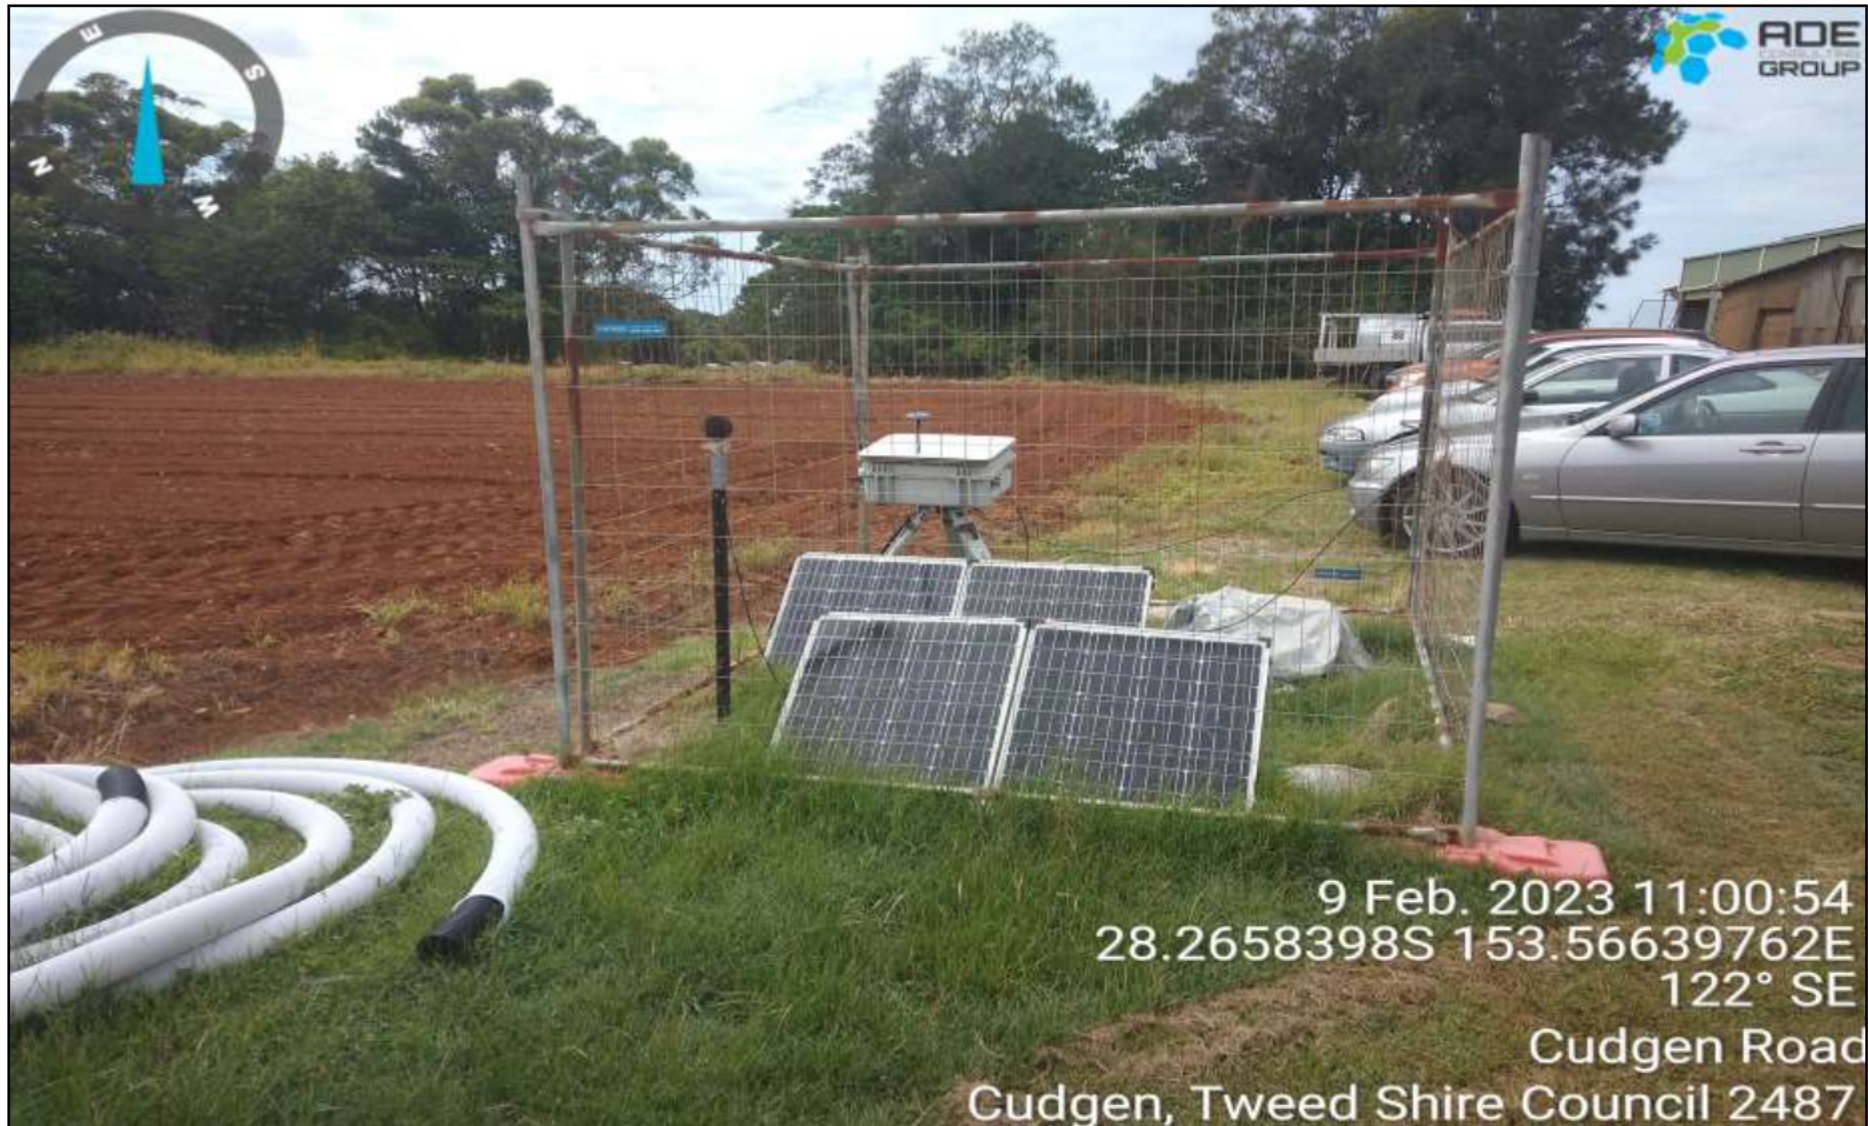
Photograph 3 Representative photograph of monitoring location 006 – Mate and Matts, as observed 09/02/2023
