# Vibration Monitoring Assessment Report (October 2022)

**Tweed Valley Hospital Project, Cudgen NSW**

A101021.0286.00 | VIB39.Rev0 | Date: 30/11/2022

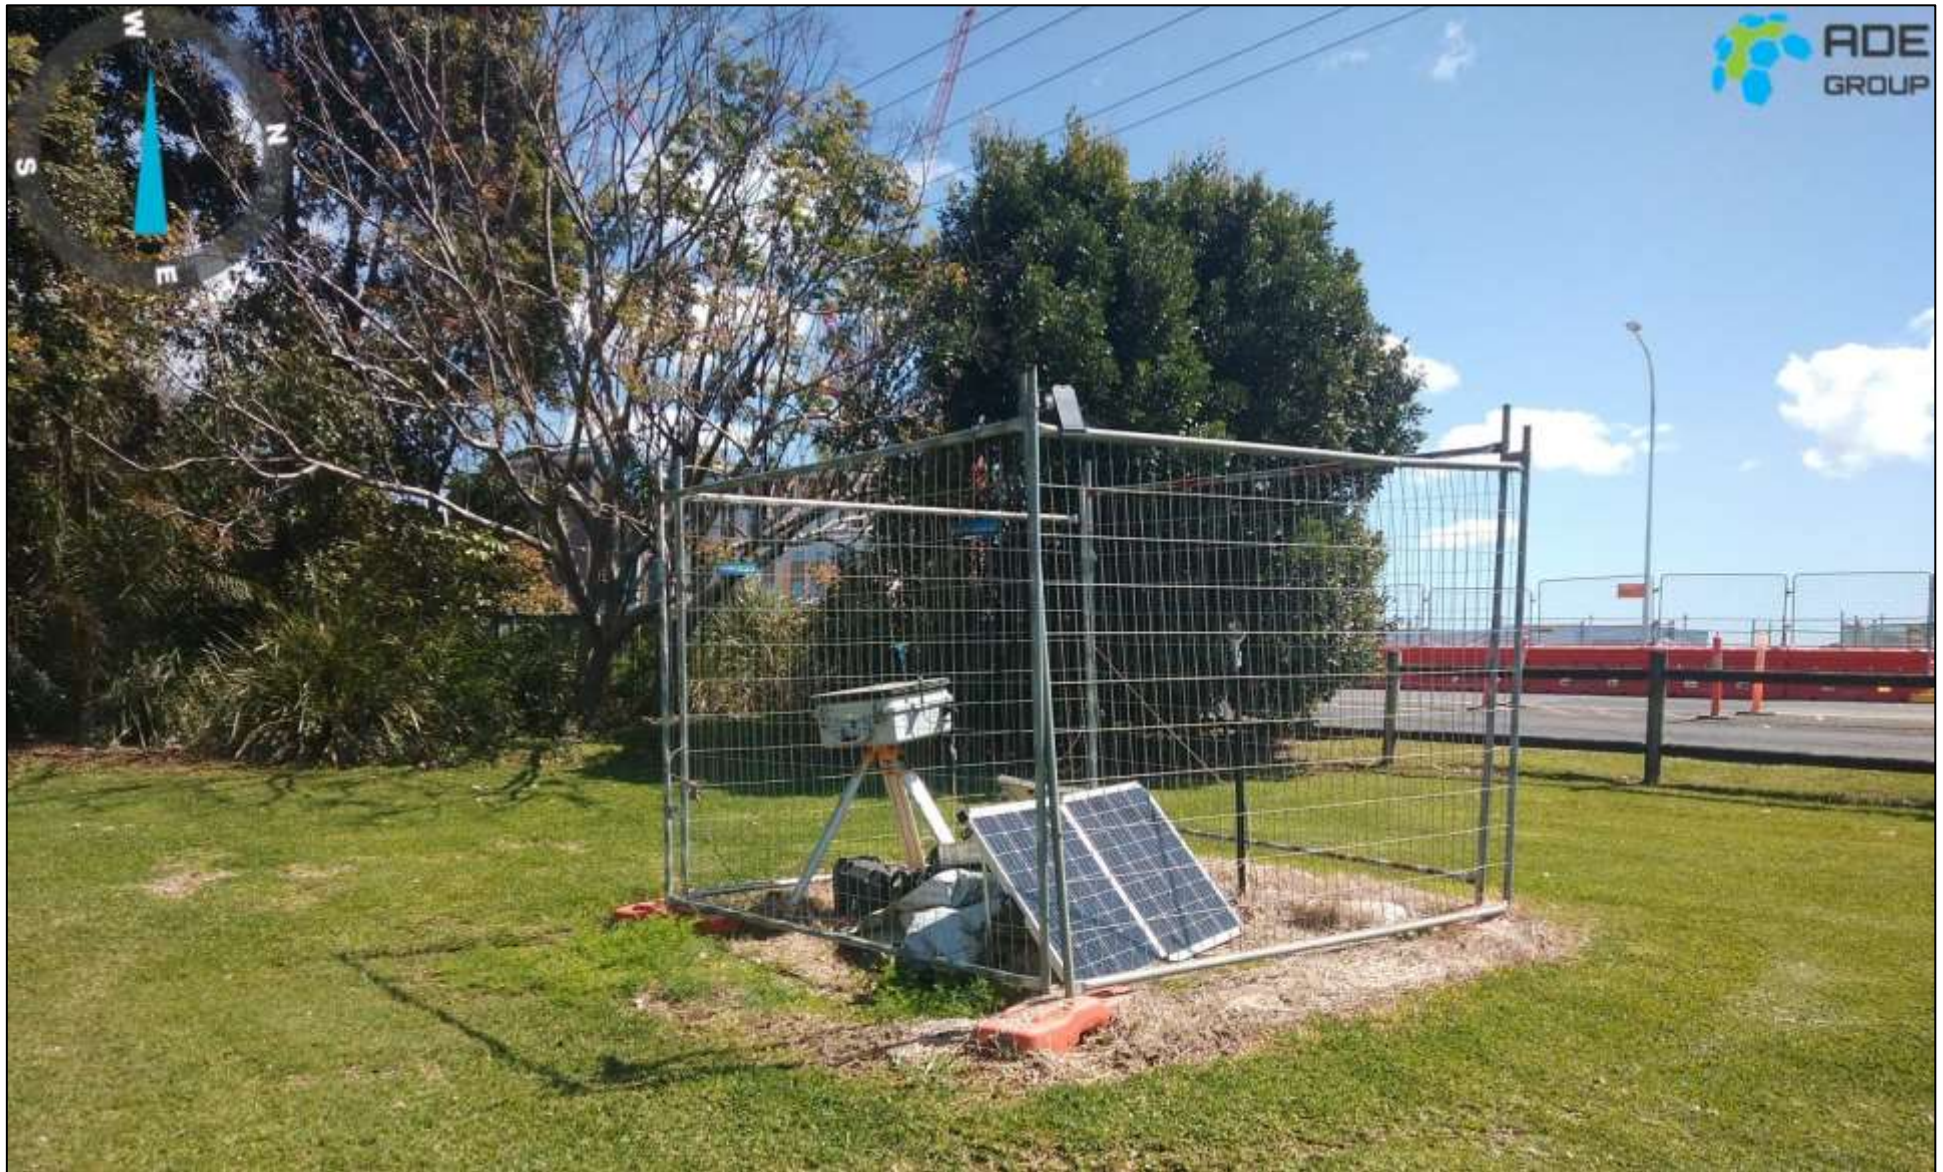
Photograph 1 Representative photograph of monitoring location 004 – TAFE East, as observed 12/10/2022

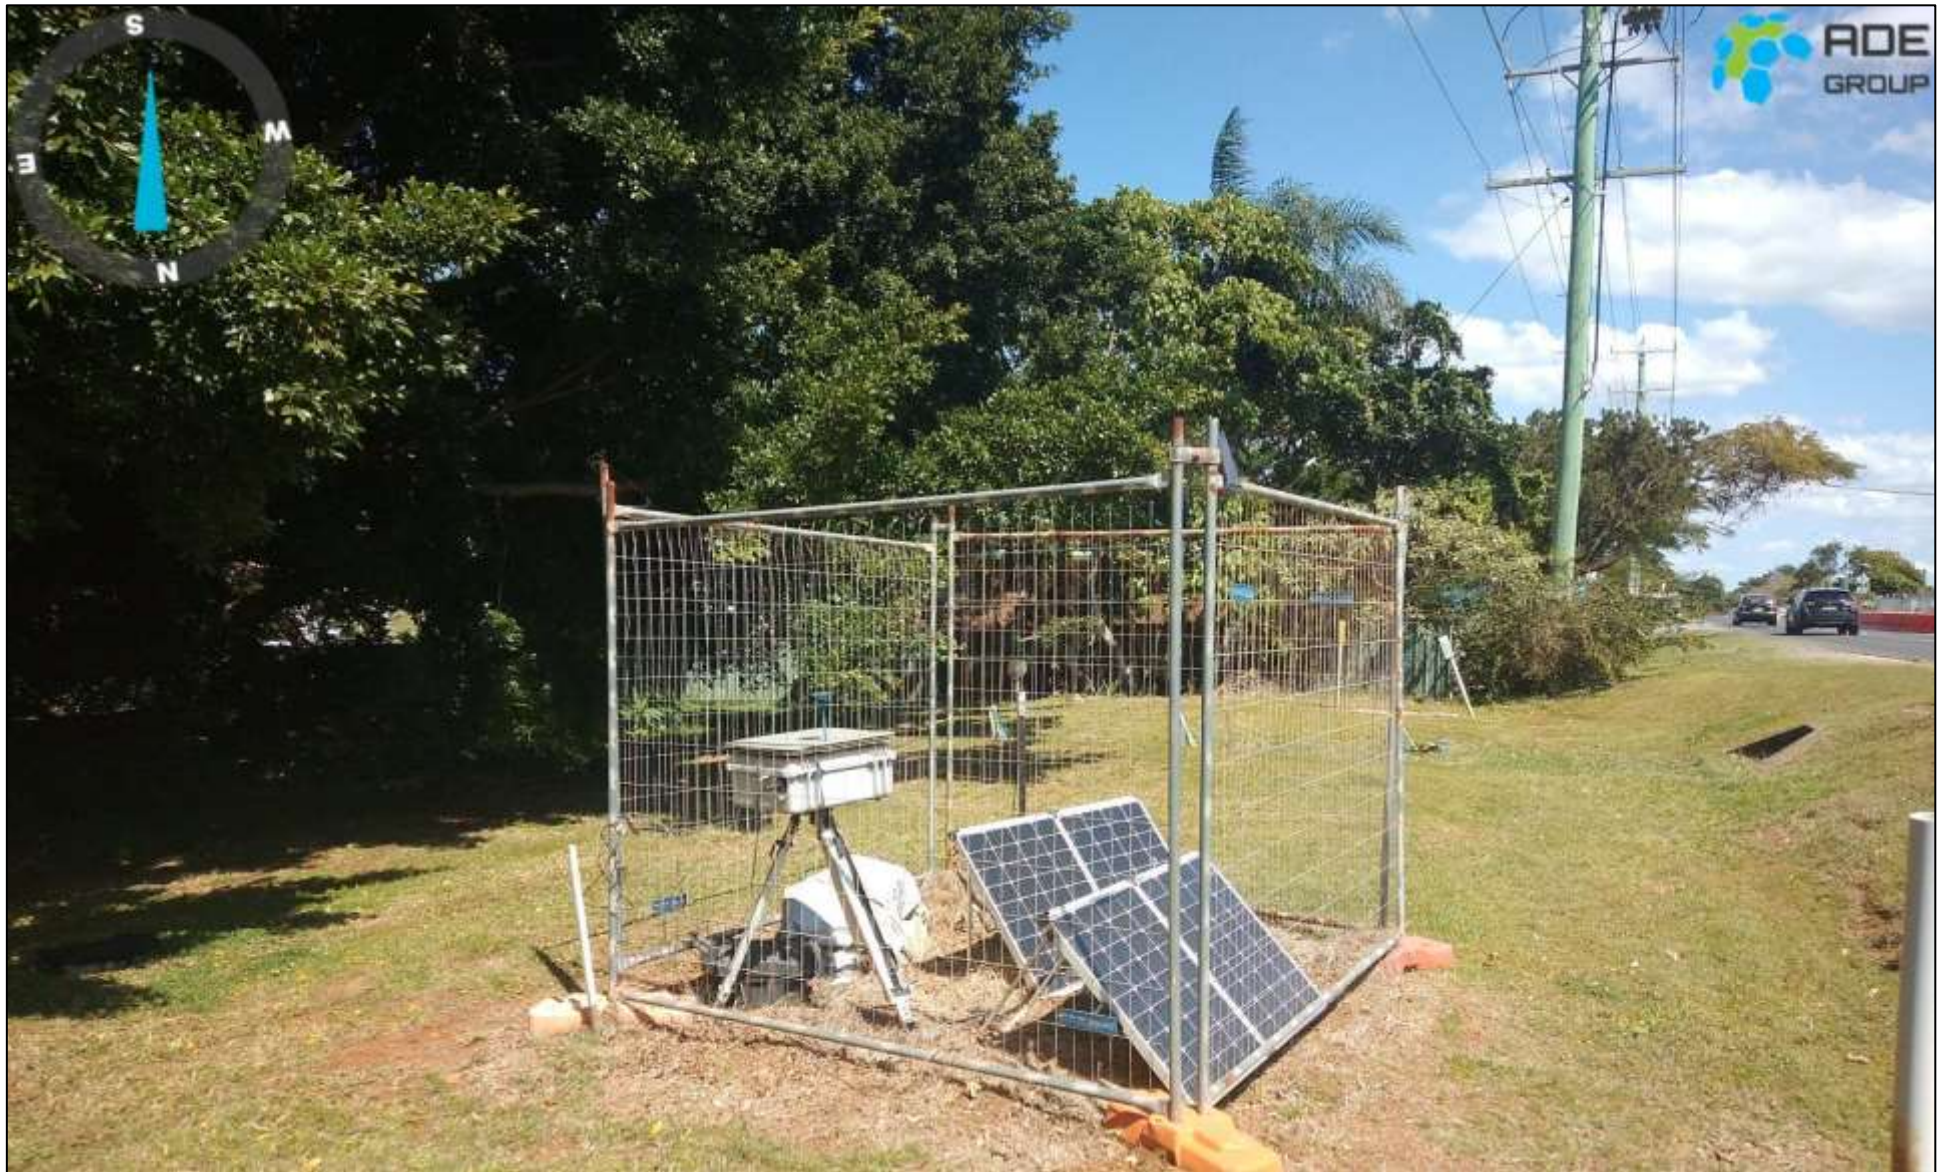
Photograph 2 Representative photograph of monitoring location 005 – TAFE West, as observed 12/10/2022

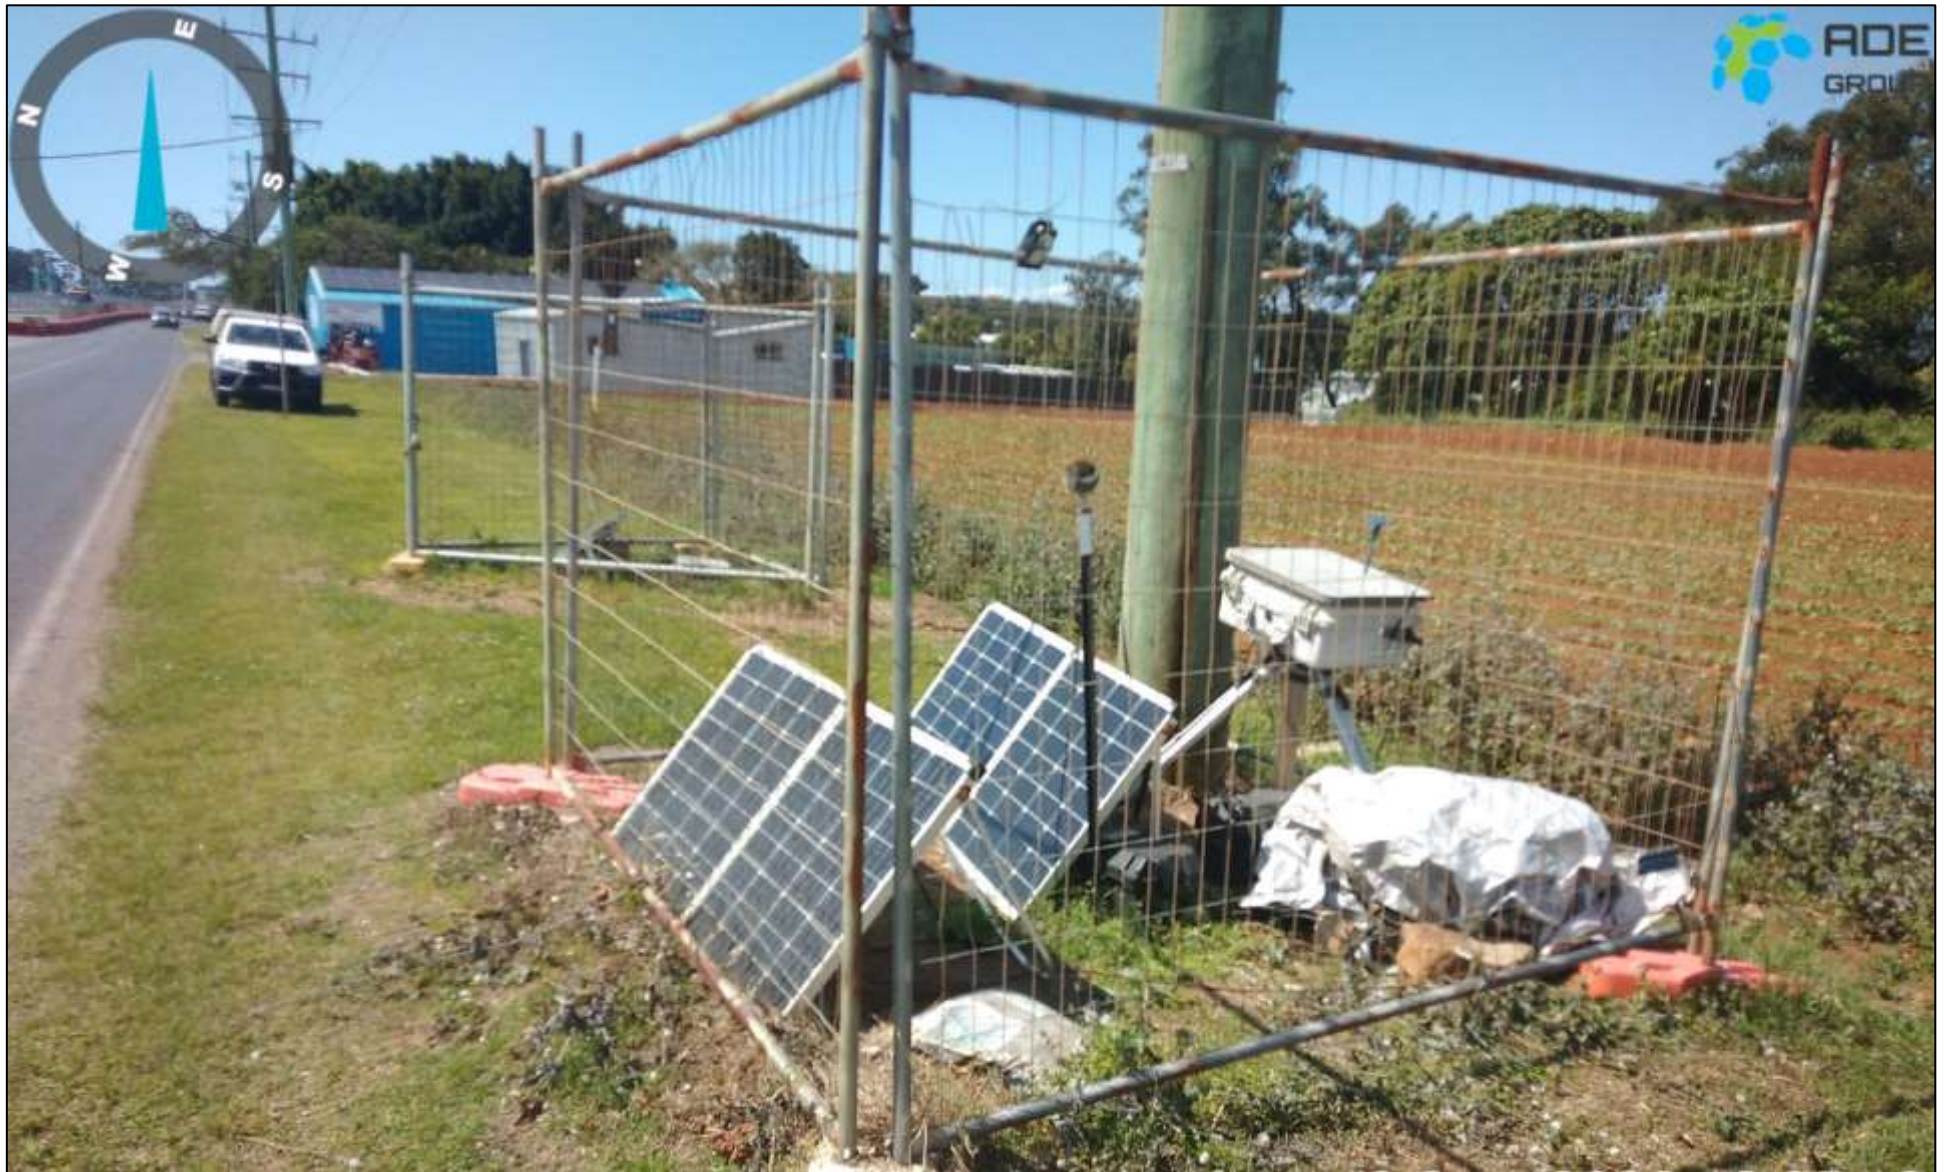
Photograph 3 Representative photograph of monitoring location 006 – Mate and Matts, as observed 12/10/2022
